GRENFELL TOWER: PHASE 1 REPORT

Prof. José L. Torero CEng, RPEQ, FREng, FRSE, FTSE, FIFE, FSFPE, FICE, FCI

23rd May 2018

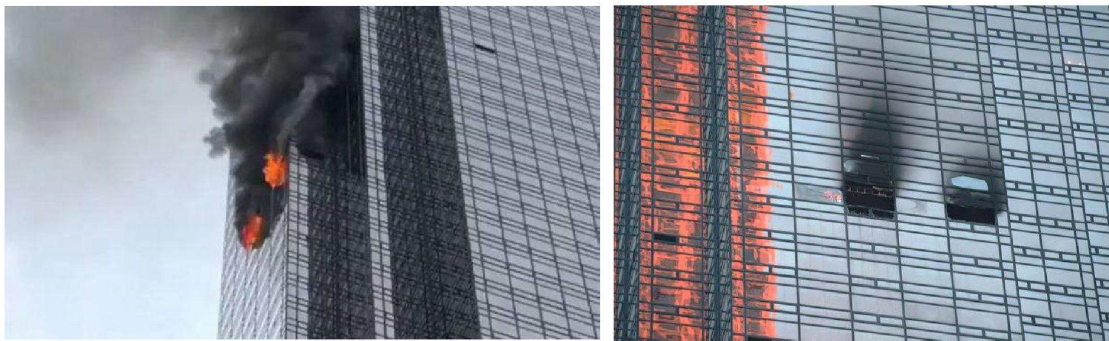
FIGURE 1: TRUMP TOWER FIRE, APRIL 8TH, 2018 (A) THE FIRE DURING BURNING SHOWING A FULLY DEVELOPED POST-FLASHOVER FIRE (B) THE AFTERMATH SHOWING THE EXTENT OF DAMAGE OF THE GLAZING.

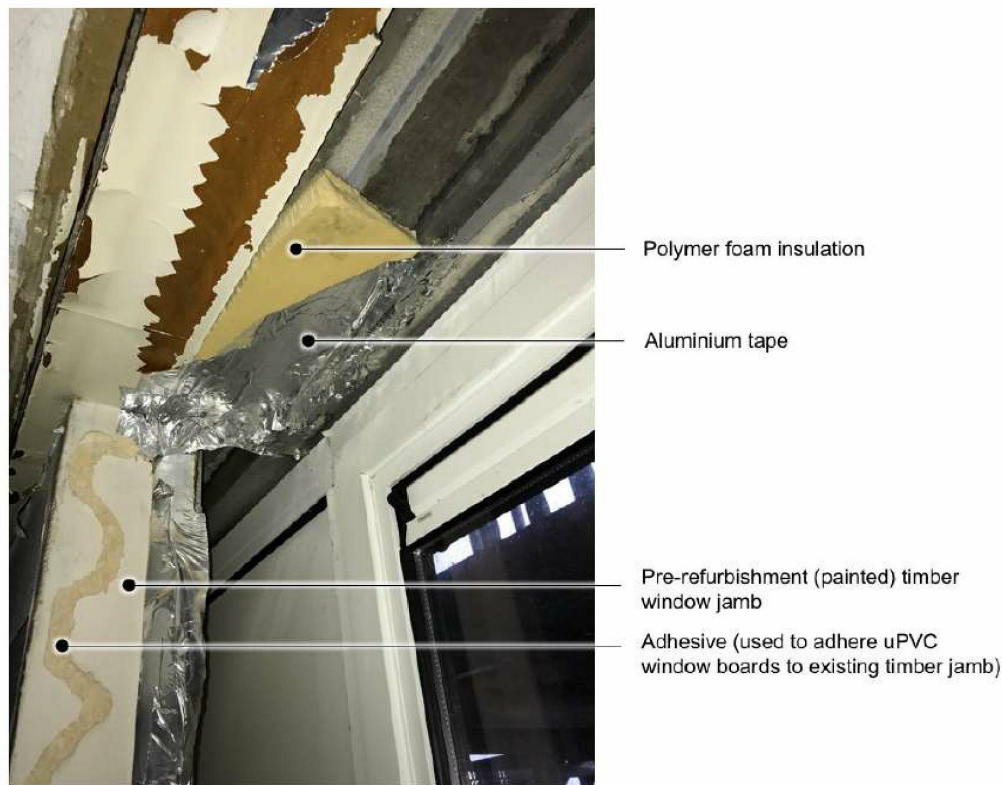
Figure 55 Line of adhesive used to bond uPVC refurbishment window jamb boards to the pre-existing painted (in this case) timber window jamb board. Considerable use of aluminium tape within refurbishment window frame construction [My photo, Flat 13, 09/01/2018].

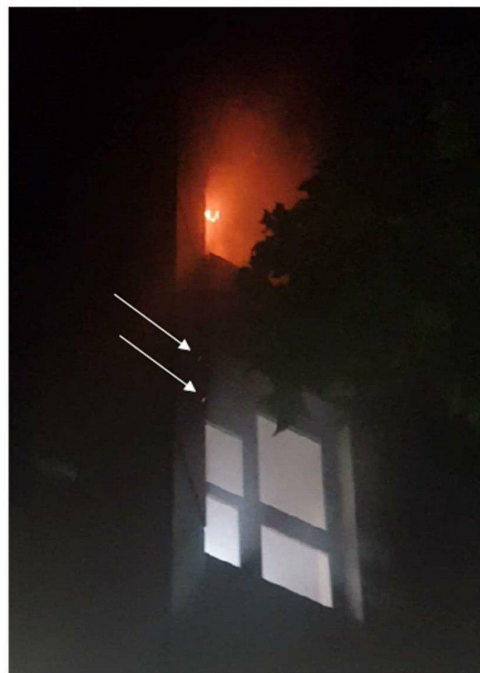
Figure 20: Screen shot taken from the video recovered from Mr KEBEDE's mobile phone [A14] at time stamp 01:05:57. This shows some material falling from the building beneath the left hand side of the window (as viewed from outside).

FIGURE 18: FIRST EVIDENCE OF FLAMES EXITING THE COMPARTMENT OF ORIGIN [2].

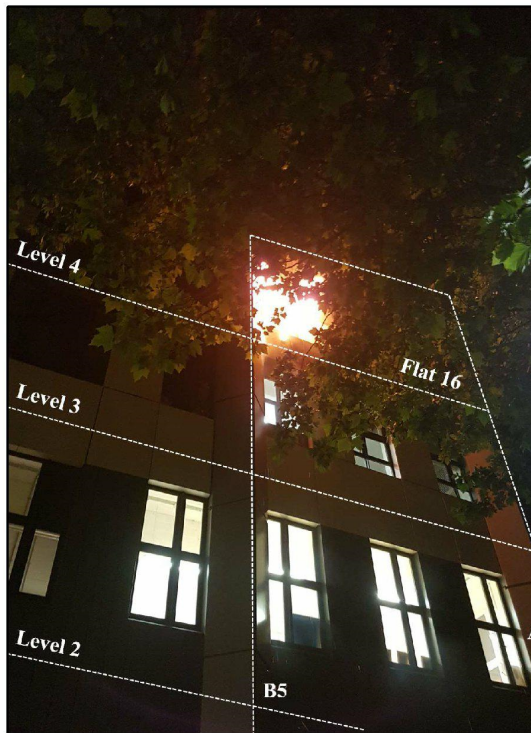
FIGURE 19: EARLIEST IMAGE OF EXTERNAL FIRE OBSERVED ON LEVEL 4, AT 01:14 ON 14 JUNE 2017 (MET00006589)

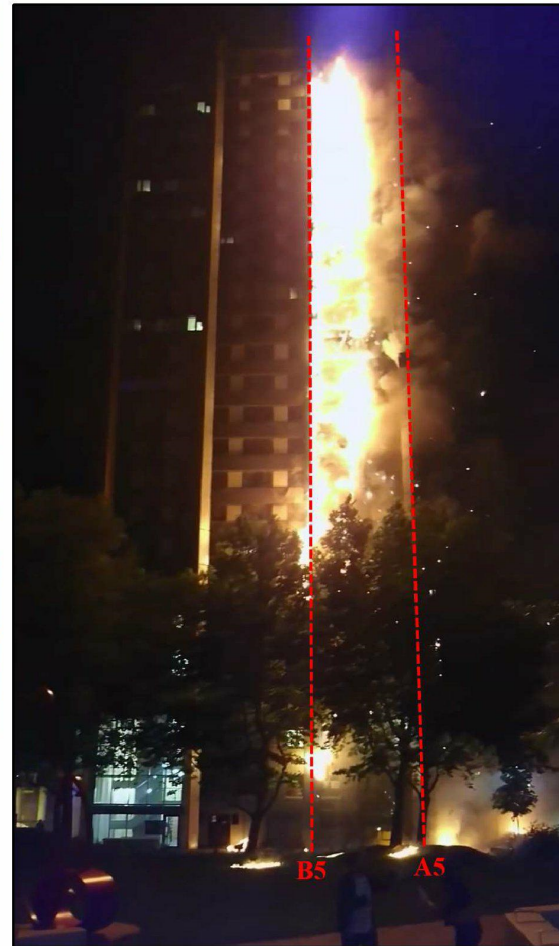
FIGURE 20: FIRE ON THE FULL HEIGHT EAST ELEVATION OF THE BUILDING ENVELOPE ON 14 JUNE 2017, ESTIMATED TIME 01:26 (COUNSEL TO CONFIRM TIME) ([HTTPS://WWW.YOUTUBE.COM/WATCH?V=6AYUZ5SNxZO](https://www.youtube.com/watch?v=6AYUZ5SNxZO))

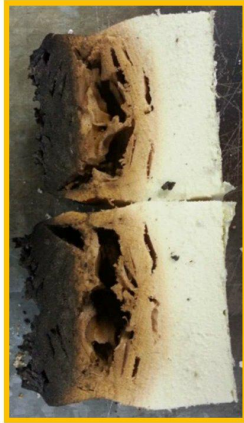
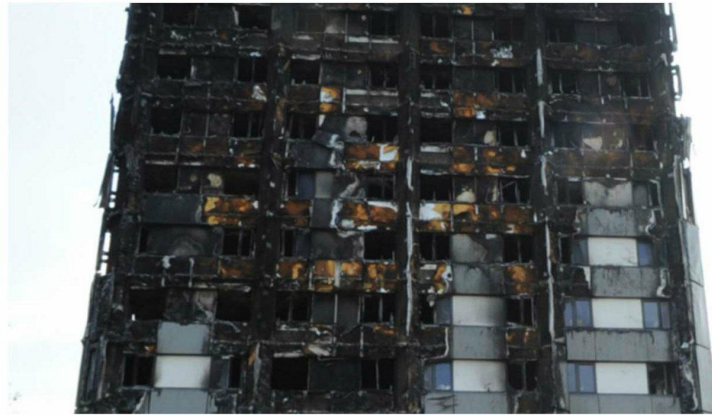
FIGURE 24: IMAGE OF THE GRENFELL TOWER AFTER THE FIRE SHOWING DIFFERENT LEVELS OF DAMAGE IN ONE SINGLE LOCATION. INFILL PHOTOGRAPH FROM HIDALGO ET AL [25] SHOWING THE DIFFERENT LEVELS OF DEGRADATION OF PIR.

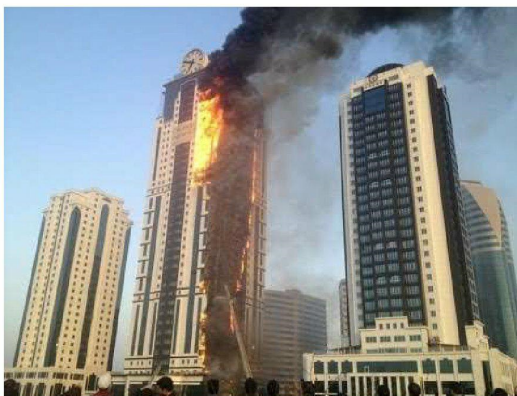
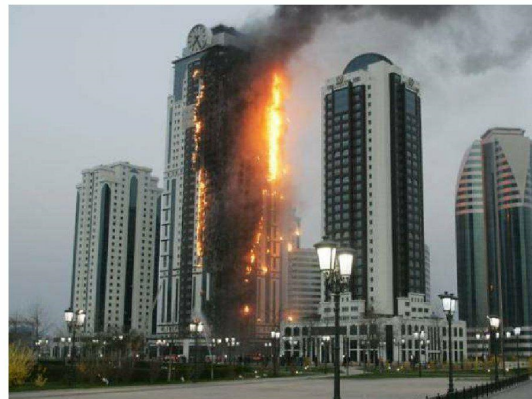
FIGURE 25: SULAFU TOWER (DUBAI) DURING THE FIRE. LATERAL PROPAGATION EXTENDED TO ALMOST HALF OF THE BUILDING.

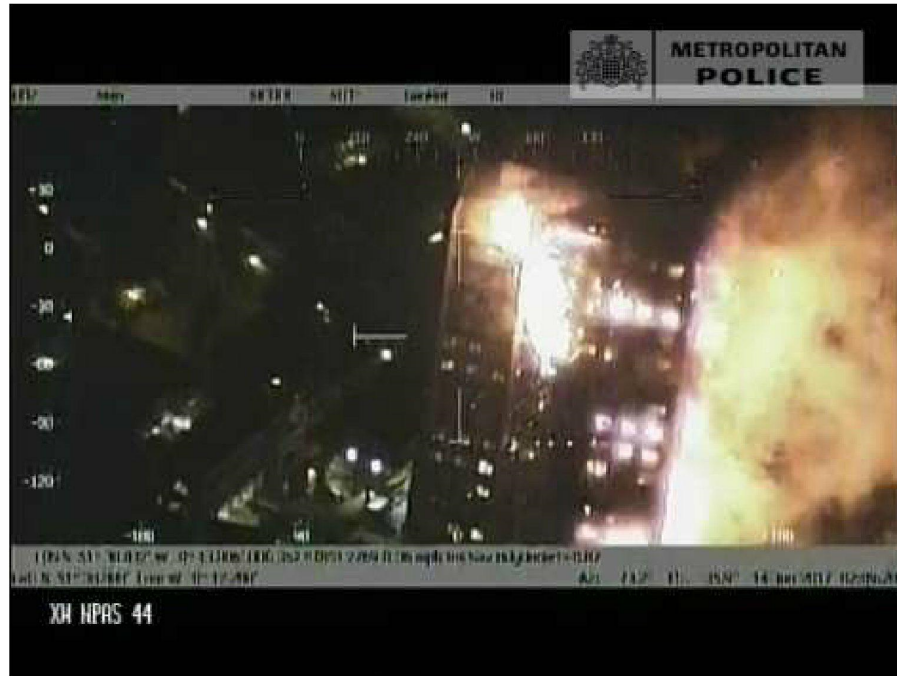
2024 **FIGURE 27: EAST FAÇADE - BURNING DEBRIS GATHERING ON LEDGES BELOW FIRE AT ~LEVEL 18 (FLAT 151, 2:09:20)**

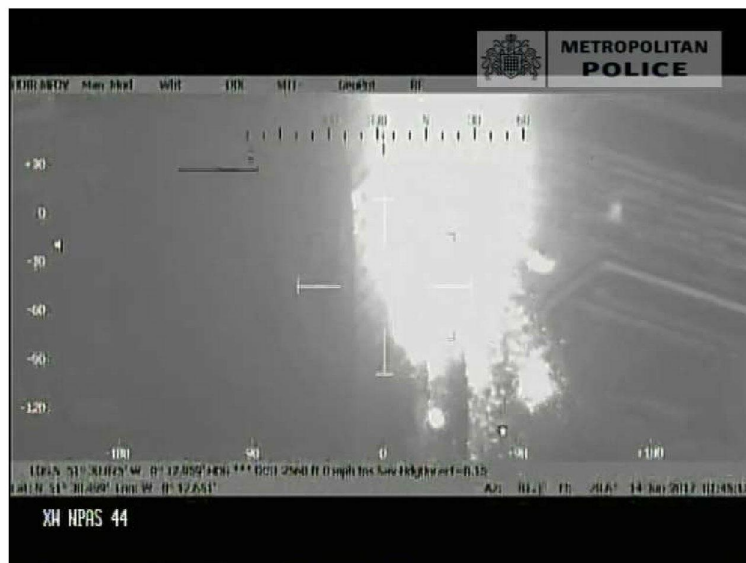
FIGURE 31: FIRE VISIBLE ON FAÇADE BELOW FIRE ON EAST ELEVATION

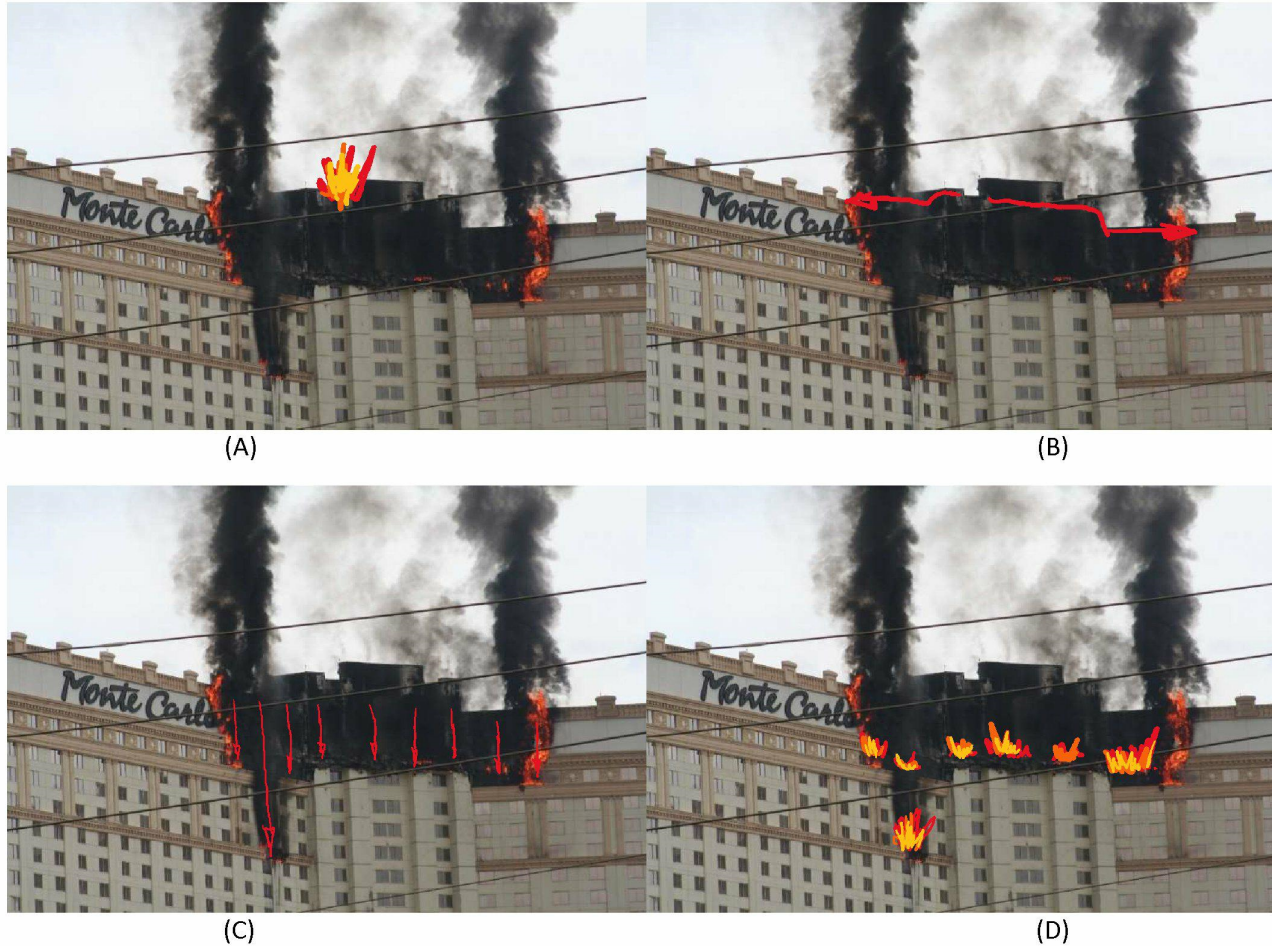
FIGURE 32: MONTE CARLO CASINO & HOTEL FIRE, LAS VEGAS, JANUARY 25TH, 2008. (A) SHOWS THE EXTERNAL FIRE SPREAD FROM THE INITIAL IGNITION AT THE ROOF LEVEL OF THE BUILDING. (B) THE FIRE SPREADS Laterally ACROSS THE PARAPET. (C) Molten burning material drips down the façade and builds up on lower level parapets. (D) Build-up of molten material ignites fresh fires which break in through windows and results in further compartment fires.

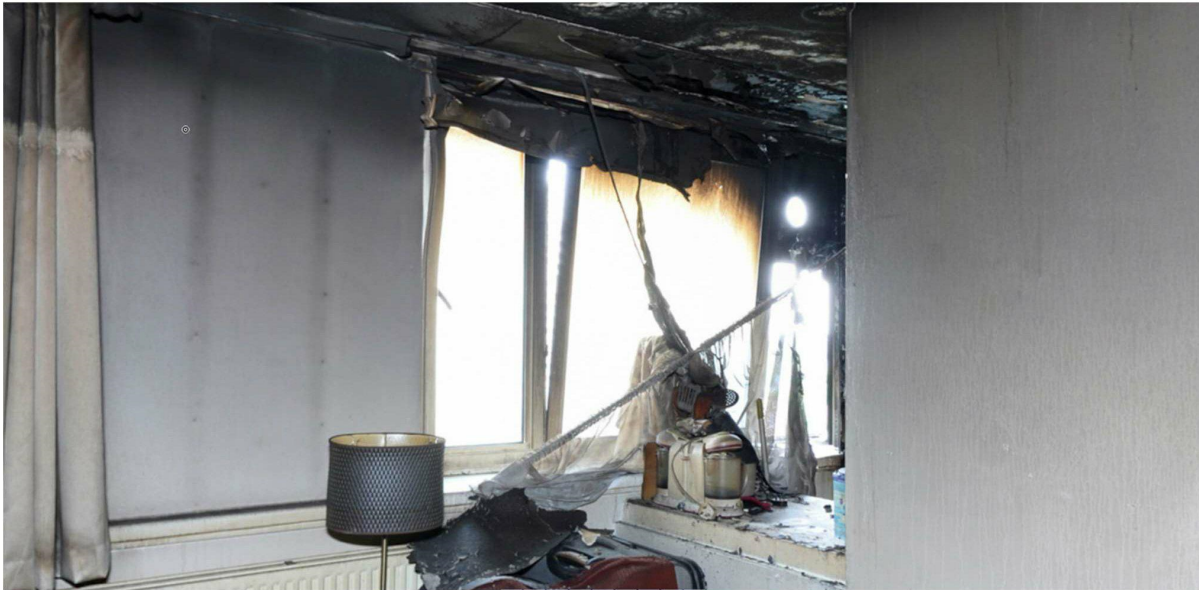
FIGURE 58: EXAMPLES OF MODERATE DAMAGE FROM FLAT 93, FLOOR 12.

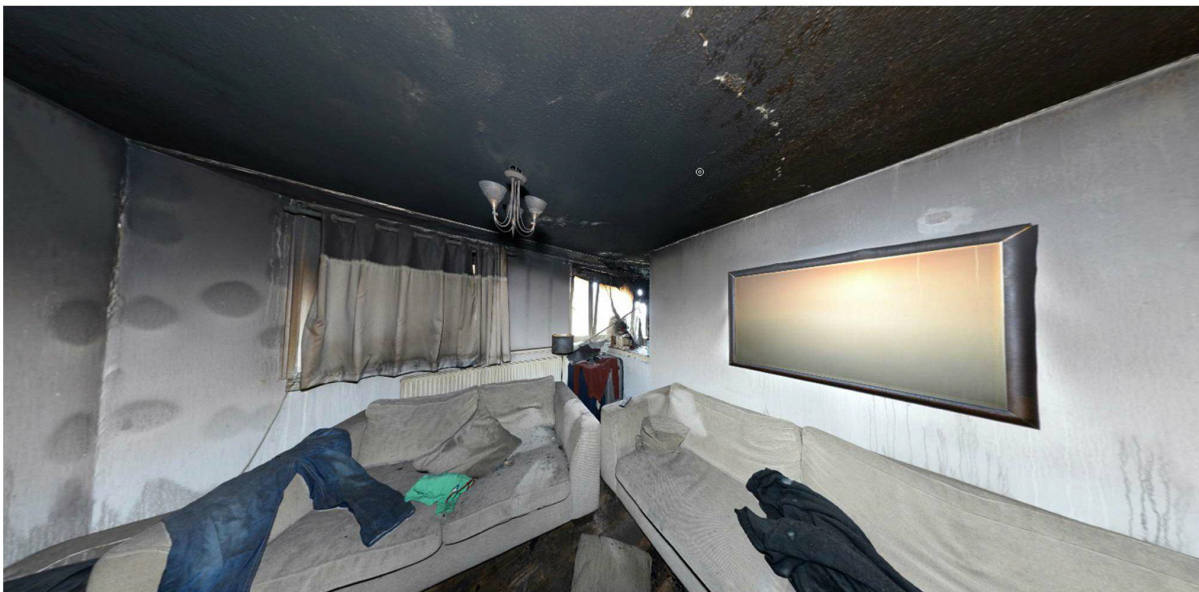
FIGURE 59: EXAMPLES OF MODERATE DAMAGE FROM FLAT 93, FLOOR 12.

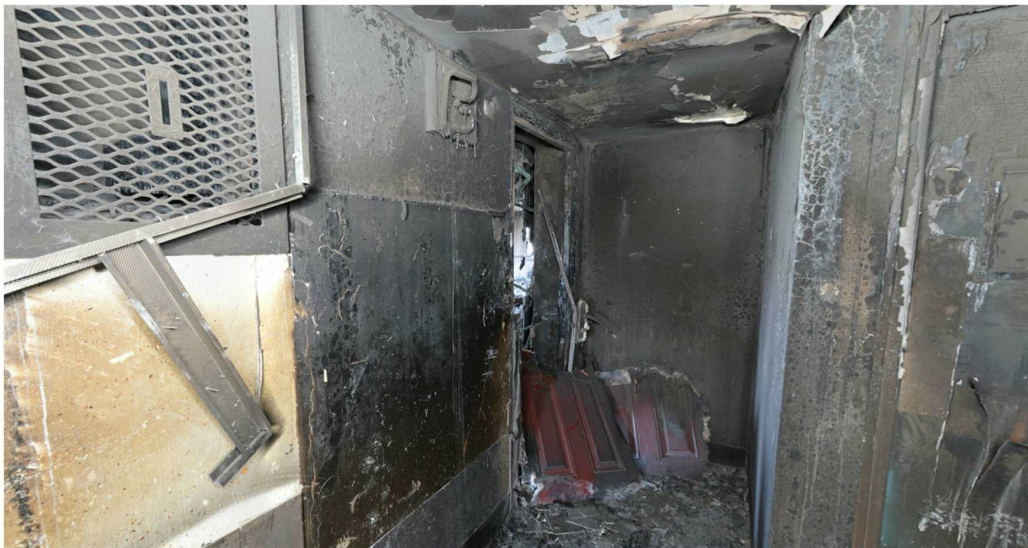
174 Inspection of all the doors shows that areas where there was major fire impact (i.e. evidence of high
175 temperatures and significant soot deposition) correlate well with areas where doors are either missing
176 or significantly damaged. Other potential paths for smoke and flames have been identified (e.g.
177 inadequate fire stopping material surrounding service penetrations, absent door seals, etc.)
178 nevertheless no significant compartmentalization deficiencies could be established in the post-event
179 inspections. While any deficiency could have contributed to the migration of smoke into the lobby, it
180 would have been highly unlikely that flames could have migrated into the lobby via these routes to
181 create conditions that could compromise the doors separating the lobby from the stairs.

FIGURE 70: FLAT 96 AS VIEWED FROM THE LEVEL 12 LOBBY, WITH BROKEN FRONT DOOR VISIBLE IN DOORWAY

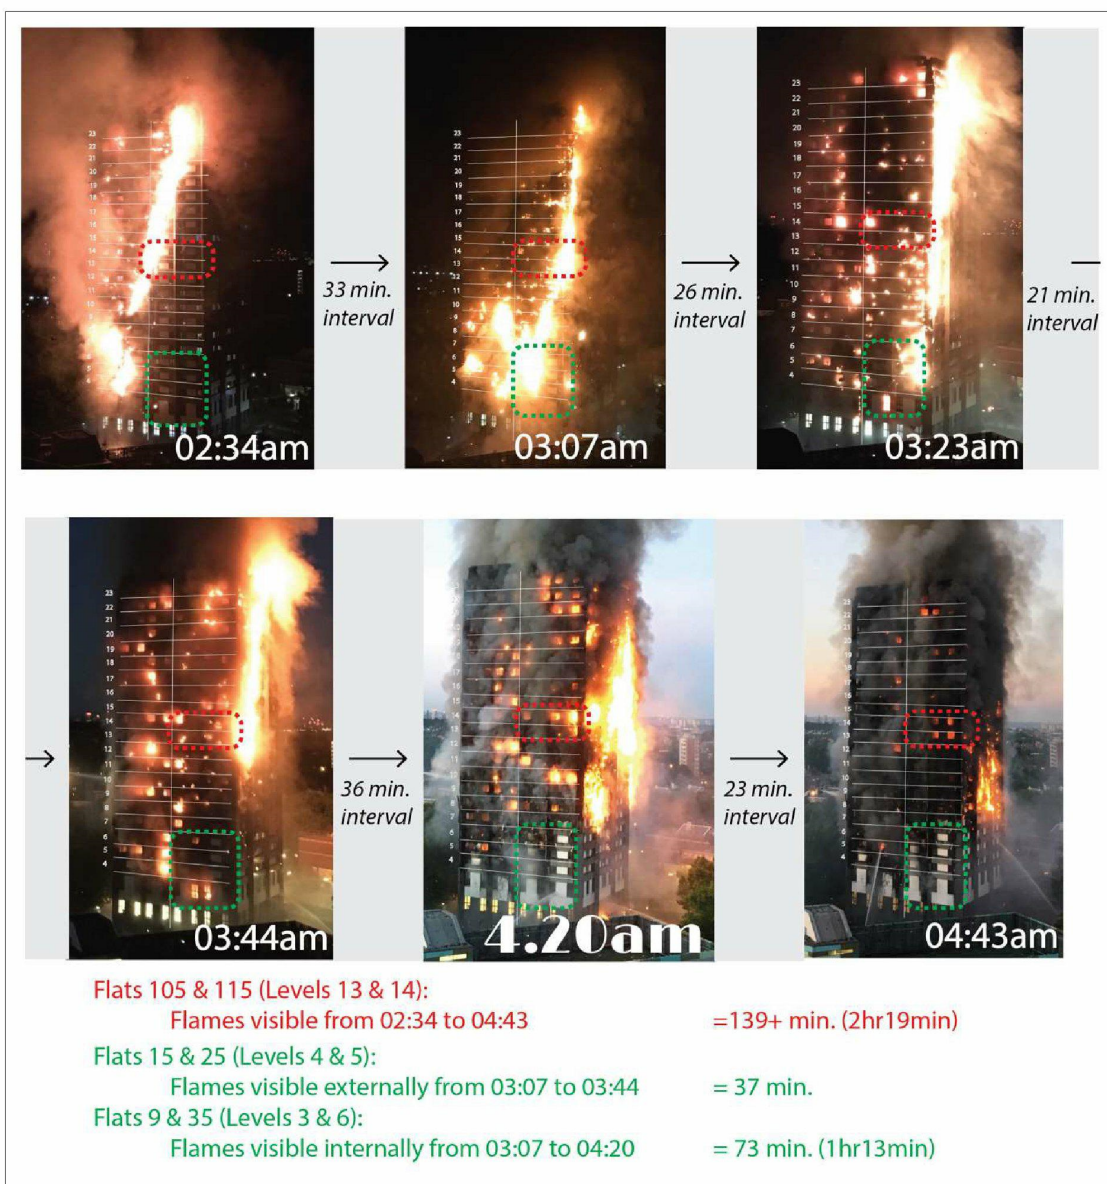
FIGURE 78: A SEQUENCE OF PHOTOGRAPHS OF GRENFELL TOWER NORTH ELEVATION DURING FIRE EVENT. FLATS SHOWING INDICATIVE LONG AND SHORT DURATION FIRES ARE HIGHLIGHTED IN RED AND GREEN, RESPECTIVELY.

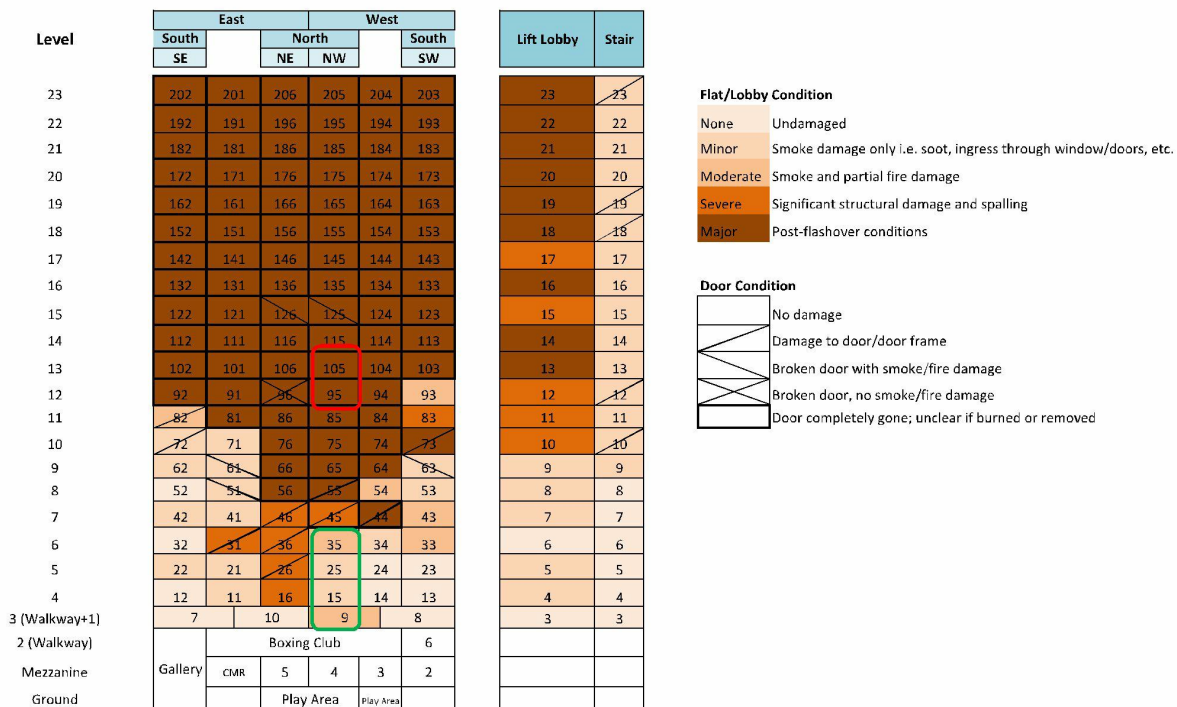
FIGURE 79: GRAPHIC SUMMARY OF POST-FIRE DAMAGE ASSESSMENT INCLUDED IN APPENDIX. FLATS HIGHLIGHTED IN FIGURE 78 ARE HIGHLIGHTED IN RED AND GREEN. NOTE THAT TWO FLATS 9 AND 35 CORRESPOND WITH MODERATE DAMAGE CONDITIONS, WHEREAS FLATS 15 & 25 CORRESPOND WITH MINOR DAMAGE CONDITIONS
