Grenfell Tower

Existing Building Overview

Prepared by
Simon Simpson
12th November 2017

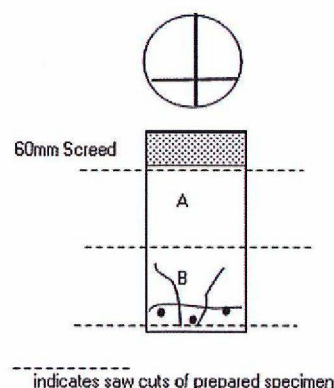
Comments: Signs of Fire Damage at around up to a depth of 40mm.

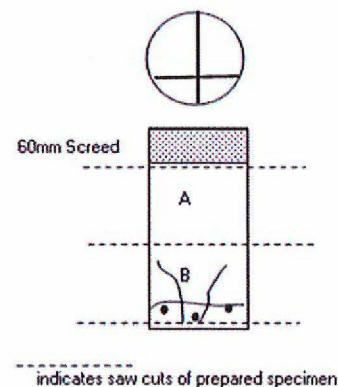
Comments: Signs of Fire Damage at around up to a depth of 40mm.

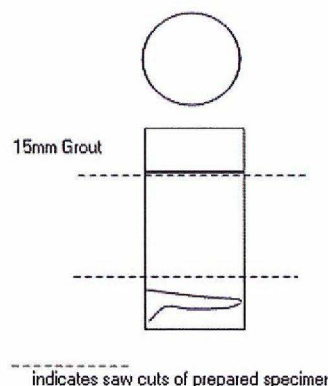
Comments: Signs of Fire Damage at around up to a depth of 15mm.

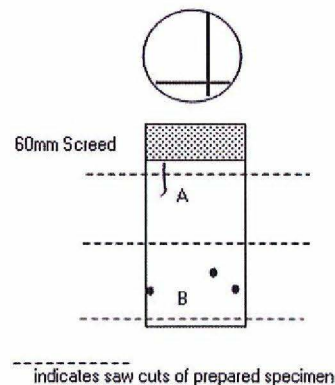
Comments: No Signs of Fire Damage.

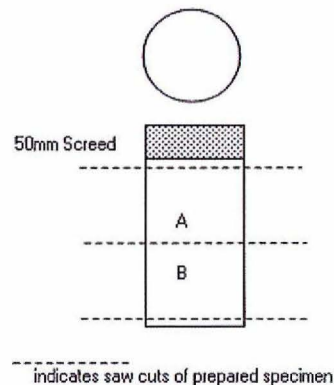
Comments: No Signs of Fire Damage.

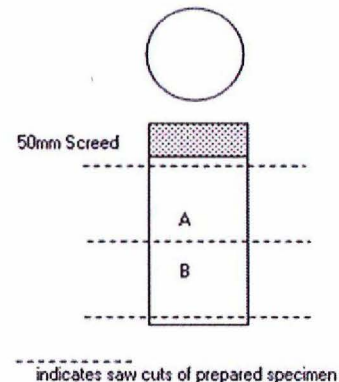
Comments: No Signs of Fire Damage.

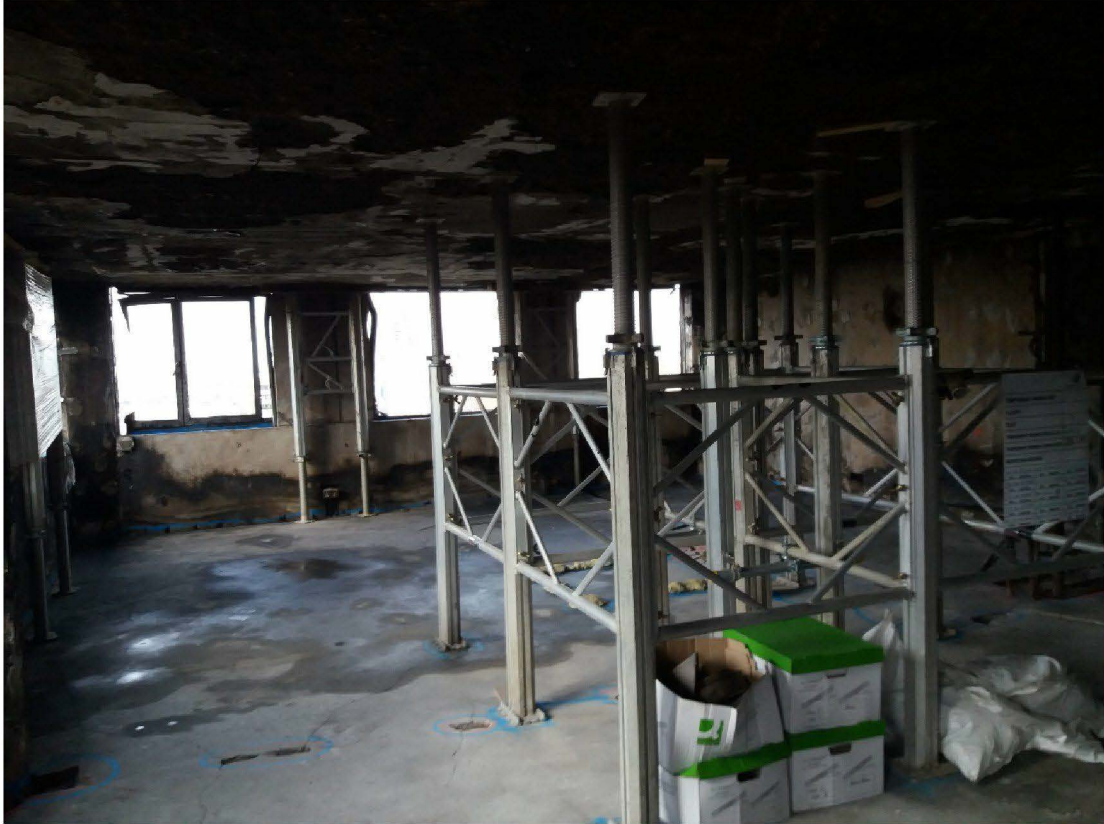
Typical floor propping – Green floor

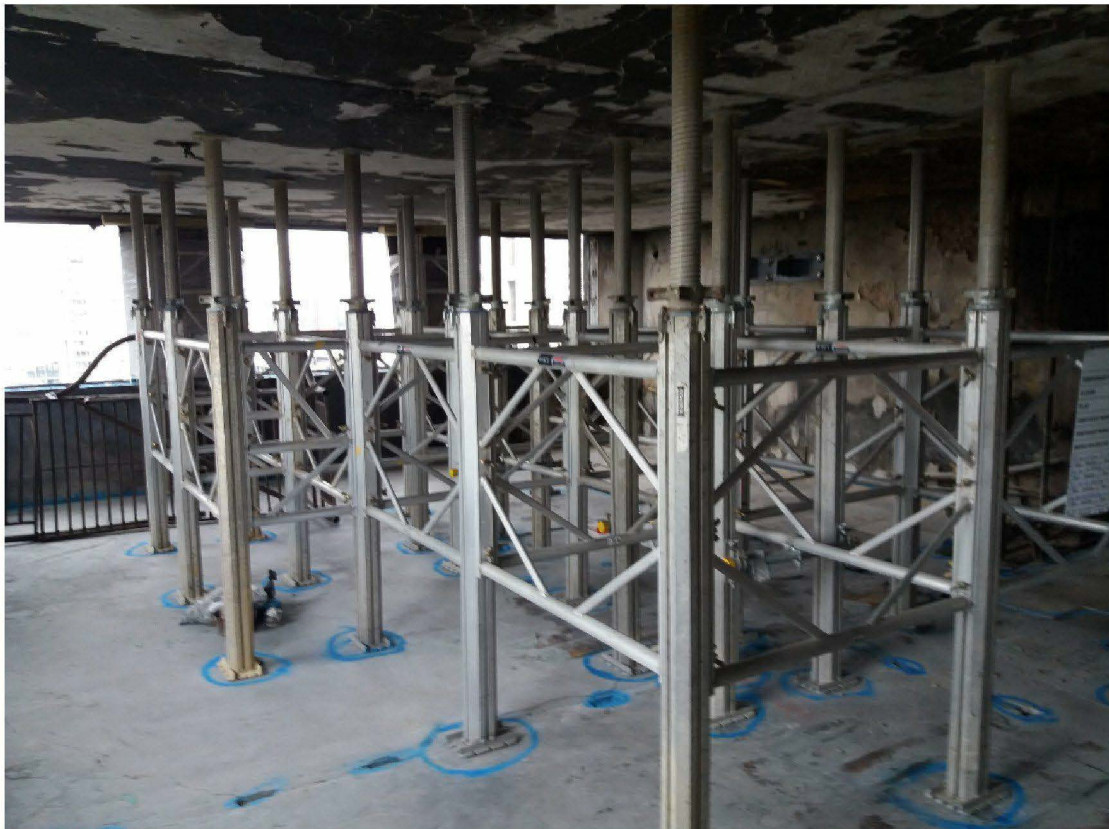
Typical Floor propping – Red floor

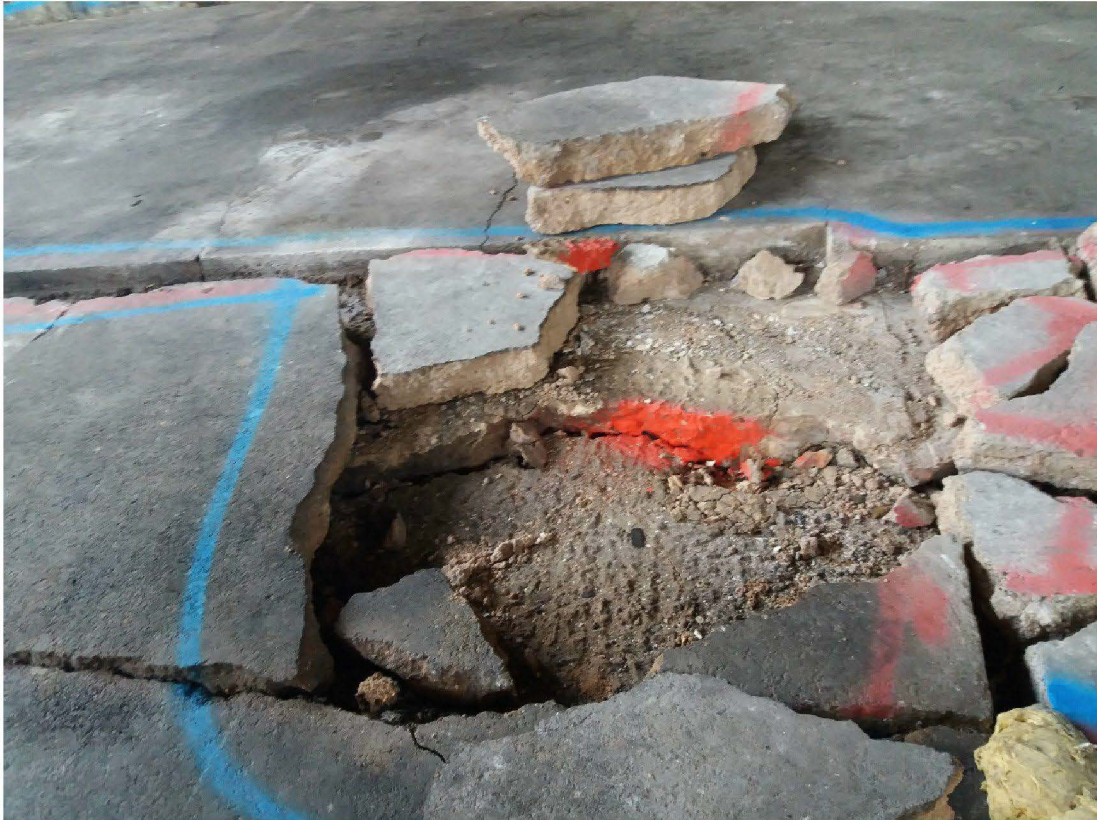
- 6.9 Within flats 3, 5, and 6 at a number of levels, existing construction (day) joints have either opened up or have dropped; this varies quite significantly in extent between units. At some locations a gap of 1-2mm is present between opposing faces, whilst at other locations a tearing (in the form of a short slope can be seen at the soffit of the slab which manifests itself in a 40-50 millimetre step in the top of the slab. We are satisfied that these slabs are adequately back propped.

Damage to floor slabs (where noted in body of report)

Viewed above (note step 40-50mm,)

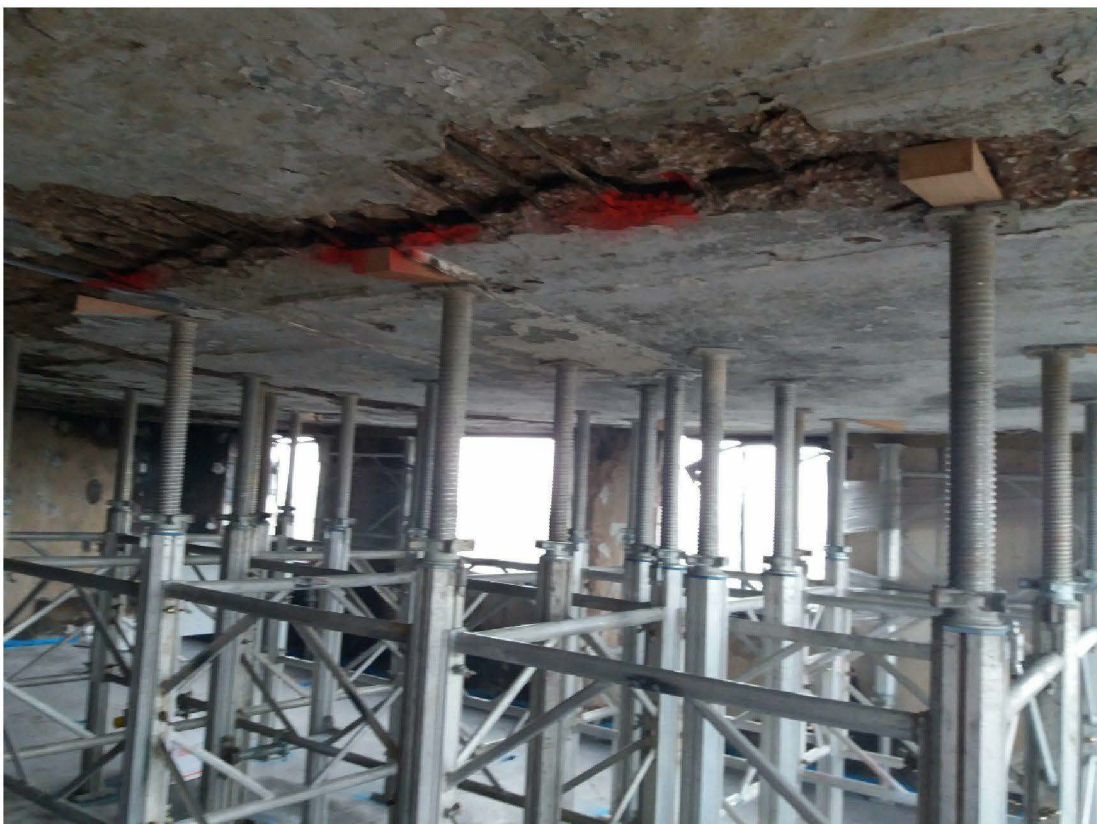
Viewed below (note tear and slope)

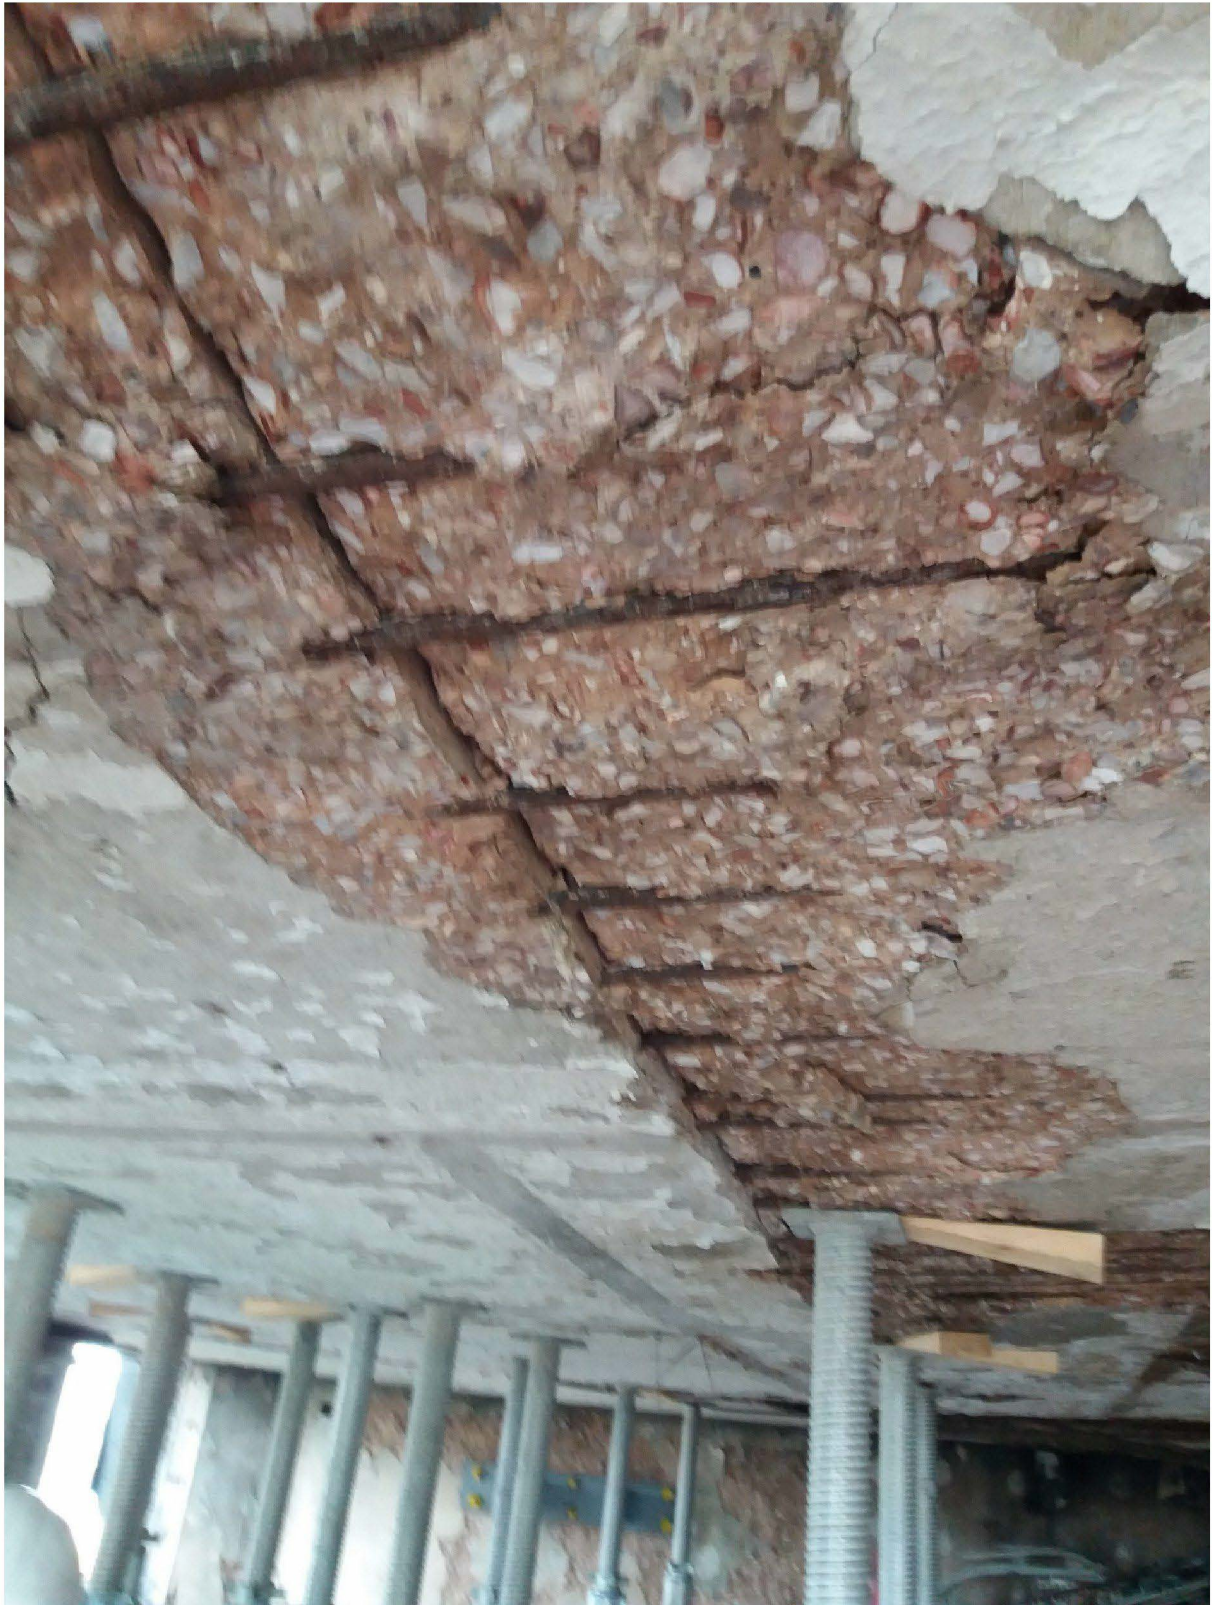
Open construction joint (at locations noted in report approximately 1-2mm wide)

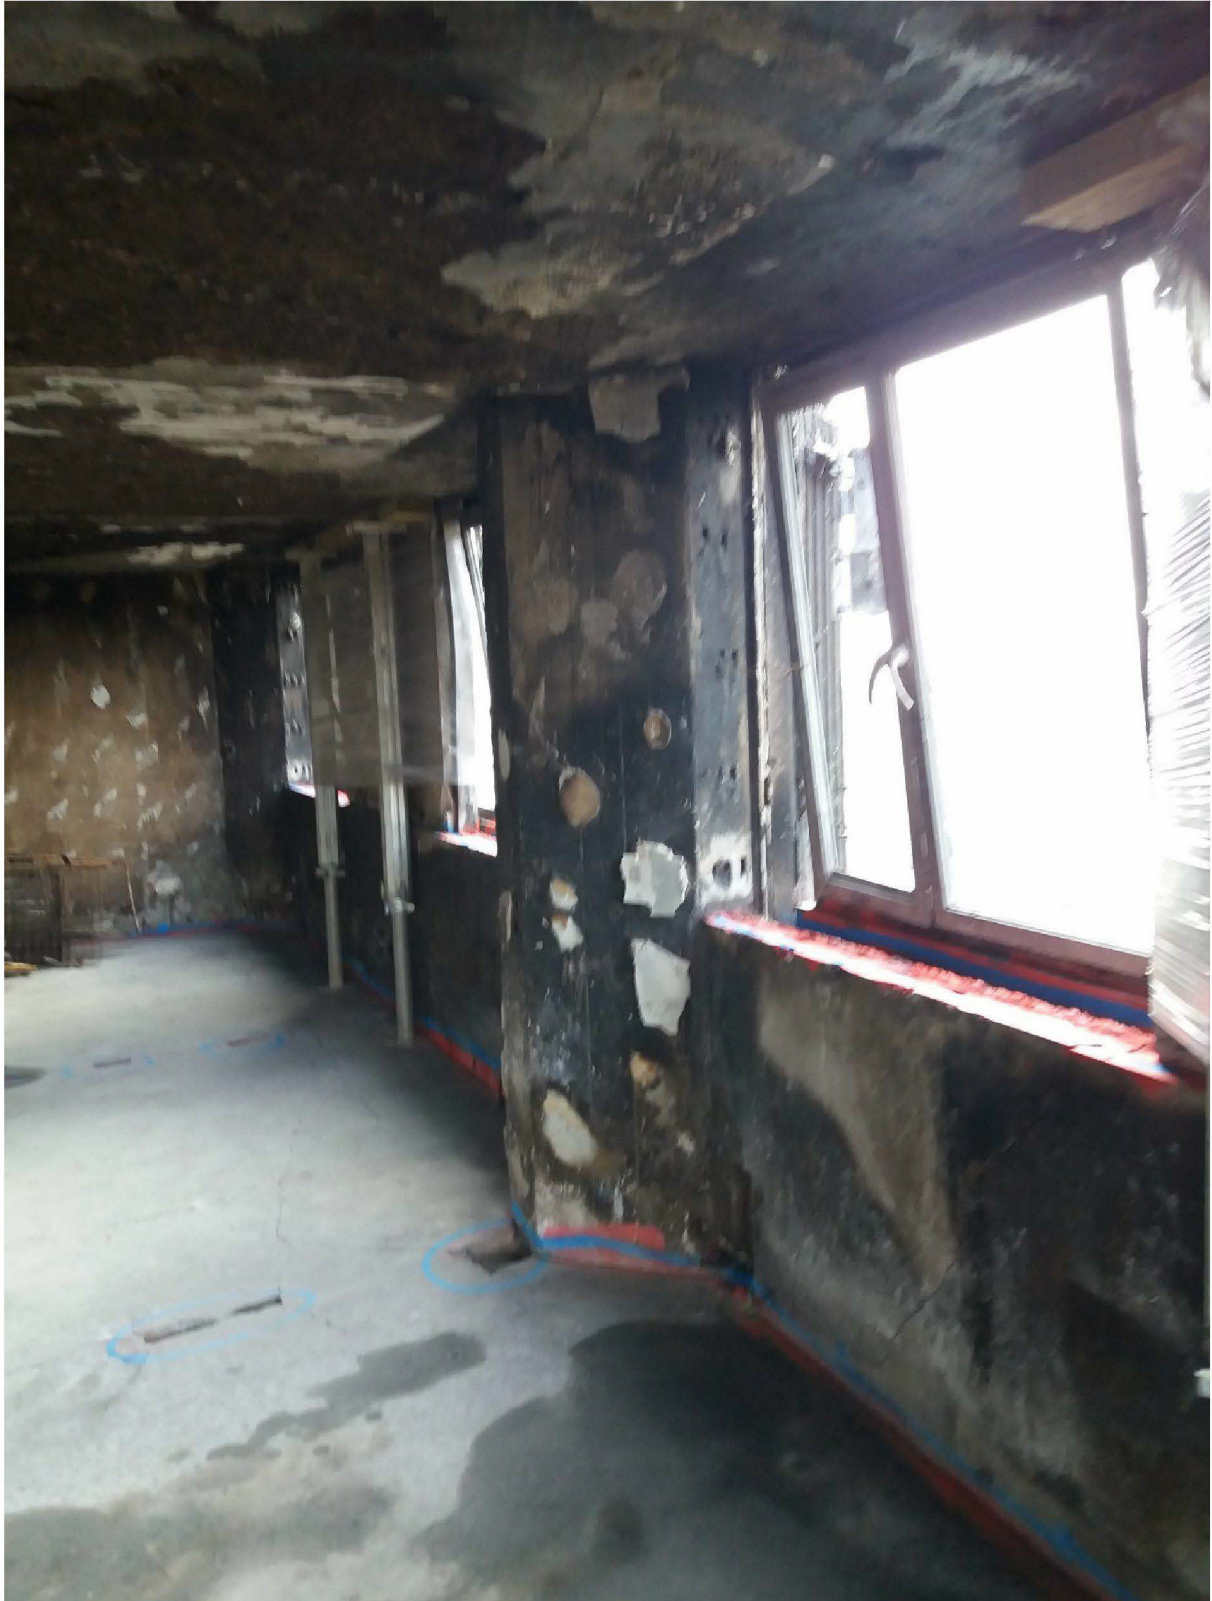
- 7.4 Joints between the concrete outrigger walls, and the internal core walls, along with the joint between the outrigger wall and the concrete column have been inspected for the presence of any cracking or signs of separation. Minor cracking is apparent at some locations typically 1 mm in width, however there is nothing that is causing us concern, generally the quality of these joints is in good order.

Outrigger walls (demise of apartments)
(in background)

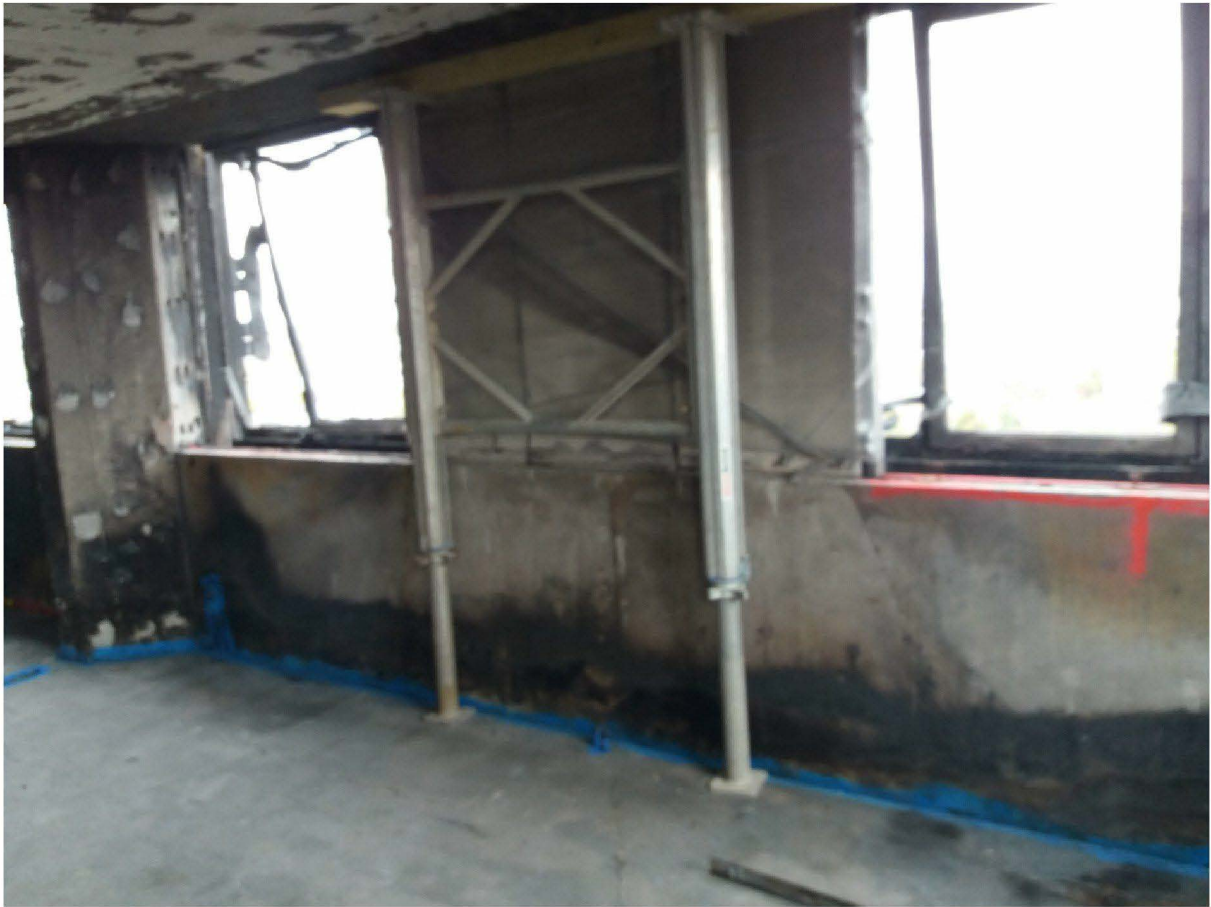
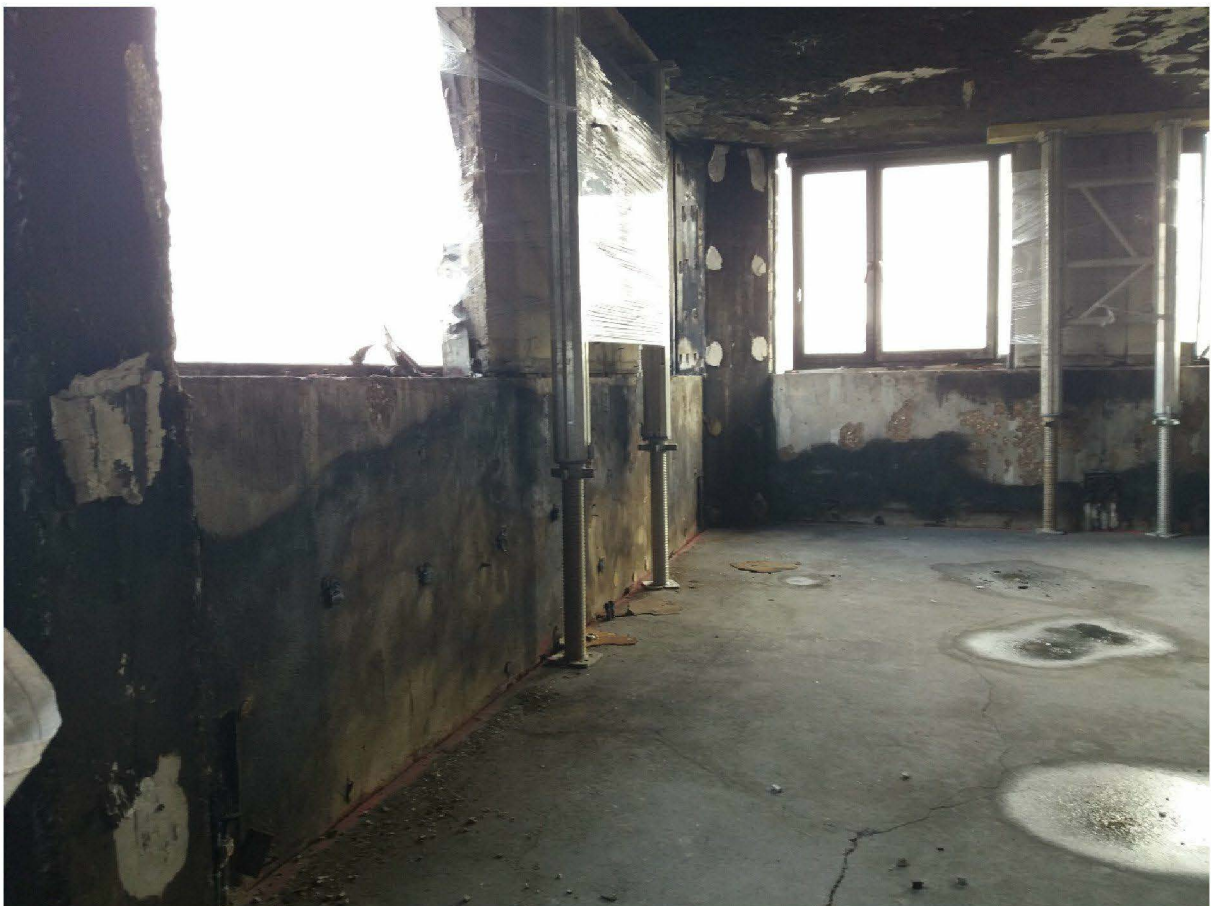
- 7.5 We have also undertaken close examination of the joints between the precast spandrel panels and the floors and the columns. Inclined tapering cracking is present in the spandrel panels at third points, in a way that suggests that the spandrel panel is in tension at the top rather than the bottom. The joints between the spandrel panels and the columns are generally crack free, other than for the presence of some hairline cracking at discrete locations. Photographs are included at appendix D.

- 7.6 From our inspections of the edge spandrel panels, it is clear that they have been used as a shutter to restrain the edge of the concrete slab pour, reinforcement has clearly been lapped into the slab reinforcement. A construction joint exists at the inside edge of the spandrel panel with lap reinforcement extending approximately 750mm into the slab, as evidenced on site. Refer to Appendix D for photographic plates.

Typical views of a spandrel panels

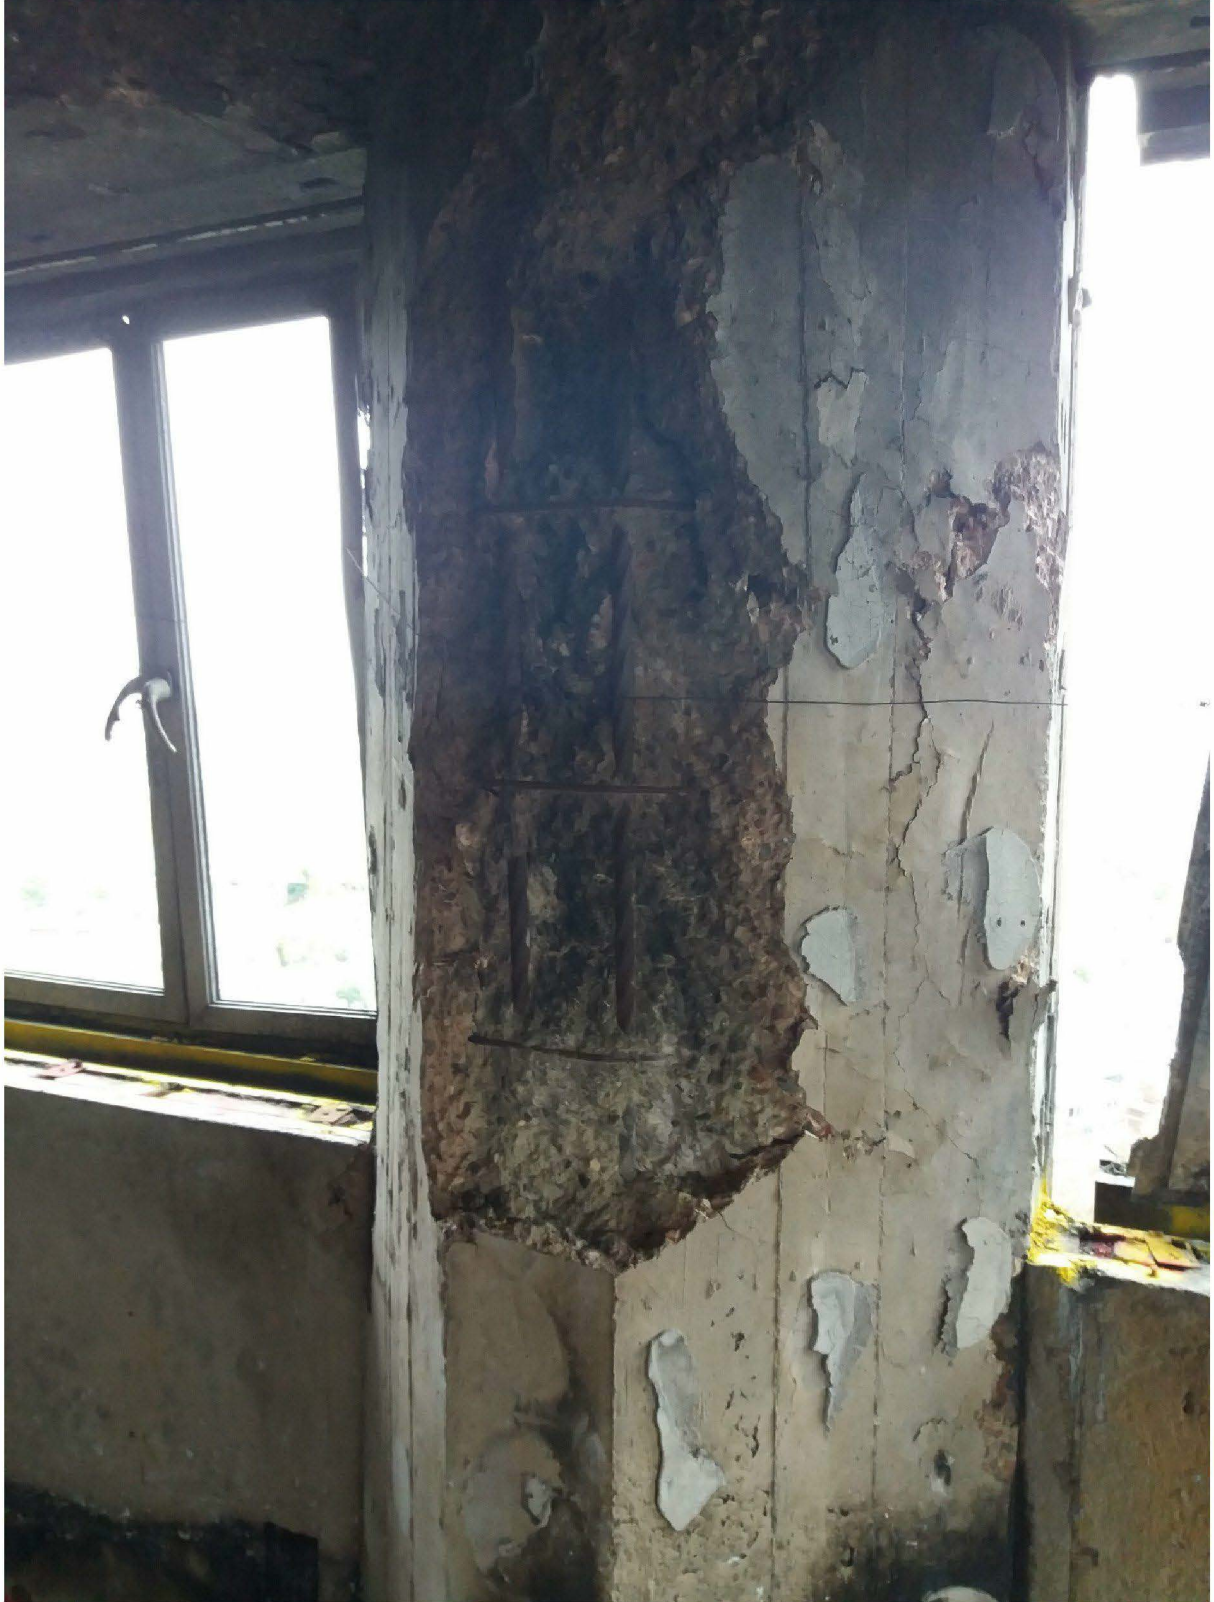
At some locations the internal face of column cover has been lost, this can be seen to vary from 35 to 100 millimetres depending on location. This spalling has exposed two number column reinforcement bars (and links) at two separate locations it can be seen that these two bars have yielded. Photographs of the perimeter columns are included at Appendix D.

The affected columns are located at 14th floor level, flat 2; 16th floor level, flat 3; 20th floor level, flat 3 and 21st floor level, flat 2. The loss of cover to the column is not a cause for concern, it is noted that the exposed aggregate is a natural aggregate colour. We are satisfied that these columns are not in need of further propping, i.e. sufficient propping has been prior installed.

Columns – Spalled (typical)

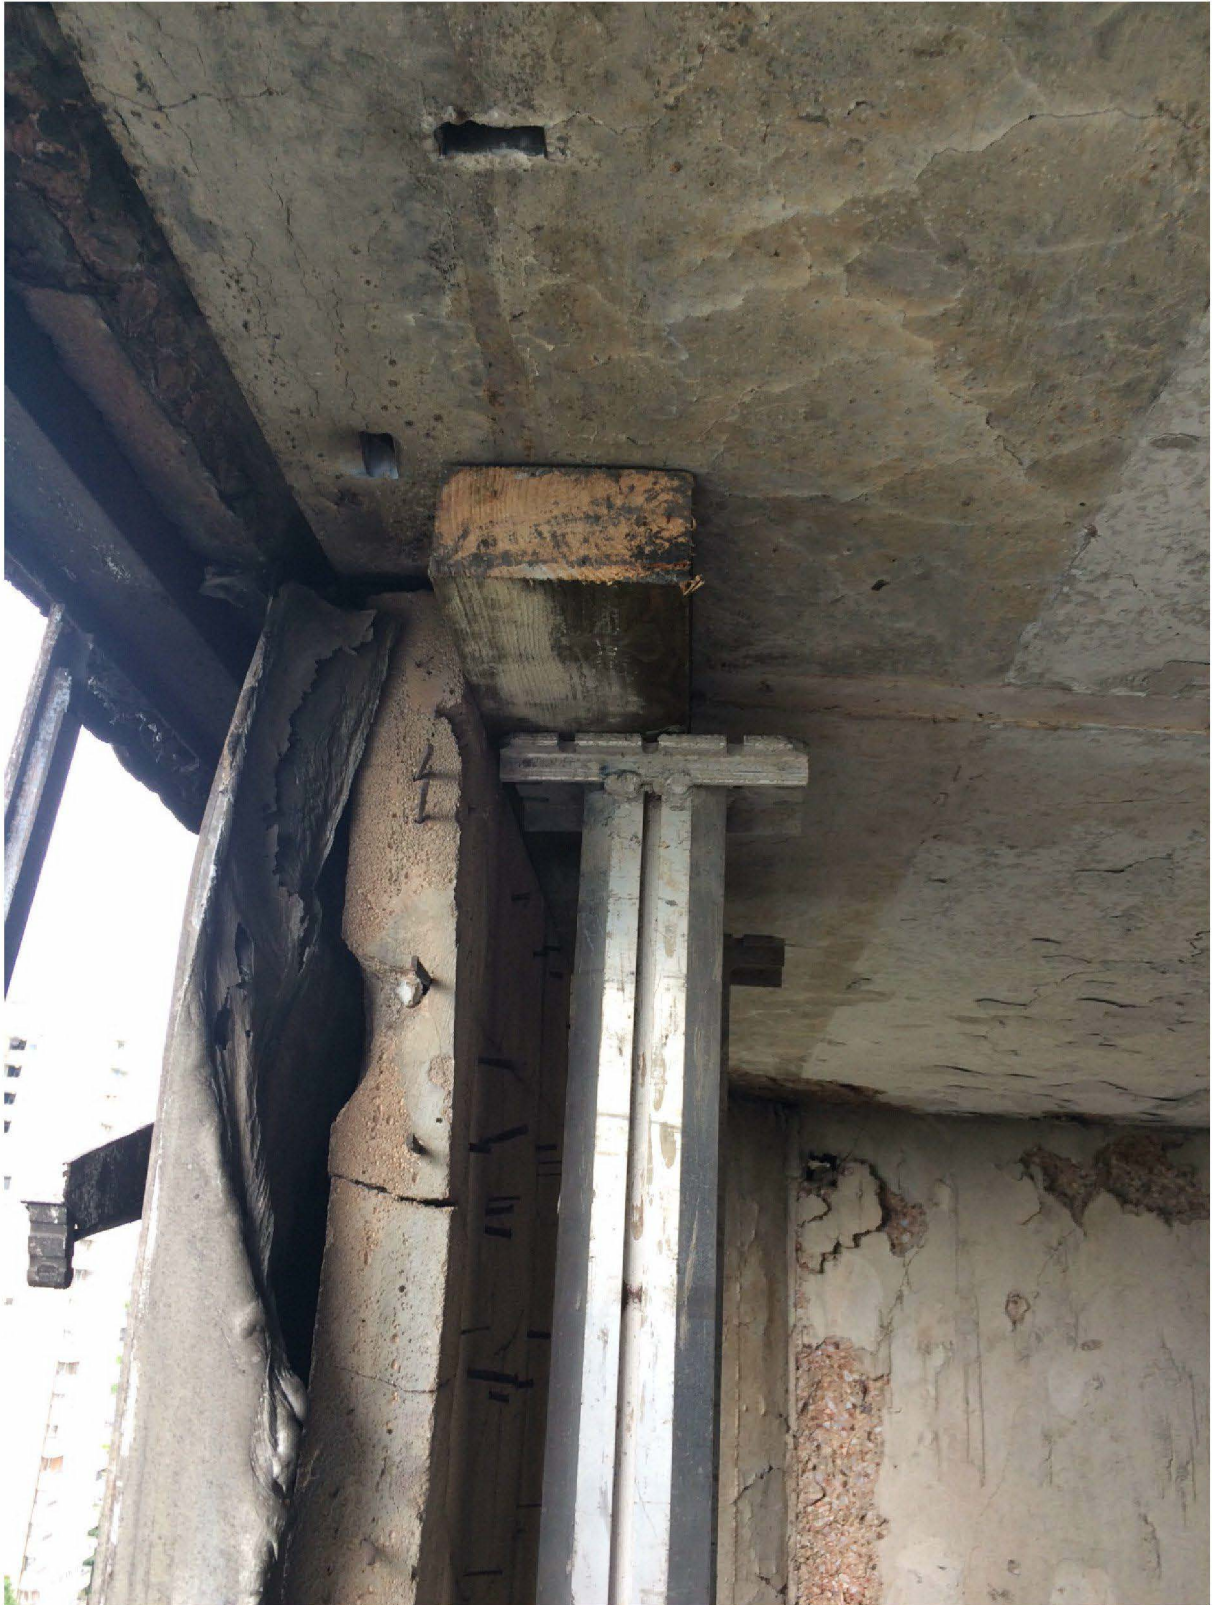
- 6.6 Around the perimeter are 20 number infill mullion panels, these have been established as being non-loadbearing mullions which are comprised of a lightweight backing restraining asbestos sheets. These mullions have since been shrink wrapped to protect the asbestos sheet from falling and equally to reduce potential exposure to the occupants. A movement joint in the form of an approximate 15 mm air gap is present between the soffit of the existing floor slab and the top of the mullion. A photograph of a typical mullion is included at Appendix D.

Some of these mullions have bowed outwards where they have started to attract load from the deflected spandrel/ floor slabs. Suitable protection has been installed to mitigate the possibility of these panels falling out, and propping installed to provide an alternative load path.

Detail at head of non-loadbearing mullions
