SITE INSPECTION REPORT

PROJECT:	Grenfell Tower	REFERENCE:	7654
SITE ADDRESS:	Grenfell Tower, Grenfell Road, London W111TQ	CLIENT:	KCTMO
MAIN CONTRACTOR:	Rydon	REPORT NO:	9
INSPECTOR:	Jon White	INSPECTION DATE:	24 April 2015

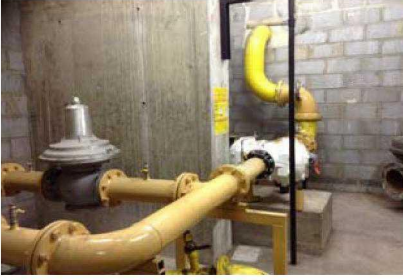
The boiler gas intake room in the basement showing the pipework that was leaking gas, that appears to have been repaired. KCTMO to confirm if this has happened.

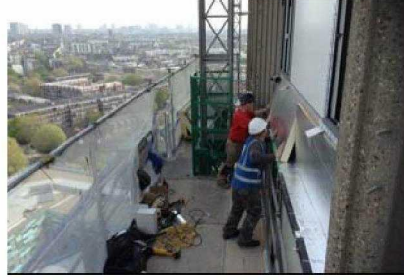
The insulation is being installed on the external cladding.

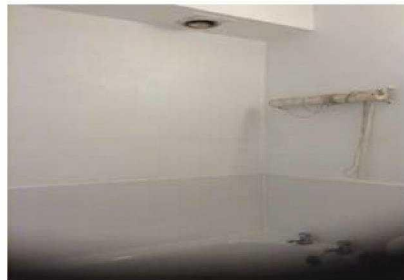
The specification calls for each bathroom ventilation grille and internal duct to be replaced. Rydons to inform all parties when this will start.

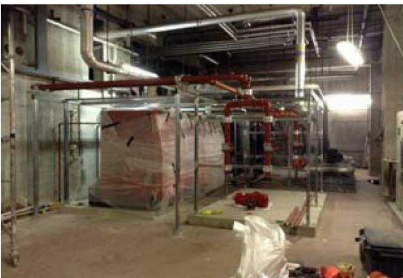
In the Basement plant room, the new three boilers and heat exchange plant are beginning to be installed, with the pipework and framing works being installed.
