BRE Global Test Report

BS 8414-2 : 2005 Test on a Gebrik Rainscreen Cladding System

Date: 21 September 2015

Report Number: P100838-1000 Issue 2

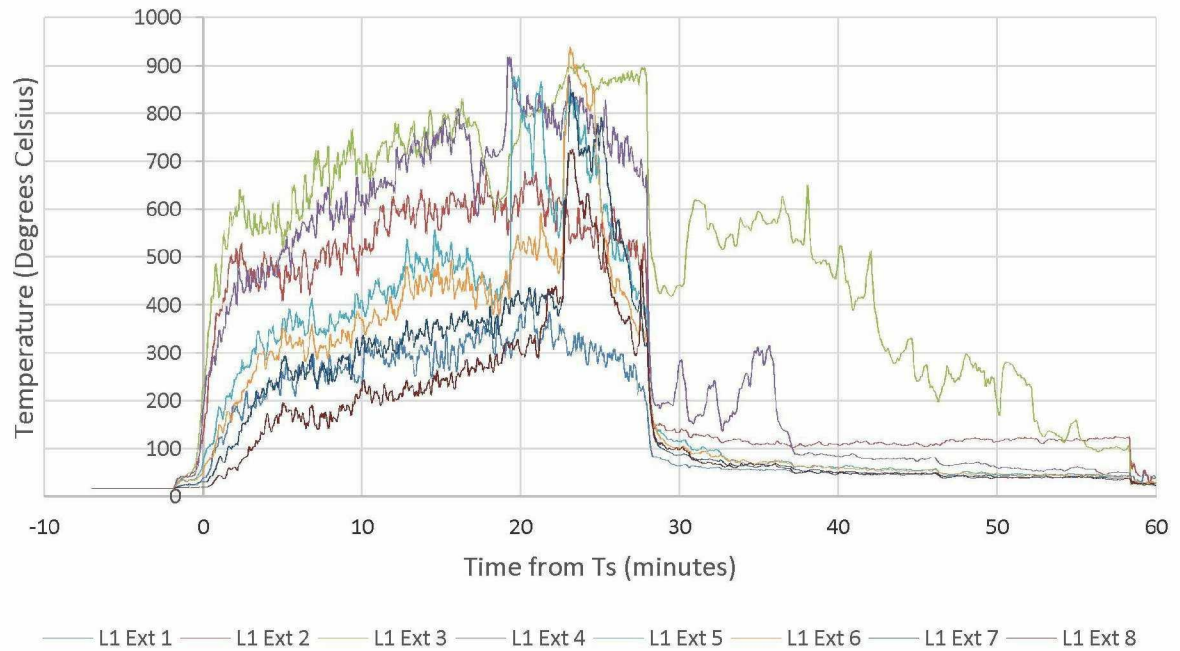
Figure 10. Temperatures Level 1 External

Parameter	Result
T _s , Start Temperature	221.7°C
Peak Temperature in first 15 minutes of test	770.5°C 15 minutes after ignition of the crib at thermocouple "Level 1 Ext 3"
t _s , Start time	2 minutes; 1 second after ignition of the crib
Peak temperature/time at Level 2, 50mm external	651.2°C 23 minutes; 8 seconds after ignition
Peak temperature/time at Level 2, Cavity 1	154.6°C 60 minutes after ignition
Peak temperature/time at Level 2, Insulation Layer	295.6°C 57 minutes; 30 seconds
Peak temperature/time at Level 2, cement particle board	84.1°C 58 minutes; 48 seconds
Peak temperature/time at Level 2, cavity 2	27.5°C 41 mins; 15 seconds
Peak temperature/time at Level 2, Plasterboard	20.9°C 58 minutes; 12 seconds

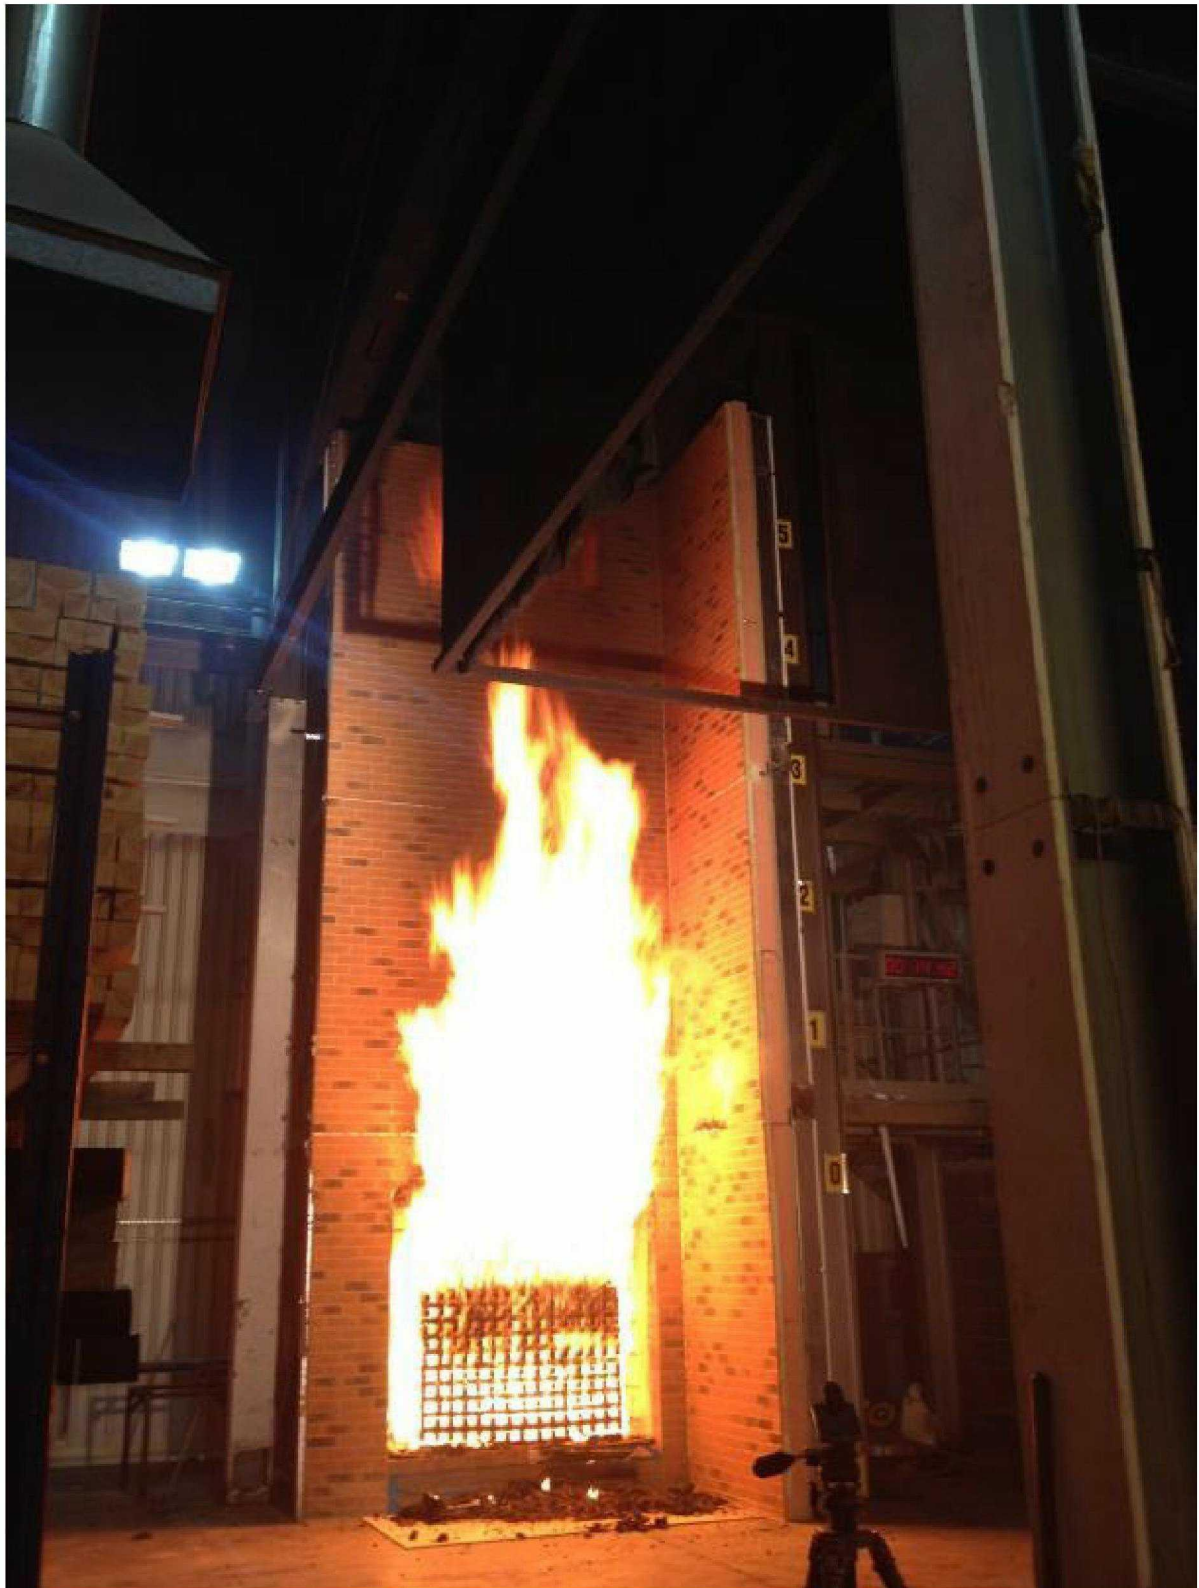
Figure 15. Cladding system during the test.

Figures 10 to 14 provide the temperature profiles recorded during the test. Figure 15 shows the system during the test.

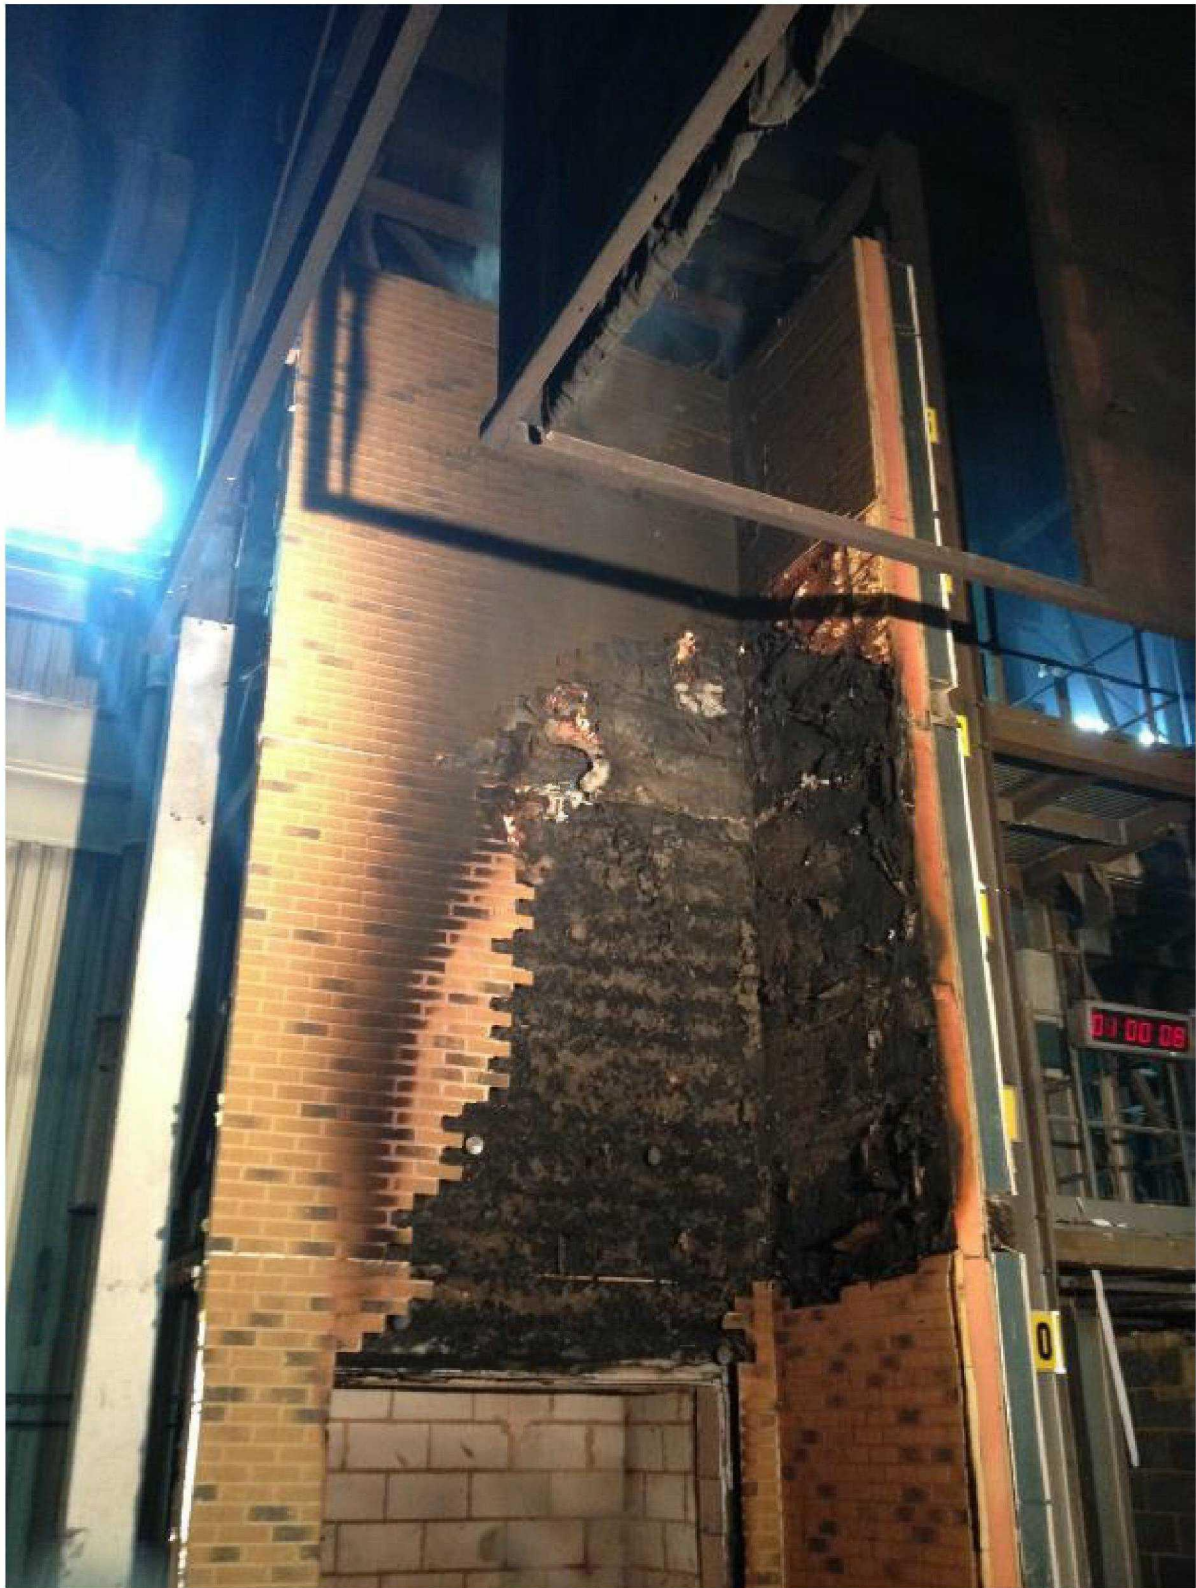
Figure 16. System on completion of the test

Figure 16 shows the condition of the system following completion of the test. The following sections comprise a summary of visual observations made following the test.

Brickslip sections had detached from the system and fallen to the floor at the following locations:

On the main face of the wall, between the centreline and the right side of the face, up to ~4m above the hearth level

On the wing face of the wall, across the full width of the wall from ~0.5m up to ~4.5m above the hearth.

Sections of Brickslip were cracked (or beginning to detach) out-with these detached areas, above the fallen panels on the wing and main faces of the system.

On the main face of the system, insulation was charred beneath all of the areas where brickslip sections had fallen away up to the level 2 fire break (~4m above the hearth opening).

On the wing face of the system, the insulation had charred across the full width of the wall up to ~4m above the hearth opening height.

There was an area of non-charred insulation where the bricks had fallen away without flames impinging on the insulation surface. This area was on the wing face of the wall immediately below the second level fire break at ~4.5m, as evidenced in Figure 16.
