Site Visit Report

External Doors

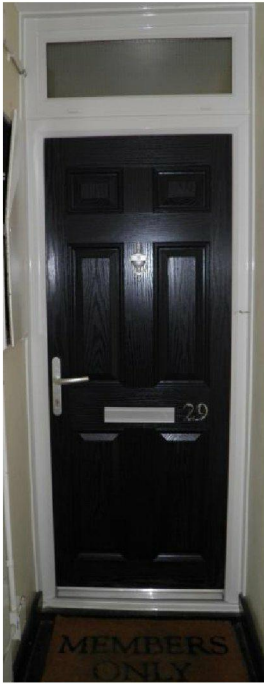
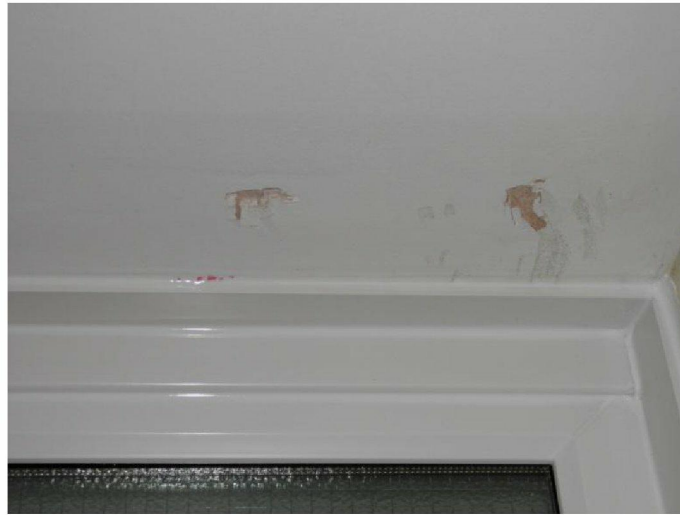
Ceiling needed to be touched up as it was slightly damaged during door installation.

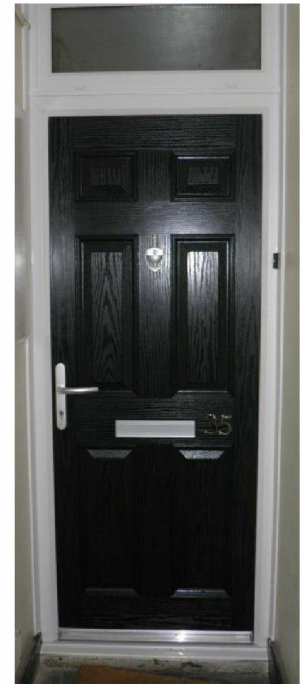
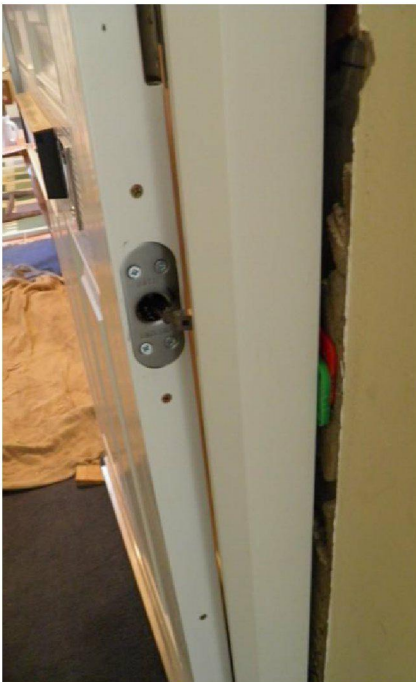
This door closer is supplied and fitted for all inspected doors.
