Investigation of real fires -
Cable Supports Experiments

Technical Journal article on Cable supports experiments

A series of experiments to assess the effect of fire on a selection of electrical cable supports and fixings

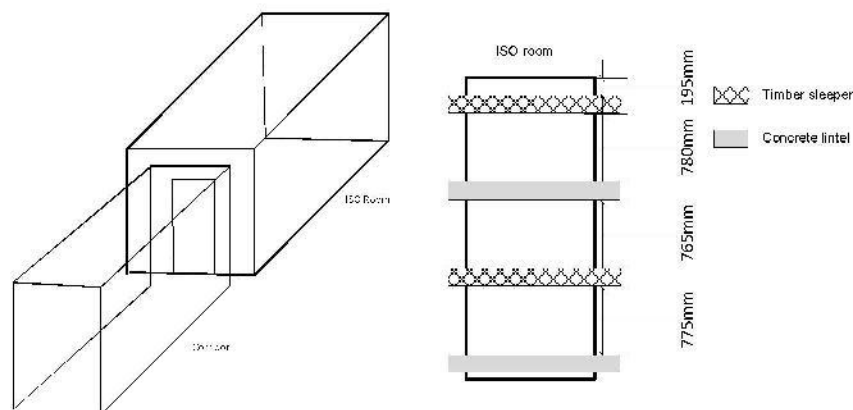
Figure 1 - Schematic of experimental rig, left, and plan view of corridor, right, indicating the layout of the timber sleepers and lintels to which the cable supports were fixed

An experimental rig was designed and constructed using the ISO 9705 fire test room [7] (ISO room) of dimensions 3.6 m x 2.4 m x 2.4 m, extended with a timber-frame and plasterboard (single layer 12.5 mm Type F [8]) lined corridor of dimensions 3.5 m x 1.5 m x 2.4 m attached to the front of the ISO room (see Figure 1 and Figure 2). The walls, floor and ceiling of the ISO room were lined with two layers of 12.5 mm Type F plasterboard. The ISO room used for the experiments is a portable room on wheels which was raised approximately 300 mm from the ground; hence the corridor was not in line with the top of the ISO room.

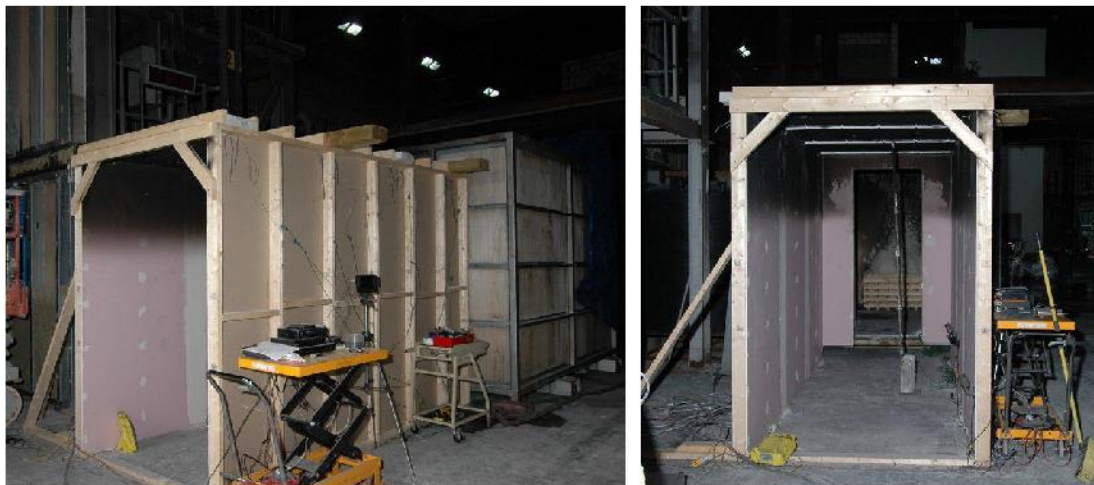
Figure 2 – Images of experimental rig

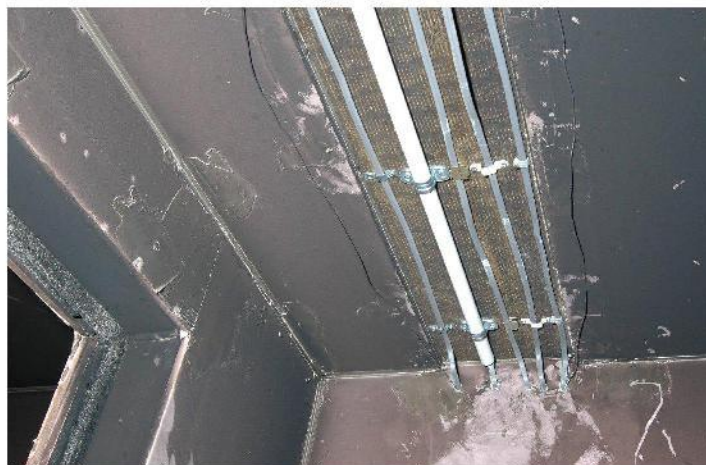
Figure 3 - Close up of cable set fixed to a timber sleeper with the selection of cable supports prior to an experiment

Four sets of five cables, supported with a selection of cable supports, were installed horizontally across the width of the corridor. The cables and supports were fixed to different structure types; timber sleepers and concrete lintels, which were placed alternately, approximately one metre apart along the corridor (see Figure 1). The timber sleepers and concrete lintels were approximately 220 millimetres wide. For the purpose of this article, these sleepers and lintels will be referred to as lintels. Typical layout of the installation of the cable supports can be seen in Figure 2. For ease of reporting, the lintels have been numbered from 1 to 4, where Lintel 1 is closest to the ISO room and hence closest to the fire.

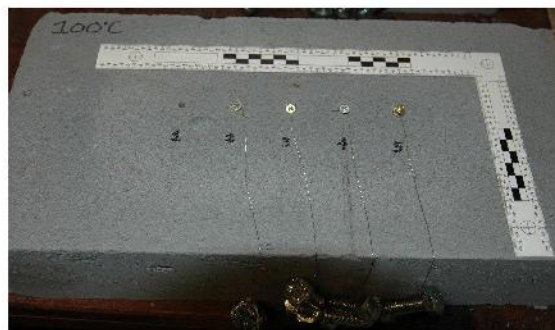
Figure 5 – Fixings installed in concrete block with weights attached

The fixings were installed into standard aerated 3.6N concrete blocks (see Figure 5) of dimensions 440mm by 215mm by 100mm deep. Each block was placed horizontally into an oven on top of two other concrete blocks (placed vertically) as supports to allow for the suspension of weights from the fixings.

Steel bolts were used as weights, attached to the fixings using steel wire. Each weight was approximately 85 g i.e. a single fixing, based on the weight of two 0.3m lengths of twin and earth cable (~ 340 g) and having two cable supports on such a length with two fixings per support.
