UK INDUSTRY & FACILITIES
Inspection or Testing Document
Electric Traction Lifts

Doc Reference:
Mech\LIF\Proc\001

Synopsis of procedure

What: This is the procedure for carrying out the Thorough Examination of Electric Passenger or Passenger/Goods/Service Lifts. The scope and extent of a Thorough Examination of a lift will depend on an assessment of the risks associated with the probability and consequences of deterioration or failure of the parts, components or systems under consideration. The Competent Person undertaking the Lift Thorough Examination will also need to consider its type and configuration, the environment in which it is operated and in some cases records of maintenance, repairs, and inspections.

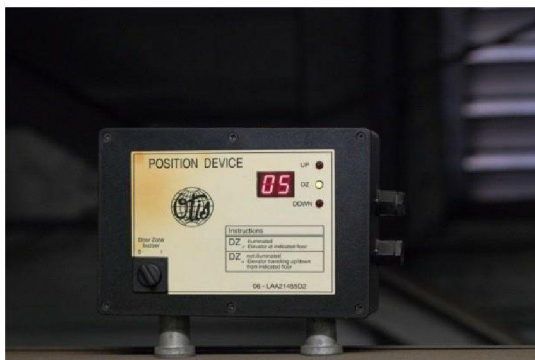
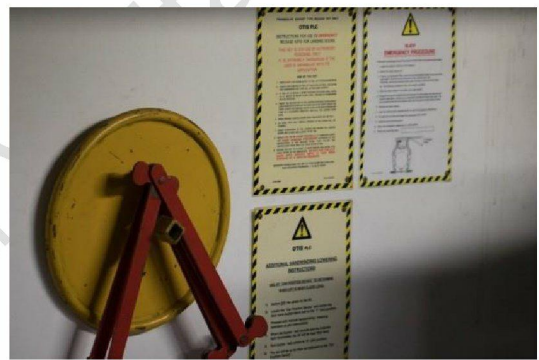
- Hand winding equipment should present and correct for its purpose with a function test of any switches carried out. There may be a brake release tool required and this should also be available for emergency use. If fitted, the floor level indicator/sounder should operate correctly with power off.

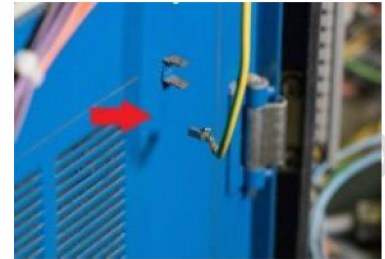
- Carry out a visual inspection of the controller equipment. Look for signs of overheating and damaged/loose components.
- Listen for unusual sounds from the drive gear. If so, investigate further visually. Take care around moving parts.
- Look for any strange behaviours. This could be constant releveling or brake operation indicating a control fault. Is there erratic drive present? Inconsistent/incorrect speeds or stopping/starting could also indicate a control fault.

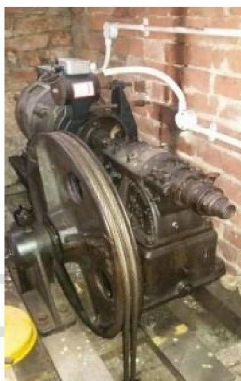
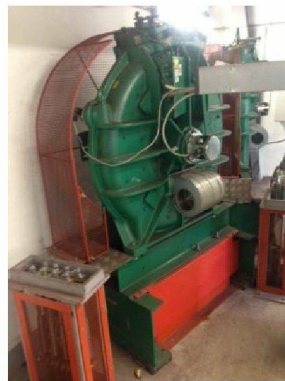
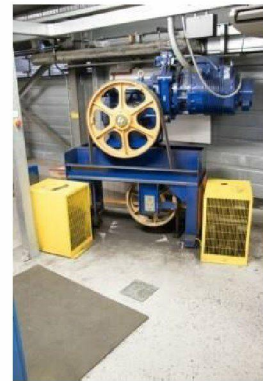
- Visually inspect gearless drive, gearboxes, worm or reduction gear for wear/damage. Refer to [Technical Library - Section 1 – Traction Lifts – TGN001, TGN002, TGN003, TGN004, TGN011, TGN014 and TGN016.](#)

- Check any sheave grooves, pulleys and sprockets for wear. Ropes sitting too low in the drive sheave could indicate a worn sheave. Poor alignment of chains over sprockets could also indicate wear.

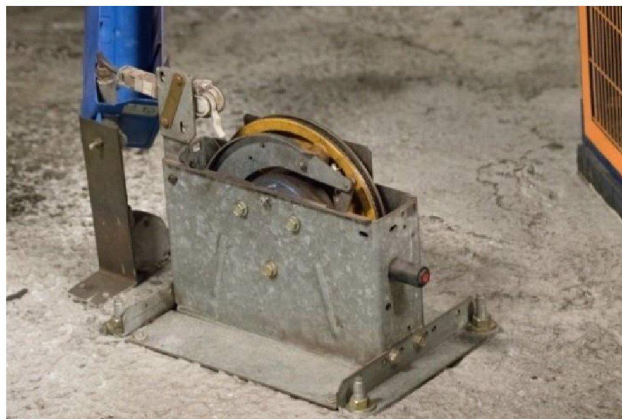
- The over-speed governor should be observed during movement of the lift for any abnormalities. Fixings should be secure and the switch should function correctly. Calibration seals should not be broken and be in place.
- Check for suspension rope slip by visually observing and if needed verifying by marking across ropes and traction sheave with chalk, running through a cycle of terminal floors and then comparing variations in measurements
- Oil leakage – are there any leaks from the gearbox? These should be eliminated and reported as such in the appropriate section of the Thorough Examination Report. Have they contaminated the brake linings as this could cause incorrect levelling and start/stopping of the lift?

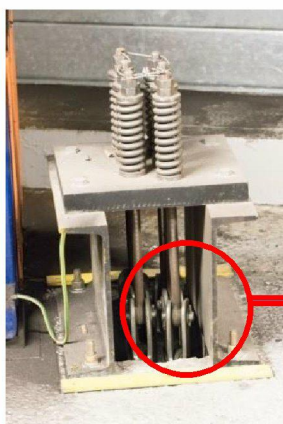
- Check for Vibration – can you hear or feel any vibrations? This could indicate gearbox problems.
- Check for Heat – can you feel excessive heat? This could indicate lack of oil or over use.
- Check the oil condition – has the oil got water in it which could be indicated by a white colour? Is it clean? Brass filings could be a sign of wear on crown wheel or worm teeth.
- Check and internally examine the worm & crown wheel as far as practicable with an inspection mirror/device. Check there are no teeth missing, worn or pitted teeth. A SAFed Supplementary Test may be required if serious concerns are raised. Refer to [TGN 035 - MISC - 2007 SAFed Guidelines on supplementary tests for in service lifts.](#)

- Check any suspension rope anchorages. Tightness and security of fixings and locknuts should be in place and secure with equal spring tensions if fitted. Refer to [TGN 038 - MISC - 2008 Dry Rope Socket Terminations](#) and [TGN 026 - TRAC - 2008 Suspension Rope Anchorages Using Rope Grips.](#)

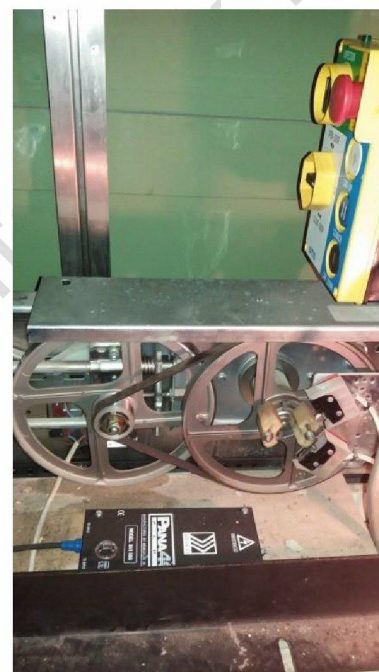
- Check function of car door operating equipment and header equipment. All linkages and fixings should be secure and serviceable. If drive belts are fitted they should not be worn or damaged. All covers should be in place securely. Refer to [TGN 037 - MISC - 2007 Sliding Door Clearances](#). **Caution!** When opening the car door manually or under power, ensure that the landing door pick up lock rollers on the landing door below the car have not caught on the car door equipment which would expose the liftway. This would pose a risk to persons entering and falling.

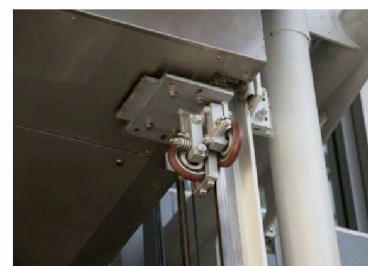
- Ensure car guide shoes are secure and any liners are not missing or worn giving excessive movement. If guide rollers are fitted these should be checked for wear, security and centralisation with no uneven wear on the tyres present. Wear could be perished tyres, uneven wear or flat spots.

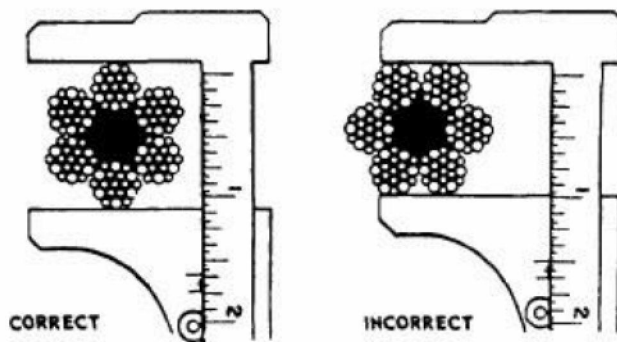
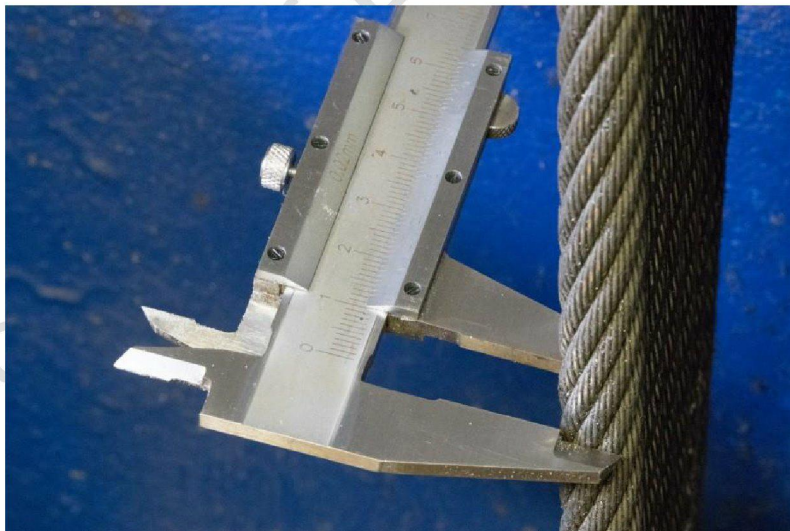
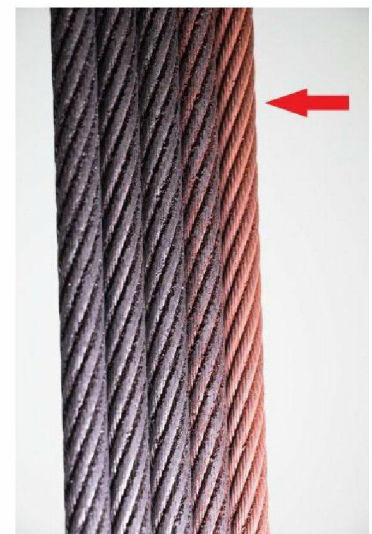
- Inspect suspension ropes/chains/belts during car top travel from top to bottom. Refer to
 - (1) [Technical Information and Rejection Criteria, Section 6. SAFed Guidelines on Supplementary Tests for in-service lifts.](#)
 - (2) [TGN 017 - TRAC - 2005 Otis Gen 2 – Flat Coated Steel Belts.](#)
 - (3) [TGN 021 - TRAC - 2008 Schindler – Flat Coated Steel Suspension Belts.](#)
 - (4) [TGN 033 - TRAC - 2010 Plastic Coated Suspension Ropes \(SDR ropes\).](#)
 - (5) [TGN 028 - TRAC - 2009 Crossed Suspension Ropes.](#)

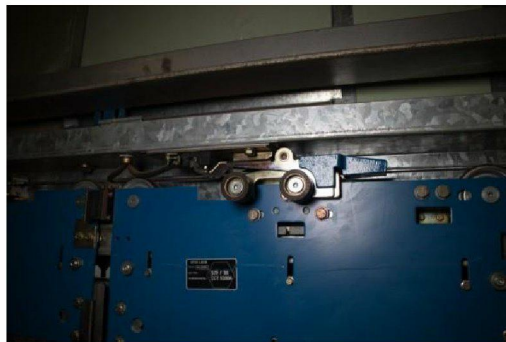
- Check the landing door locks and associated equipment for correct function and security. The emergency release device must operate correctly and with ease. Remove covers for internal lock examination at least every 12 months and indicate this on the report of examination. Wiring should be secure and correct clearances obtained.

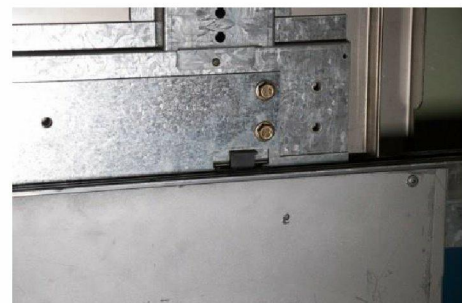
- Check landing door header equipment. Rollers should be secure, not be worn and run smoothly. Upthrust 'kicking' rollers should be secure and adjusted correctly to eliminate the possibility of doors becoming dislodged.
- Check car and counterweight guides. The brackets and fixings should be secure, with none missing. The guides should be sufficiently lubricated if guide shoes are fitted.

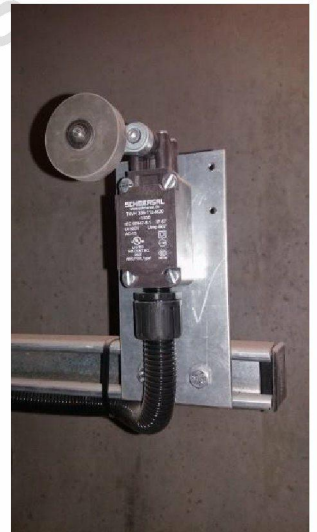
- Check lift-way fascia panels. They should be secure and none missing.
- If a safety gear is fitted on the car top, the linkages should be checked for freedom of movement and the function of the switch verified. Refer to [TGN 018 - MISC - 2000 Torpedo Rope Release Device – Dewhurst Type LCT.](#)

- Any access door/hatch switches, i.e. for overspeed governor reset procedures, should be checked for correct function and be secure.

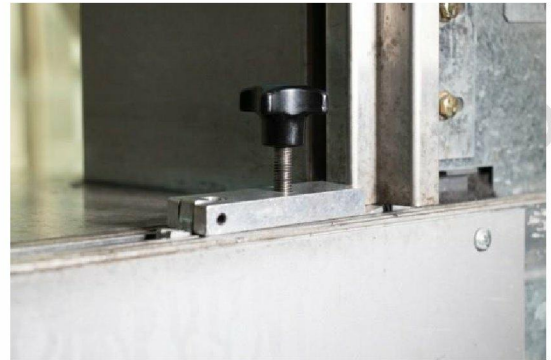
Caution! A landing safety barrier should be in place before opening of landing doors to access the pit. The company issued landing door stop tool should always be used to hold open the landing doors when entering the pit. Screwdrivers and other devices should not be used as there is risk of displacement and the doors closing unexpectedly causing entrapment.

- Verify Emergency pit stop switch before entering the pit. It should function correctly and be secure. Refer to [TGN 022 - MISC - 2000 Klockner Moeller Stop Switches](#).
- General operational lift pit components should be verified for correct function, wear and security.

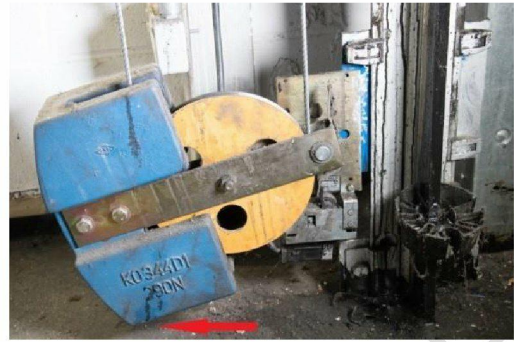
- Operate any other limit switches which should function correctly.
- Check Governor return pulley and switch (if fitted). There should be sufficient clearance to enable correct operation of the switch and to allow the rope to be correctly tensioned. **Remember**, if there is insufficient clearance then the safety gear may not operate.

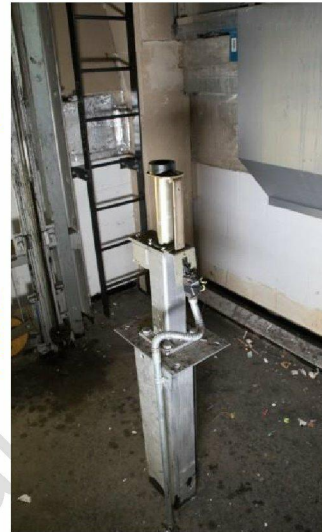
- Condition of buffer and return switches (if fitted). There must be no oil leaks and fixings must be in place, good condition and secure. Refer to [TGN 001 - MISC -1994 Seized or Depressed Oil Buffers](#).
- If a safety gear is fitted underneath the car, the linkages should be checked for freedom of movement and the function of the switch verified. Refer to (1) [TGN 018 - MISC - 2000 Torpedo Rope Release Device – Dewhurst Type LCT](#). (2) [TGN 021 - MISC - 2000 Safety Gear Mechanisms by Barron & Shepherd](#).
- The security and fixings of the car apron should be checked.

- If any under car pulleys/diverters are fitted these should be checked for security and groove wear. Any rope retaining devices should be secure.
- All under car equipment should be checked for security and correct function. The trailing flexes should be fully secure at their termination.
