**GRENFELL TOWER
PUBLIC ENQUIRY**

**EXHIBITS TO
WITNESS STATEMENT OF ROY JONES**

A fire resistance test conducted generally in accordance with BS EN 1366-2:1999 on a multi blade damper assembly.

309850

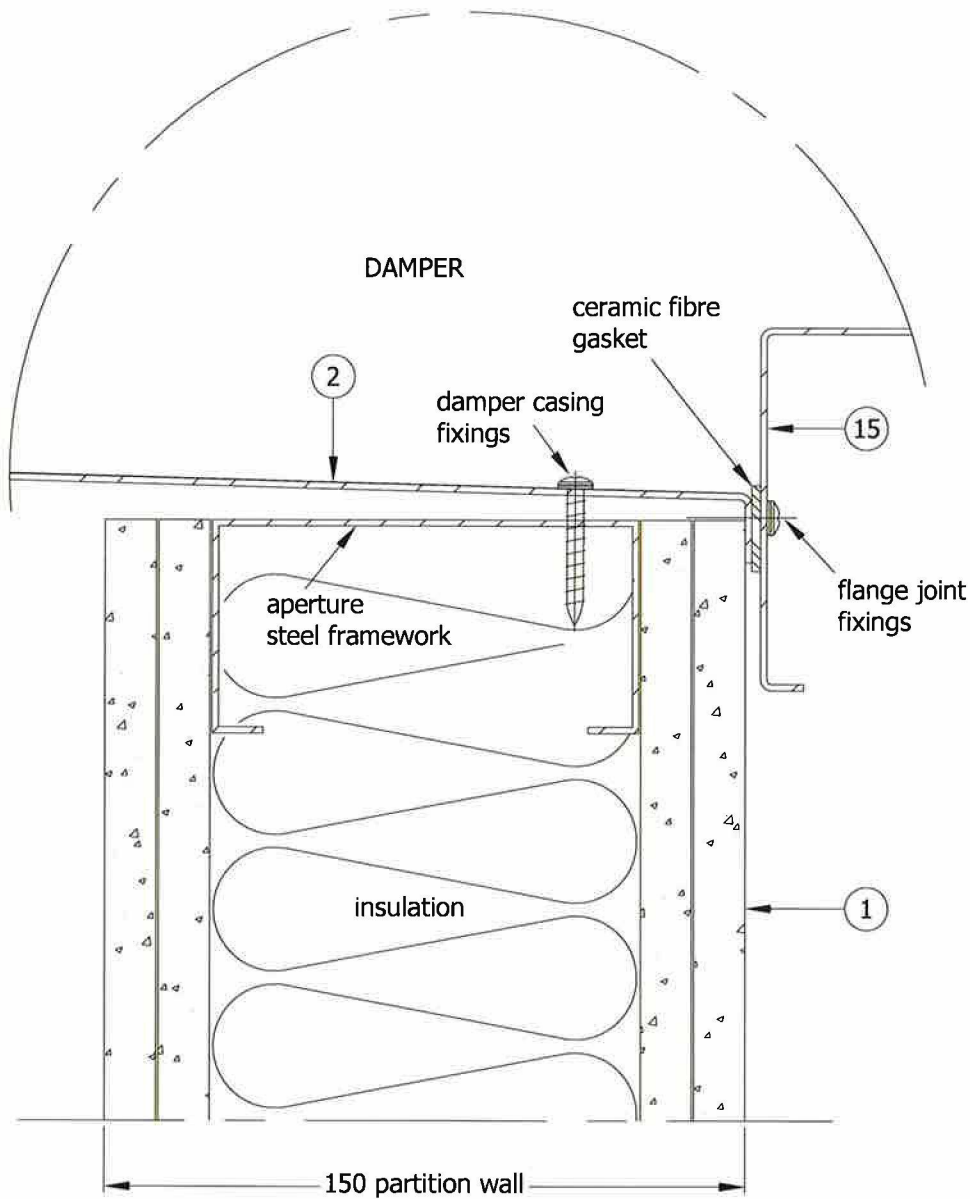
Figure 4 – Detail 'B'

Typical fixing details all around aperture

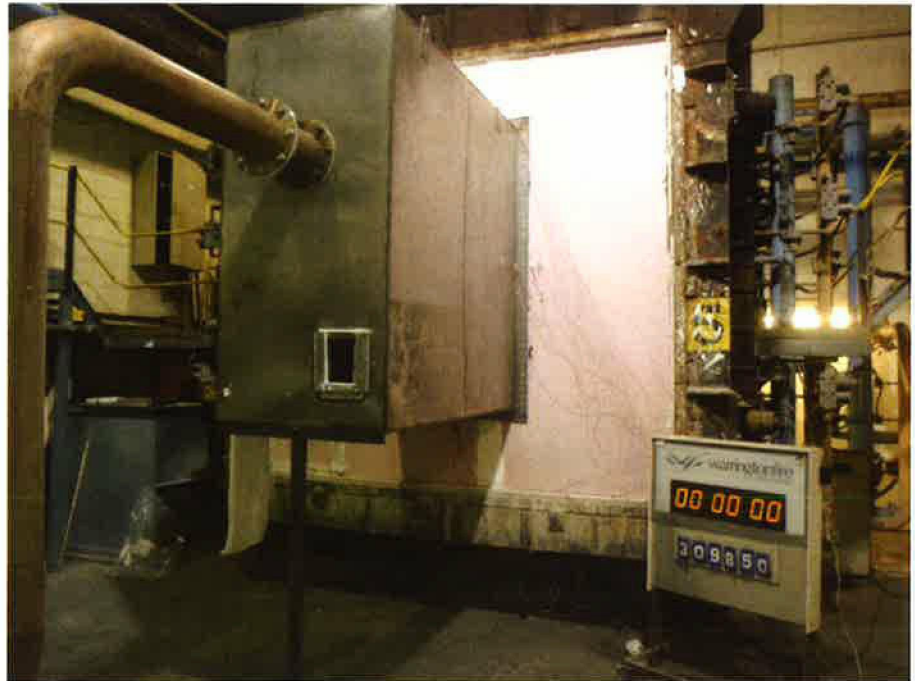
The unexposed face of the assembly prior to testing

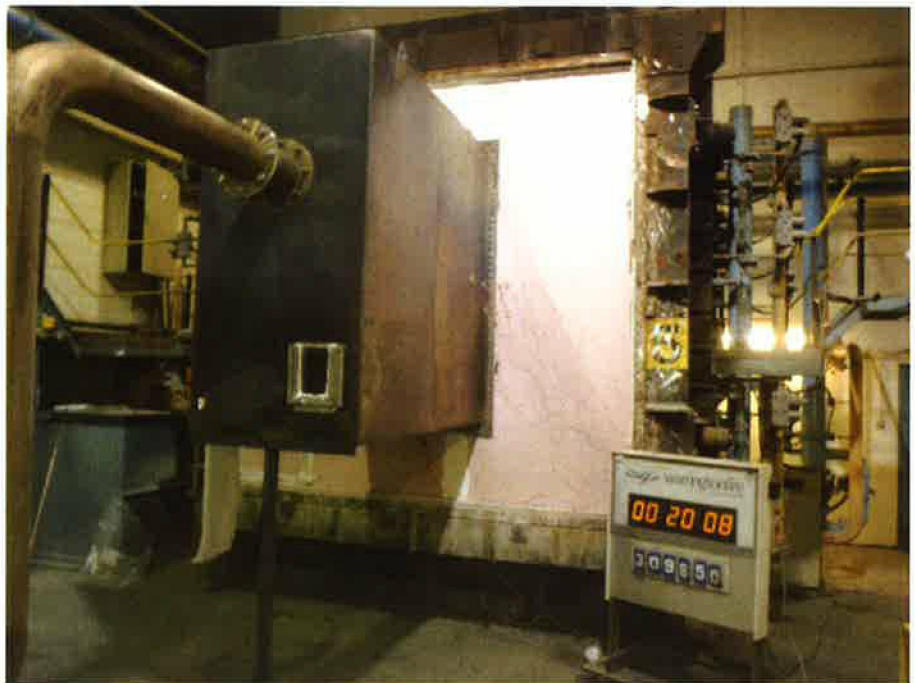
The exposed face of the assembly after a test duration of 20 minutes

Time		All observations are from the unexposed face unless noted otherwise.
mins	secs	
		The ambient air temperature in the vicinity of the test construction was 19°C at the start of the test with a maximum variation of 8°C during the test.
00	00	The test commences. The damper was in the closed position at the start of the test.
02	40	Smoke / steam release is visible across the top of the wall assembly.
03	36	Smoke release is visible across the top face of the plenum.
05	00	Viewed from the exposed side, the paper face of the plasterboard starts to burn away and the edges of the damper blades start to glow a dull red.
08	55	The wall assembly starts to bow in along its horizontal axis at mid-height.
09	35	The top two corners of the plenum start to discolour blue / black.
12	52	Viewed through the plenum window the edges of the damper blades glow orange.
20	00	The exposed face of the damper glows orange.

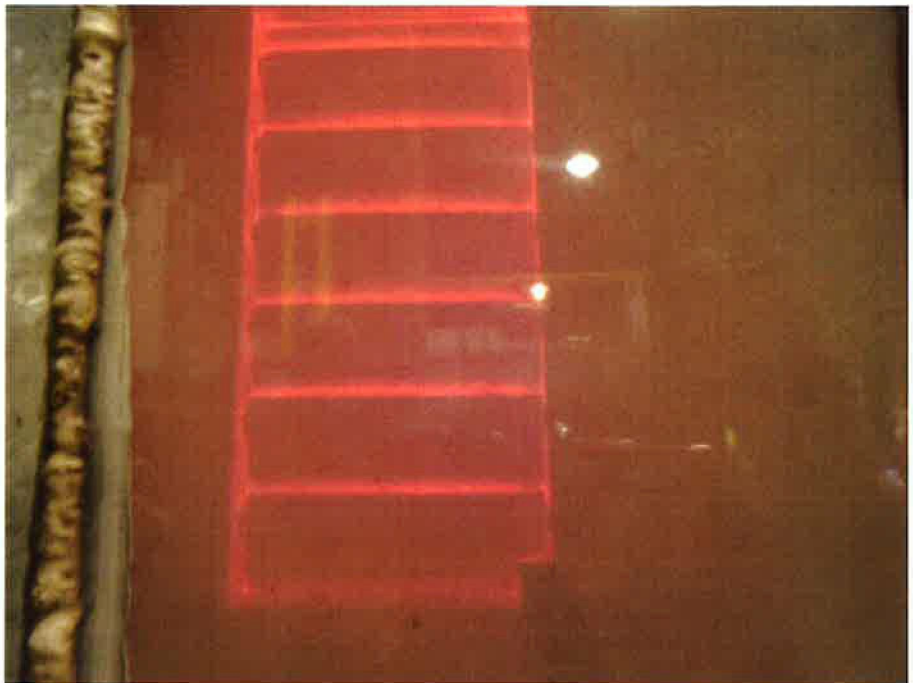
The damper viewed through the plenum window after a test duration of approximately 60 minutes

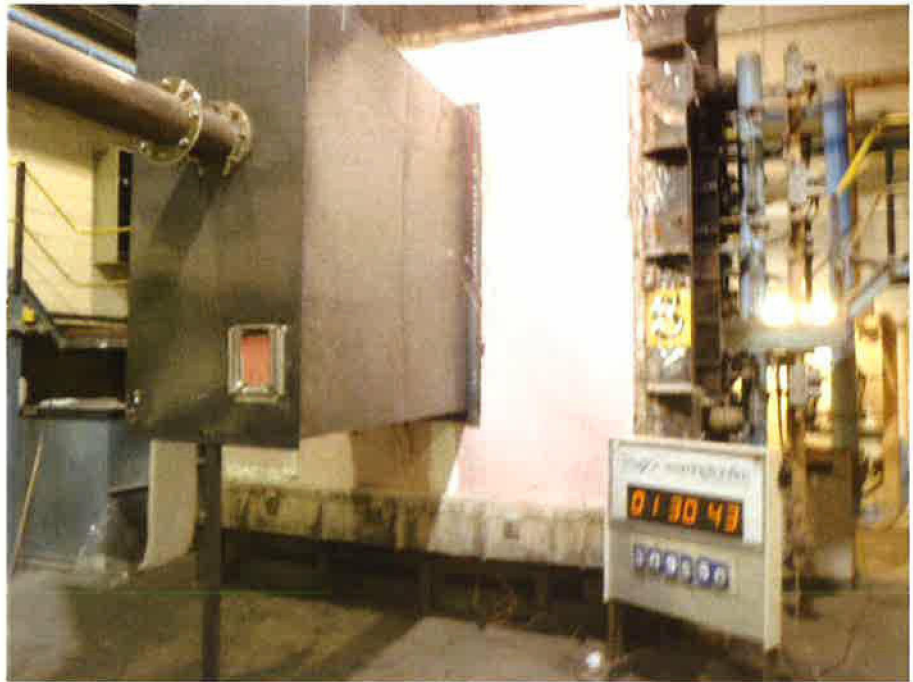
The exposed face
of the assembly
after a test
duration of 90
minutes

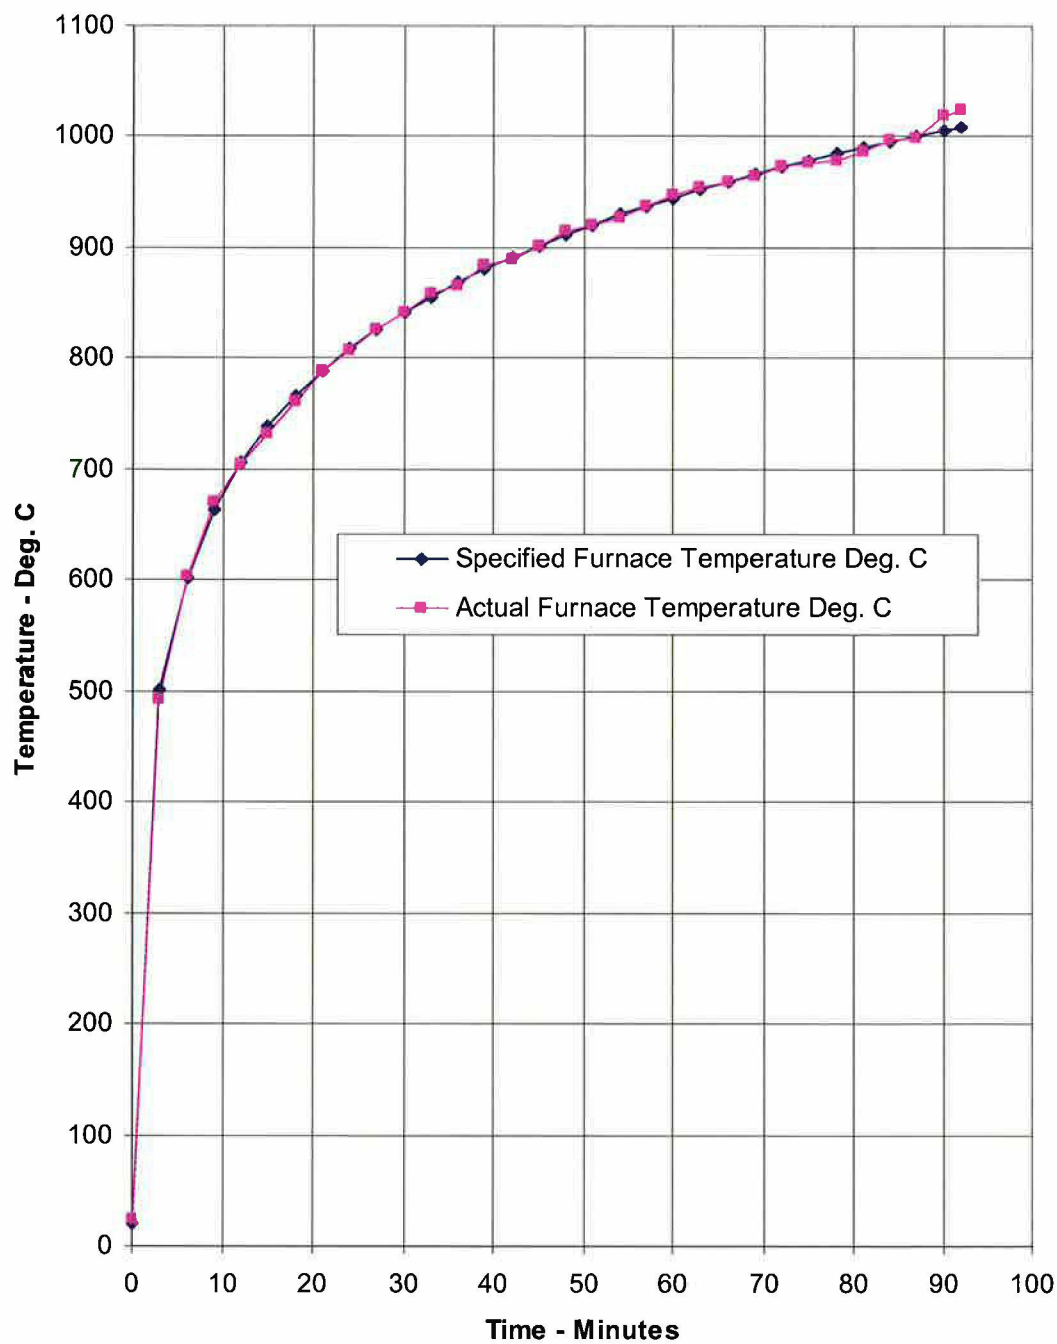
Graph showing mean furnace temperature, together with the temperature/time relationship specified in the Standard

Time Mins	Specified Furnace Temperature Deg. C	Actual Furnace Temperature Deg. C
0	20	24
3	502	493
6	603	604
9	663	671
12	706	705
15	739	732
18	766	762
21	789	789
24	809	807
27	826	826
30	842	842
33	856	858
36	869	865
39	881	884
42	892	890
45	902	901
48	912	916
51	921	921
54	930	927
57	938	938
60	945	947
63	953	954
66	960	959
69	966	965
72	973	973
75	979	977
78	985	979
81	990	987
84	996	997
87	1001	999
90	1006	1019
92	1009	1024

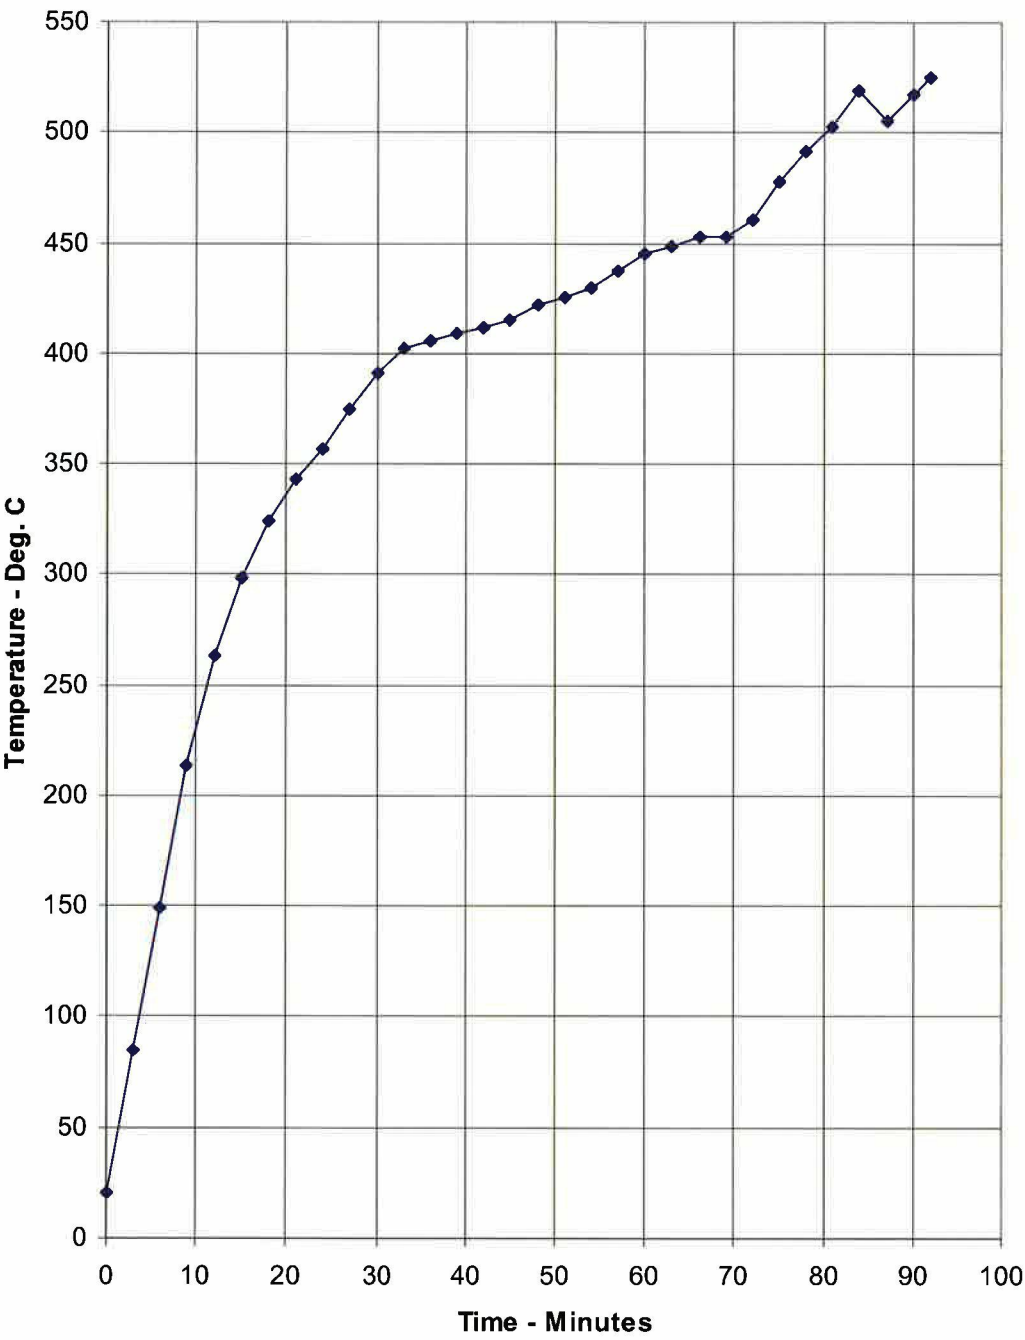
Graph showing mean temperature recorded on the surface of the duct by the thermocouples referenced T₂

Time Mins	T/C Number 10 Deg. C	T/C Number 11 Deg. C	T/C Number 12 Deg. C	T/C Number 13 Deg. C	Mean Temp. Deg. C
0	22	22	22	21	21
3	68	155	73	49	85
6	115	266	115	101	149
9	185	326	180	168	214
12	235	360	226	235	263
15	270	382	259	287	299
18	296	394	283	326	324
21	313	402	304	354	343
24	328	410	323	369	357
27	345	424	348	383	375
30	360	435	373	397	391
33	373	442	386	408	402
36	380	445	386	415	406
39	386	447	385	418	409
42	392	451	388	419	412
45	397	453	392	421	415
48	404	460	400	424	422
51	409	464	406	425	426
54	413	471	413	426	430
57	421	479	423	430	438
60	427	488	431	436	445
63	431	494	432	439	449
66	434	501	438	441	453
69	433	504	438	440	453
72	441	514	445	444	461
75	456	537	462	458	478
78	470	555	474	471	492
81	481	570	487	478	503
84	498	588	503	489	519
87	481	571	489	480	505
90	495	589	501	487	517
92	504	591	509	495	525

Cotton pad	92 minutes*
	*The test duration. The test was discontinued after a period of 92 minutes.
Insulation	The mean temperature rise of the unexposed surface shall not be greater than 140°C (determined by the mean value of the thermocouples referenced T₂) and the maximum temperature rise shall not be greater than 180°C. Insulation failure also occurs simultaneously with integrity failure as specified in BS EN 1363-1: 1999. A maximum temperature rise greater than 180°C was recorded after a test duration of 3 minutes
Smoke leakage	Smoke leakage - failure in accordance with the performance criterion of leakage is deemed to occur when leakage through the fire damper exceeds 200m³/h.m² measured after the first 5 minutes of the test duration. The test specified that an under pressure of 300 ± 15 Pa be utilised. The specimen did not satisfy this criterion after the first five minutes of the test.

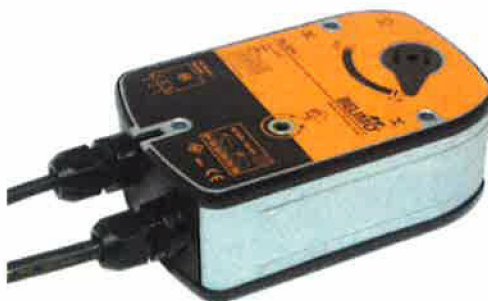
Actuator for
smoke control dampers 90° ↺.

- Torque 15 Nm
- Nominal voltage AC/DC 24 V
- Control: Open/close
- Damper rotation: 12 mm form-fit

Electrical data	Nominal voltage	AC 24 V, 50/60 Hz / DC 24 V
	Nominal voltage range	AC 19.2 ... 28.8 V / DC 21.6 ... 28.8 V
	Switching thresholds	min. ON voltage AC 19.2 V / DC 21.6 V
		max. OFF voltage AC 6.5 V / DC 6.5 V
	Power consumption	motoring 7.5 W @ nominal torque
		holding < 0.5 W
		for wire sizing 9 VA / I _{max} . 2.7 A @ 5 ms
	Auxiliary switch	2 x SPDT
	Contact rating (contacts gold plate on silver)	1 mA ... 3 A, DC 5 V ... AC 250 V □
	Switching points	3° ↺ / 87° ↺ (referred to 0 ... 90° ↺)
Functional data		Tolerance ±2° ↺
	Connecting cable	motor 1 m, 3 x 0.75 mm ² (halogen-free)
		auxiliary switch 1 m, 6 x 0.75 mm ² (halogen-free)
	Torque (nominal torque)	Min. 15 Nm @ nominal voltage
	Blocking torque	dynamic Min. 15 Nm
		steady-state Min. 20 Nm
	Direction of rotation	Selected by mounting L/R
	Angle of rotation	Max. 105° ↺
		(incl. mechanical overrun on each side)
	Running time	< 30 s for 90° ↺
Safety	Sound power level	Max. 62 dB (A)

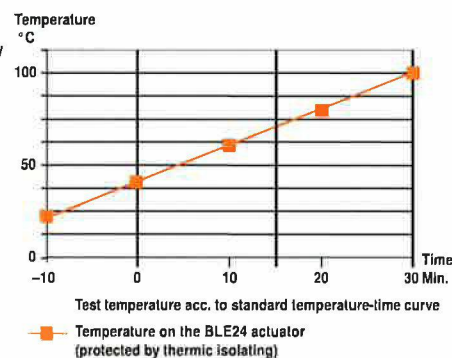
Safety function	The safety function is guaranteed within the temperature range shown in the diagram below which is based on standard ÖNORM H 6029 and DIN 18232.

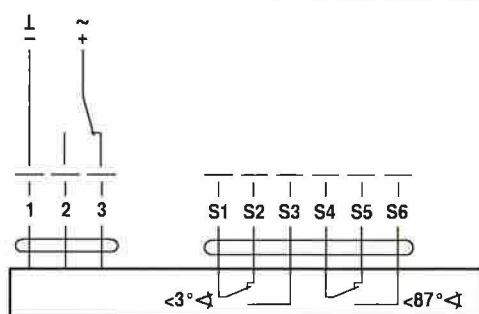
Wiring diagram

- Supply via safety isolation transformer
- Parallel connection of several actuators possible. Power consumption and switching thresholds must be observed!
