THE GRENFELL TOWER INQUIRY

EXHIBIT TNG/6

This is the Exhibit marked “TNG/6”
referred to in the witness statement
of Tobias Neville Guise

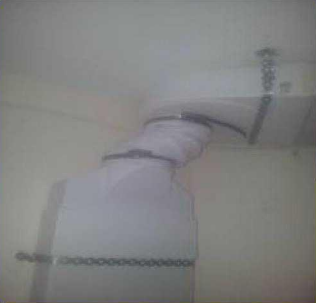
Grenfell Tower 9497						GREEN HIGHLIGHT - VERY GOOD STANDARD	YELLOW HIGHLIGHT - NOT YET ACTIONED							CALL OUT RISK			POTENTIAL COST OF CALL			DATE RECTIFIED	COMMENTS
No of inspections	Item Number	DATE OF INSPECTION	BLOCK / FLOOR / PLOT	LOCATION	ISSUE DESCRIPTION / STANDARD	PICTURE	JSW / SUB CONTRACTOR	STATUS	SNAGGED Y / N	COMMISSIONED	HANDED OVER	GOOD PRACTICE	LOW	MEDIUM	HIGH	LOW	MEDIUM	HIGH			
8	1	02/09/2015	mezzanine floor	Kitchen	Flex ductwork has not been fully connected also it is heavily restricted
