# BRE Global Test Report

**BS 8414-1:2015 + A1:2017 test on ventilated façade system with phenolic thermal insulation and ACM (ALPOLIC/A2) Cassette panels BML 100 Hook On**

**Prepared for:** Mitsubishi Chemical Corporation

**Report Number:** P109973-1000 **Issue:** 1.0

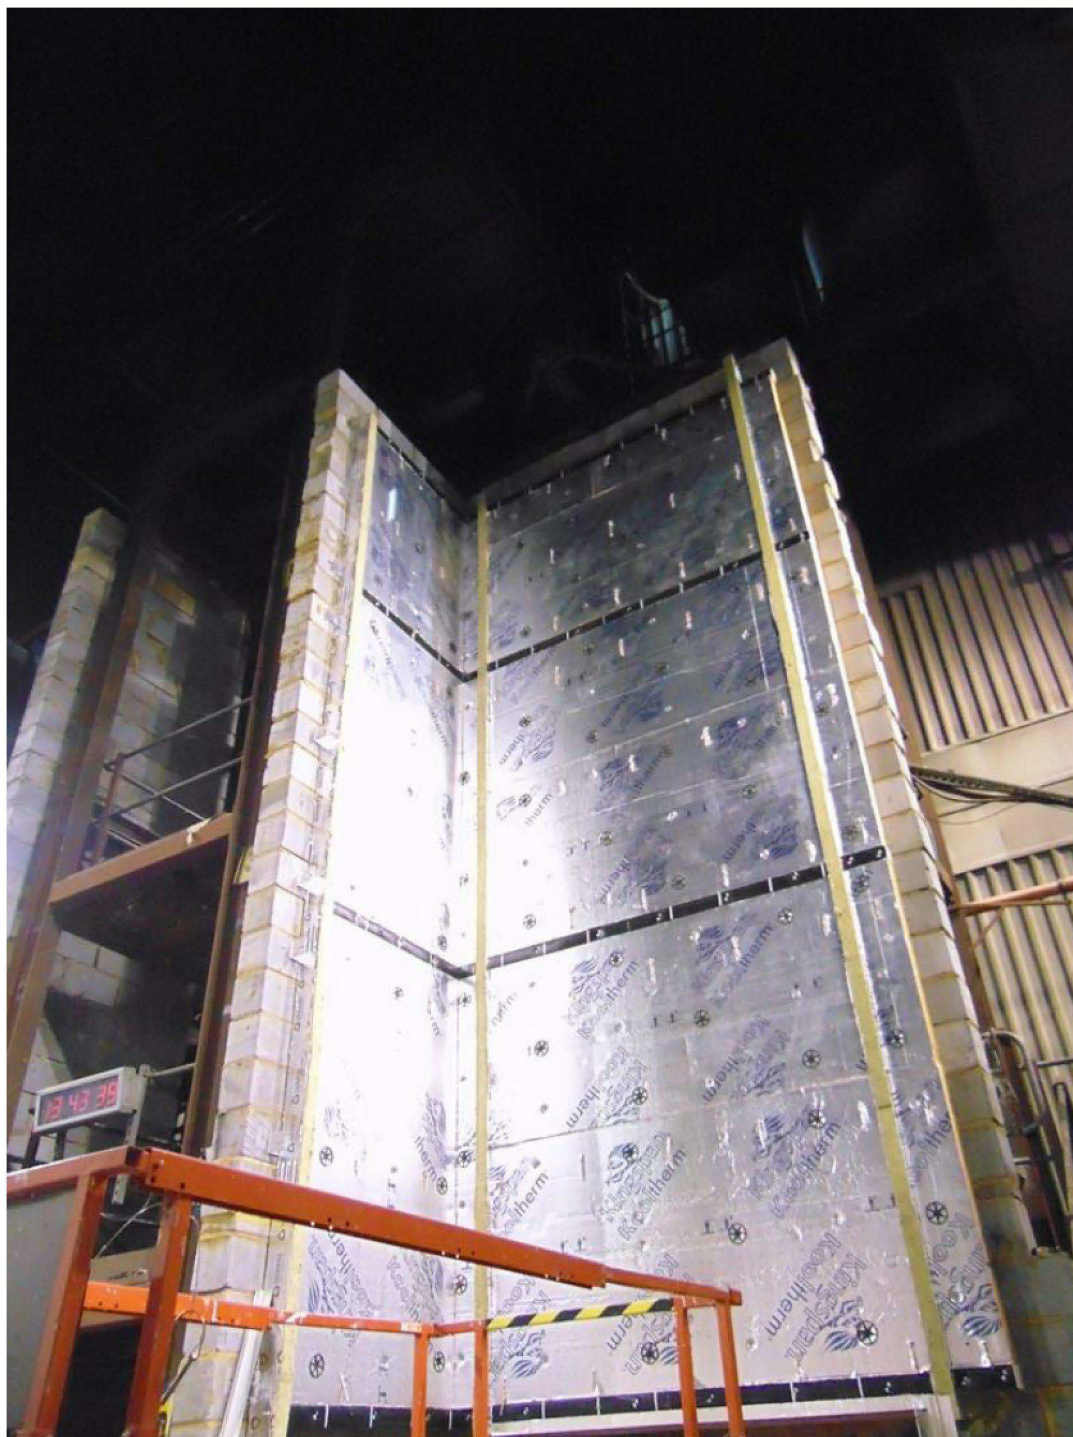
Figure 4. Installation of the thermal insulation, vertical and horizontal cavity barriers

The system included vertical and horizontal cavity barriers. On the main face, two 75mm-wide×150mm-deep stone wool vertical cavity barriers, with 10mm compression, were fixed in position either side of the combustion chamber opening with a clear distance of 2100mm between them.

A set of four 75mm-wide×115mm-deep intumescent horizontal cavity barriers were butted up to the continuous vertical barriers and fixed in rows at approximate heights of:

The 100mm-thick K15 insulation boards (supplied in 1200mm×600mm and cut to fit) were installed in position through the substructure bracket fixing systems and fixed to the support structure (masonry wall) using six 125mm-long× $\phi$ 8mm plastic anchors and six 140mm-long× $\phi$ 8mm stainless steel anchors per full size panel. On the main wall the insulation panels were installed with the long edge orientated horizontally. On the wing wall the insulation panels were installed with the long edge orientated vertically. All the gaps between the insulation panels and the intersection with aluminium brackets or fixings were sealed with aluminium tape as recommended by the manufacturer.

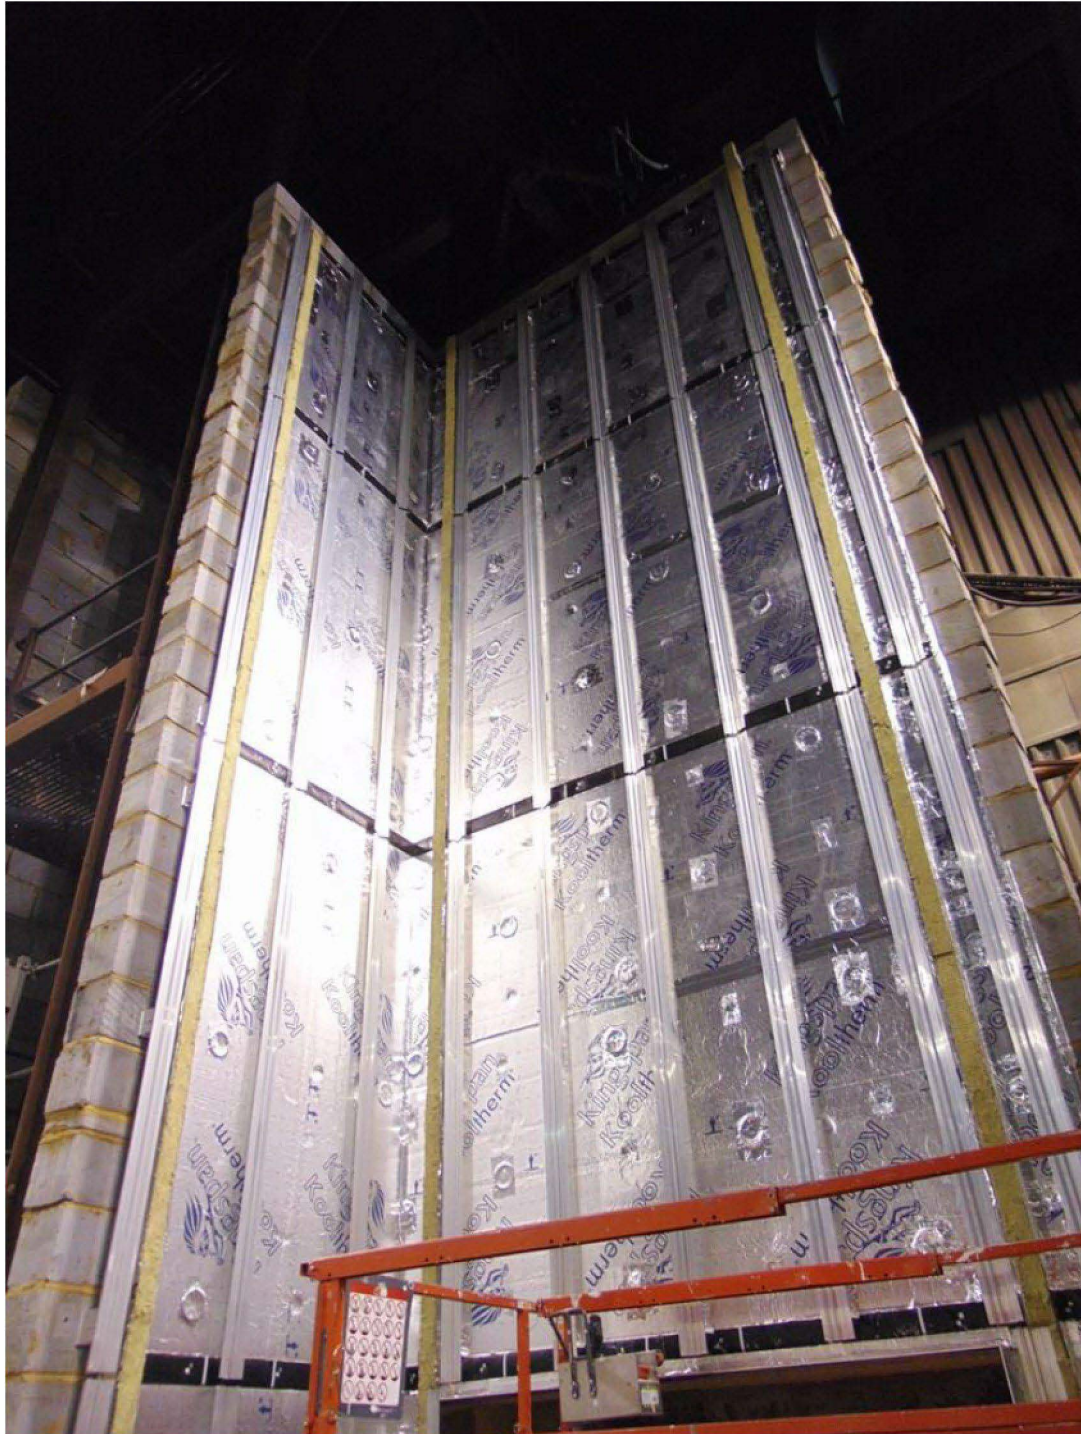
Figure 6. Aluminium substructure, cavity barriers (horizontal and vertical) and thermal insulation installed on the system.

After the insulation was fixed in position the 'Y'-section framing were installed at horizontal spacings ranging from 300mm to 500mm. The aluminum vertical rails, with a typical length of 2300mm, were positioned 10mm inside the thermal insulation with each rail fixed to the brackets with 2×4.8×16mm self-drilling, self-tapping, stainless steel screws. The aluminum rails were installed with a 30mm gap at the floor levels to allow for structural movement. Three brackets supported each section of rail: the middle bracket was fixed while the top and bottom brackets were connected with movement holes.

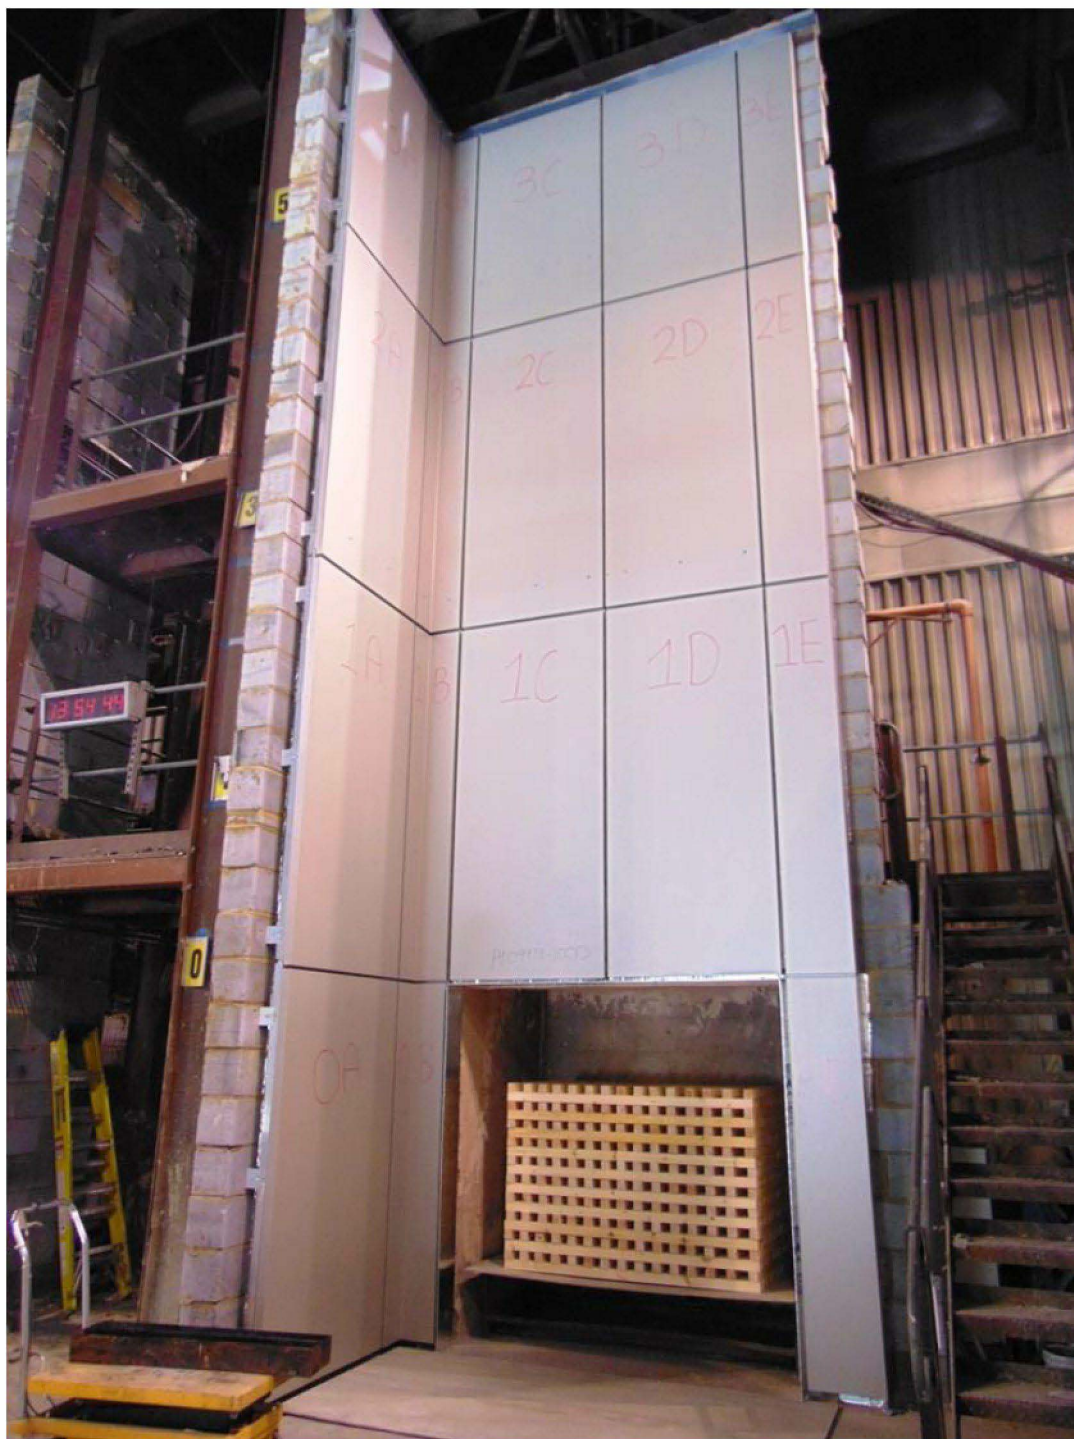
Figure 8. Completed installation prior to test.

Figures 11-14 provide the temperature profiles recorded during the test. Figure 8 shows the system before the test.

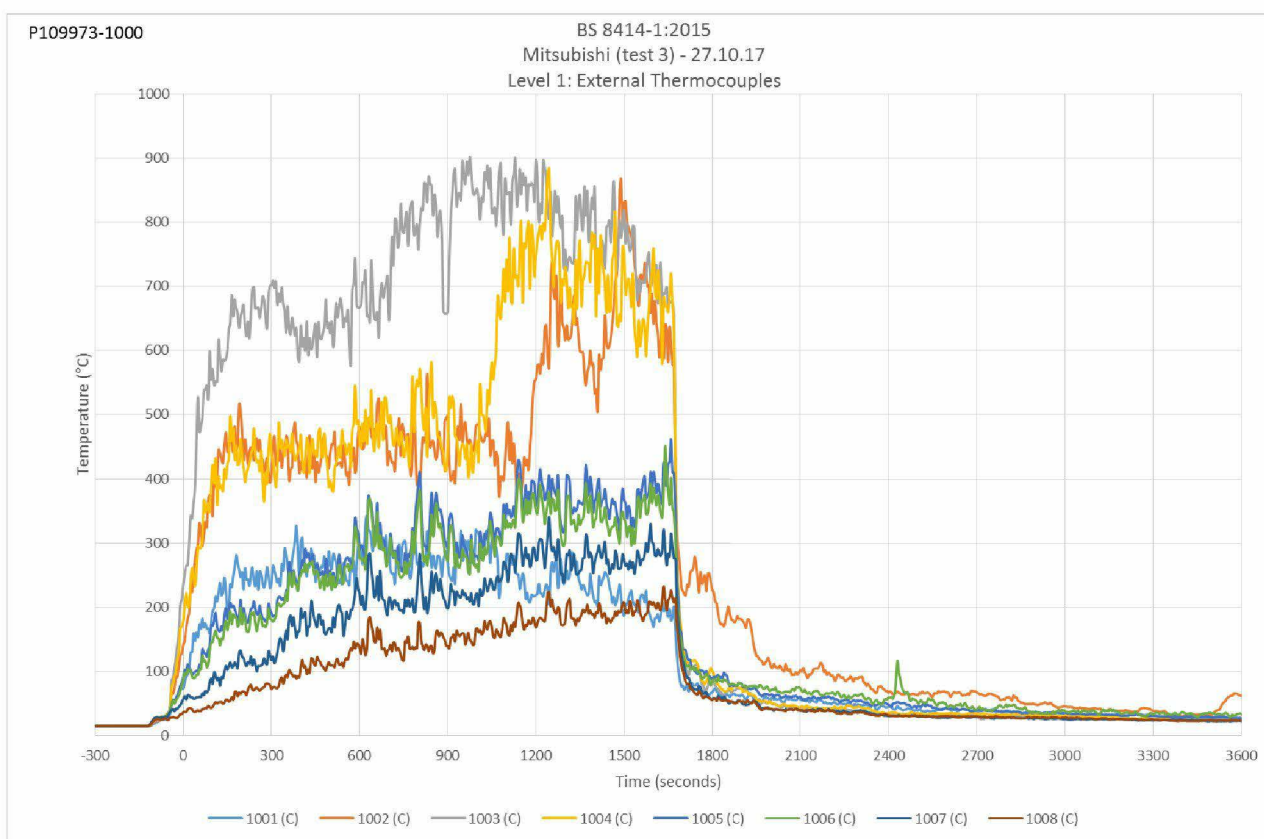
Figure 11. Level 1 external thermocouples.

$t_s$  = 2 minutes and 10 seconds after ignition of the crib.

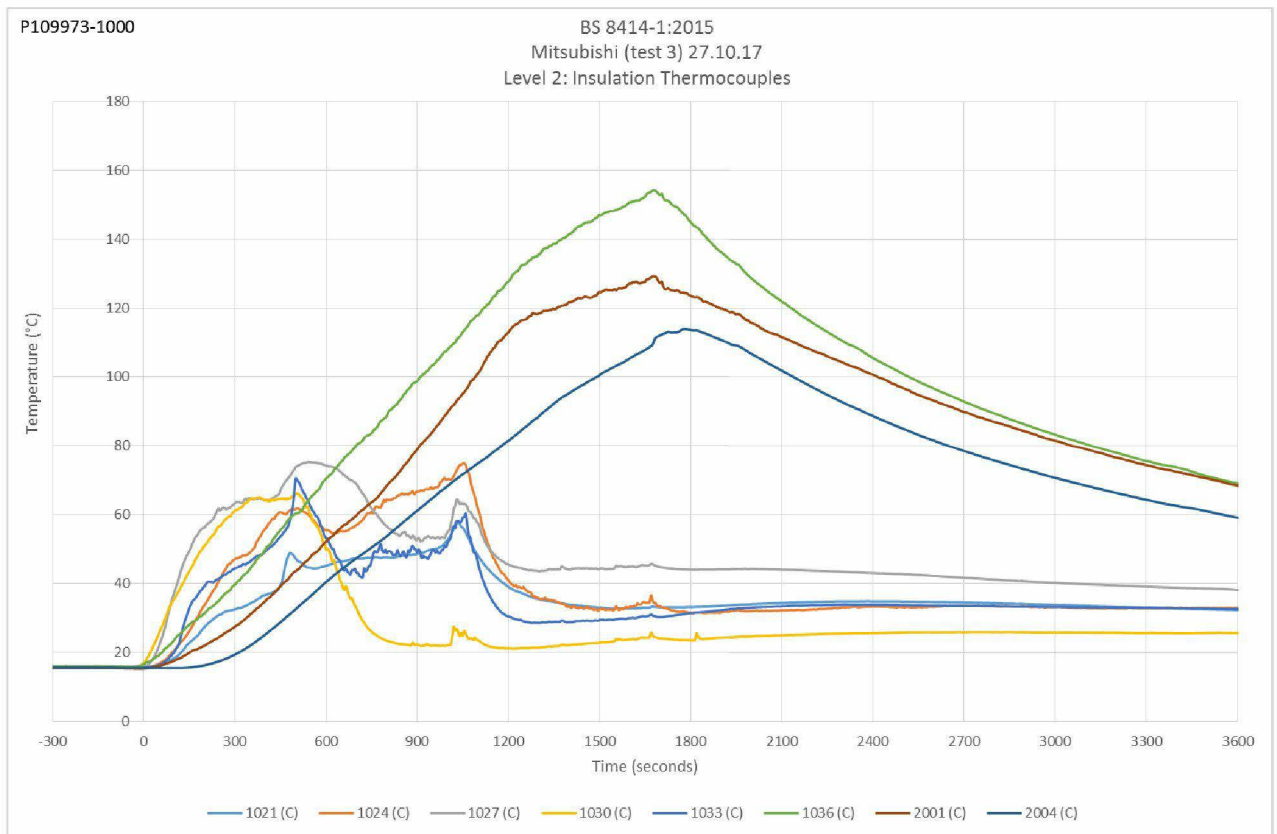
Figure 14. Level 2 insulation thermocouples.

$t_s$  = 2 minutes and 10 seconds after ignition of the crib.

Parameter	Result
T <sub>s</sub> , Start Temperature	15°C
t <sub>s</sub> , Start time	2 minutes and 10 seconds after ignition of crib.
Peak temperature / time at Level 2, External	442°C (19 minutes and 45 seconds after t <sub>s</sub> ).
Peak temperature / time at Level 2, cavity	613°C (29 minutes and 10 seconds after t <sub>s</sub> )
Peak temperature / time at Level 2, insulation	154°C ( 27 minutes and 55 seconds after t <sub>s</sub> )

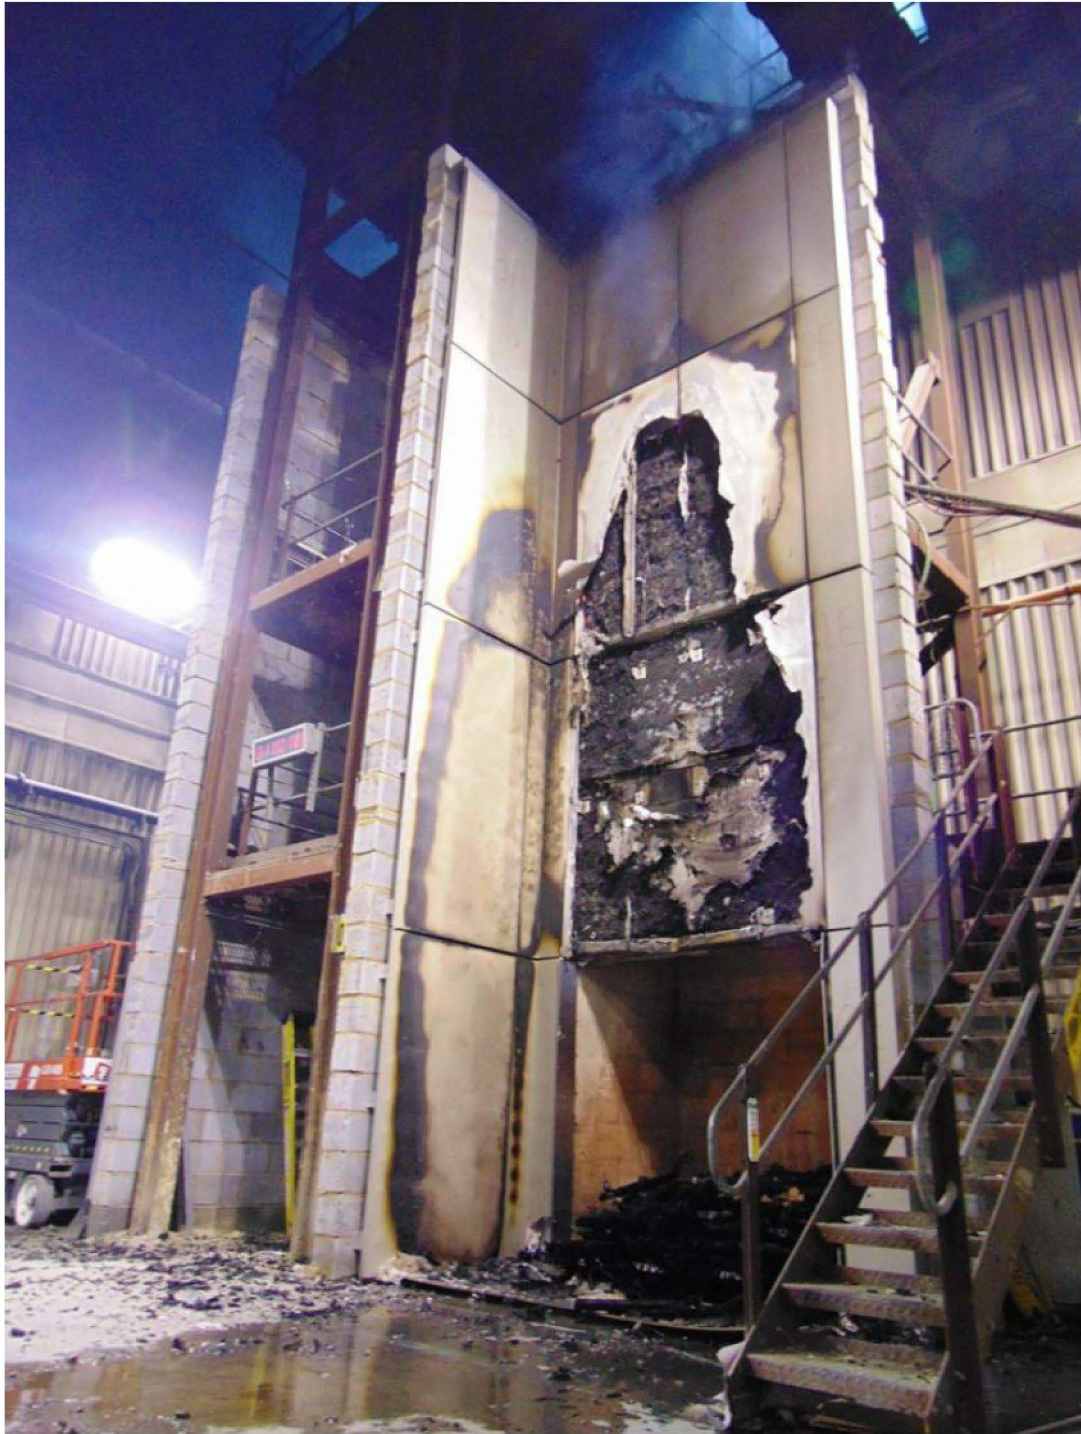
Figure 15. Full height of the system post-test (main and wing wall).

The fire damage to the cladding system on the main wall was contained within the bounds of the vertical cavity barriers across the combustion chamber opening. The cavity barriers remained intact. There was significant charring and discolouration along the inside edges running parallel to the vertical edges of the combustion chamber.

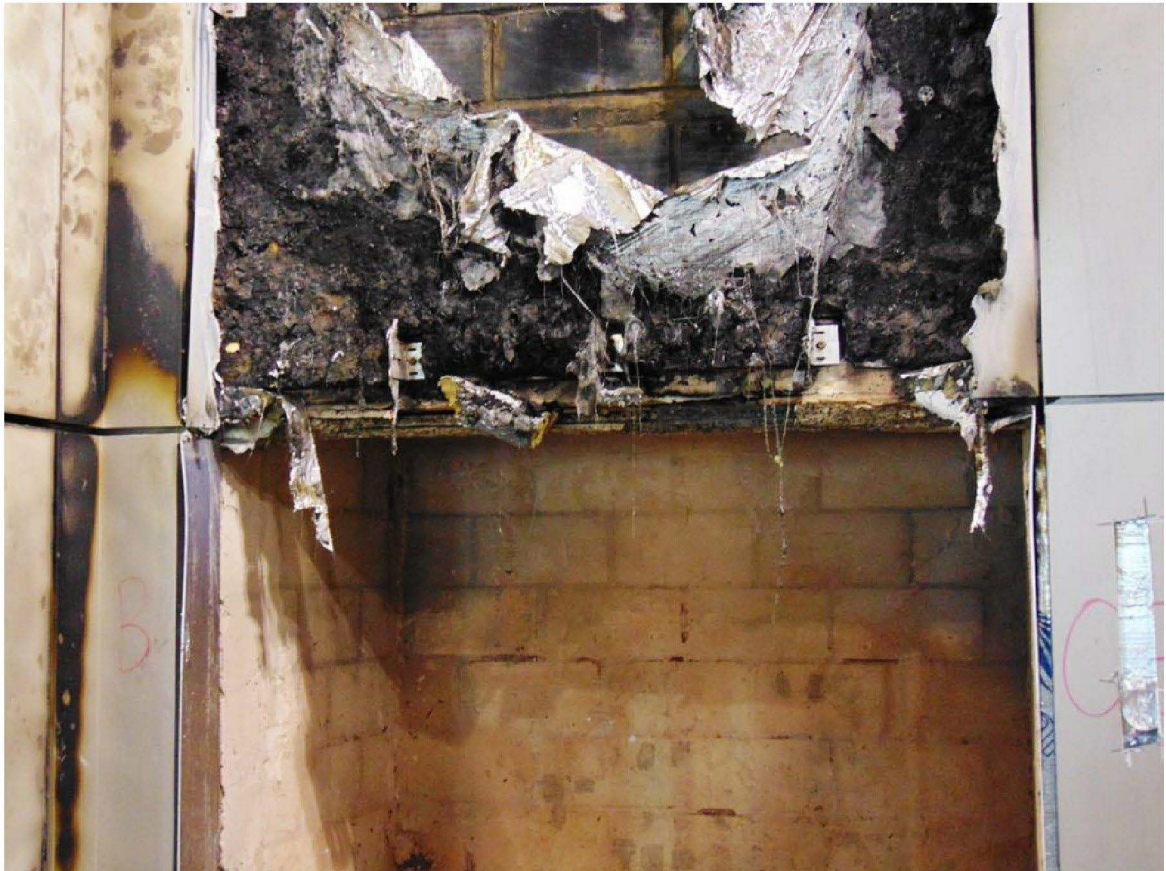
Figure 16. Row 0 post-test (combustion chamber, main and wing wall).

Panel 0A had significant distortion and approximately 90% discoloration.

Panel 0B had visible distortion and discoloration (<40%).

Panel 0E did not sustained any visible damage.

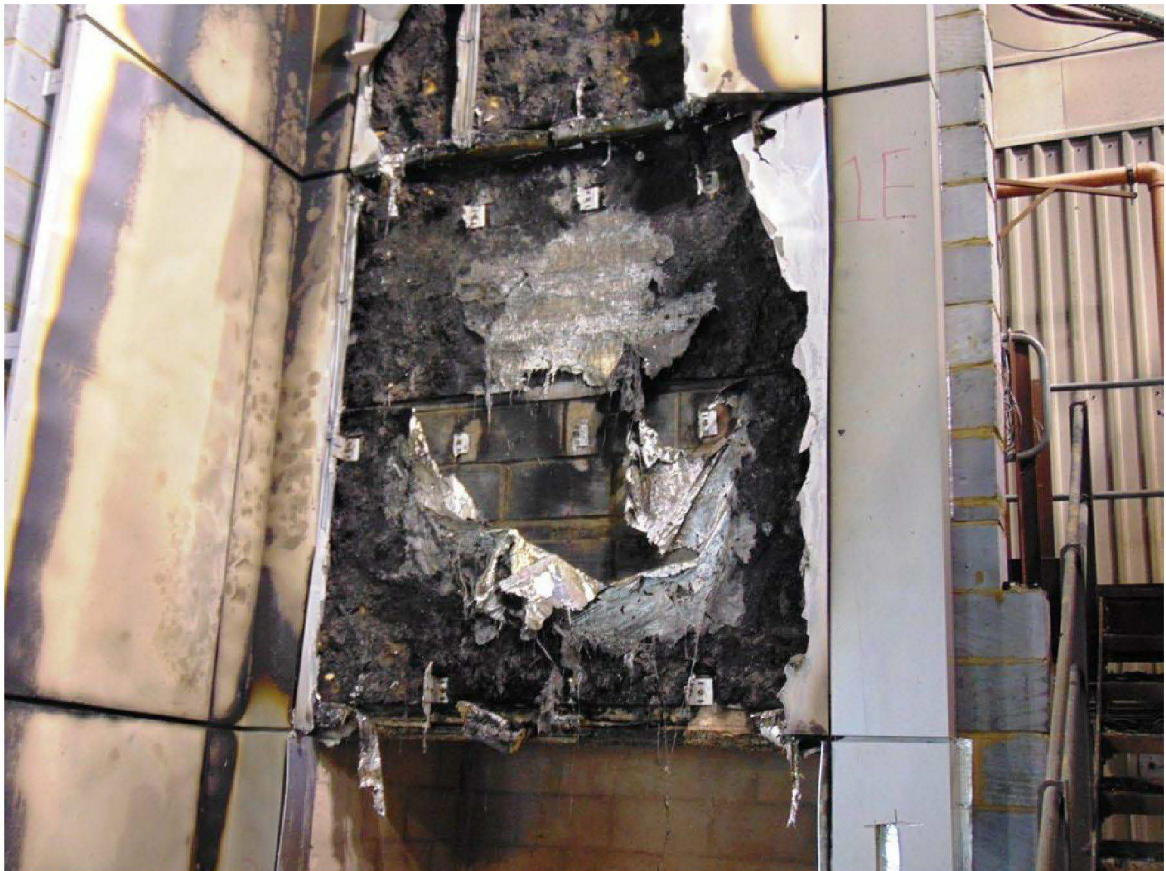
Figure 17. Row 1 post-test (main and wing wall, approximately 2300mm above combustion chamber).

Panel 1A had significant distortion and approximately 90% discoloration.

Panel 1B had distortion and discoloration on surface.

Panel 1C had significant damage and consumption up to 95%-100%.

Panel 1D had significant damage and consumption approximately 90%-95%.

Panel 1E had minor distortion on the surface.

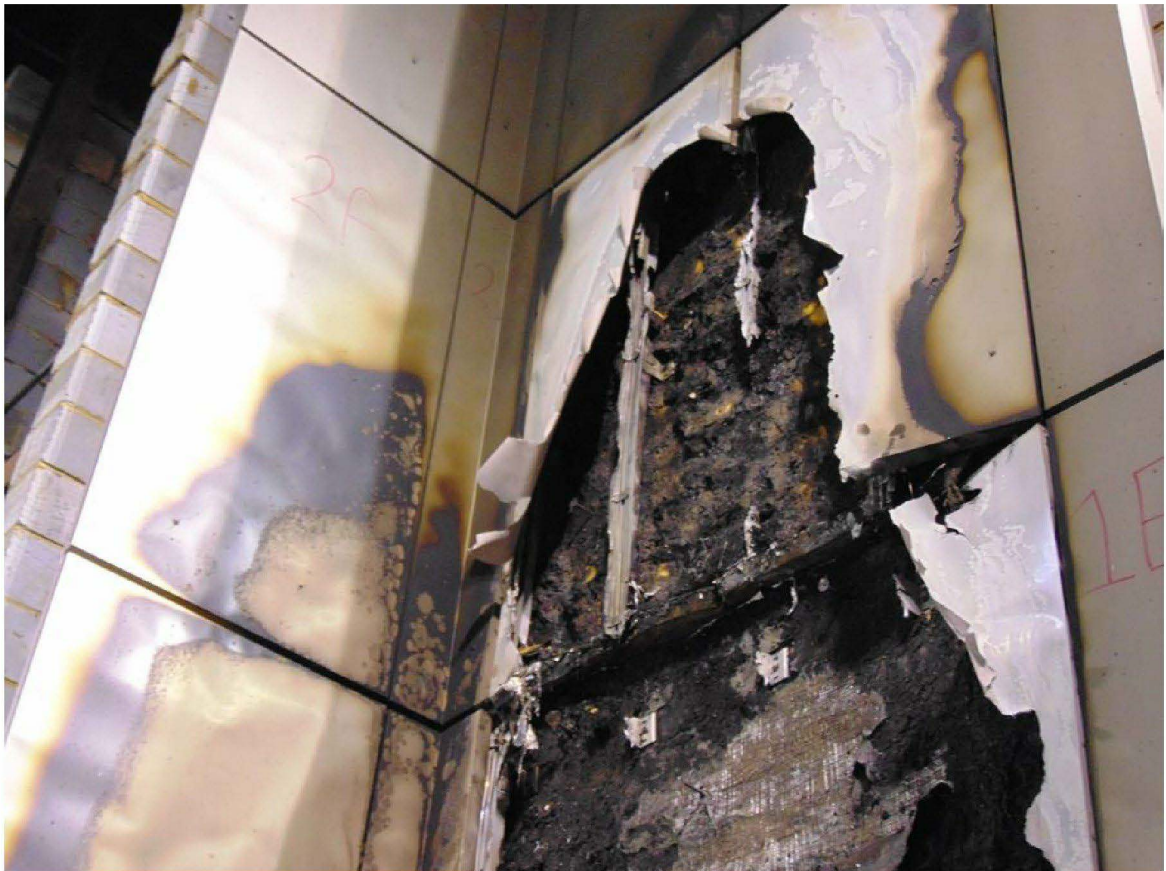
Figure 18. Row 2 post-test (main and wing wall, approximately 2300mm –4600mm above combustion chamber).

Panel 2A had distortion and discoloration on surface (up to 30%-35%).

Panel 2B had distortion and discoloration on surface (approximately 25%-30%).

Panel 2C had significant damage and consumption of approximately 55%-60%.

Panel 2D had significant damage and consumption up to 40%-45%.

Panel 2E had minor discoloration on the left hand edge (looking to main wall).

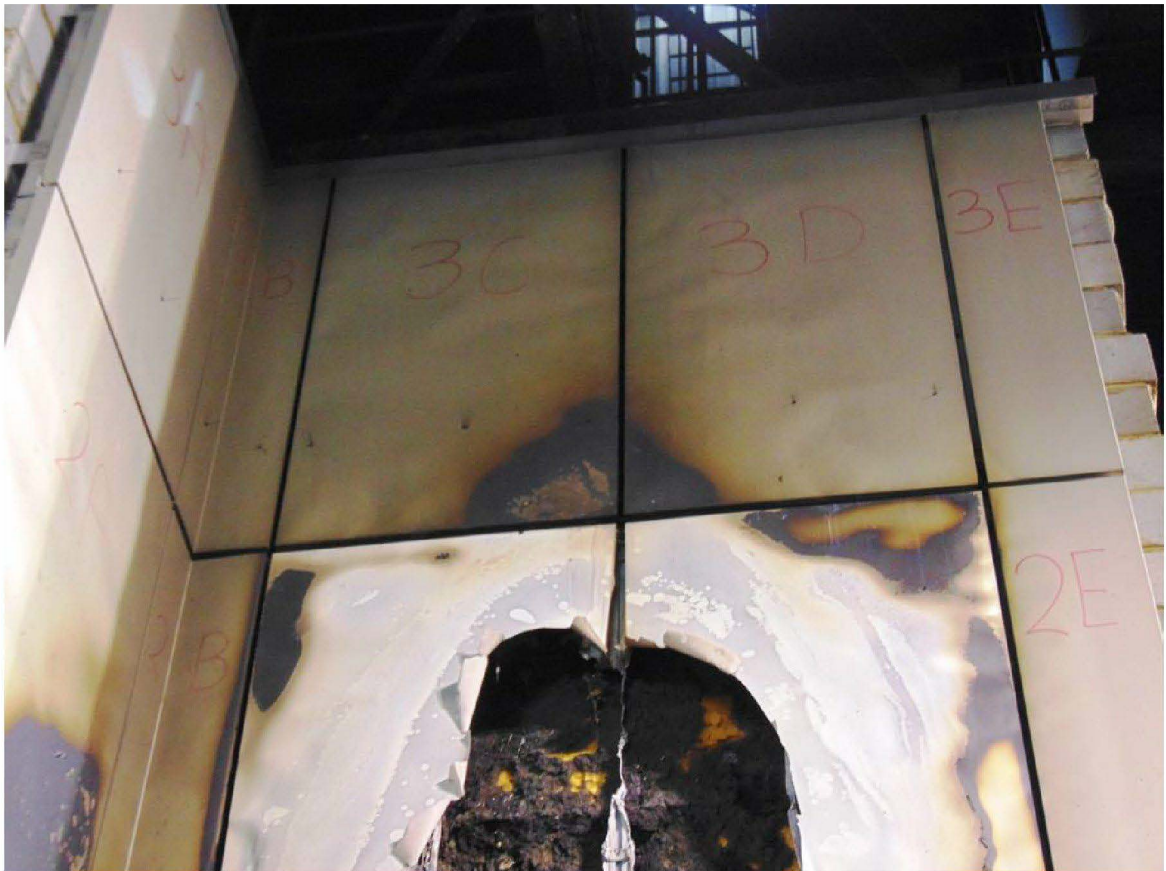
Figure 19. Row 3 post-test (main and wing wall, approximately 4600mm – 6500mm above combustion chamber).

Panel 3A did not sustained any visible damage.

Panel 3B did not sustained any visible damage.

Panel 3C had distortion and discoloration at the bottom edge (horizontal joint between 2C&3C).

Panel 3D had distortion and discoloration at the bottom edge (horizontal joint between 2D&3D).

Panel 3E did not sustained any visible damage.

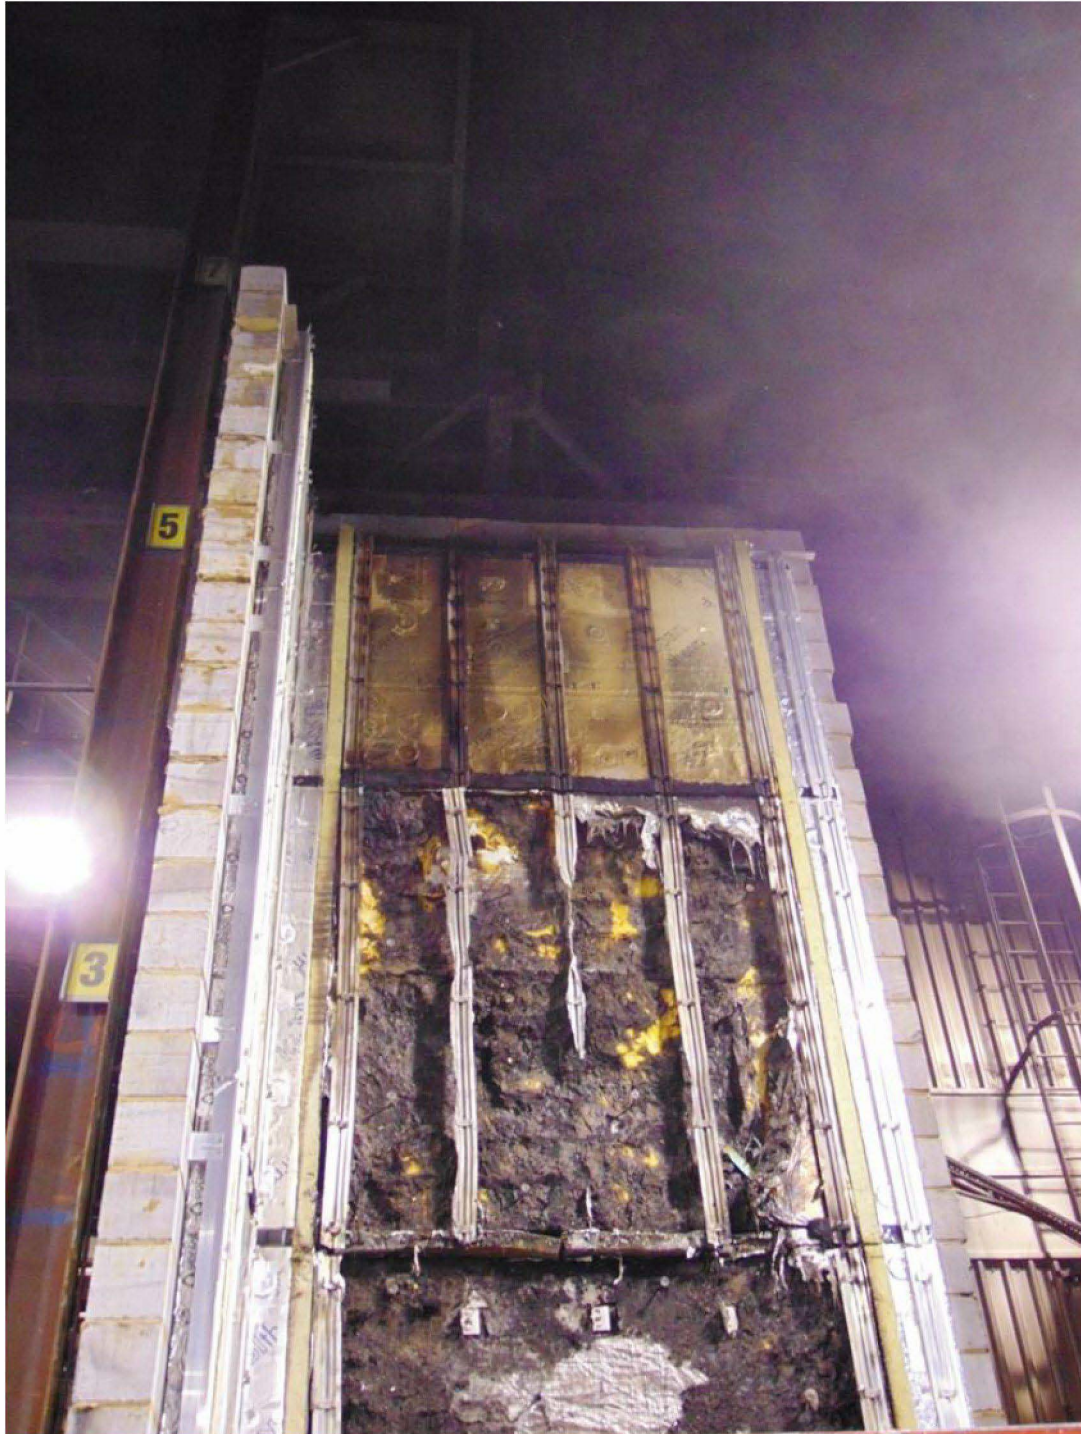
Figure 20. Aluminium rail substructure and thermal insulation following removal of ACM panels (main wall, approximately 1800mm-6500mm above the combustion chamber).

The central aluminium 'Y'-shaped rail on the main wall was intact from a height of approximately 4.0m-4.4m. The adjacent aluminium 'Y'-shaped rails (500mm offset from central rail to left and right) were fully consumed up to a height of approximately 2.3m-2.4m (behind panels 1C&1D).

Behind panels 2C&2D and 3C&3D, the aluminium rails (500mm offset from central rail to left and right) were discoloured and slightly distorted.

Behind panels 3C&3D, the aluminium rails were intact and slightly discoloured.

The aluminium brackets situated immediately above the combustion chamber were severely damaged or melted.

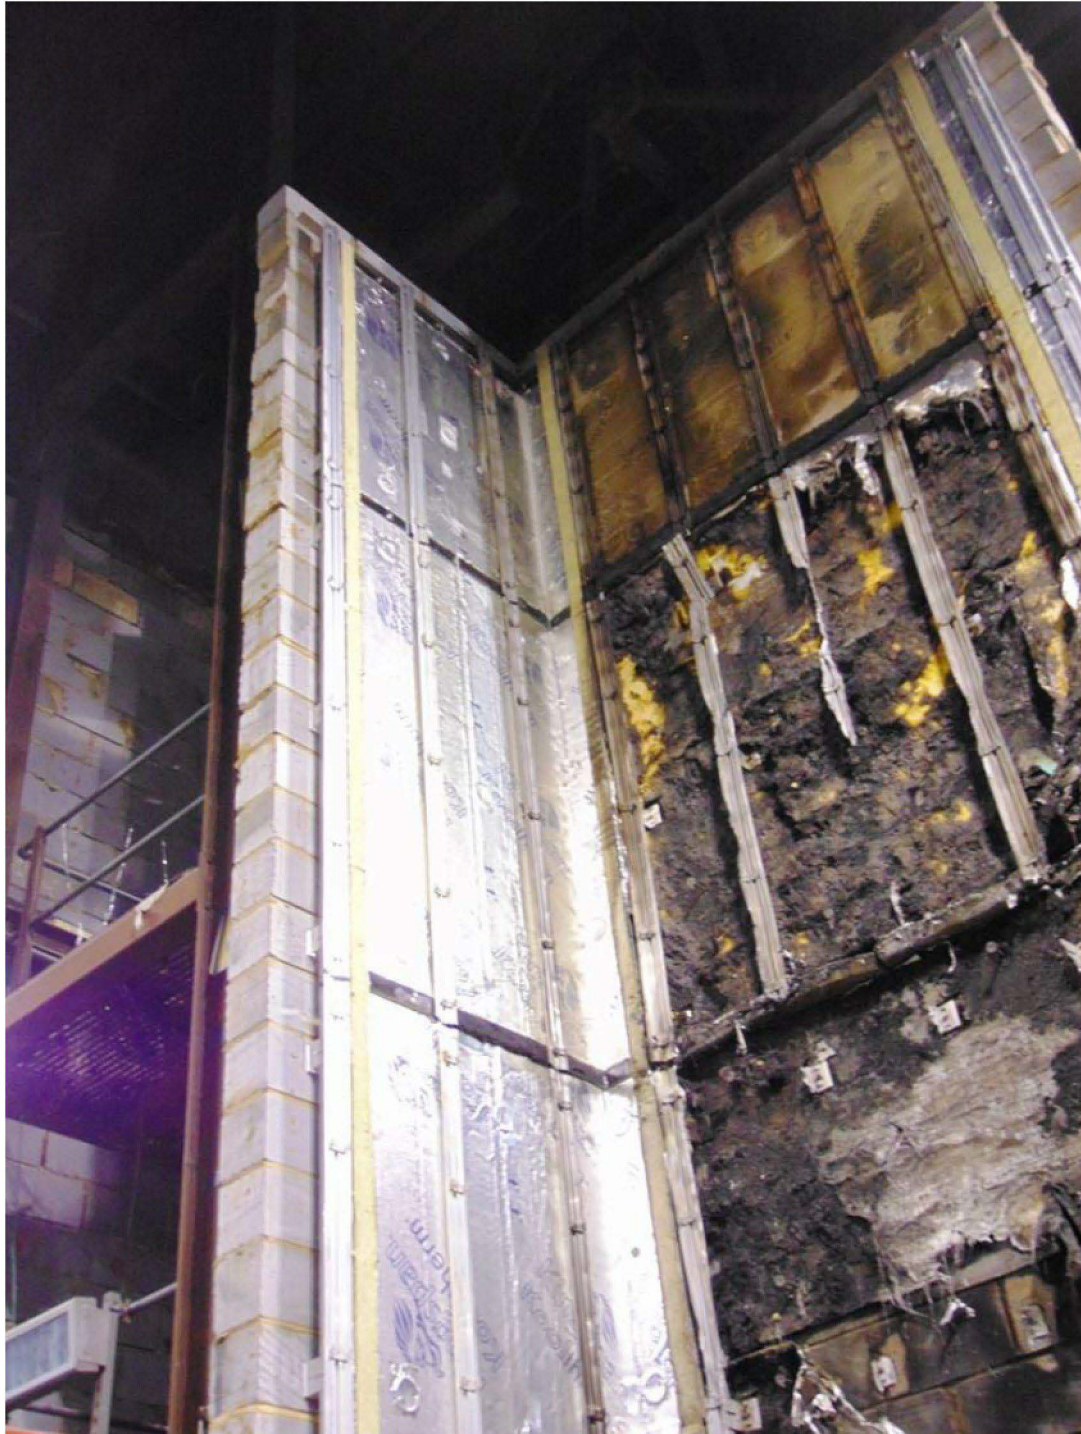
Figure 21. Aluminium rail substructure and thermal insulation following removal of ACM panels (wing wall, approximately 1300mm-6500mm above the combustion chamber).

Following the removal of the ACM panels from the wing wall the aluminium substructure which held the panels in place had not sustained significant damage.

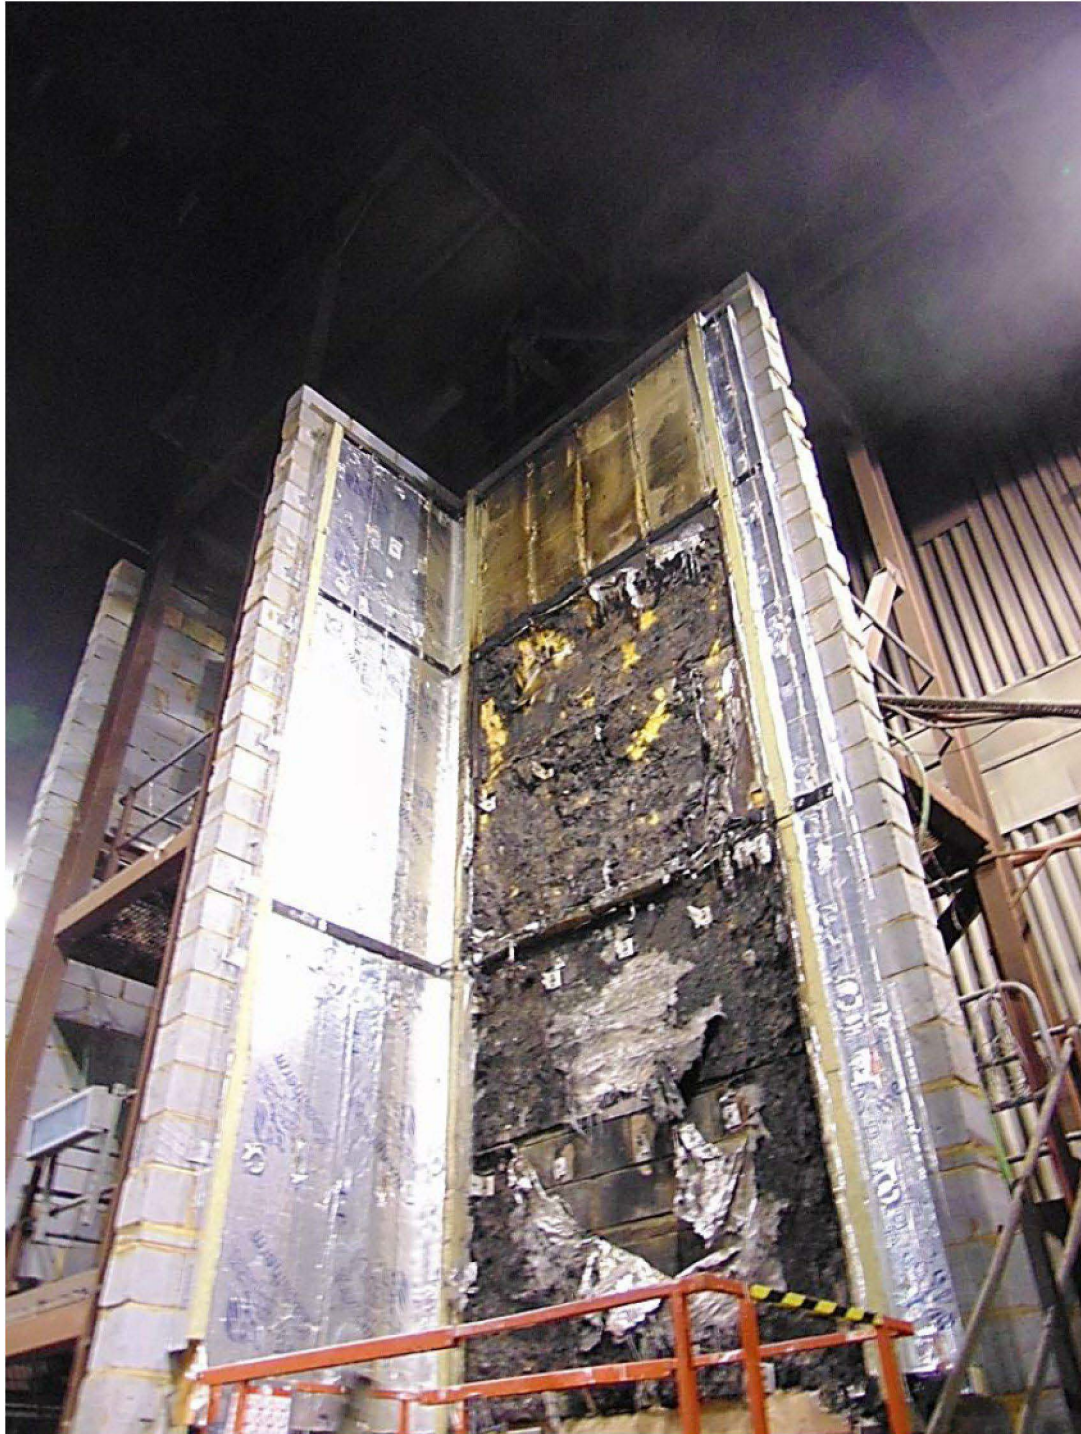
Figure 22. Thermal insulation following removal of ACM panels and aluminium substructure on the main and wing wall (approximately 200mm – 6500mm above combustion chamber).

Panel 1C had sustained significant damage and was consumed up to 90%-95%. The rear aluminum foil of the insulation was visible.

Panel 1D had sustained significant damage and was consumed up to 90%-95%. The rear aluminum foil of the insulation was visible.

Panel 2C had sustained significant damage and was consumed between 30%-80%. Uncharred material was visible to the top edge of the panel (underneath the horizontal cavity barrier).

Panel 2D had sustained significant damage and was consumed between 40%-80%. Uncharred material was visible to the top edge of the panel (underneath the horizontal cavity barrier).

Panel 3C had discoloration on surface, from white to dark yellow. The aluminium foil remained attached to the insulation.

Panel 3D had discoloration on surface, from white to dark yellow. The aluminium foil remained attached to the insulation.
