BRE Global Test Report

Classification of fire performance in accordance with BR 135: 2013 Annex A for a ventilated façade system with Kingspan (K15) thermal insulation and ACM panels Booth Muirie BML400 rivet fixed

Report Number: P109971-1001 Issue: 1.0

Product name: Ventilated façade system with Kingspan (K15) thermal insulation and ACM panels Booth Muirie BML400 rivet fixed

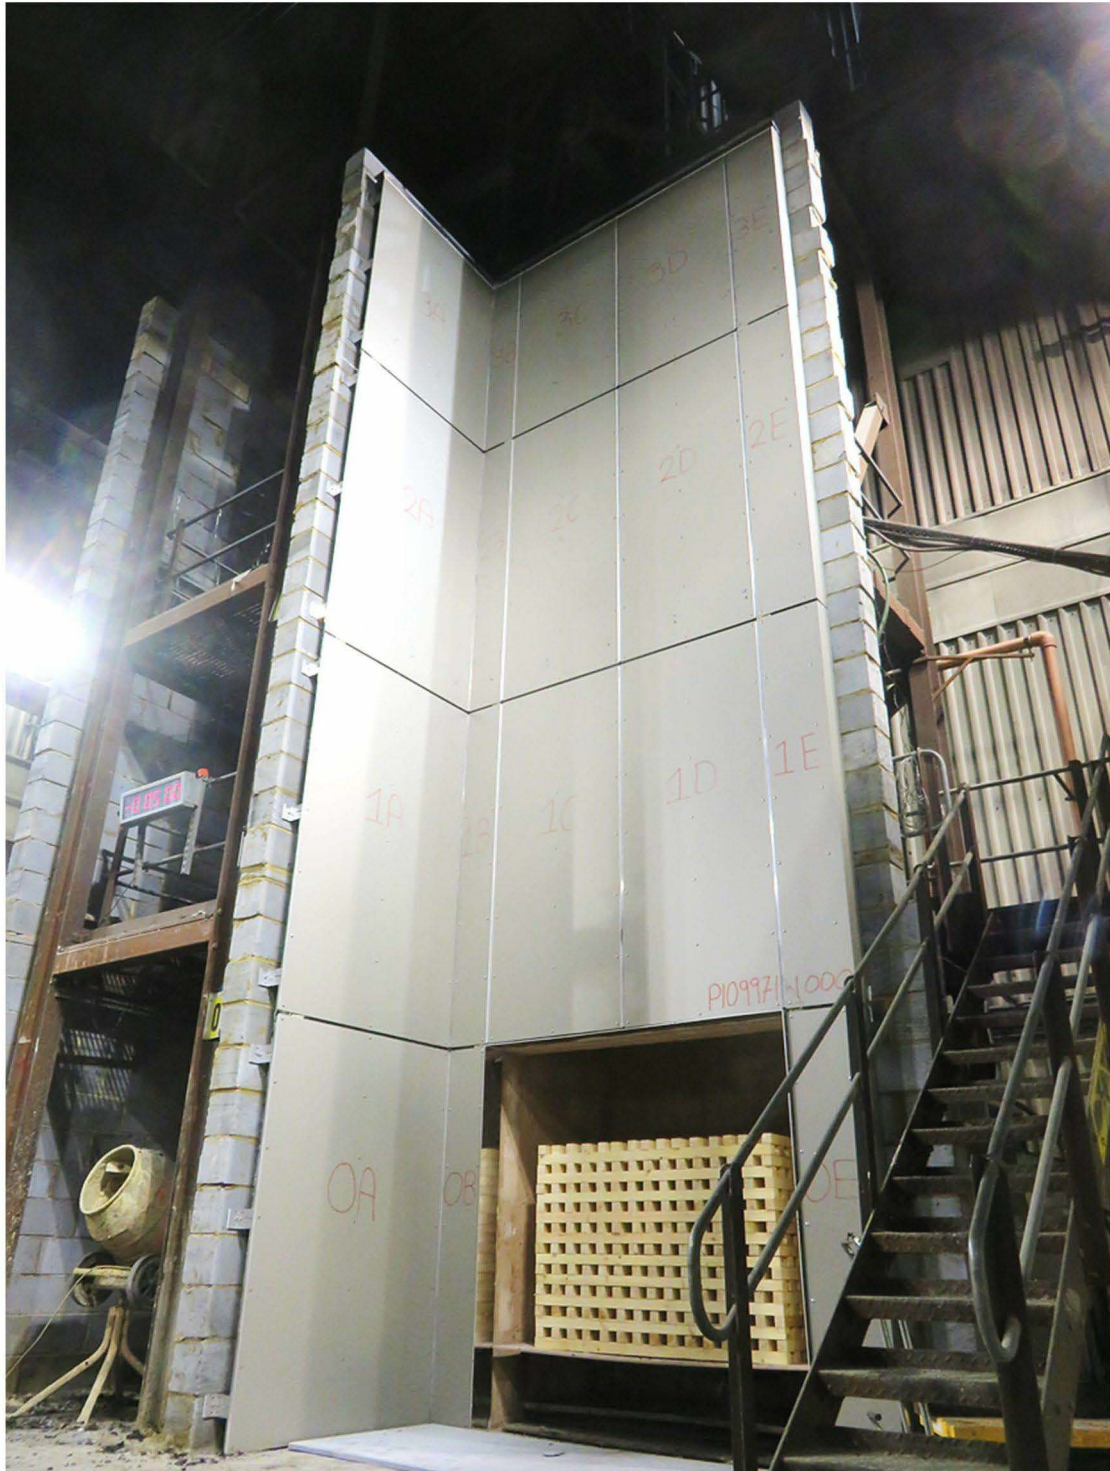
Figure 1. Completed installation prior to test.
