## BRE Global Classification Report

**Classification of fire performance in accordance with BR 135: 2013  
Annex A for a ventilated façade system with Kingspan Kooltherm K15 insulation  
and Alpolic/fr panels.**

**Report Number:** P109939-1001 Issue 1

**Product name:** Ventilated façade system with Kingspan Kooltherm K15 insulation and Alpollic/fr  
ACM panels installed with a 10mm ventilation gap between panels on all sides.

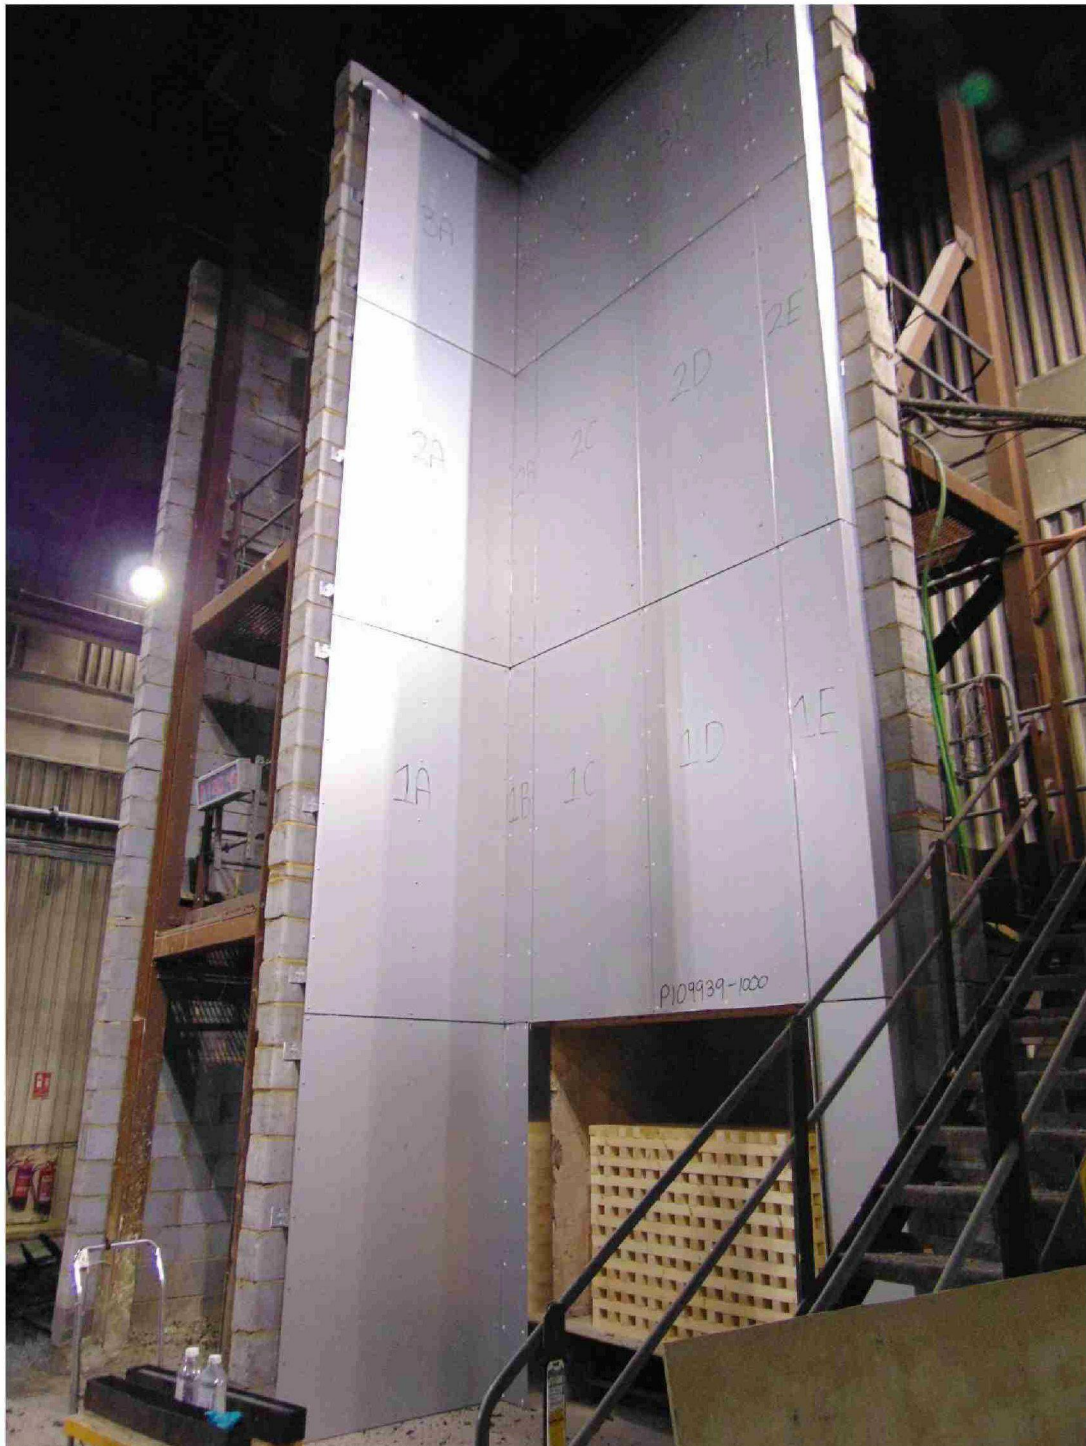
Figure 1. The main wall of system prior to test.

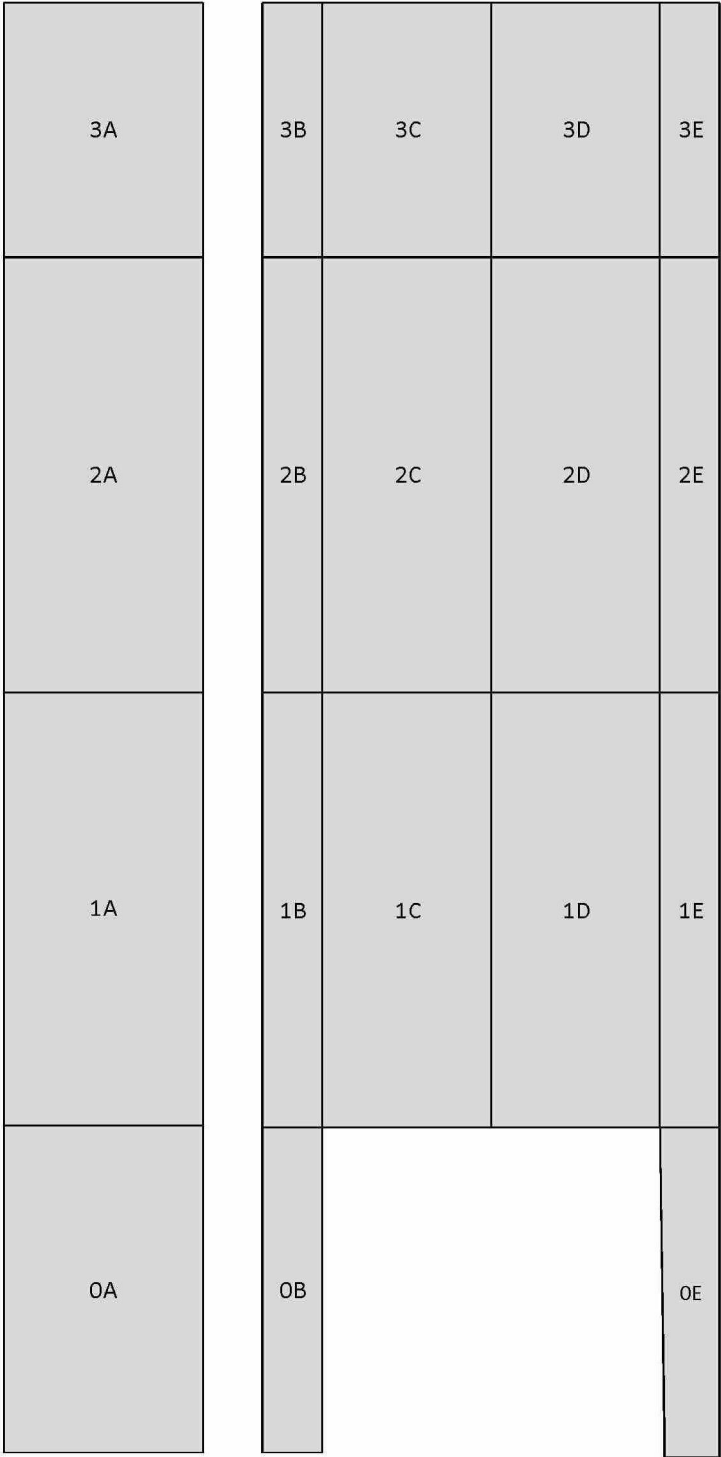
Figure 2. Layout of panels and numbering system used for reporting. Not to scale.

With reference to *Figure 2*, the panel widths were:

Column 'A' (wing wall) - 1340mm

Column 'B' - 288mm

Column 'C' - 993mm

Column 'D' - 992mm

Column 'E' - 385mm

The panel heights were:

Row 0 - 1985mm,

Row 1- 2320mm,

Row 2 - 2320mm

Row 3 - 1830mm

The insulation under panels (with reference to figure 2):

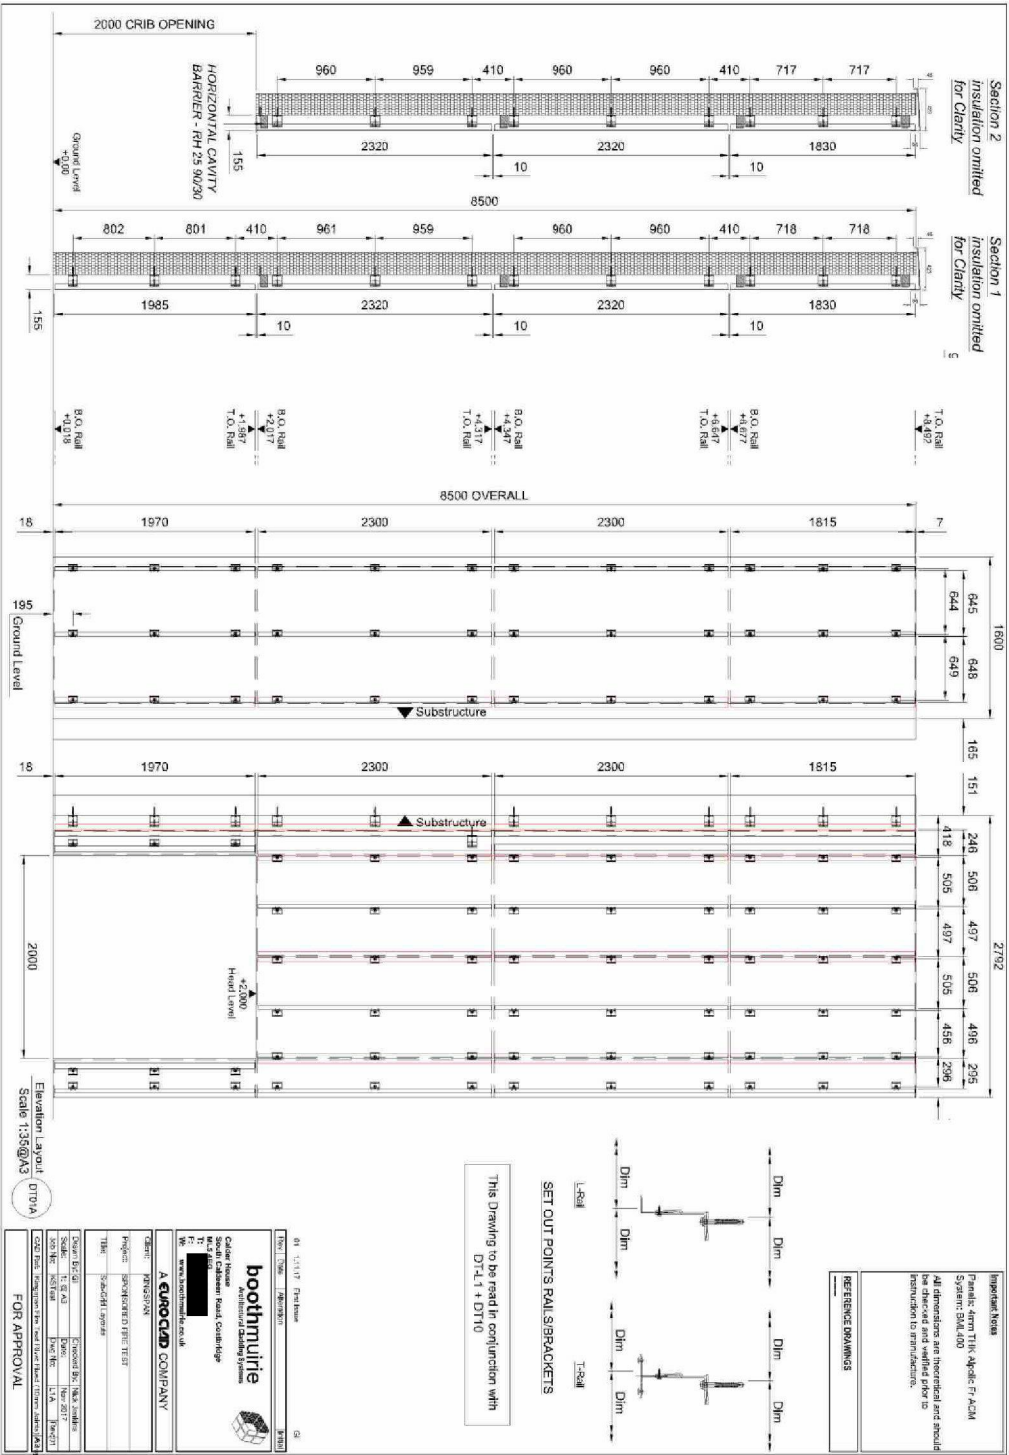
Figure 3. Elevation drawings (supplied by the test sponsor).

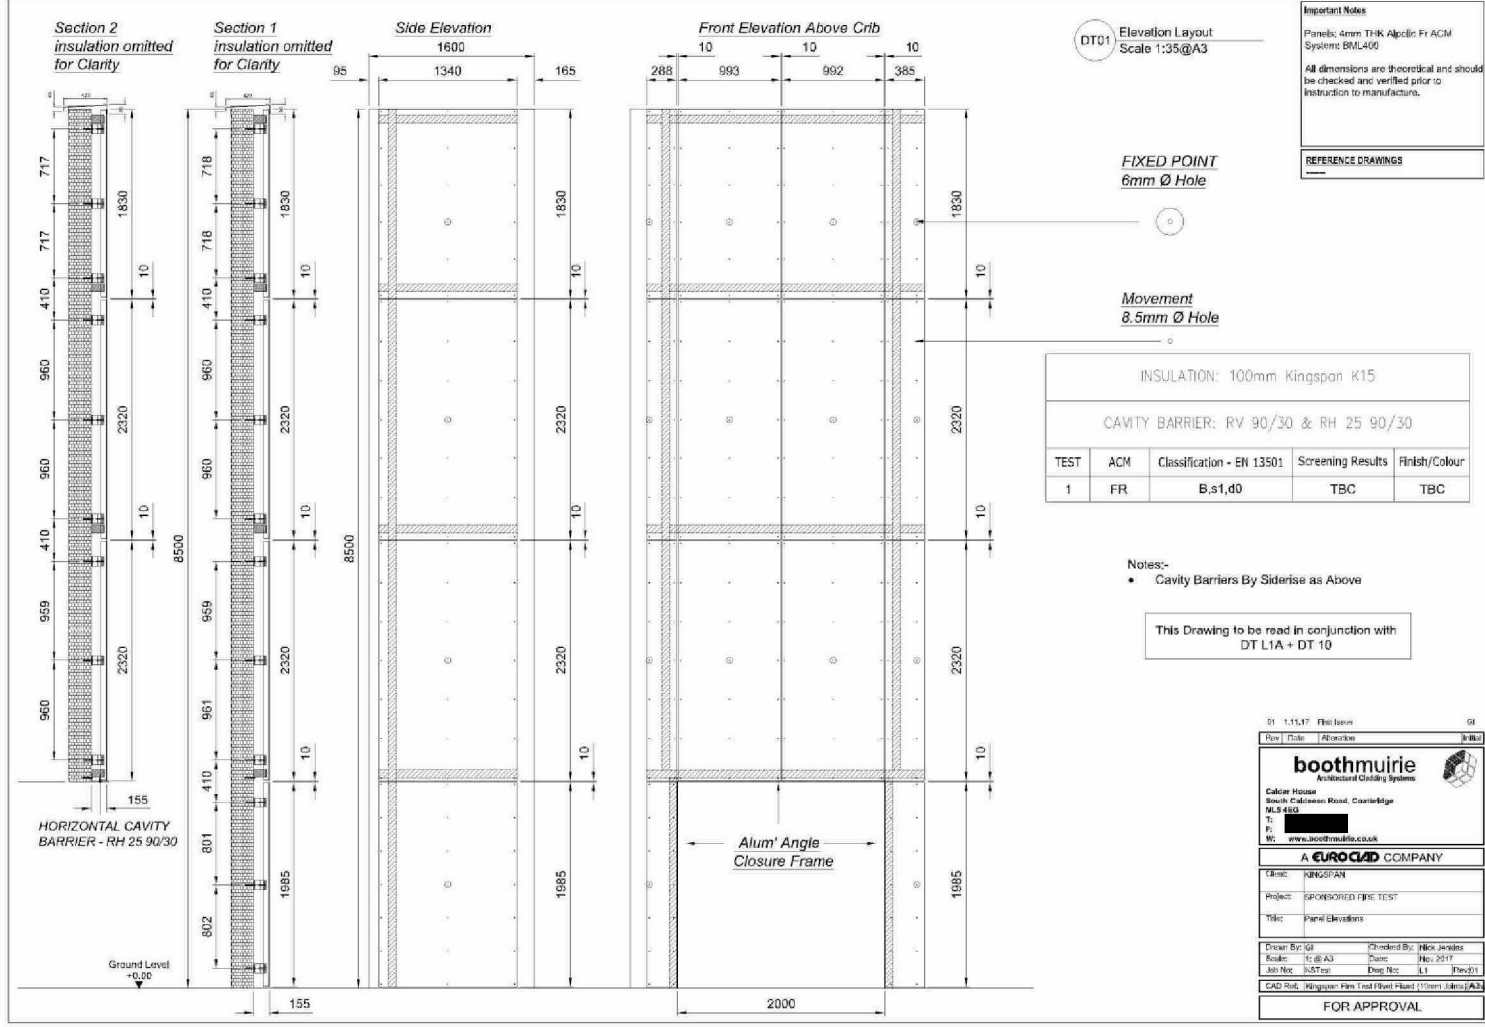
Figure 4. Cross sectional drawing (supplied by the test sponsor).

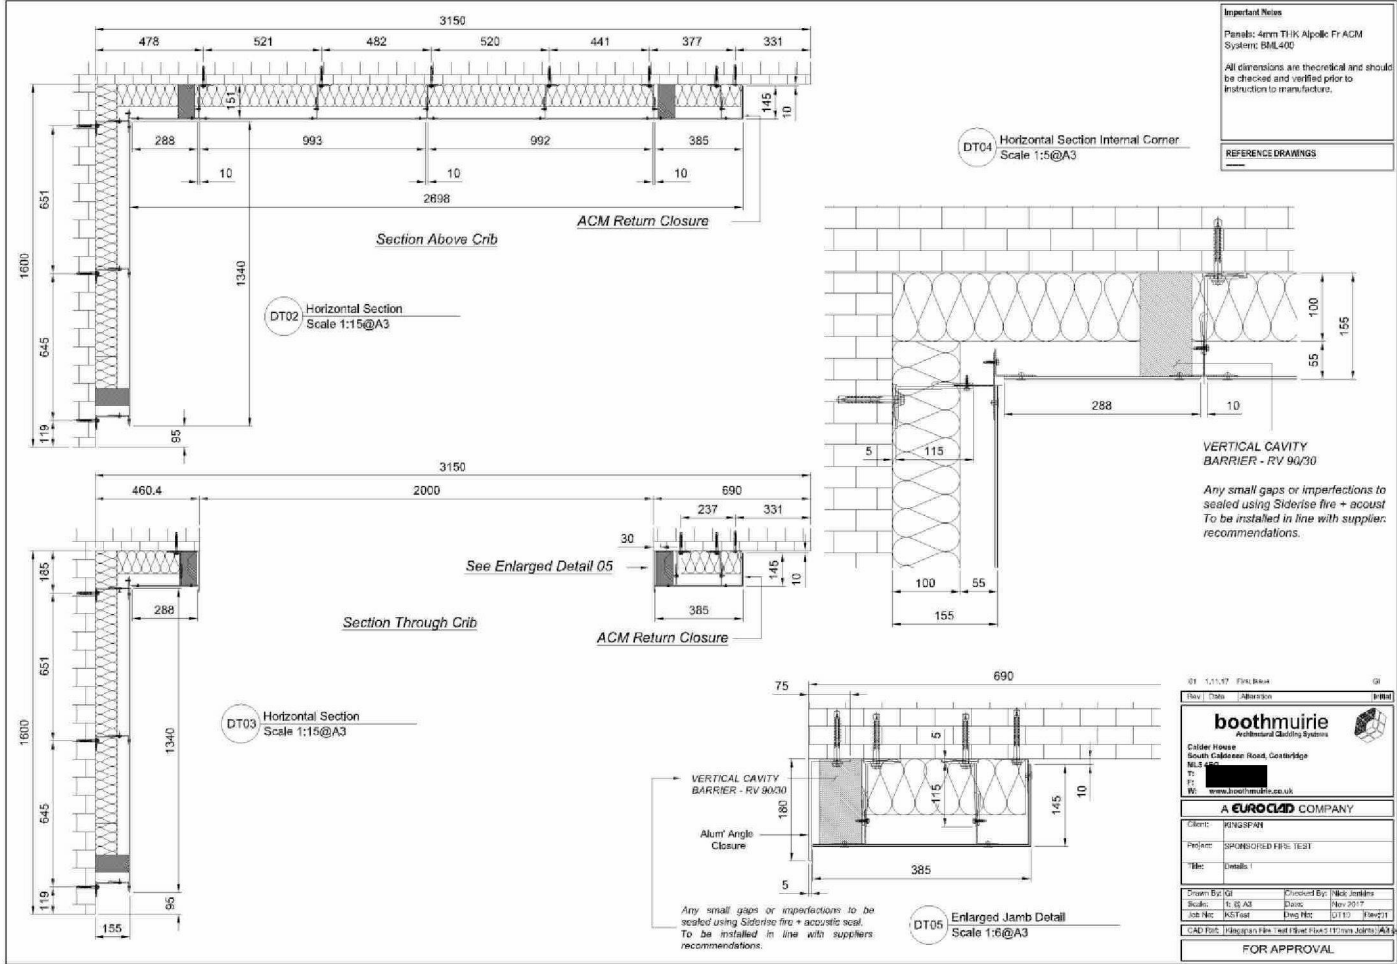
Figure 5. Construction drawings (supplied by the test sponsor).

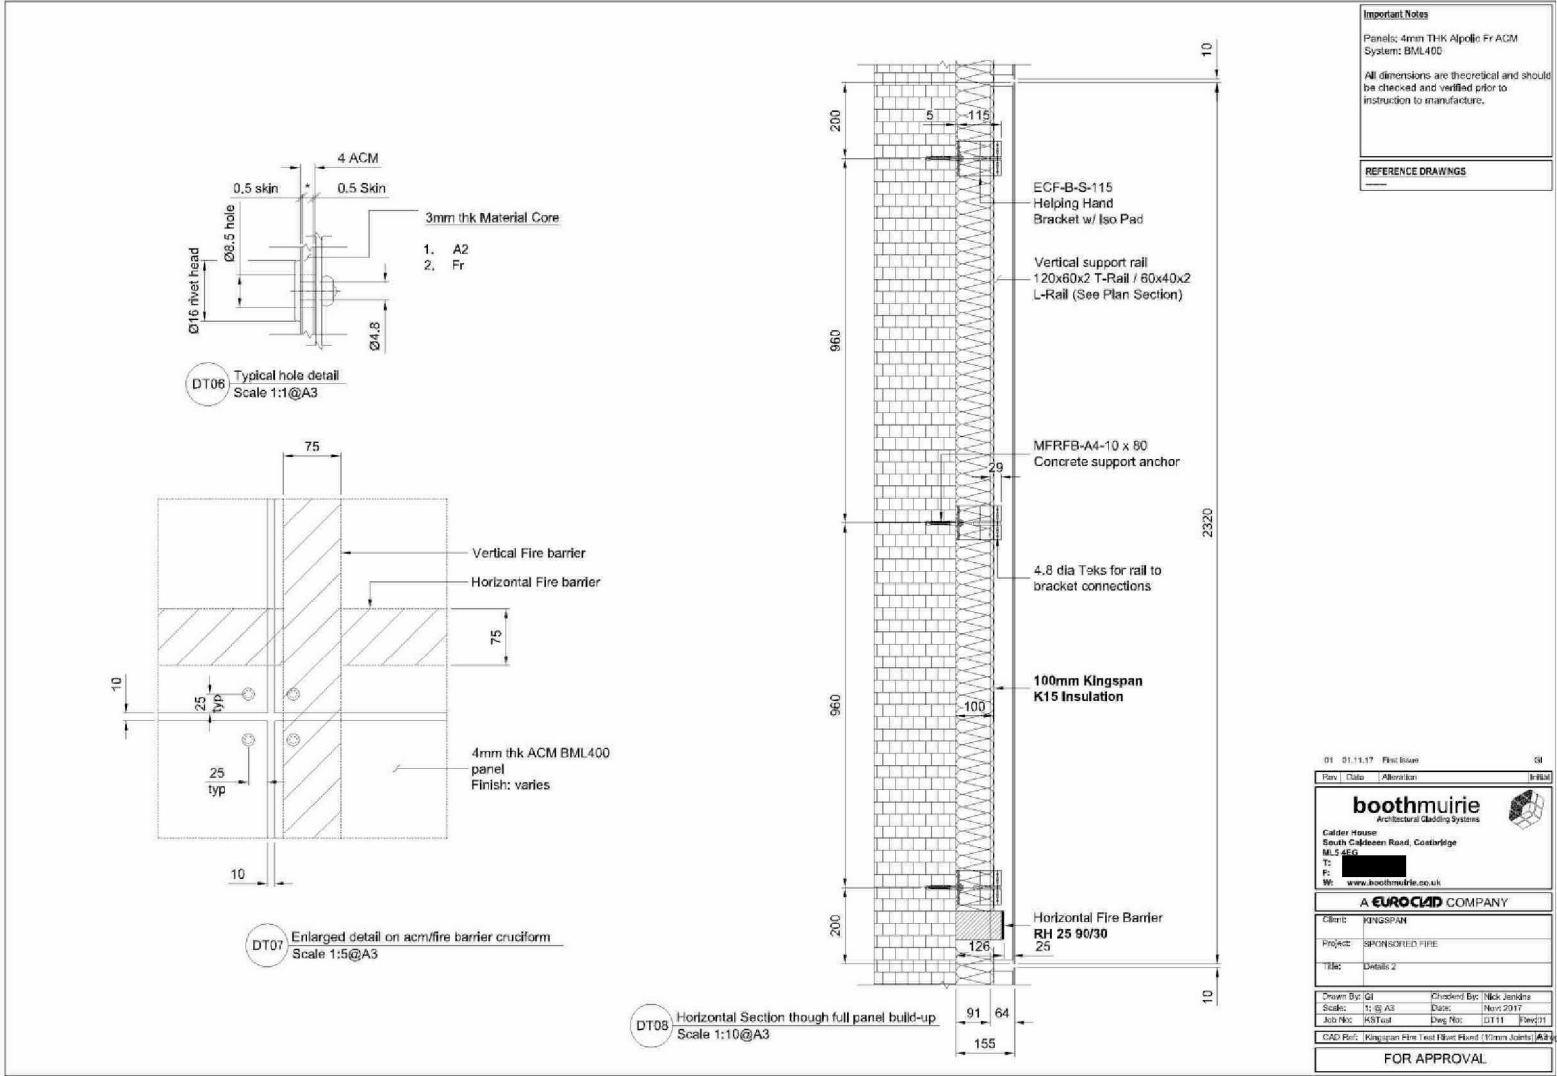
Figure 6. Construction drawings (supplied by the test sponsor).
