Fire Performance Testing of an External Cladding System BS 8414-1:2015 + A1:2017

Test Report

Prepared for : NDM (Metal Roofing & Cladding) Ltd
Project : Little Venice Towers, London, England
Report No. : DLR1537 Rev.0
Sample : Alucobond A2 Composite Panel on Fischer
Aluminium Support Frame with 100mm Rockwool
Duo Slab Insulation and Fischer Ventistop FFB-VS
Cavity Barrier

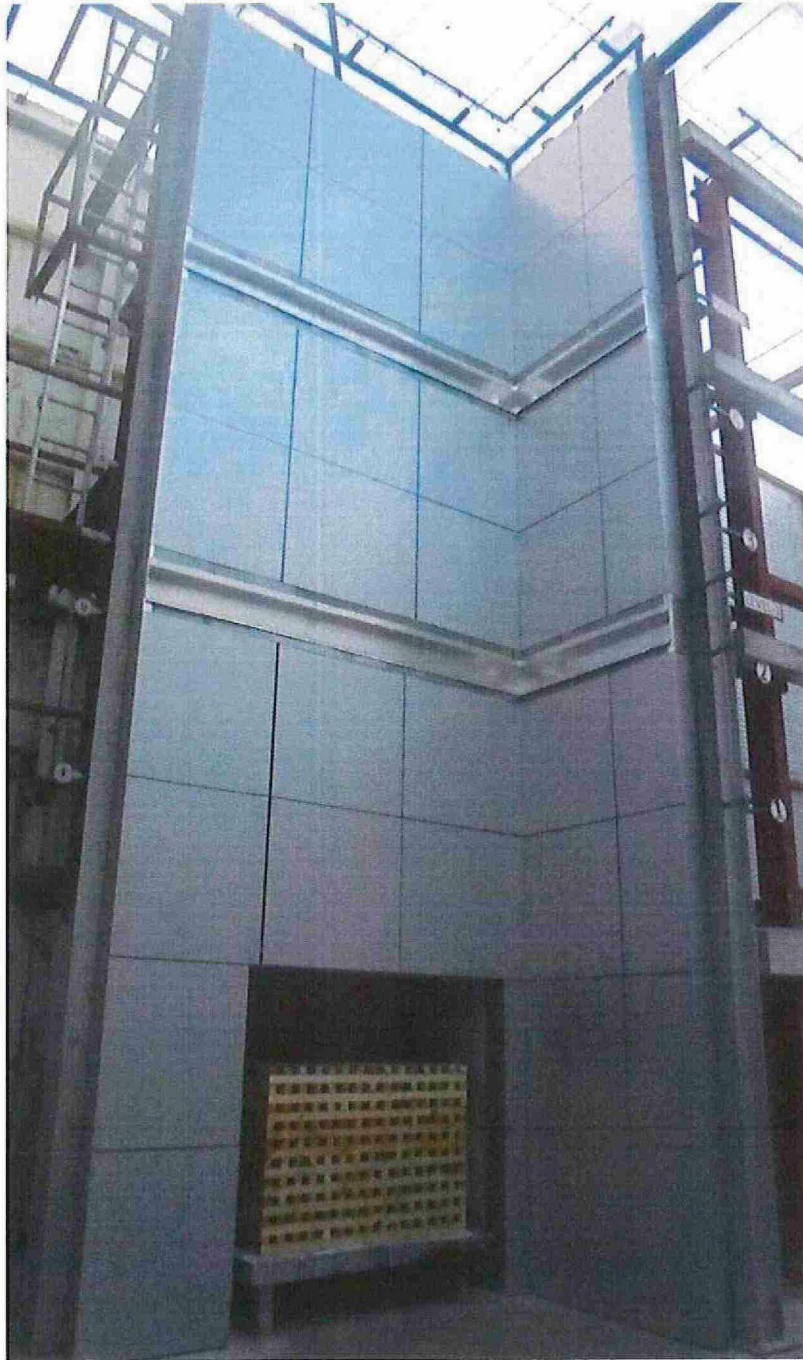
Figure 1 Photo DLP C2881/2117 External View of the Test Sample

Photo DLP C2881/2117 shows an external view of the sample.

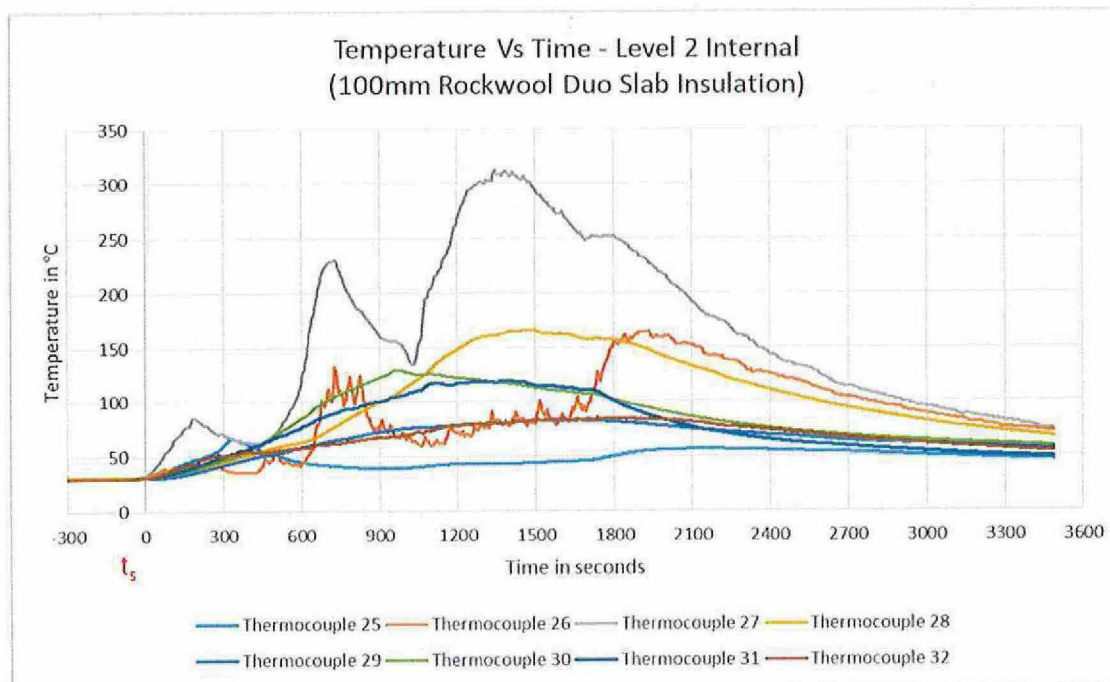
Figure 8 Thermocouple Readings on Level 2 – Internal (Mid-depth of 100mm Rockwool Duo Slab Insulation)

For thermocouple locations see Figure 3 & 4.

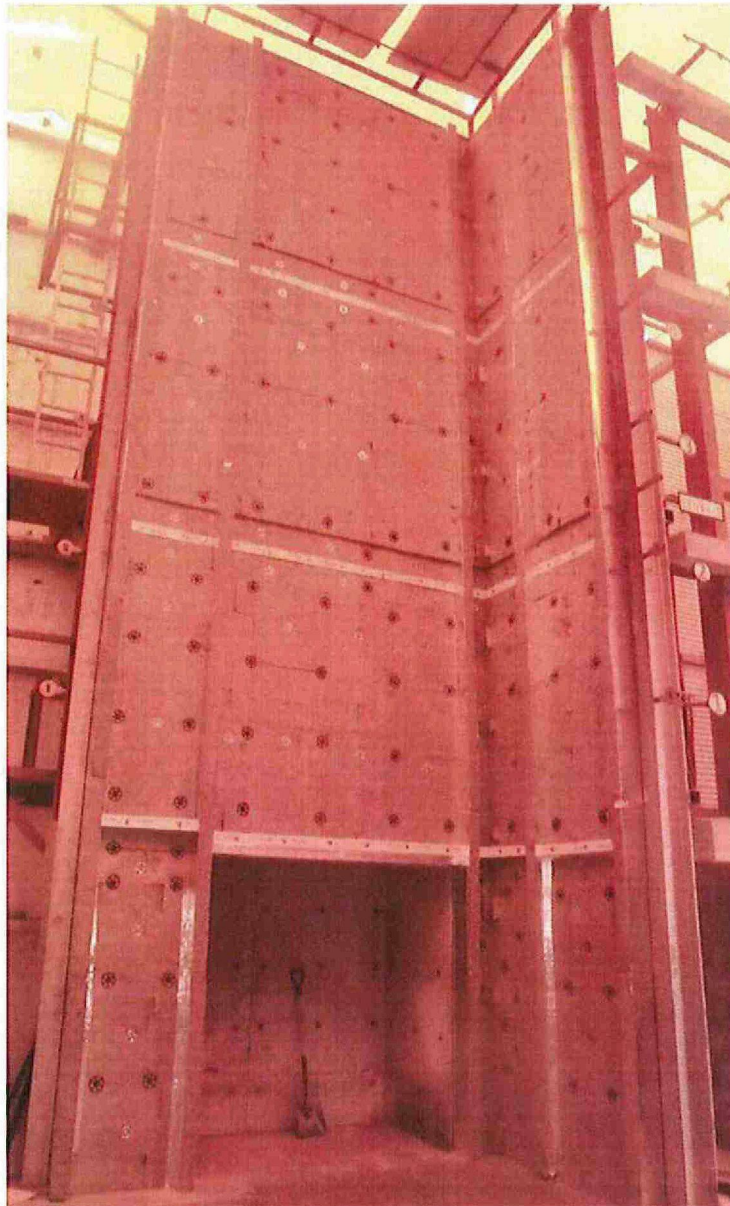
Fischer cavity barriers and Rockwool Duo Slab insulation

<p>Vertical cavity barrier:</p> <p>Fischer FcFcl 100 vertical cavity barrier.</p> <p>See photos DLP C2881/1955 & DLP C2881/1957 in Appendix A.</p>	<p>The vertical cavity barriers were fixed to the masonry with Fischer ultracut FBS II concrete screws and nylon wall plugs.</p> <p>4 nos. of continuous vertical cavity barriers were fixed to the masonry, two on the main wall and two on the wing wall.</p>
Insulation	<p>100mm Rockwool Duo Slab insulation.</p> <p>See photos DLP C2881/1955 & DLP C2881/2023 in Appendix A.</p>	<p>Insulation was fixed to the masonry wall with Fischer DHM 100 A2 stainless steel pins and Fischer DHK 100 plastic pins.</p>
Railing	<p>Fischer horizontal 'C' profile section : 2mm thick aluminium</p> <p>Fischer vertical 'T' profile section : 2mm thick aluminium</p> <p>See photo DLP C2881/2023 in Appendix A.</p>	<p>Vertical 'T' railings were fixed to the Helping hand brackets with Ejot self-drilling JT4-4-4.8mm Tec screws.</p> <p>Horizontal 'C' railings were fixed to the vertical 'T' railings with 4x10mm stainless countersunk screws.</p>

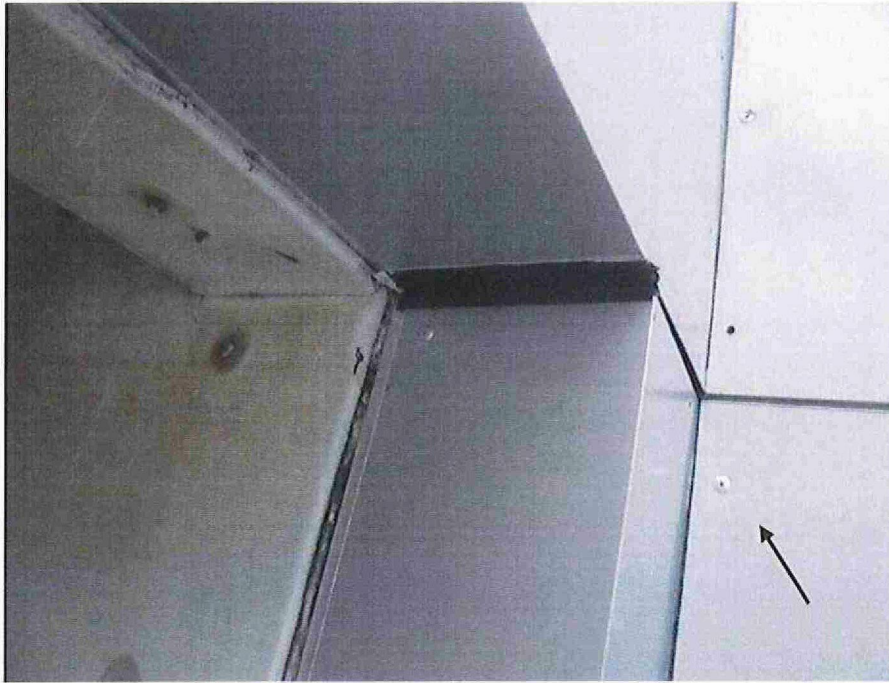
DLP C2881/2119

'I' beam and perforated zinc insect mesh

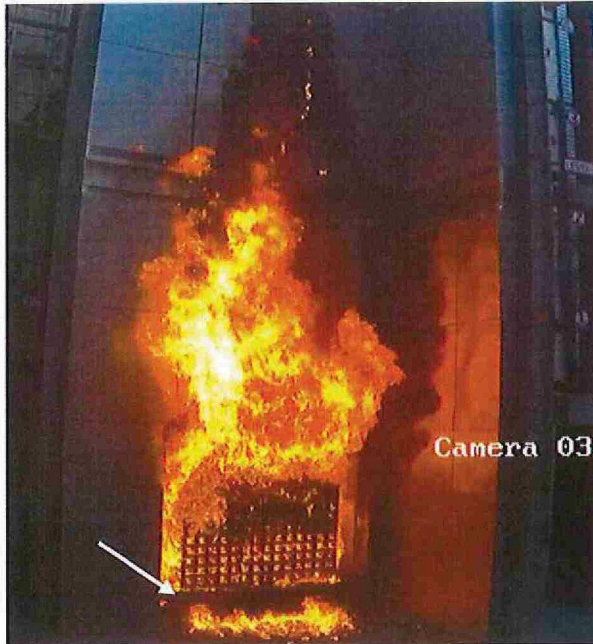
DLP C2881/0007

High intensity flaming debris on the floor.

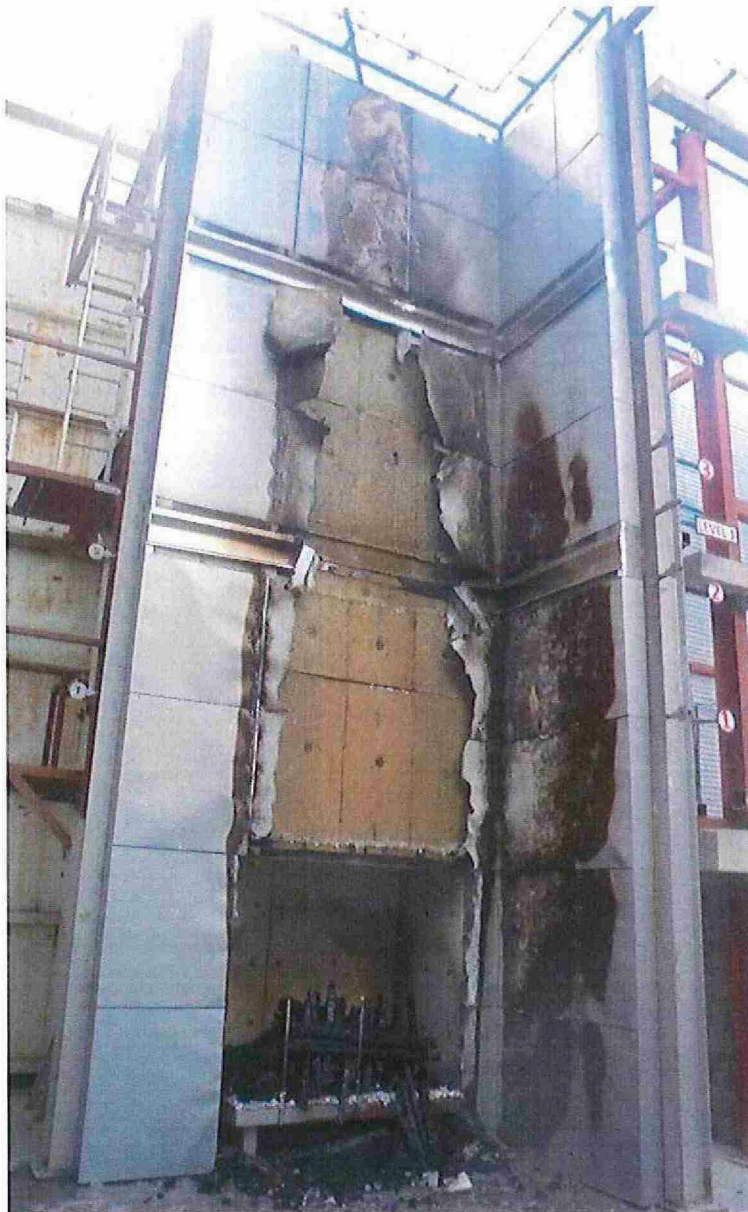
DLP C2881/0012 View of the sample after the test

Sl. No.	Components	Observation	Photo Reference
1	Aluminium composite panels	<p>Panels M1, M17 & M20 – Minor buckling observed.</p> <p>Panels M2, M3, M4, M5, M8, M11, M14 & M22– Minor buckling and discoloration on the panels.</p> <p>Panels M6, M7, M9 & M10 - Approximately 85% of the panel was consumed and remaining area was discoloured and buckled.</p> <p>Panels M12, M13, M15 & M16 – Approximately 65% of the panel was consumed and remaining area was discoloured and buckled.</p> <p>Panel M18 – Approximately 80% of the panel was discoloured. Minor material loss on the panel.</p> <p>Panels M19 & M21 - Approximately 50% of the panel was discoloured. No material loss on the panels.</p> <p>Panels W1, W3 & W9 – Approximately 90% of the panel was discoloured. Minor material loss observed.</p> <p>Panels W2, W10 & W11 – Minor discoloration on the panels.</p> <p>Panels W5 & W7 – 100% discolouration on the panels. Material loss observed.</p> <p>Panels W4, W6 & W8 – Approximately 50% of the panel was discoloured.</p> <p>Panels W12, W13, W14, W15 & W16 – No significant changes to the panels</p>	<p>DLP C2881/0012.</p> <p>See Figure 9 in this section for the damaged areas.</p>

2.	'I' Beam	<p>Main wall:</p> <p>Approximately 50% of the 'I' beam at level 1 melted. Remaining area was buckled and discoloured.</p> <p>Buckling, minor material loss and discoloration on the 'I' beam at level 2.</p> <p>Wing wall:</p> <p>Minor buckling and discoloration on the 'I' beam at level 1 and level 2.</p>	<p>DLP C2881/0012 & DLP C2881/0015.</p>

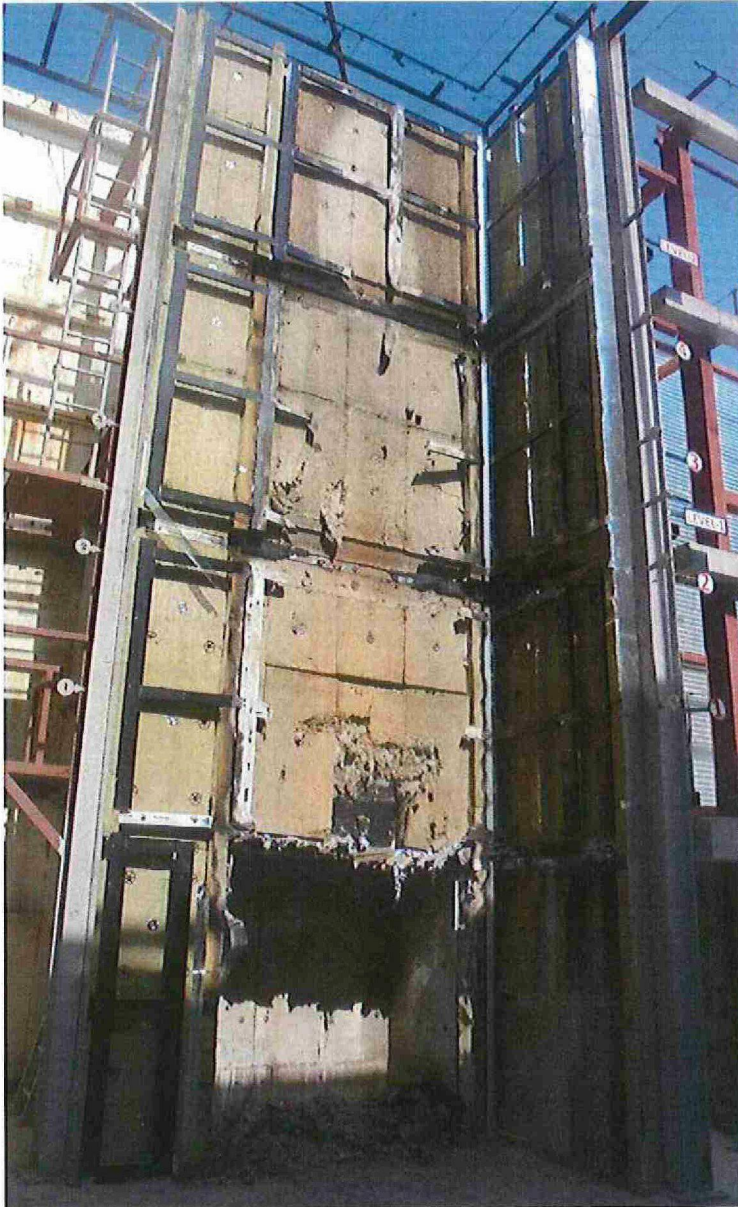
DLP C2881/0013

Sl. No.	Components	Observation	Photo Reference
3	Fischer cavity barriers	<p>Horizontal intumescent cavity barrier:</p> <p>Main wall:</p> <p>The 1st horizontal cavity barrier at 75mm above the combustion chamber was activated except the cavity behind panel M5 (beyond the left side (viewing from outside) vertical fire barrier on the main wall). Intumescent layer was not present during the dismantling. Material loss and damage observed.</p> <p>The 2nd horizontal cavity barrier at 2190mm above the combustion chamber was activated except the cavity between panels M8 & M11 (beyond the left side (viewing from outside) vertical fire barrier on the main wall). Intumescent layer was partially present during the dismantling. No material loss observed.</p> <p>The 3rd horizontal cavity barrier at 4690mm above the combustion chamber was activated except the cavity between panels M14 & M17 (beyond the left side (viewing from outside) vertical fire barrier on the main wall). Intumescent layer was present during the dismantling. No material loss observed.</p> <p>Wing wall:</p> <p>The 1st horizontal cavity barrier at 2075mm above the ground level was activated. Intumescent layer was present during the dismantling. No material loss observed.</p> <p>The 2nd horizontal cavity barrier at 4190mm above the ground level was activated except the cavity between panels W8 & W10 (between the vertical fire barriers on wing wall). Intumescent layer was present during the dismantling. No material loss observed.</p> <p>The 3rd horizontal cavity barrier at 6690mm above the ground level was activated except the cavity between panels W12 & W14 (between the vertical fire barriers on wing wall). Intumescent layer was present during the dismantling. No material loss observed.</p> <p>Vertical cavity barrier:</p> <p>Discolouration and buckling to the vertical cavity barriers on the main wall and wing wall was observed.</p>	DLP C2881/0013, DLP C2881/0014, DLP C2881/0016 & DLP C2881/0017.

Sl. No.	Components	Observation	Photo Reference
4	100mm Rockwool Duo Slab insulation	<p>Main wall:</p> <p>Discoloration and minor material loss on the insulations behind panels M6, M7, M9, M10, M12, M13, M15 & M16.</p> <p>Minor discoloration on the insulation behind panels M18, M19, M21 & M22.</p> <p>No changes on the remaining insulation on the main wall.</p> <p>Wing wall:</p> <p>Discolouration on the insulation behind panels W5, W7, W9 & W11.</p> <p>No changes on the remaining insulation on the wing wall.</p>	DLP C2881/0013, DLP C2881/0016 & DLP C2881/0017.
5	Railing	<p>Main wall:</p> <p>All railings behind panels M6, M7, M9, M10, M12, M13, M15 & M16 were melted.</p> <p>Railings behind panels M18, M19, M21 & M22 were discoloured and buckled.</p> <p>All other railings were in place and no damage was observed.</p> <p>Wing wall:</p> <p>All railings behind panels W5, W7, W9 & W11 were discoloured.</p> <p>All other railings were in place and no damage was observed.</p>	DLP C2881/0013, DLP C2881/0016 & DLP C2881/0017.

Fischer cavity barriers, Rockwool Duo Slab insulation and railings

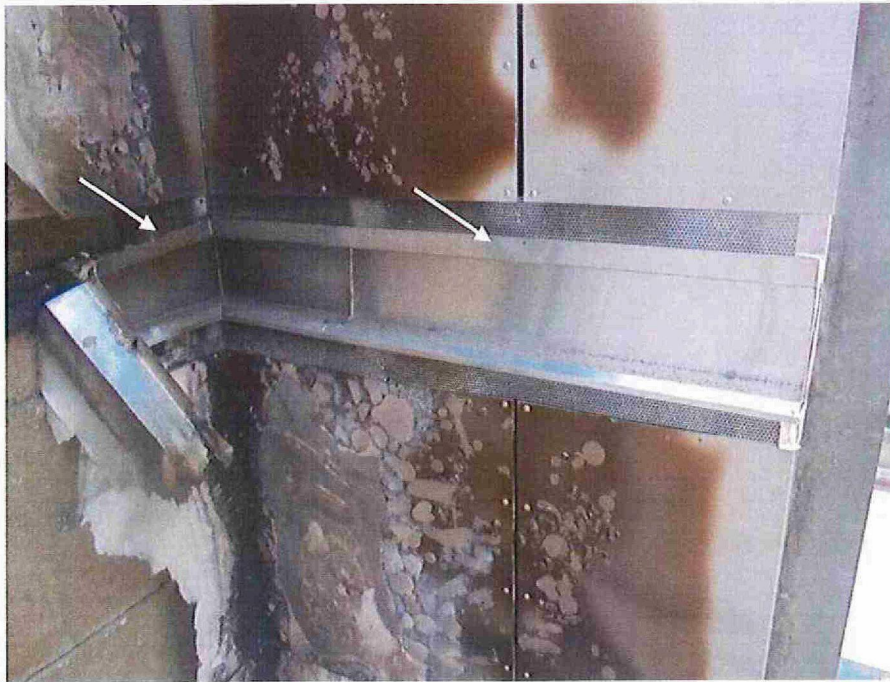
DLP C2881/0015

'I' beam at level 1

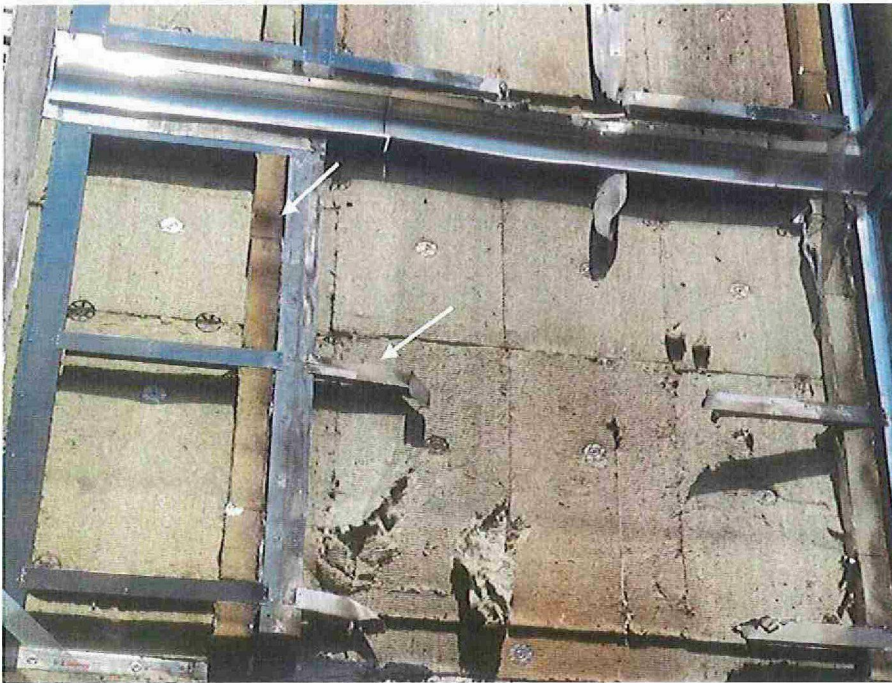
DLP C2881/0016

Fischer vertical cavity barrier, insulation and railings on main wall

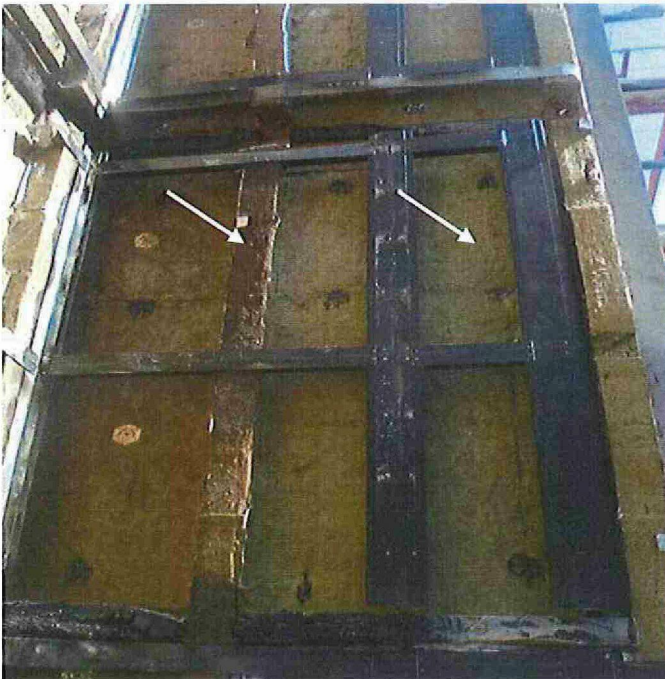
DLP C2881/0017

Fischer vertical cavity barrier, insulation and railings on wing wall
