**REACTION TO FIRE TEST REPORT No EU1-19-IST-000211B**

**Test Standard:** ISO 13785-1:2002 — Reaction-to-fire tests for façades — Part 1: Intermediate-scale test

**Product:** Insulation layer fixed on non-combustible sheathing board layer combined with 'L'-shape aluminum flashings on bottom of specimen  
Referenced: K15 Trial

**Applicant:** KINGSPAN INSULATION LTD  
Pembroke, Leominster,  
Herefordshire  
HR6 9LA, UK

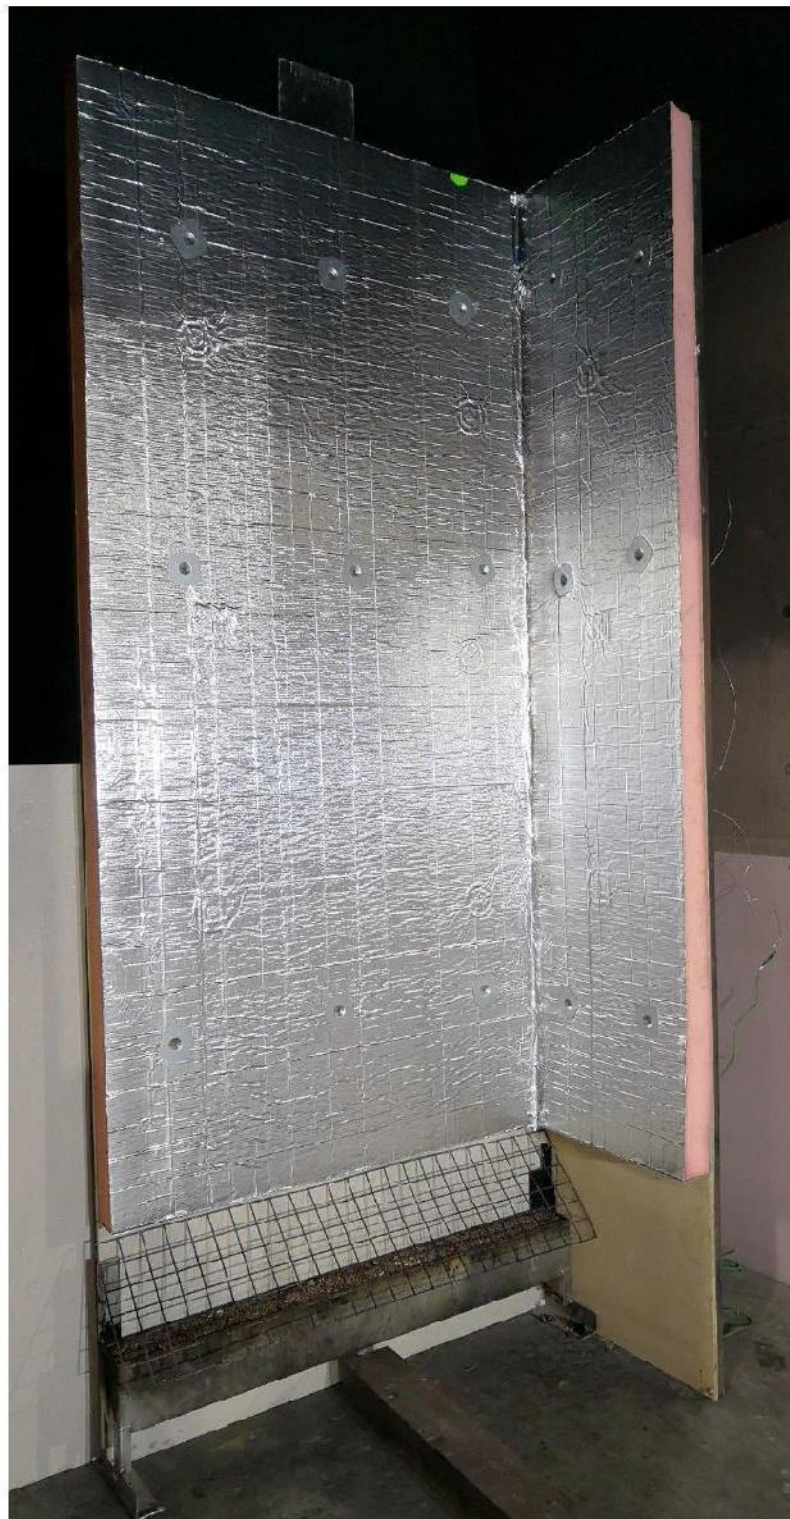
Specimen before  
ignition of fire source

**Attachment system** Insulation boards reference K15 Trial were fixed on the non-combustible sheathing board layer using fixings reference Woodscrews Ø 5 mm x 120 mm combined with washers reference SFS Intec of dimensions 70 mm x 70 mm. Aluminum 'L'- shape flashings were fixed on the bottom of the specimen, across both faces, using screws reference TEK of 25 mm length.

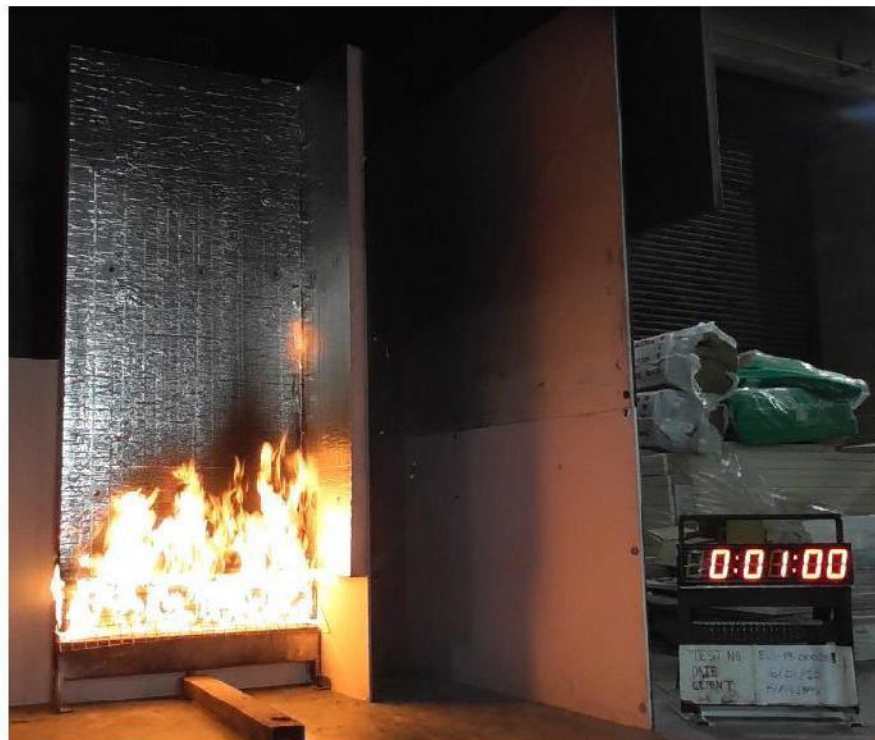
Specimen at 1 min  
after ignition

Time (min)	Observations
00:00	Ignition of burner
00:29	Hole opened on the foil facing of main face on the bottom of specimen
01:22	Detachment of bottom part of main face's foil facing
01:50	Foil facing burnt away on the main face bottom part
02:30	Bottom flashing bending on the mid-width of the main face
06:30	Flames reaching 1000mm height in the corner
09:45	Detachment of bottom part of wing face's foil
17:00	Aluminum flashing melting on the main face at about 250 mm measured from the corner
22:00	Bending of wing face's flashing
30:00	Termination of the test

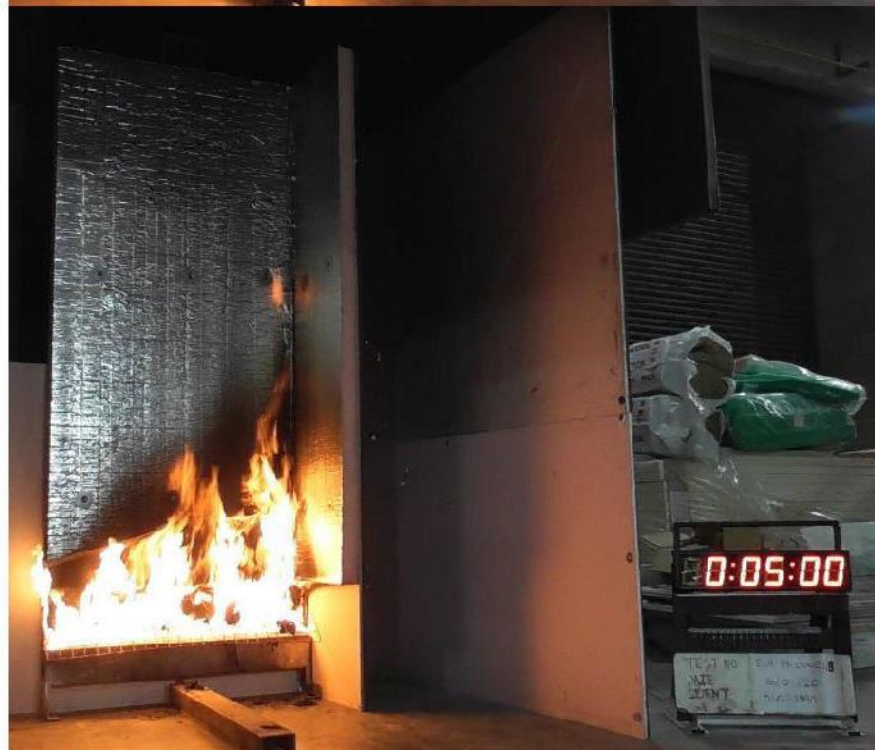
Specimen at 5 min  
after ignition

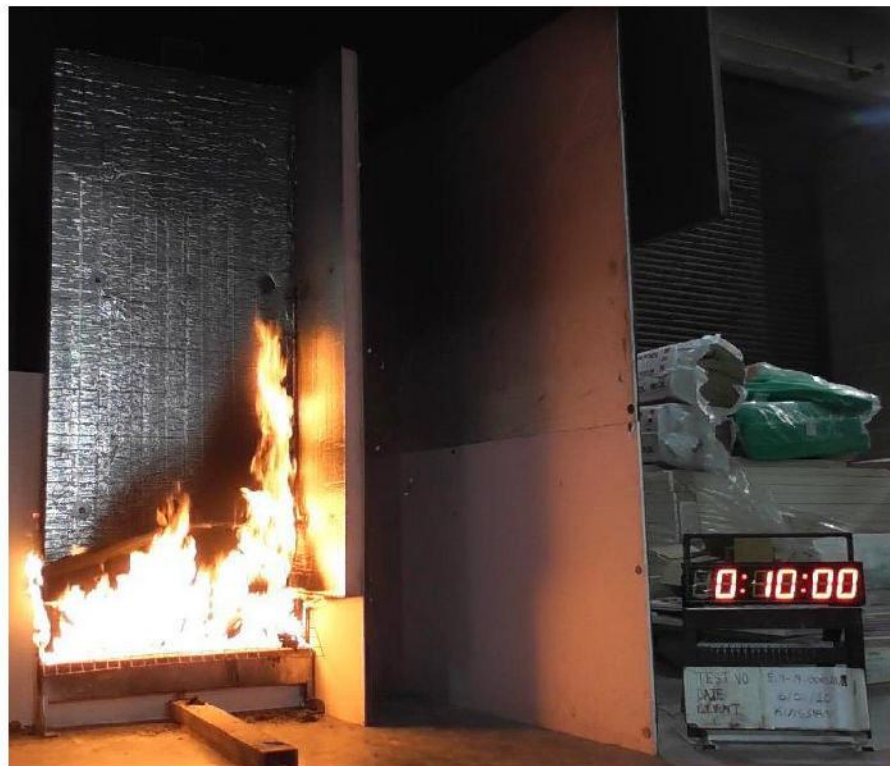
Specimen at 10 min  
after ignition

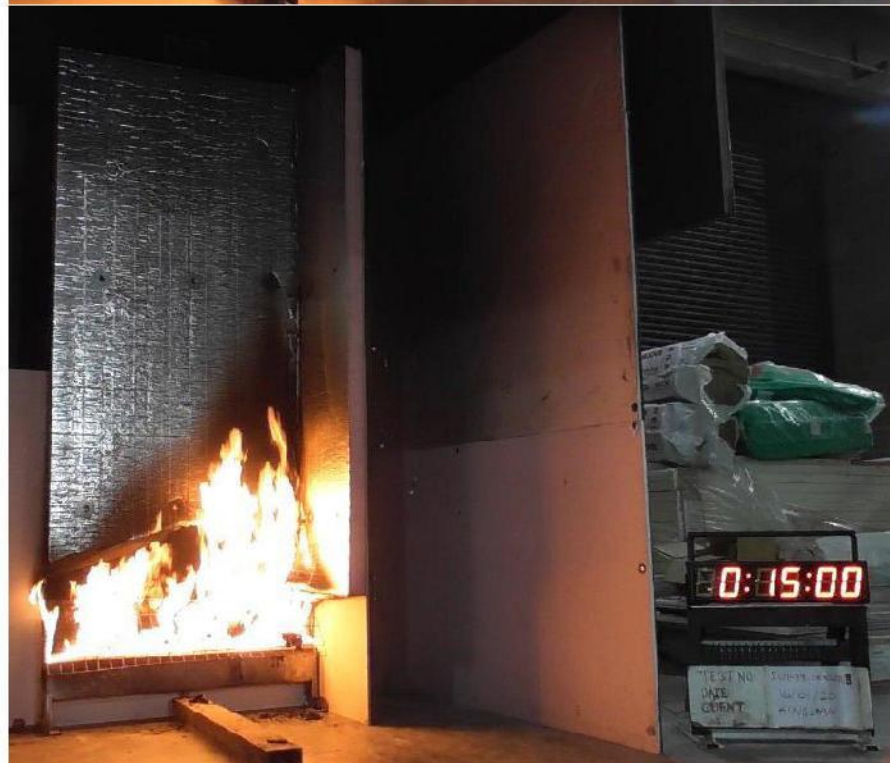
Specimen at 15 min  
after ignition

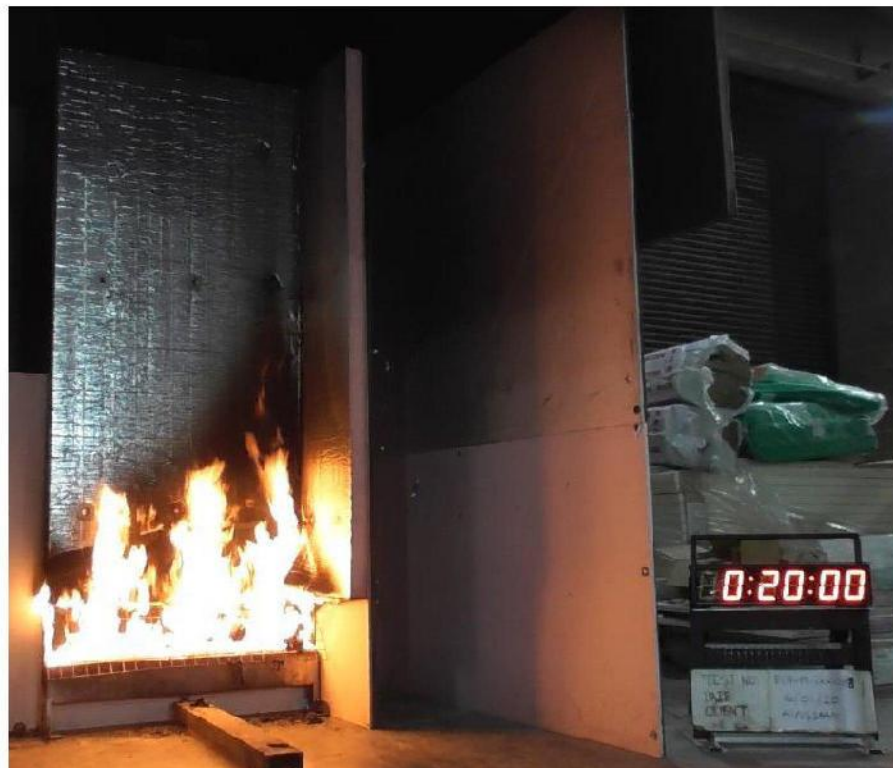
Specimen at 20 min  
after ignition

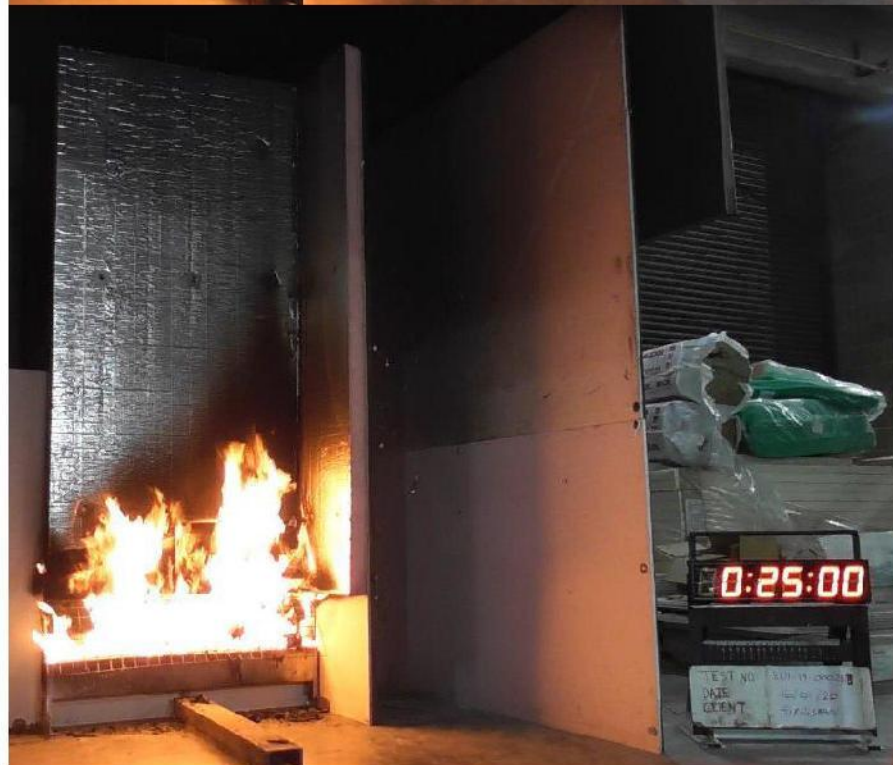
Specimen at 25 min  
after ignition

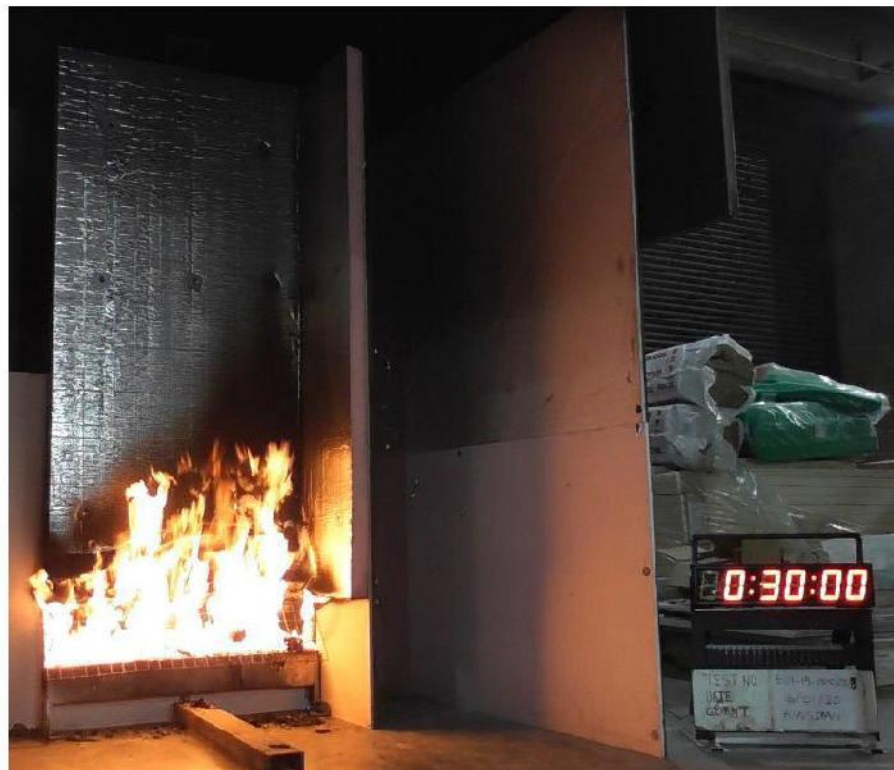
Specimen at 30 min  
after ignition

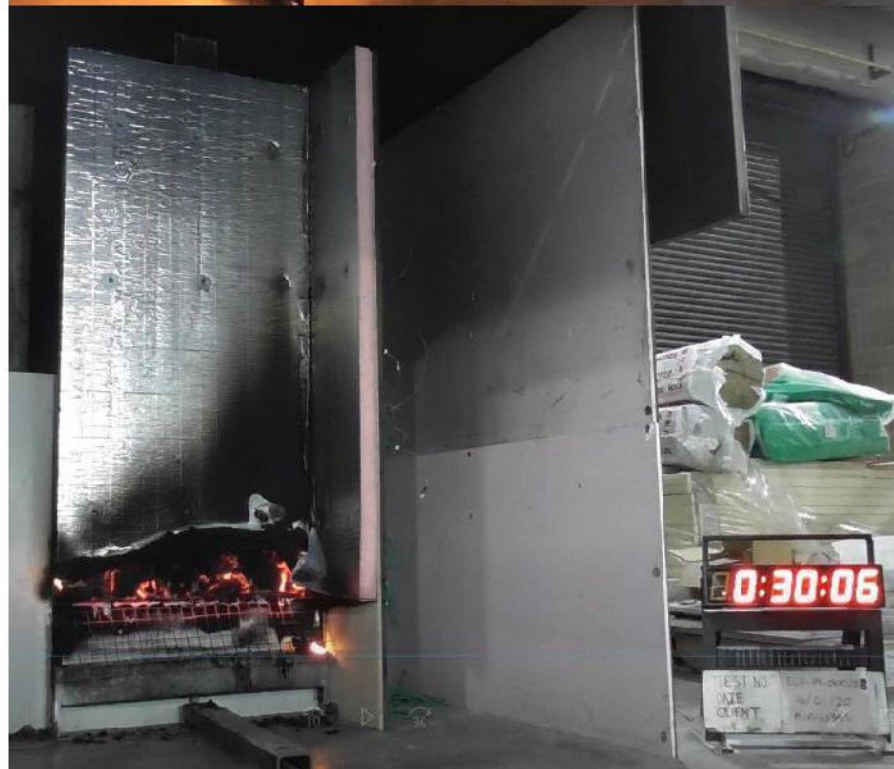
Specimen after  
extinguishment of fire  
source

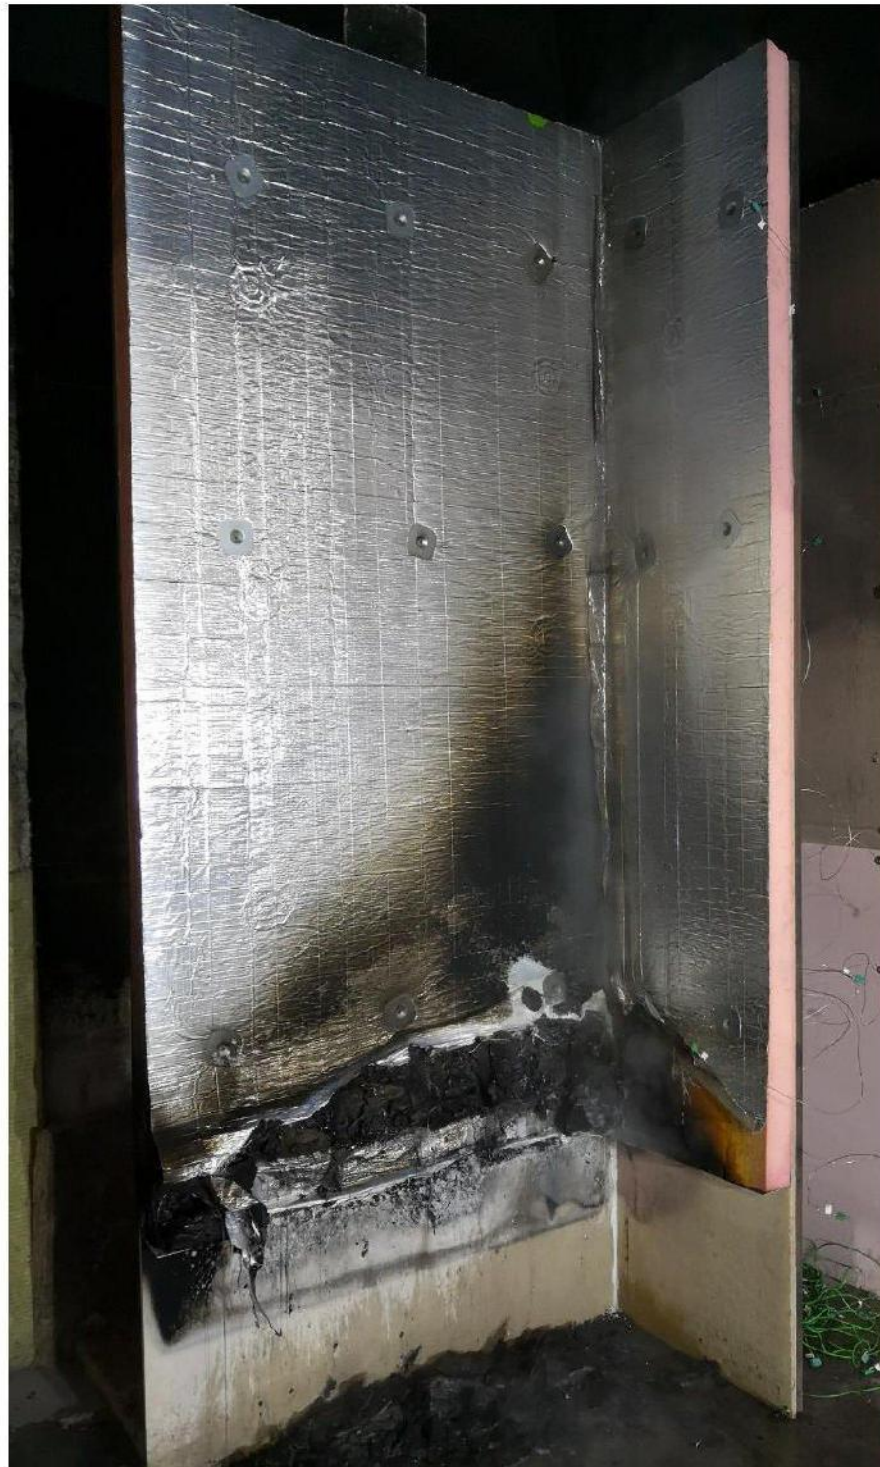
Specimen after the  
test

After the test, two 150 mm x 150 mm square parts of insulation were cut out of the specimen's main face centreline at 500 mm and 1000 mm height to examine the charring depth.

Height where measurement was taken (mm)	Charring depth (mm)
500	30
1000	20

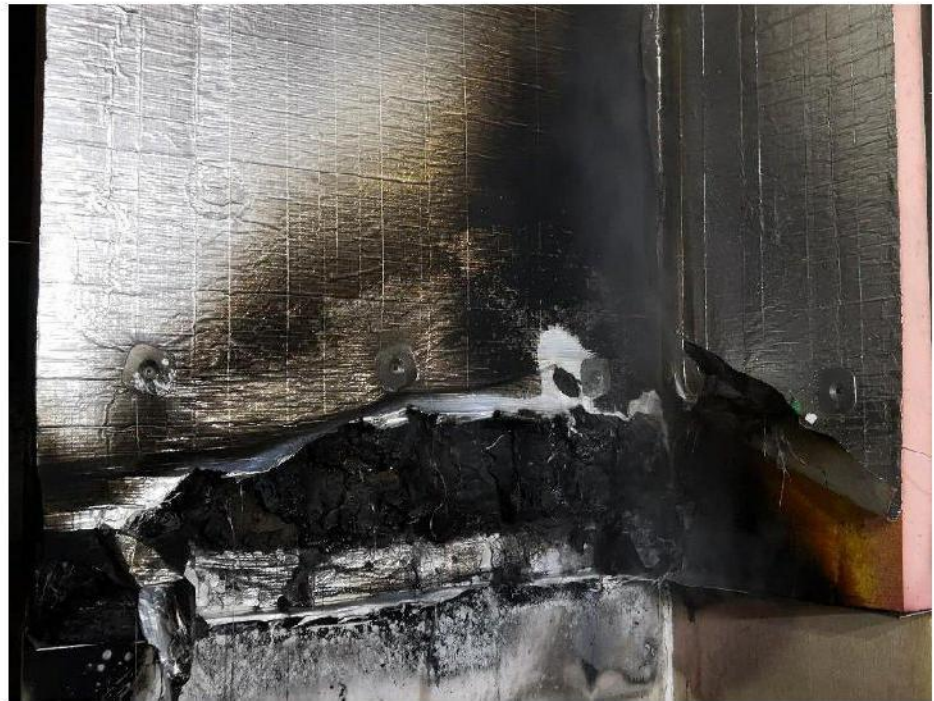
Damage on the bottom  
part of the specimen –  
Main face

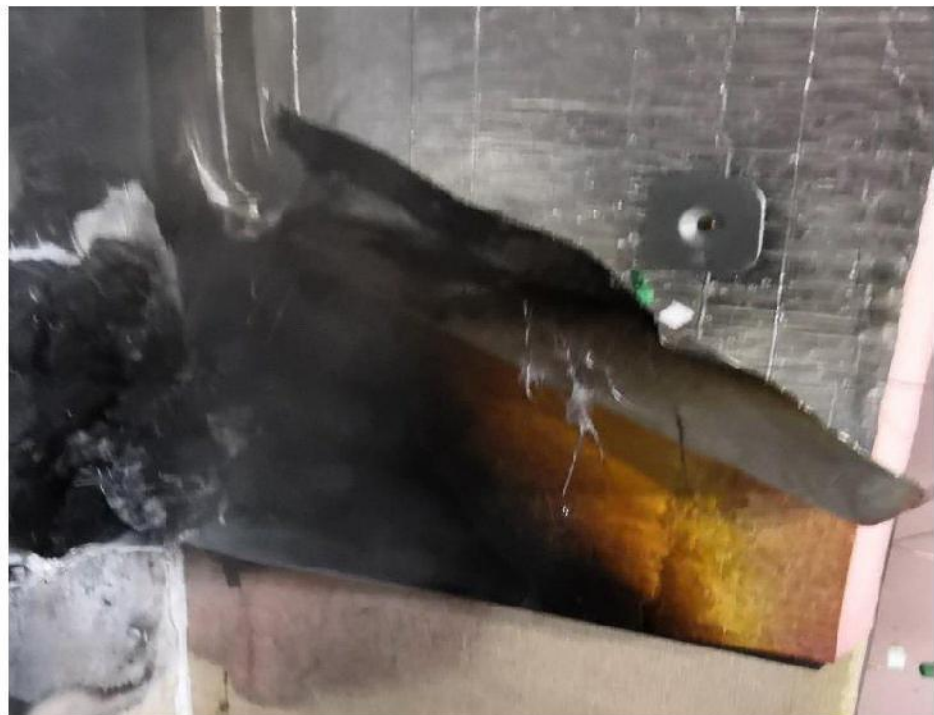
Damage on the bottom  
part of the specimen –  
Wing face

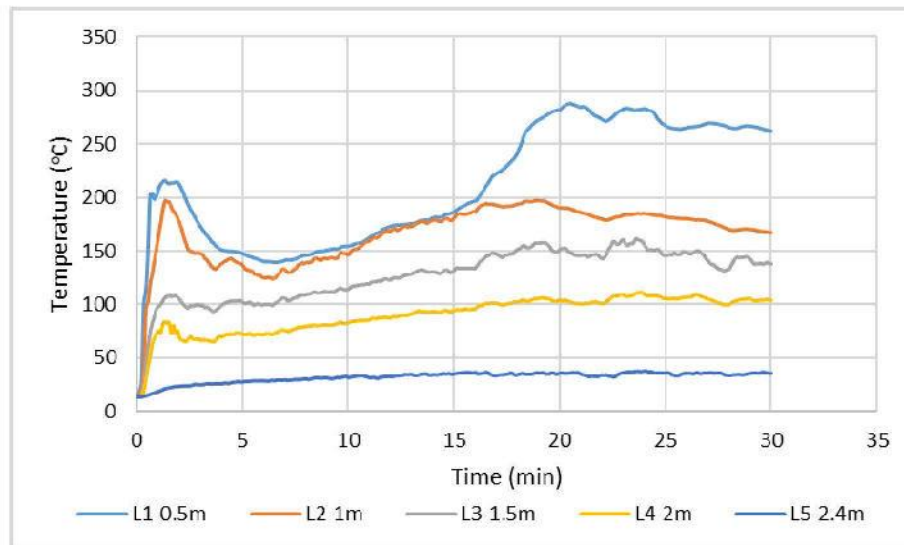
Figure 1. Temperature data history on the exposed side of the main face

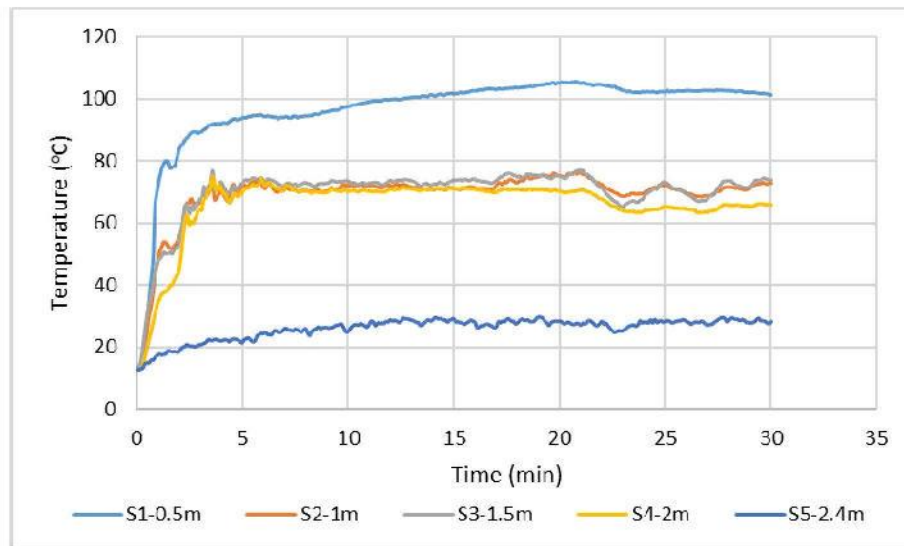
Figure 2. Temperature data history on the exposed side of the wing face

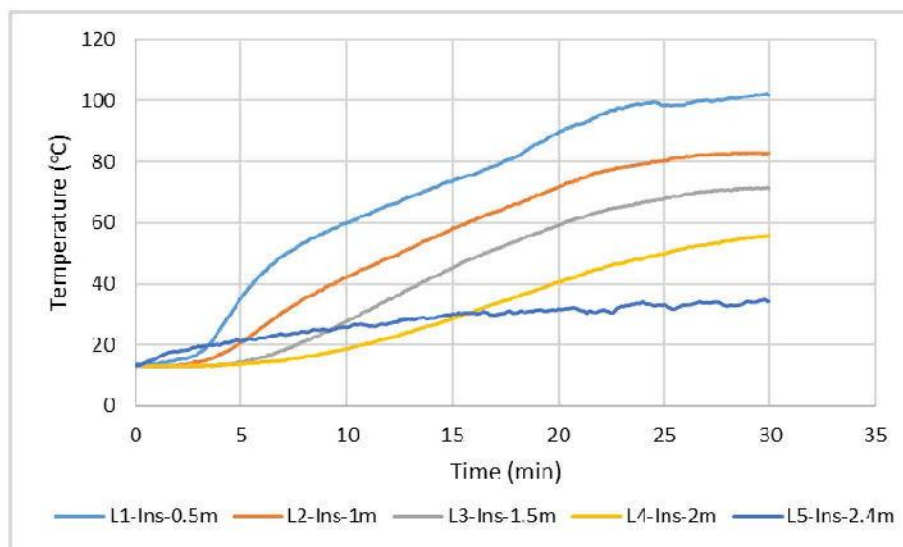
Figure 3. Temperature data history on the mid-thickness of the main face

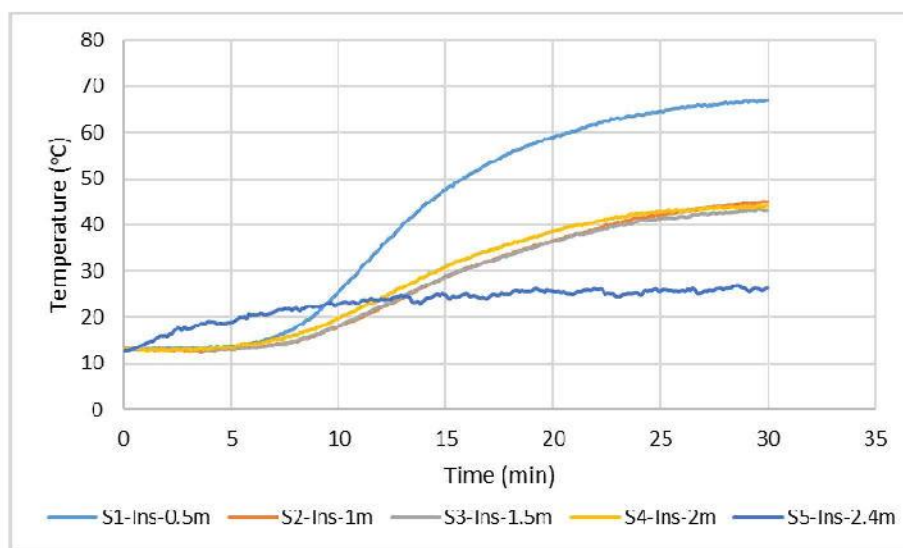
Figure 4. Temperature data history on the mid-thickness of the wing face

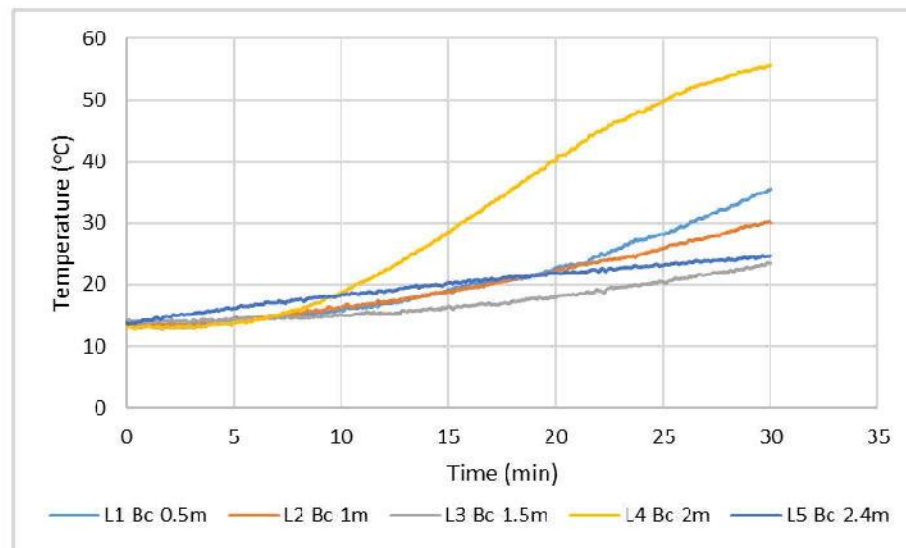
Figure 5. Temperature data history on the non-exposed side of the main face

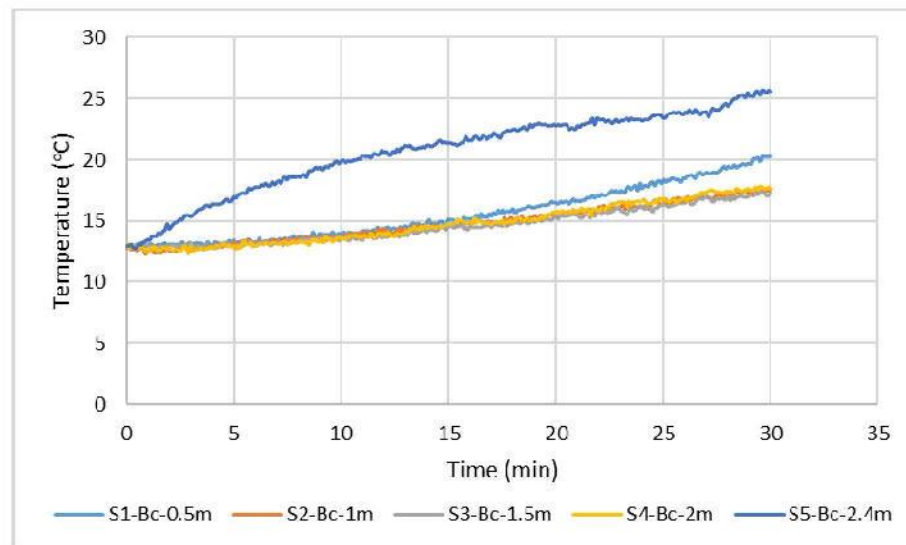
Figure 6. Temperature data history on the non-exposed side of the wing face

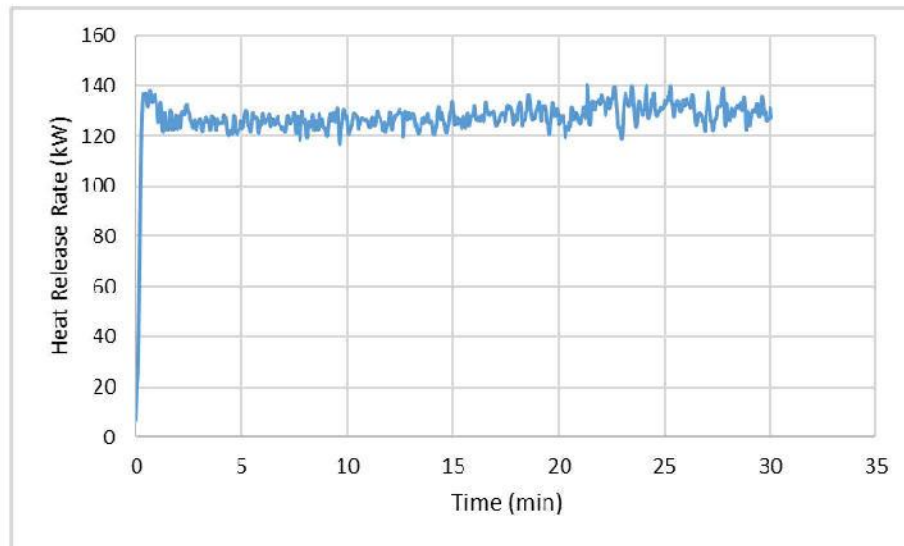
Figure 7. Heat Release Rate data history
