Test Report : Chilt/RF07024

**A fire resistance test performed on
a single leaf, single acting doorset with glazing and a
glazed side panel**

Test conducted in accordance with BS 476 : Part 22 : 1987

Test for :
LB Plastics Ltd
Firs Works
Neather Heage
Derby
DE56 2JJ

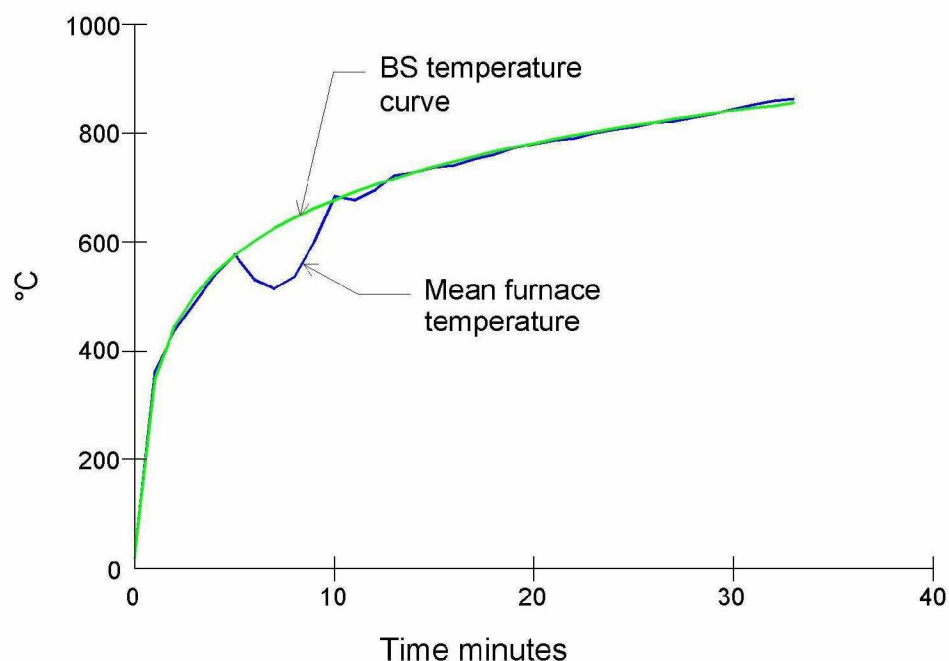
4.1 Furnace temperature curve

- 3.4 The furnace was controlled to follow the temperature/time relationship specified in BS 476: Part 20: 1987 as closely as possible, using the average of six thermocouples suitably distributed within the furnace. The temperatures recorded are shown graphically in Section 4.1.

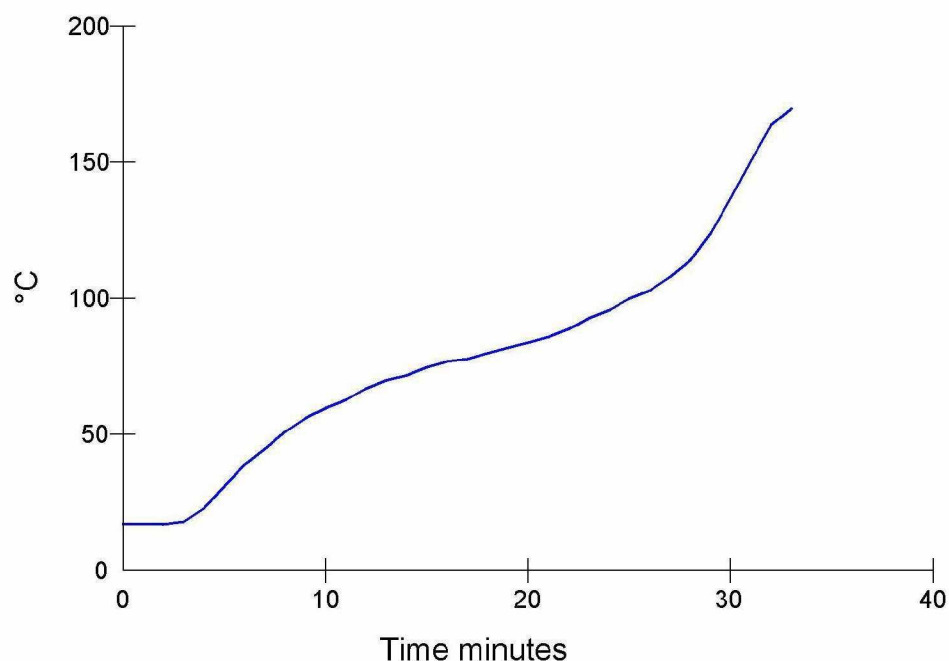
Mean temperature of leaf

- 3.5 The temperature of the unexposed face was monitored by means of five thermocouples fixed to the surface of the specimen, and four thermocouples attached to each frame, one at midheight on each jamb and one centrally located above the leaf and side panel on the frame head. Two additional thermocouples were fixed to the glass of each aperture. The thermocouple positions are shown in Figure 2. The average temperature of the door leaf and maximum temperature of the doorset are shown graphically in Section 4.2.

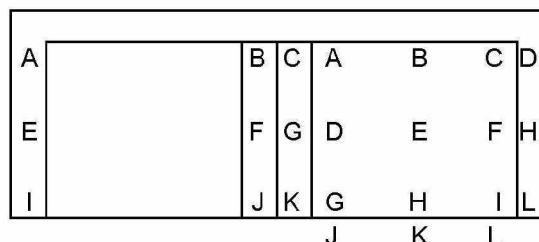
The following tables show the distortion of the doors in mm with an accuracy of ± 1 mm.
A positive measurement indicates distortion towards the fire.

A negative measurement indicates distortion away from the fire.

J, K and L give vertical movement of the door, a negative reading indicates that the door has dropped.

Leaf (hung on the right and opening in towards the fire)

Time	A	B	C	D	E	F	G	H	I	J	K	L
10	-1.5	-1.5	-1.5	0	-	-8.5	0	-0.5	0.5	0.5	0.5	5.5
20	13	2	-4	22.5	-	2.5	5	2	0.5	1	2	7.5
30	-	-	-	22.5	-	3.5	5	2	1.5	1	-	-

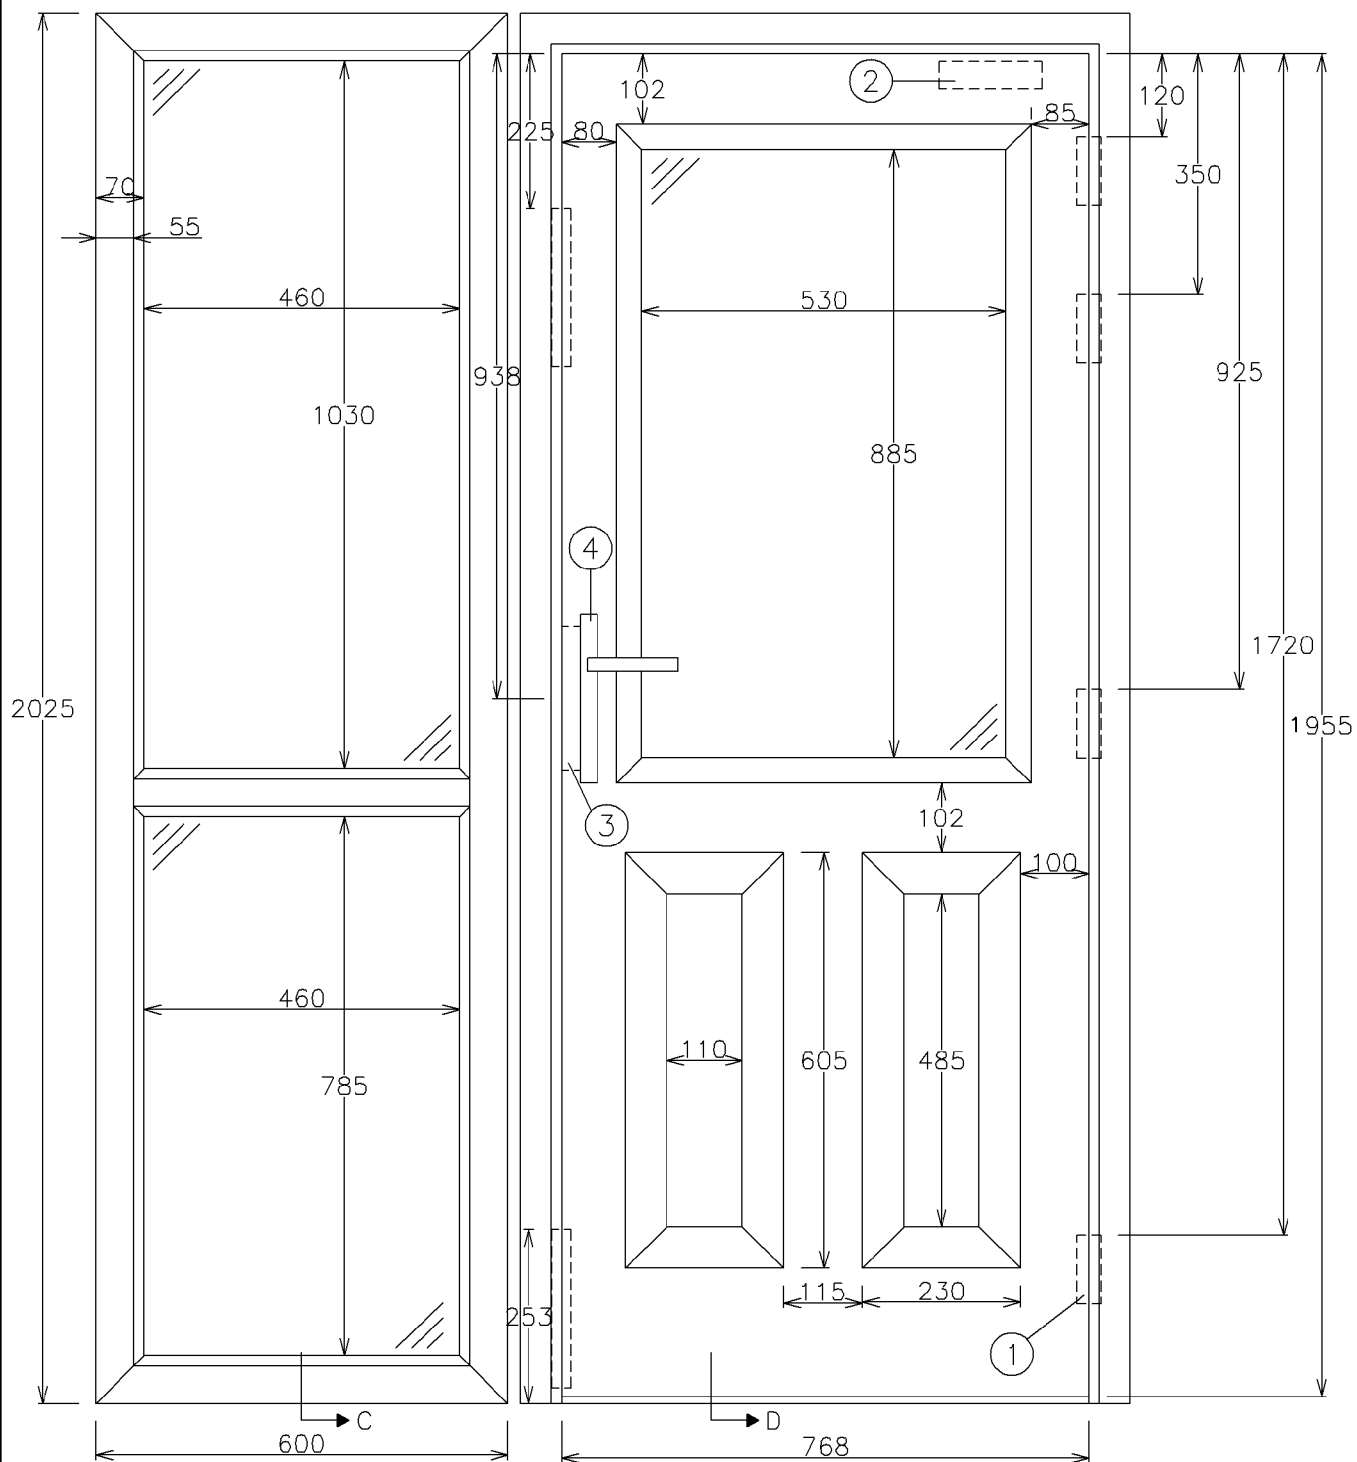
Title Unexposed face elevation
showing ironmongery positions
(All dimensions in mm)

Make/type	Size (mm)	Location	Key to figures
Hinges	4No Seely Engineering Asia Masterdor HNG 133 stainless steel hinges	100 x 35 (blade size)	Fitted 120, 350, 925 and 1720 from the head of the leaf	1
Closer	Laidlaw B2W aluminium and steel surface mounted overhead closer	150 x 40 (footprint size)	Fitted to the exposed face as per manufacturer's specification	2
Latch	Winkhaus STV-F2070 3 point lock - centre point only engaged	1770 x 20 (forend size)	Fitted 938 from the head to the centre of the latch nib	3
Furniture	Hoppe aluminium lever handles	27 x 245 (footprint size)	Fitted appropriate to the latch	4

Details of the specimen are shown in Figures 1 and 2 and the Appendix.

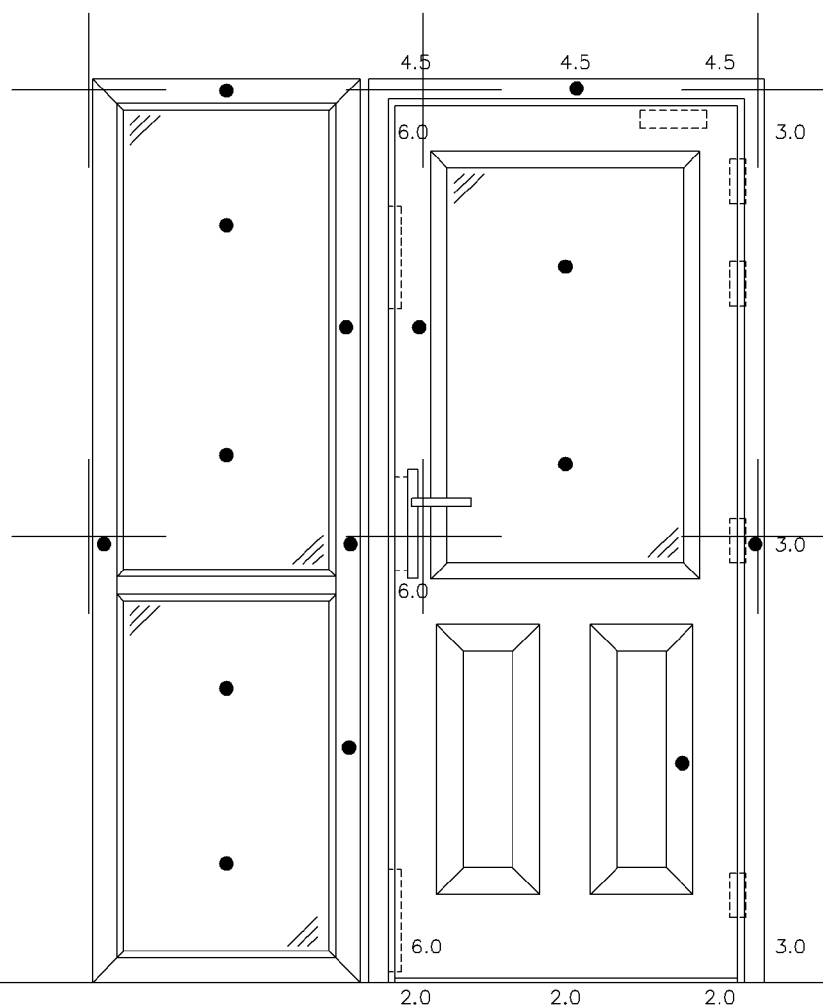
Title Thermocouple positions
 and door gaps
 (All dimensions in mm)

+ : Furnace Thermocouples
 • : Unexposed Face Thermocouples

Gaps Shown

Viewed From Unexposed Face

The gaps between the edge of the doors and frame were measured prior to test. A total of 12 readings were taken. The measurements (in mm) are given in Figure 2.

The results of this test were obtained using the door to frame gaps recorded in Figure 2. The fire resistance performance of doors of this design may change if substantially different gaps are employed.

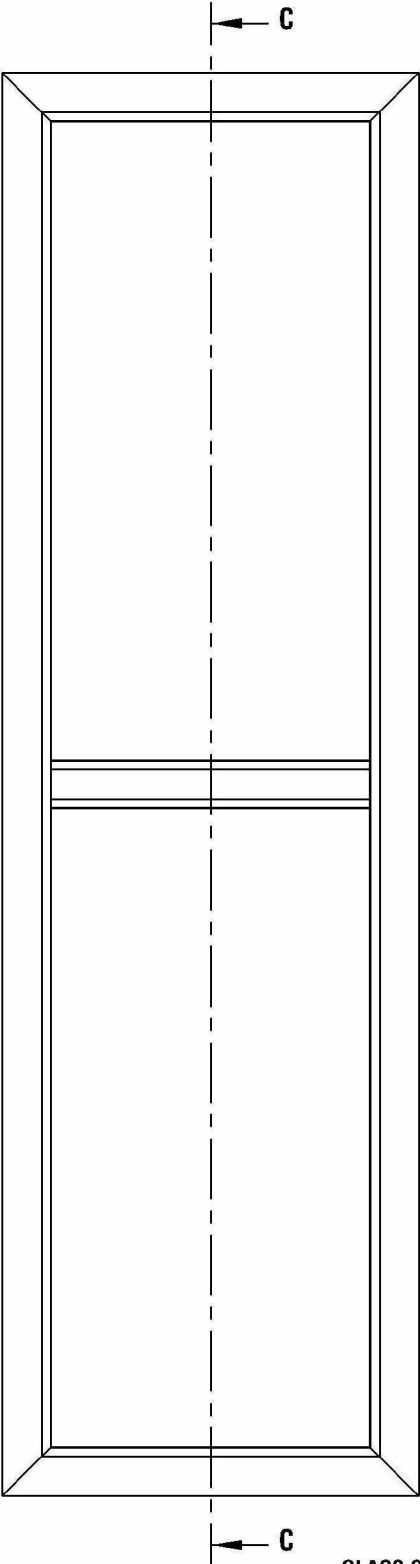
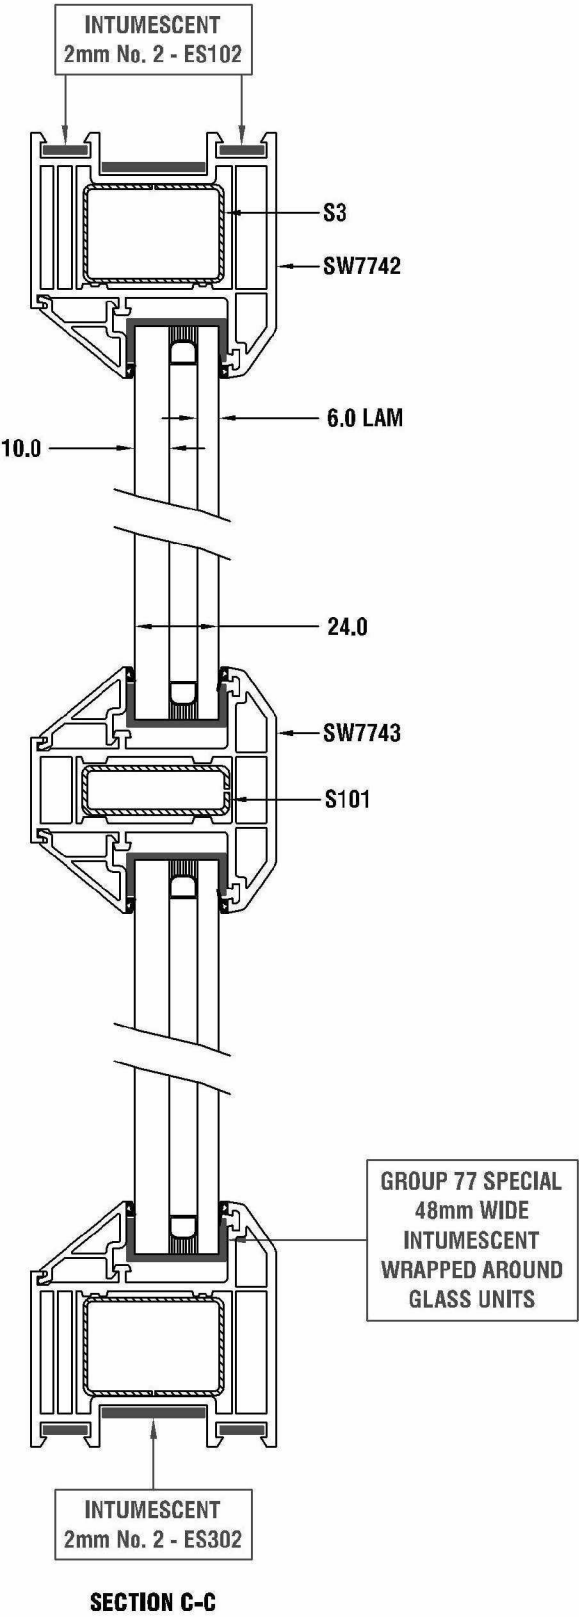
**COMPOSITE FIRE DOOR PANEL
VERTICAL CROSS SECTION**

GLASS SPECIFICATION
 6.4mm PILKINGTON 'K' LAMINATED
 8mm STEEL SPACER
 10mm PILKINGTON PYRODUR EW30-201

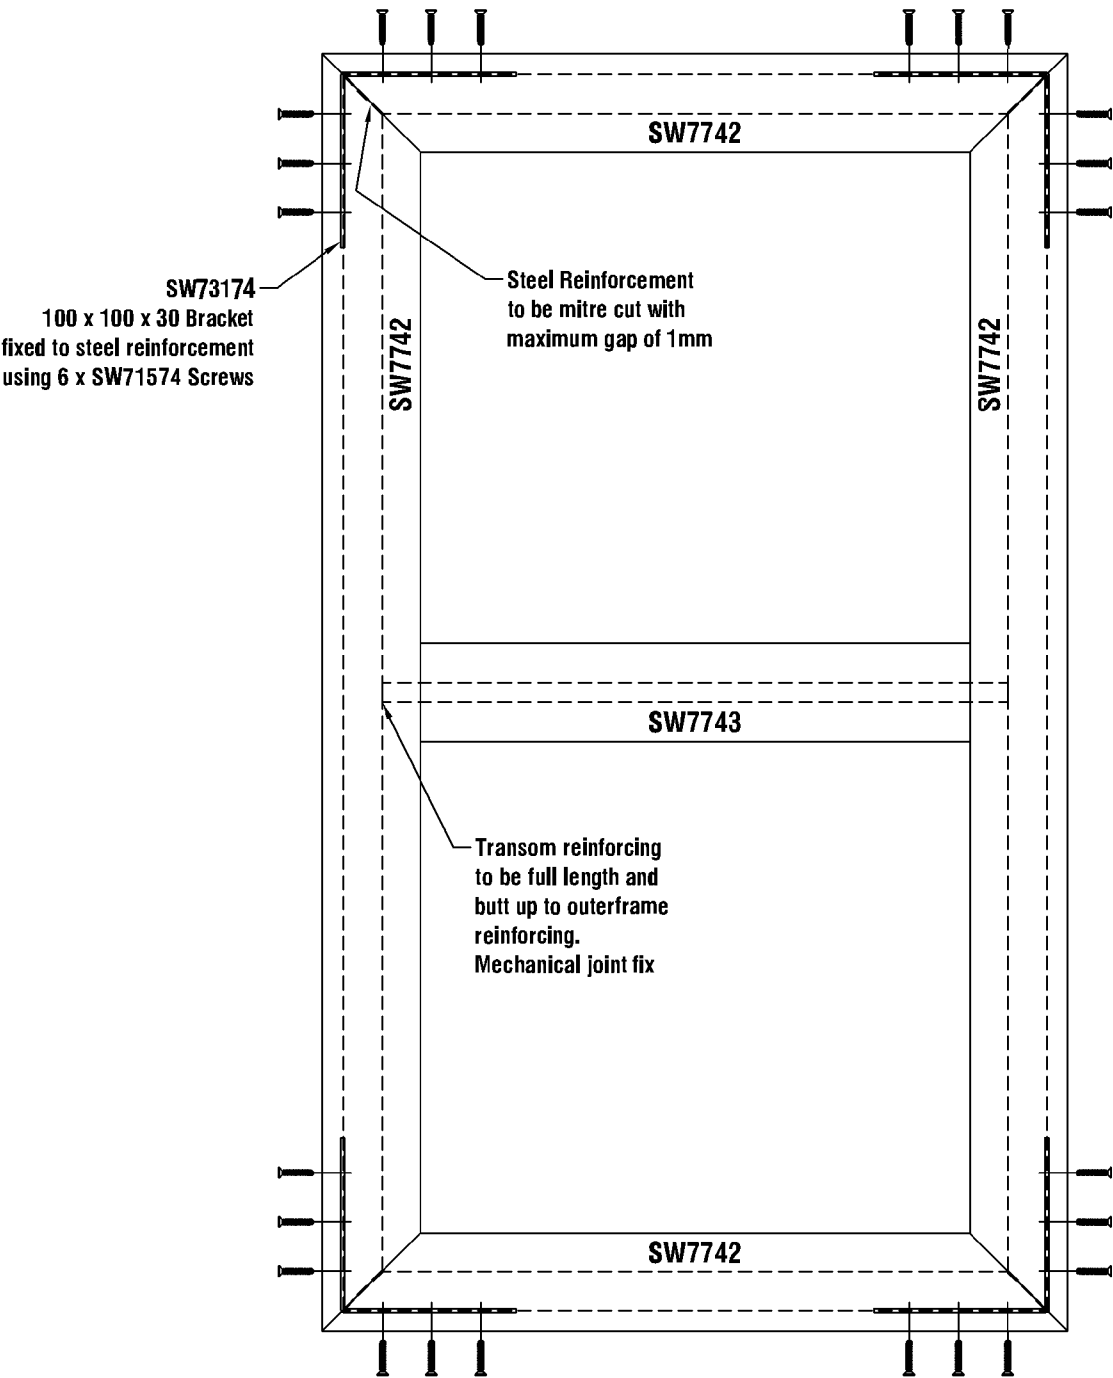
**COMPOSITE FIRE DOOR
SIDE PANEL SPECIFICATION**

Species/type	Dimensions (mm)	Density (kg/m³)	Moisture (% w/w)
Stiles		UPVC with steel reinforcement and a 19 wide x 28 deep push fit loose bead fitted to the exposed face	Overall 70 deep x 68 thick	-	-
Rails	Top & bottom	UPVC with steel reinforcement and a 19 wide x 28 deep push fit loose bead fitted to the exposed face	Overall 70 deep x 68 thick	-	-
	Mid	UPVC with steel reinforcement and 2No 20 wide x 28 deep push fit loose beads fixed to the exposed face	Overall 70 deep x 70 thick	-	-
Glass type		2No double glazed apertures comprising 10mm Pilkington Pyrodur (exposed face), 8mm steel spacer and 6.4mm Pilkington Optilam laminated glass (unexposed face)	24.4 thick	-	-
Sight size	Top aperture	-	1030 high x 460 wide	-	-
	Bottom aperture	-	785 high x 460 wide	-	-
Overall aperture size	Top aperture	-	1072 high x 501 wide	-	-
	Bottom aperture	-	827 high x 501 wide	-	-
