The fire resistance performance of two single leaf single acting doorsets, one with glazing, when tested in accordance with BS 476: Part 20/22: 1987

391787

Sealed Tight Solutions Ltd

10th November 2017

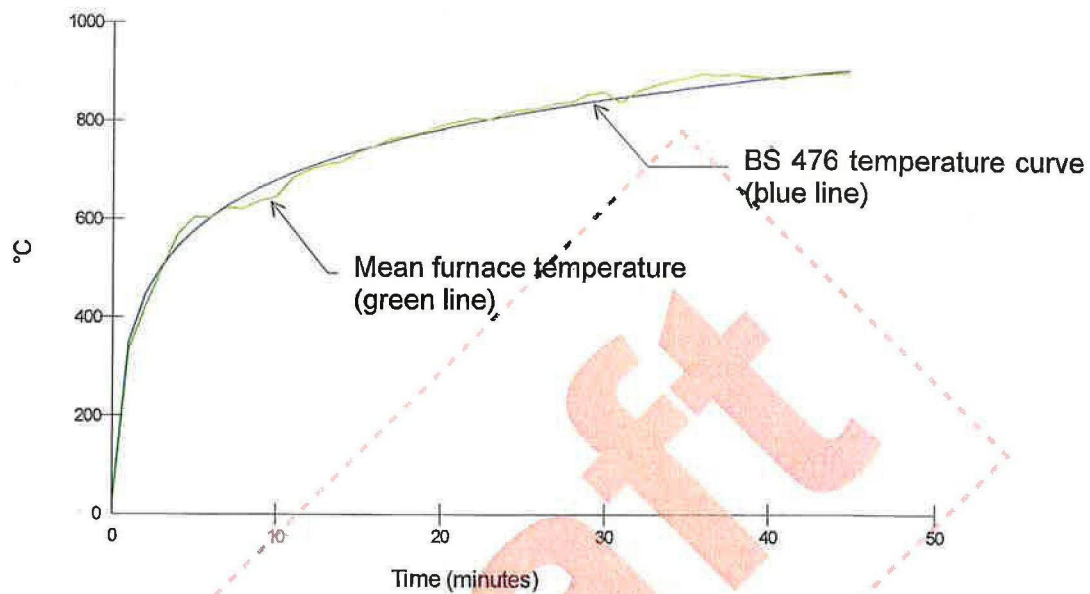
5.1 Furnace Temperature Curve

The furnace was controlled to follow the temperature/time relationship specified in BS 476: Part 20: 1987 as closely as possible, using the average of nine thermocouples suitably distributed within the furnace. The temperatures recorded are shown graphically in Section 5.1.

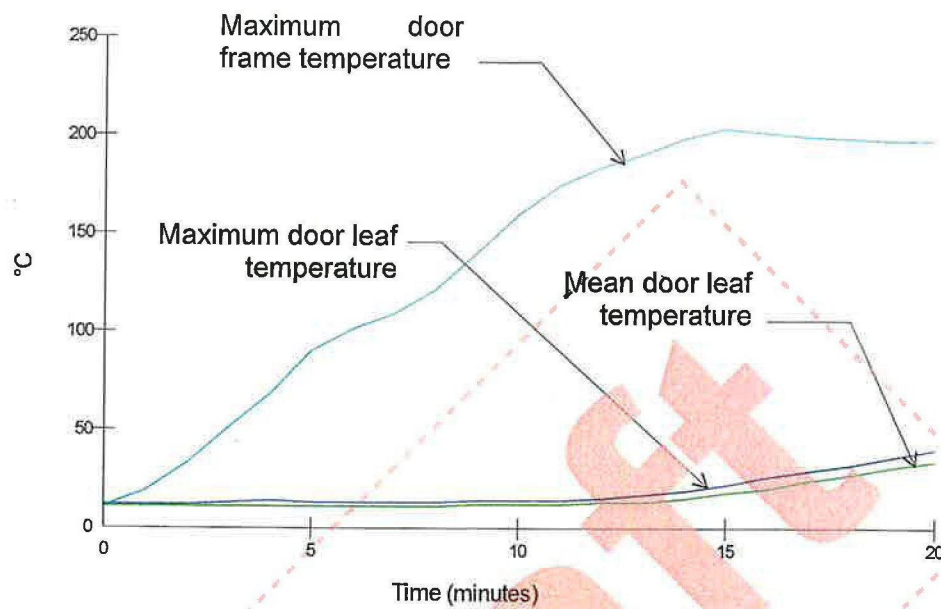
Doorset A

The temperature of the unexposed face of doorset A was monitored by means of five thermocouples fixed to the surface of the door leaf, and three thermocouples attached to the frame, one at midheight on each jamb and one centrally located above the leaf on the frame head. Two additional thermocouples were fixed to the glazing.

The thermocouple positions are shown in Figure 4 of the appendix. The average temperature of the door leaf and maximum temperature of the doorsets are shown graphically in Section 5.2.

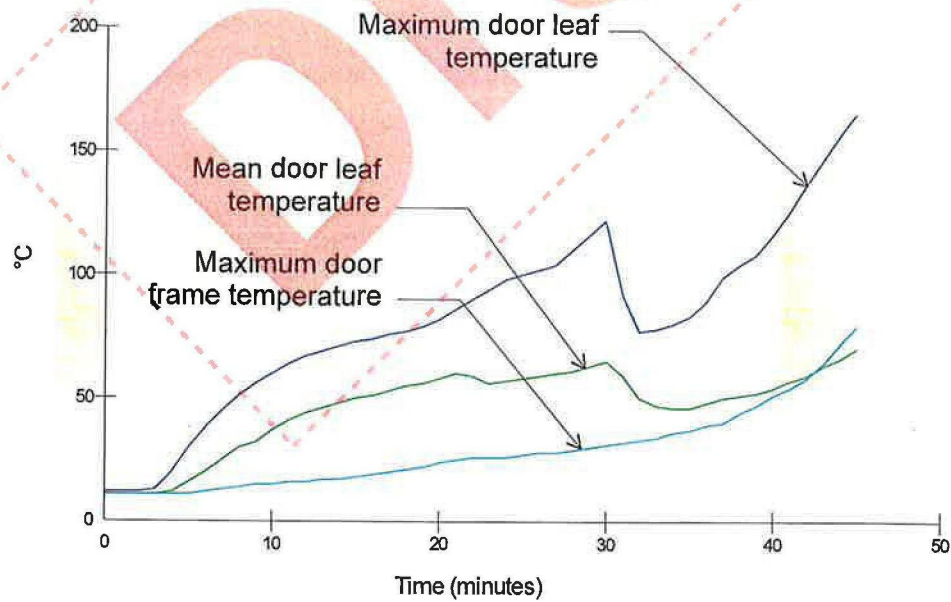
Doorset B

The temperature of the unexposed face of doorset B was monitored by means of five thermocouples fixed to the surface of the door leaf, and three thermocouples attached to the frame, one at midheight on each jamb and one centrally located above the leaf on the frame head.

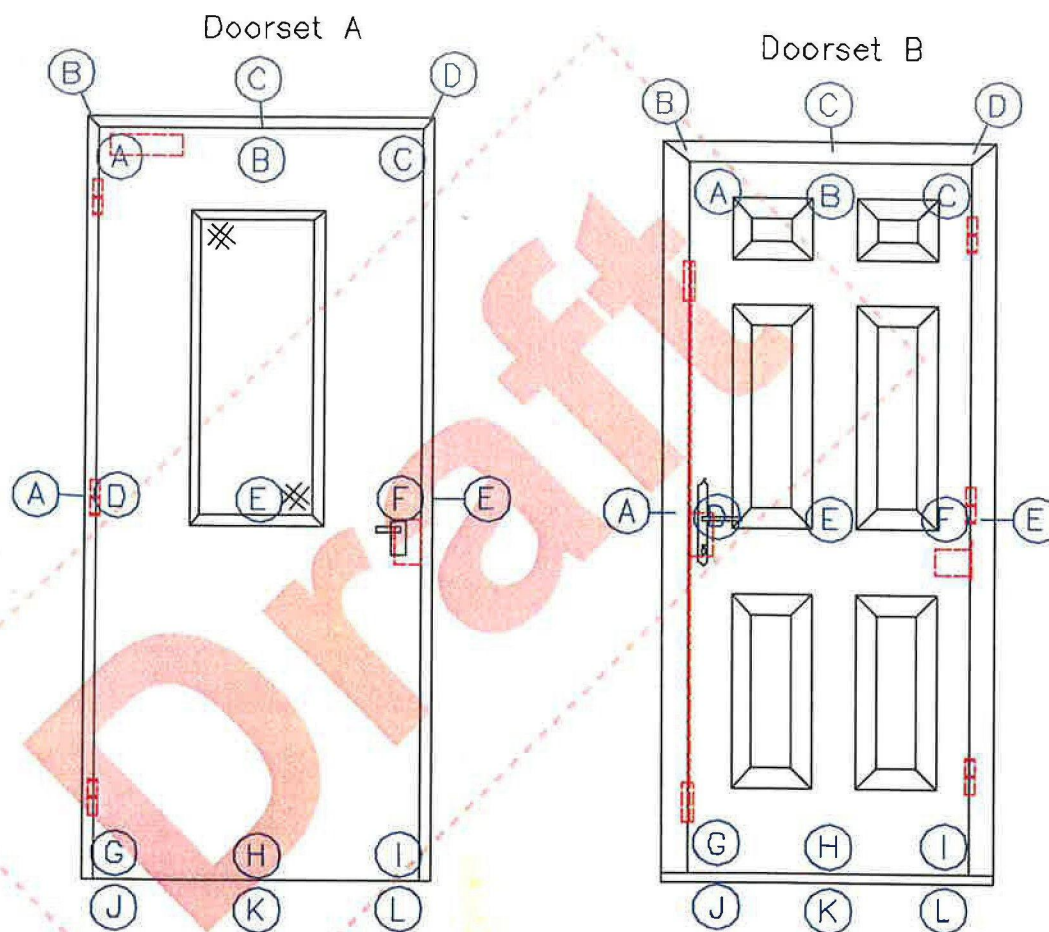
5.3 Frame and Door Distortion Data

The following tables show the distortion of the frame and door in mm with an accuracy of $\pm 1\text{mm}$.

A positive measurement indicates distortion towards the furnace.

A negative measurement indicates distortion away from the furnace.

J, K and L give vertical movement of the door, a negative reading indicates that the door has dropped.

Time	A	B	C	D	E
10	10	10	12	11	14

Time	A	B	C	D	E	F	G	H	I	J	K	L
10	8	18	30	13	15	17	1	11	2	1	0	1
20	-	-	-	-	-	-	-	-	9	-	-	-

Time	A	B	C	D	E
10	15	7	3	6	2
20	14	16	3	6	3
30	14	16	3	5	2
40	14	3	0	5	2

Time	A	B	C	D	E	F	G	H	I	J	K	L
10	14	9	7	5	-5	2	3	-4	-14	0	0	1
20	7	10	8	2	-5	4	6	-4	-8	-1	0	1
30	11	11	10	0	-3	7	4	-4	-7	-1	-3	-2
40	14	11	13	6	-2	8	9	-2	-5	-5	-2	-1

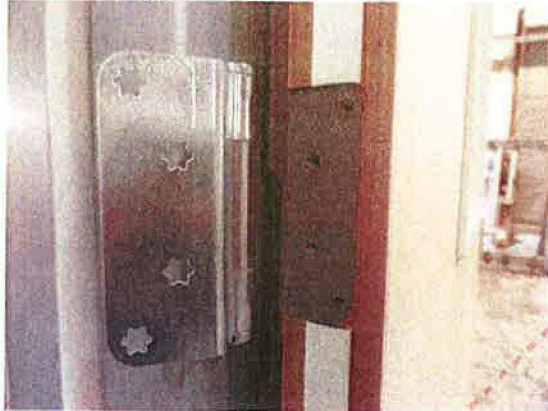
Around hinge blade – doorset A

Make/type	Size (mm)	Location
Around hinges	Fully interrupted	-	Hinge blade fully interrupts seal in leaf edge
Under hinge blade	Sealed Tight Solutions graphite	1 thick	Fitted under the hinge blade on the leaf only
Encasing lock/ latch body	None fitted	-	-
Around lock/latch forend	Fully interrupted	-	Lock/latch forend fully interrupts seal in leaf edge
Under lock/latch forend	None fitted	-	-
Under lock/latch keep	None fitted	-	-

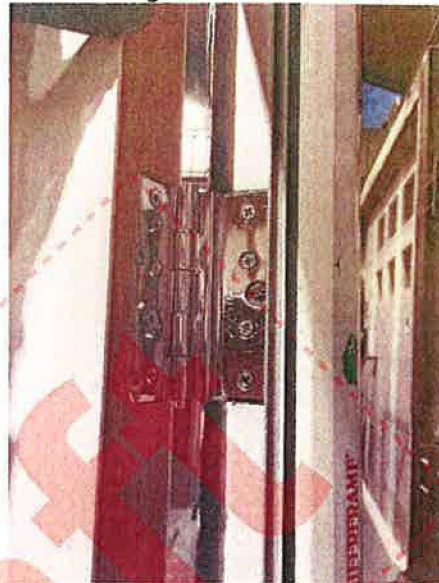
Around hinge blade – doorset B

Make/type	Size (mm)	Location
Around hinges	Fully interrupted	-	Hinge blade fully interrupts seal in frame reveal
Under hinge blade	Sealed Tight Solutions graphite	1 thick	Fitted under the hinge blade on frame and leaf
Around closer	Fully interrupted	-	Closer plate fully interrupts seal in frame reveal
Under closer	Sealed Tight Solutions graphite	1 thick	Fitted under the closer plate in the frame reveal
Encasing closer body	Sealed Tight Solutions graphite	1 thick	Fitted encasing the closer body
Encasing lock/ latch bodies	Sealed Tight Solutions graphite	1 thick	Fitted around lock/latch cases on the exposed side only
Under lock/latch forend	Sealed Tight Solutions graphite	1 thick	Fitted under the lock/latch forend
Around all latch keeps	Fully interrupted	-	Latch keeps fully interrupt seal in frame reveal
Under latch keeps	Sealed Tight Solutions graphite	1 thick	Fitted at the bottom of all keeps

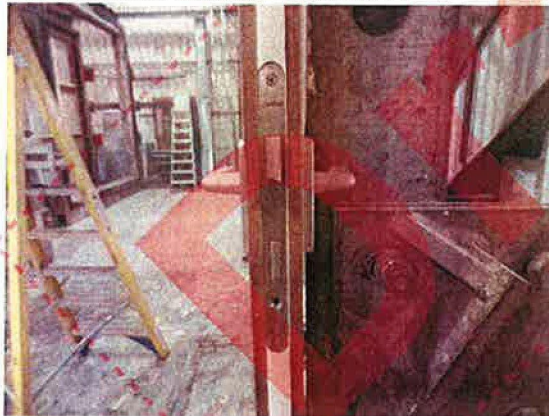
Around latch forend – doorset A

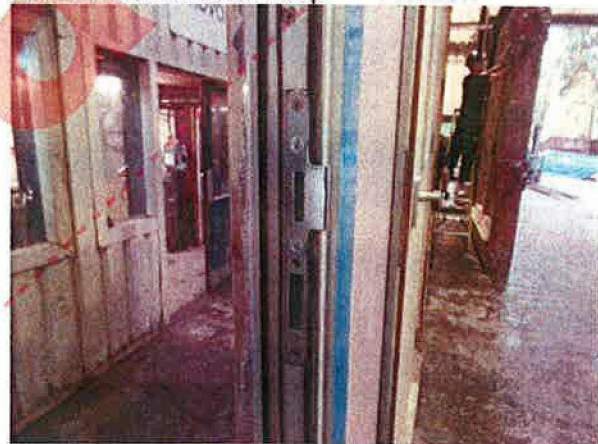
Around centre latch keep – doorset B

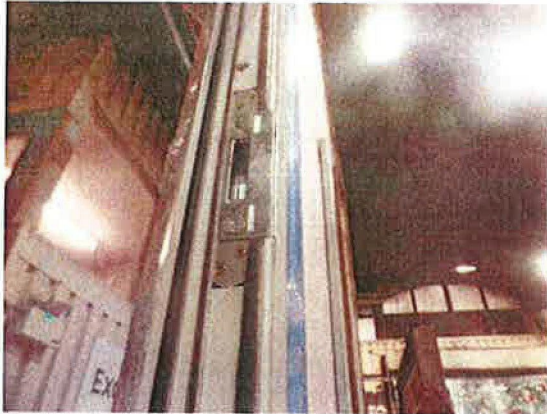
Around top and bottom hook keeps –
doorset B

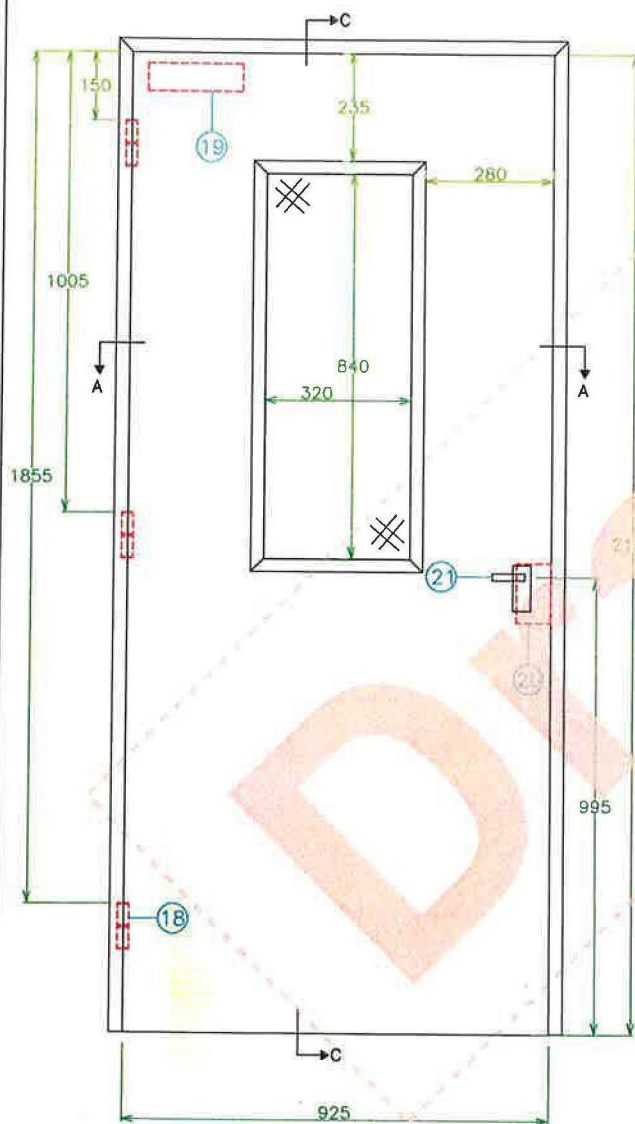
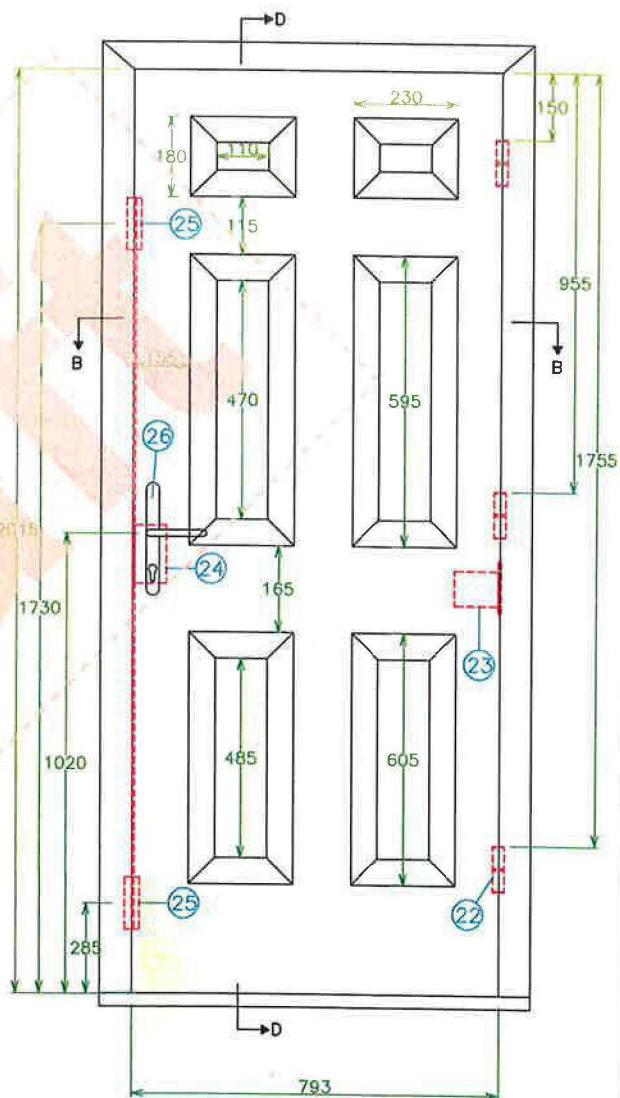
Title Unexposed face elevation
showing hardware positions
(All dimensions in mm)

3 Description of Construction (Refers to Figures 1 to 4 of the Appendix)

Make/type	Size (mm)	Location	Key to figures
Hinges	3No. Simonswerk bearing butt type hinges	95 x 35 (blade size)	Fitted 150mm, 1005mm and 1855mm from the head of the leaf	18
Closer	Rutland TS3204 overhead type closer	224 x 62 (footprint size)	Fitted on the exposed face as per the manufacturer's instructions	19
Lock/latch – engaged	Laidlaw steel mortice lock/latch	18 wide x 235 high (forend size) 165 x 95 x 16 (case size)	Lock/latch fitted 995mm from the threshold of the leaf	20
		200 x 32 (keep size)		
Furniture	Laidlaw aluminium lever type handle	100 x 40 (footprint size)	Fitted appropriate to the lock/latch	21

Make/type	Size (mm)	Location	Key to figures
Hinges	3No. SEA Ltd mk4 aluminium butt type hinges	101 x 40 x 3 (blade size)	Fitted 150mm, 955mm and 1755mm from the head of the leaf	22
Closer	Astra leaf edge/jamb fitted concealed type closer	110 x 32 (forend size)	Fitted in the leaf edge/frame jamb as per the manufacturer's instructions	23
Lock/latch – engaged at centre latch only	Winkhaus AV2 multi-point lock /latch	20 wide x 1768 high (forend size) 175 x 24 (case size)	Centre latch fitted 1020mm from the threshold of the leaf	24
	Centre keep	235 x 30 (keep size)		
	Top and bottom keeps	180 x 30 (keep size)	Fitted 285mm and 1730mm from the leaf threshold	25
Furniture	Trojan aluminium lever type handle	250 x 34 (footprint size)	Fitted appropriate to the centre lock/latch	26

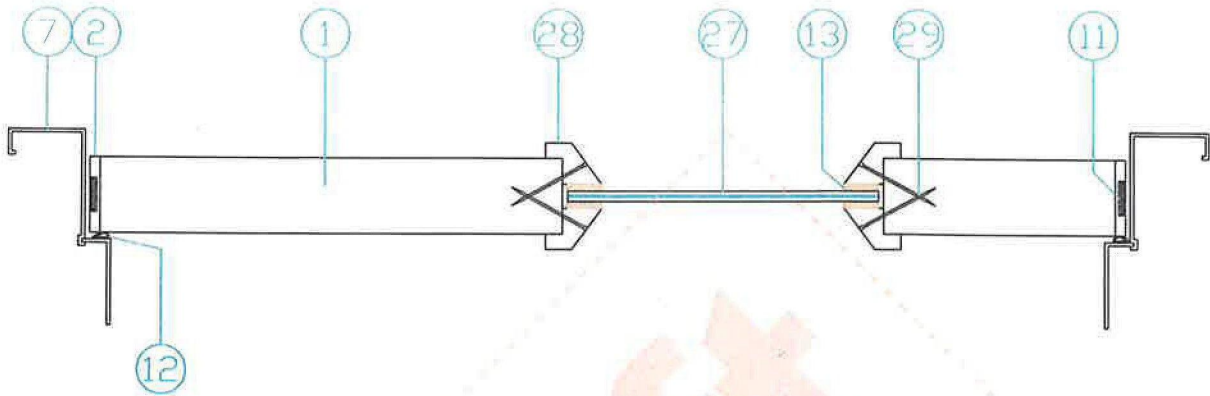
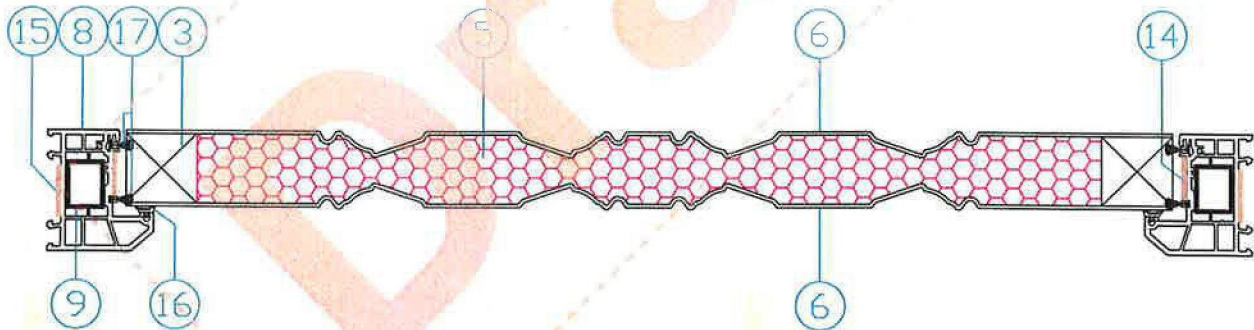
Section A-A

Section B-B

Horizontal cross-sections
(All dimensions in mm)

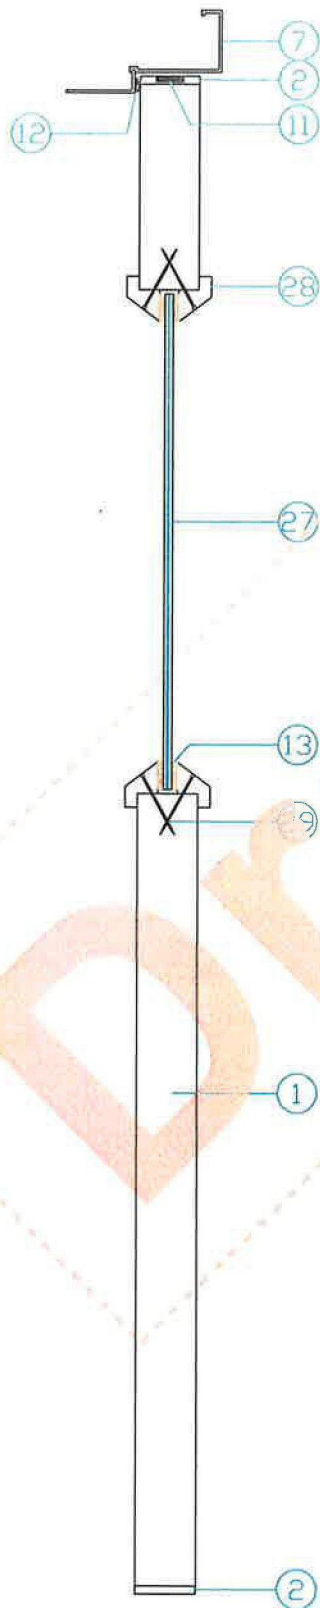
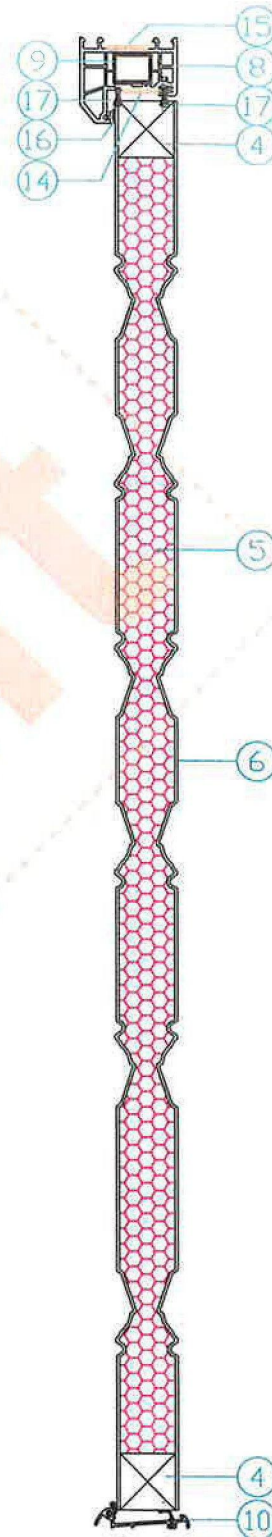
Section C-C

Section D-D

Vertical cross-sections
(All dimensions in mm)

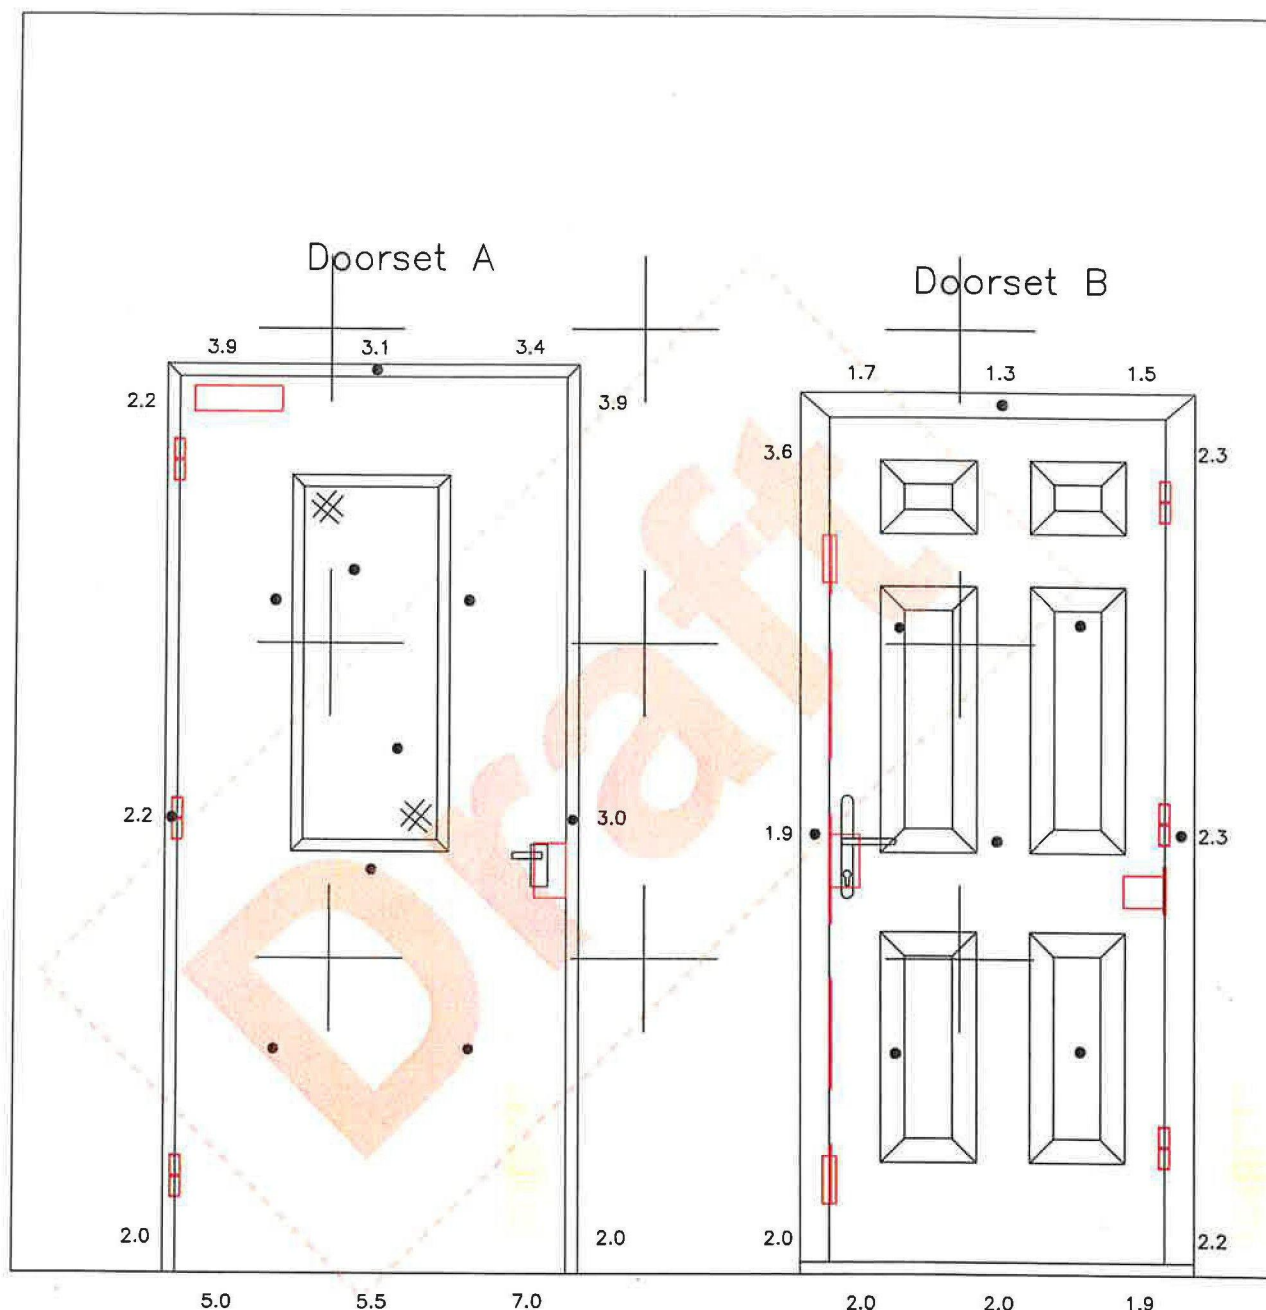
Title Thermocouple positions and
leaf/frame gaps
(All dimensions in mm)

The gaps between the edge of the door and frame were measured prior to test. A total of 24 readings were taken. The measurements (in mm) are given in Figure 4 of the Appendix.

The results of this test were obtained using the door to frame gaps recorded in Figure 4 of the appendix. The fire resistance performance of doors of this design may change if substantially different gaps are employed.
