# The Building Test Centre

performance of a fully  
insulated doorset and a  
partially insulated, single-  
acting single-leaf doorset  
when tested in accordance  
with BS 476: Part 22:  
1987, Clause 6 and 7,  
respectively.

**WF Report No:**

To determine the fire resistance performance of two fire-rated doorsets and to determine the fire resistance performance of the doorsets in accordance with BS 476 Part 22: 1987, Class 3 and 4, respectively.

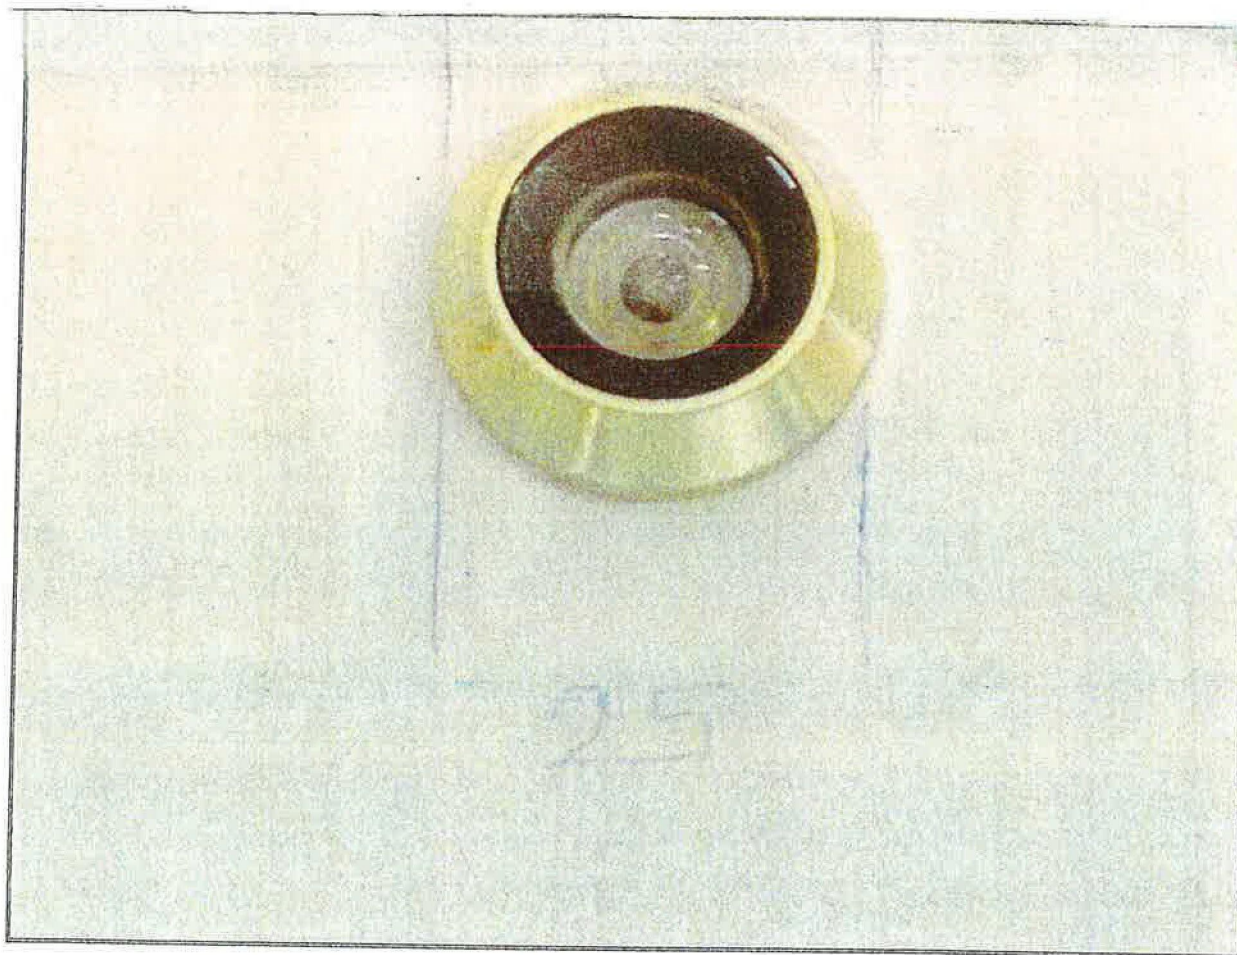
Photograph 15. Spyhole from the unexposed face.

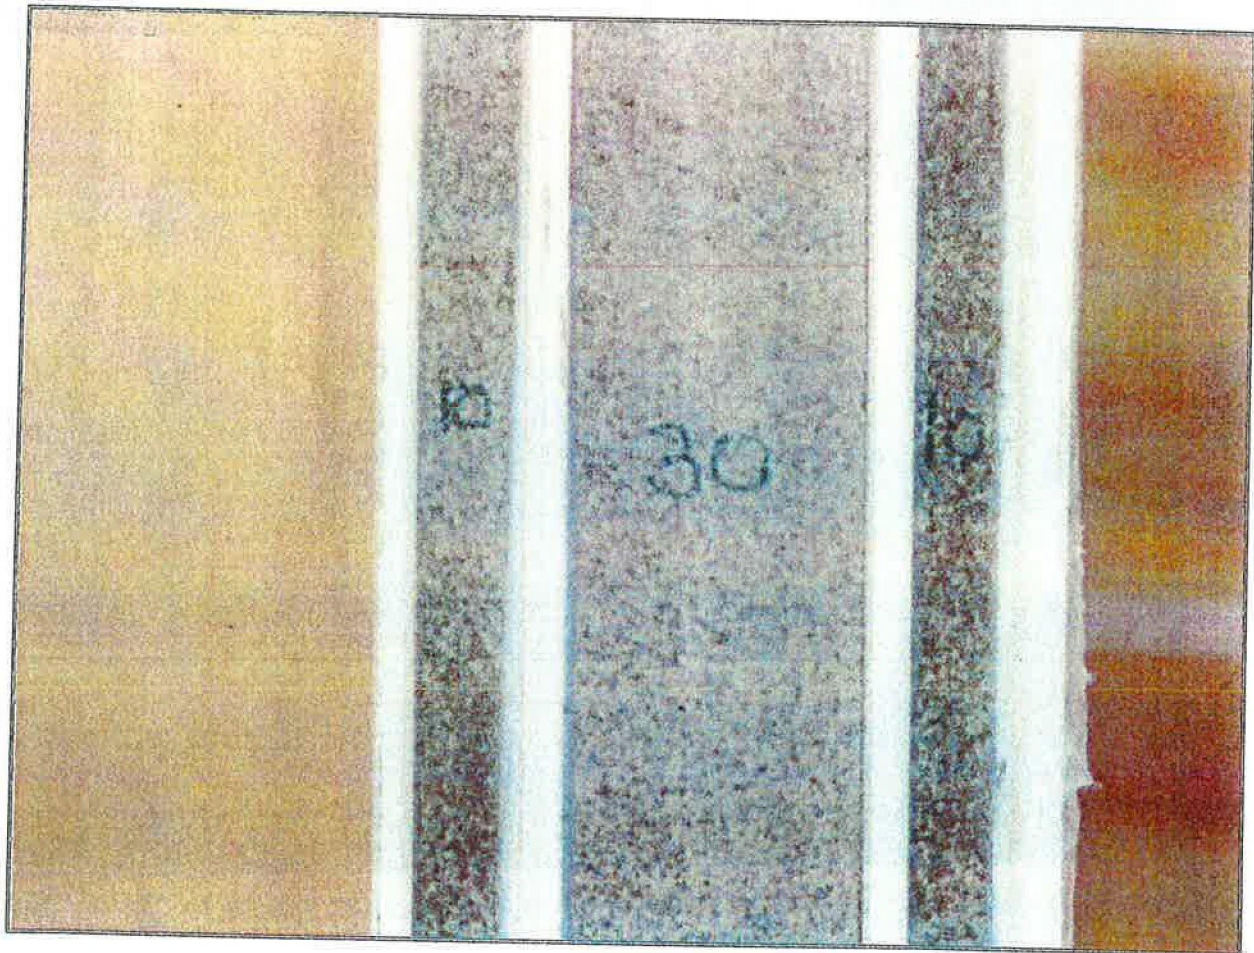
Photograph 17. Outer perimeter of frame, showing intumescent strips.

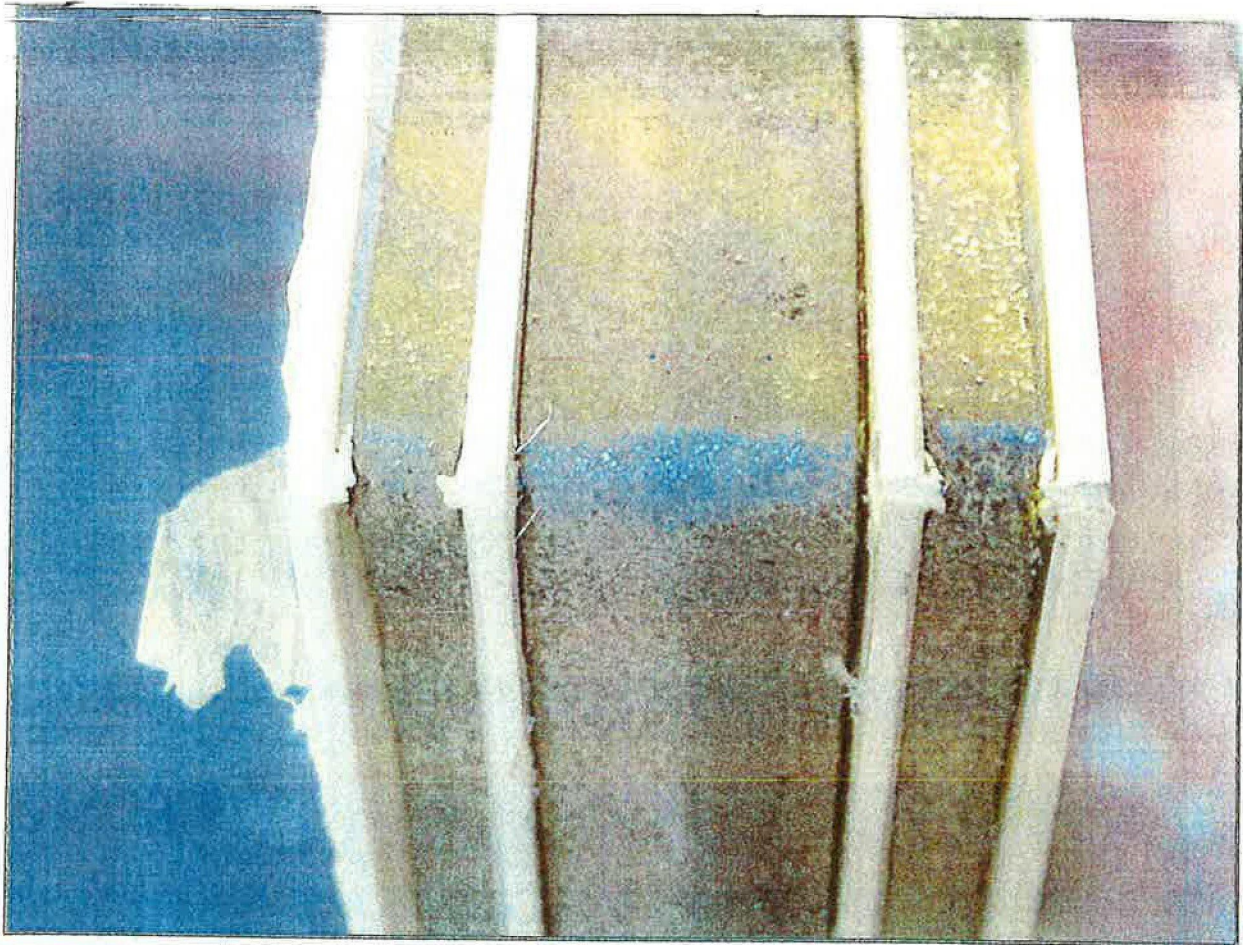
Photograph 18. Top corner of outer perimeter of frame.

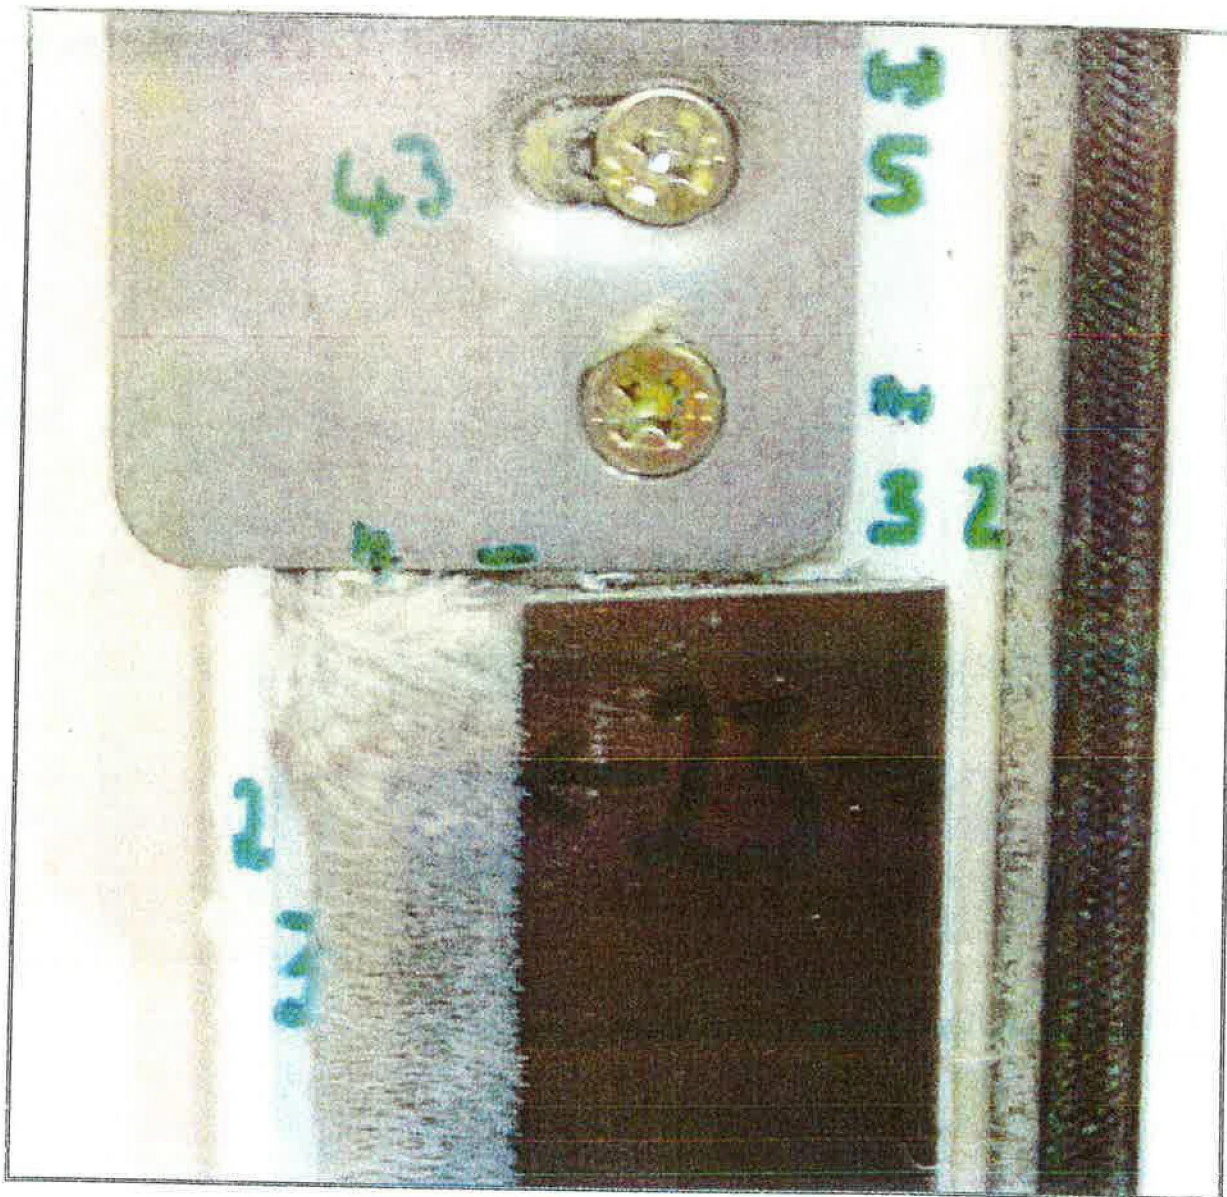
Photograph 19. intumescent in door frame, adjacent to strike plate

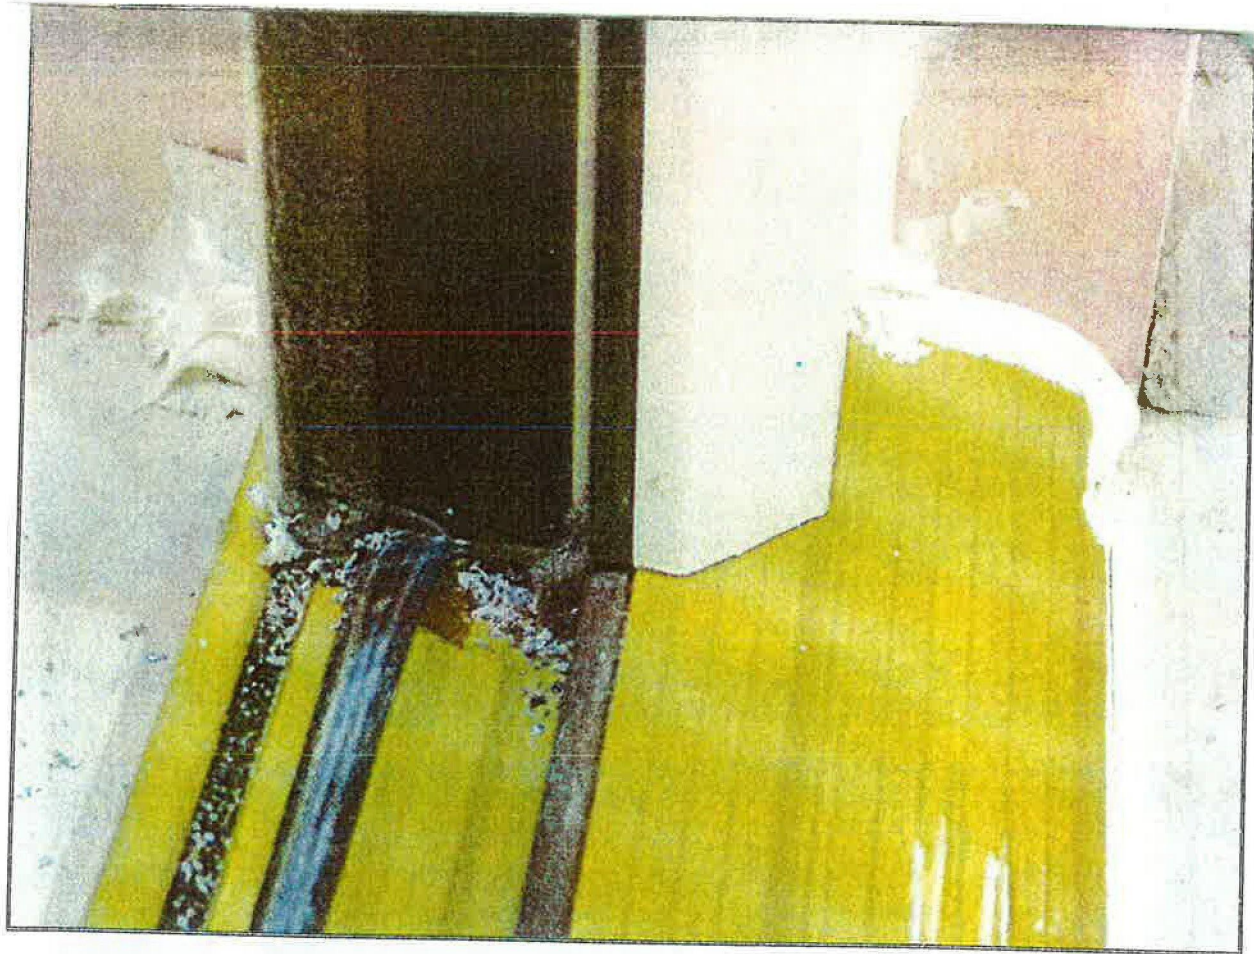
Photograph 20. Threshold at base of doorframe.

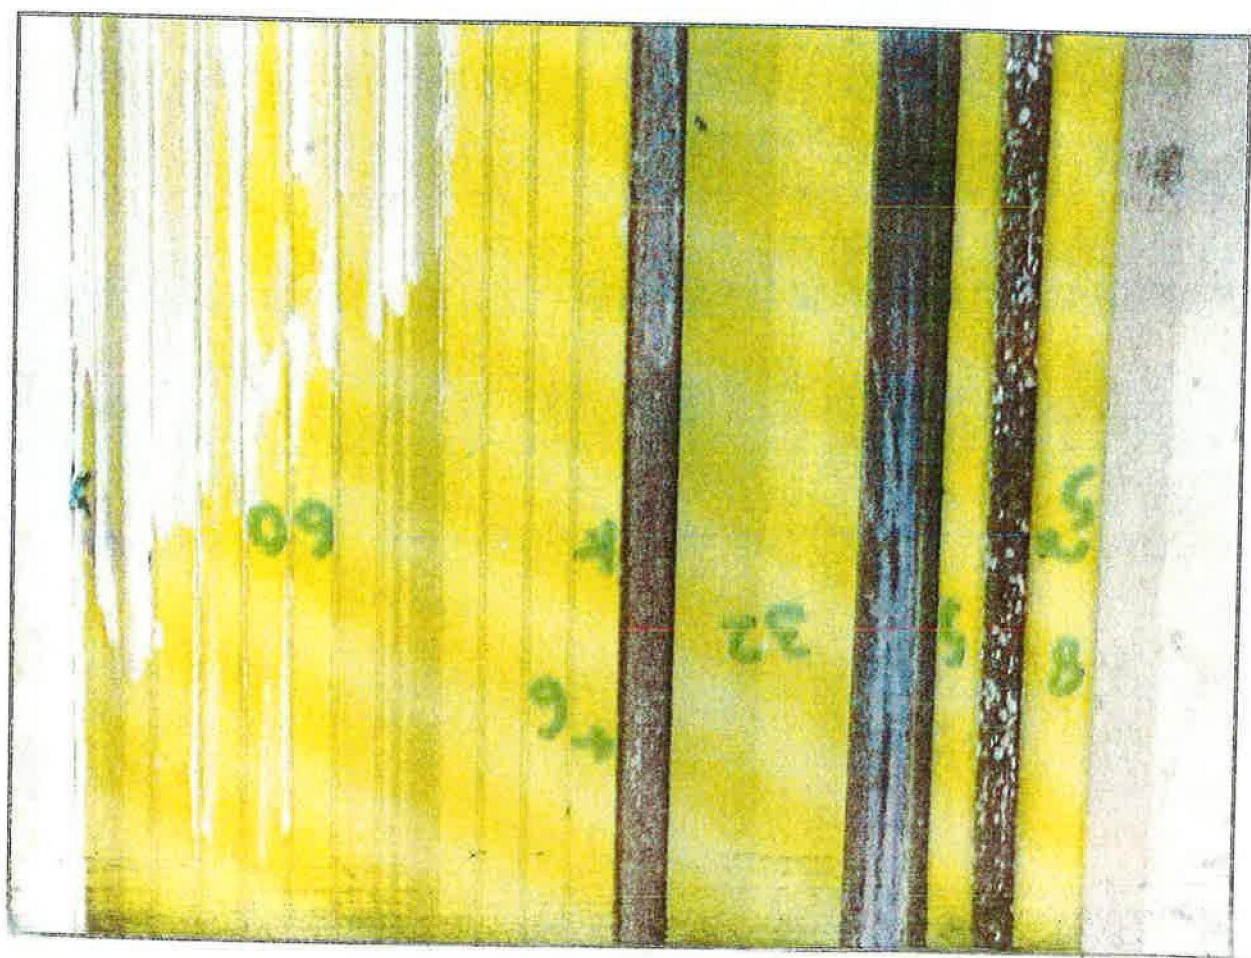
Photograph 21. Threshold at base of doorframe.

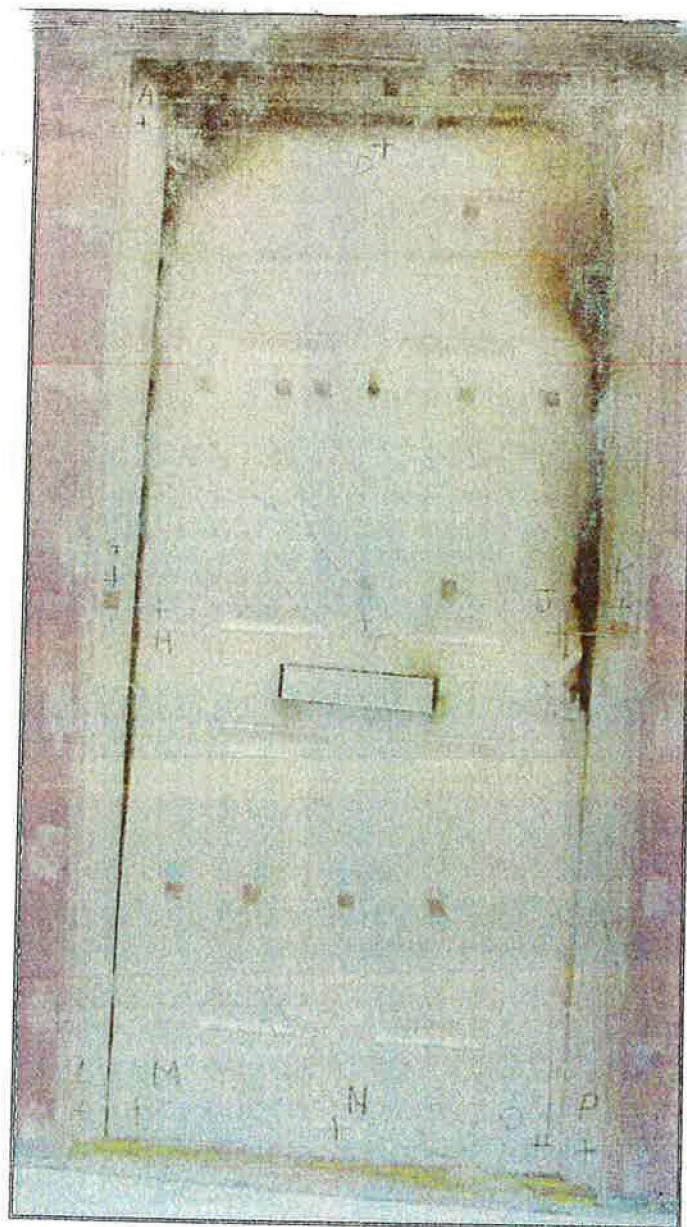
Photograph 22. Unexposed face of doorset at 20 minutes.

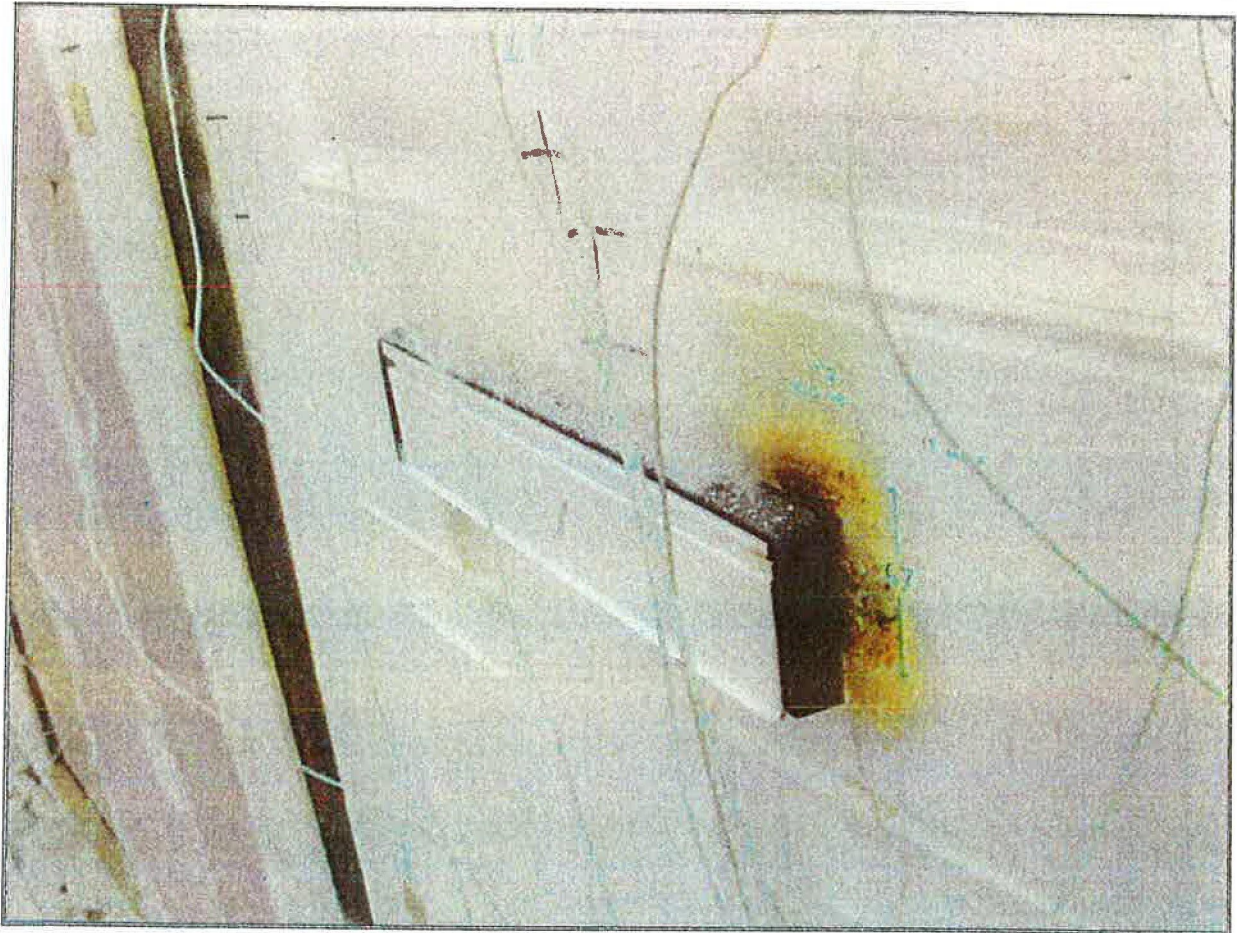
Photograph 23. Letter plate at 20 minutes.

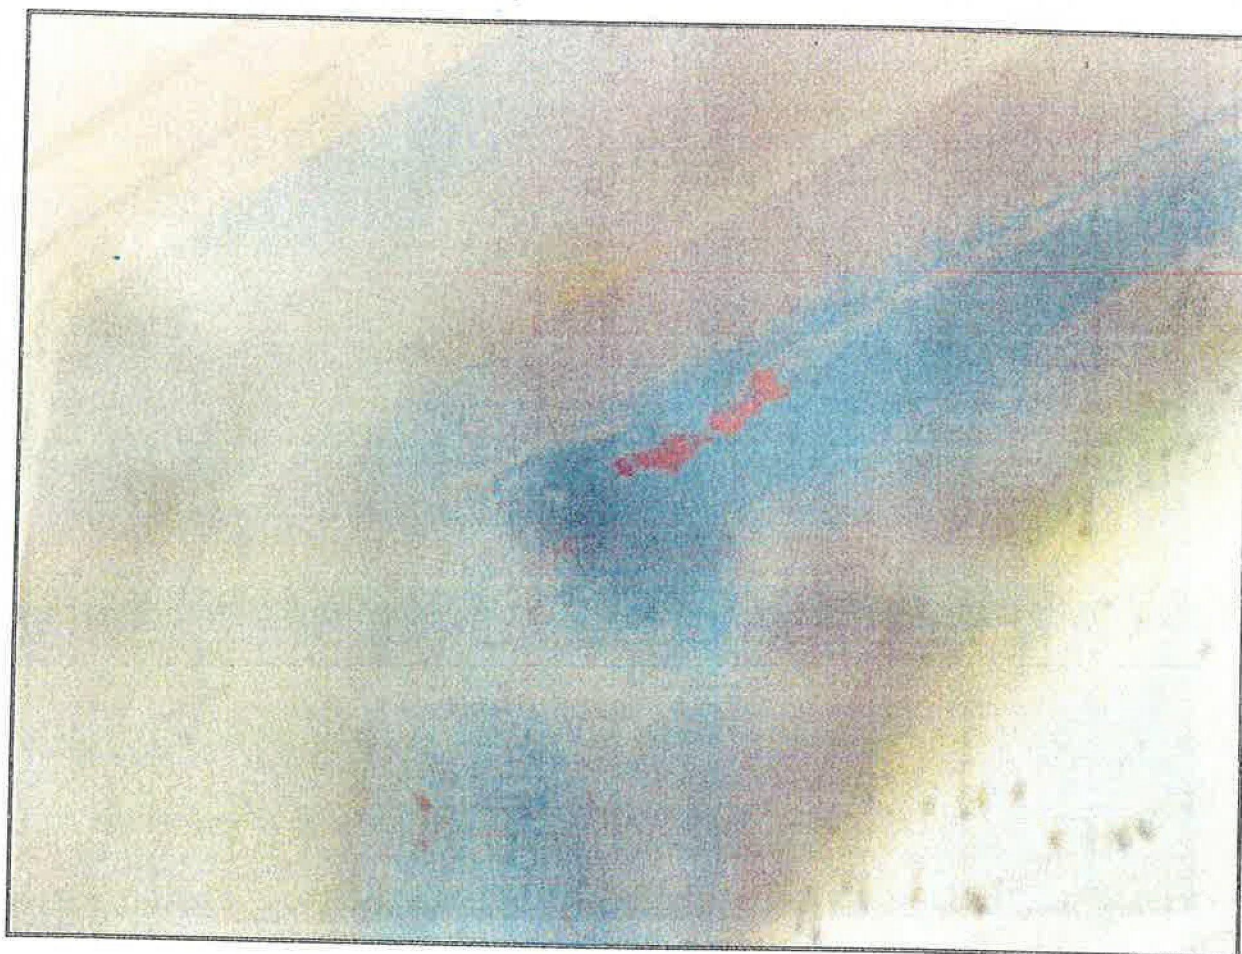
Photograph 24. Top hanging edge corner of door leaf at 20 minutes.

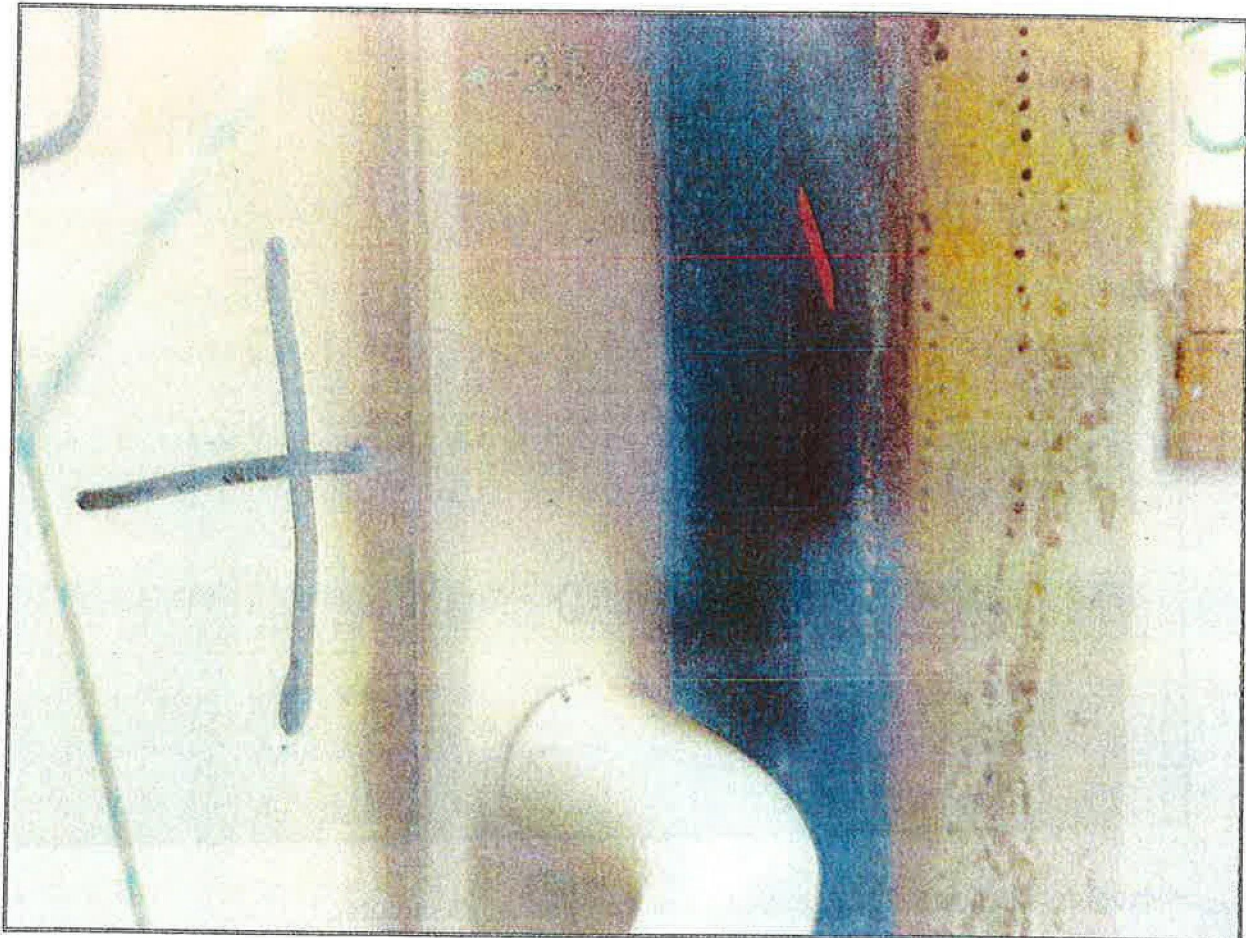
Photograph 25. Door handle at 20 minutes.

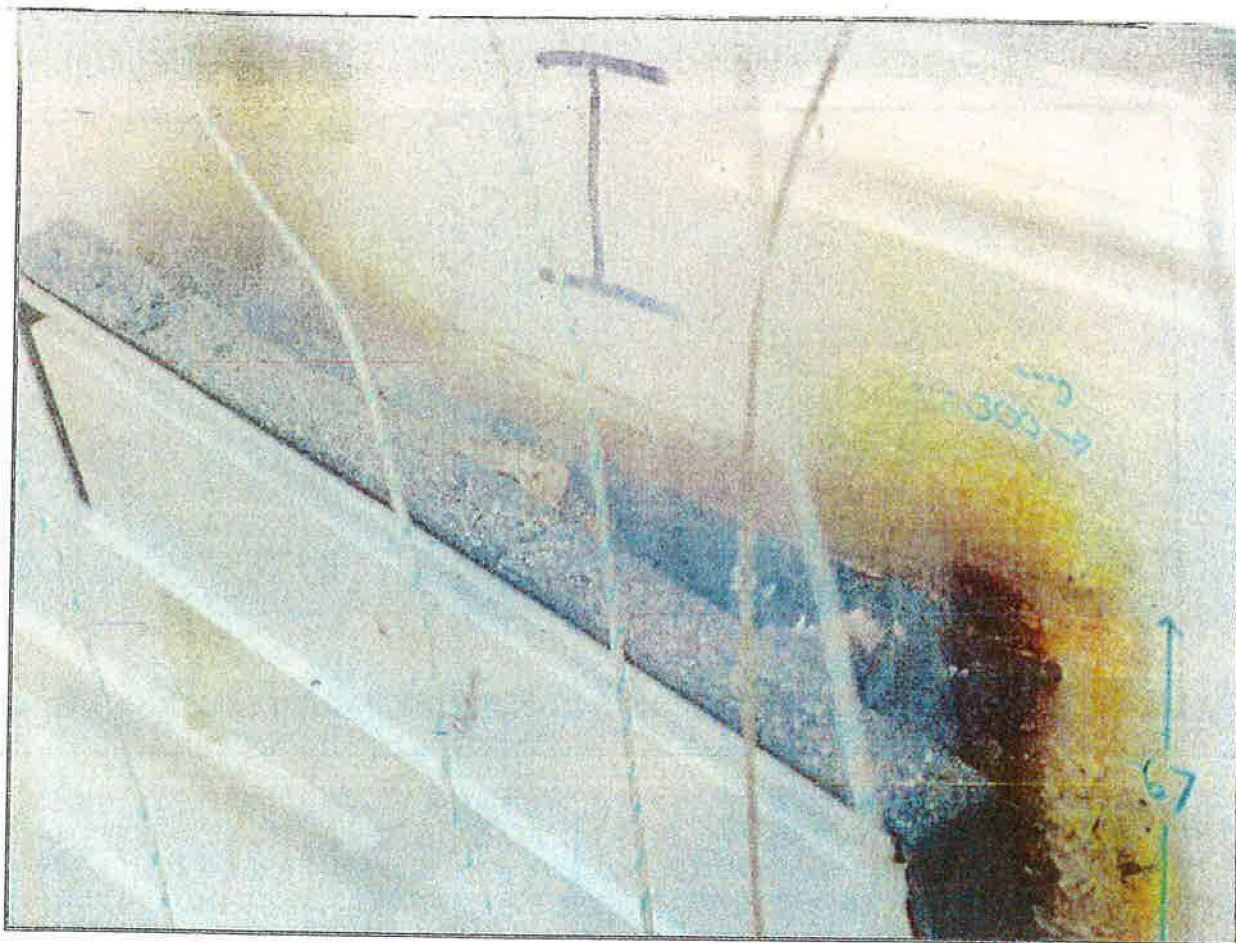
Photograph 26. Letter plate pulled away from leaf at 25 minutes.

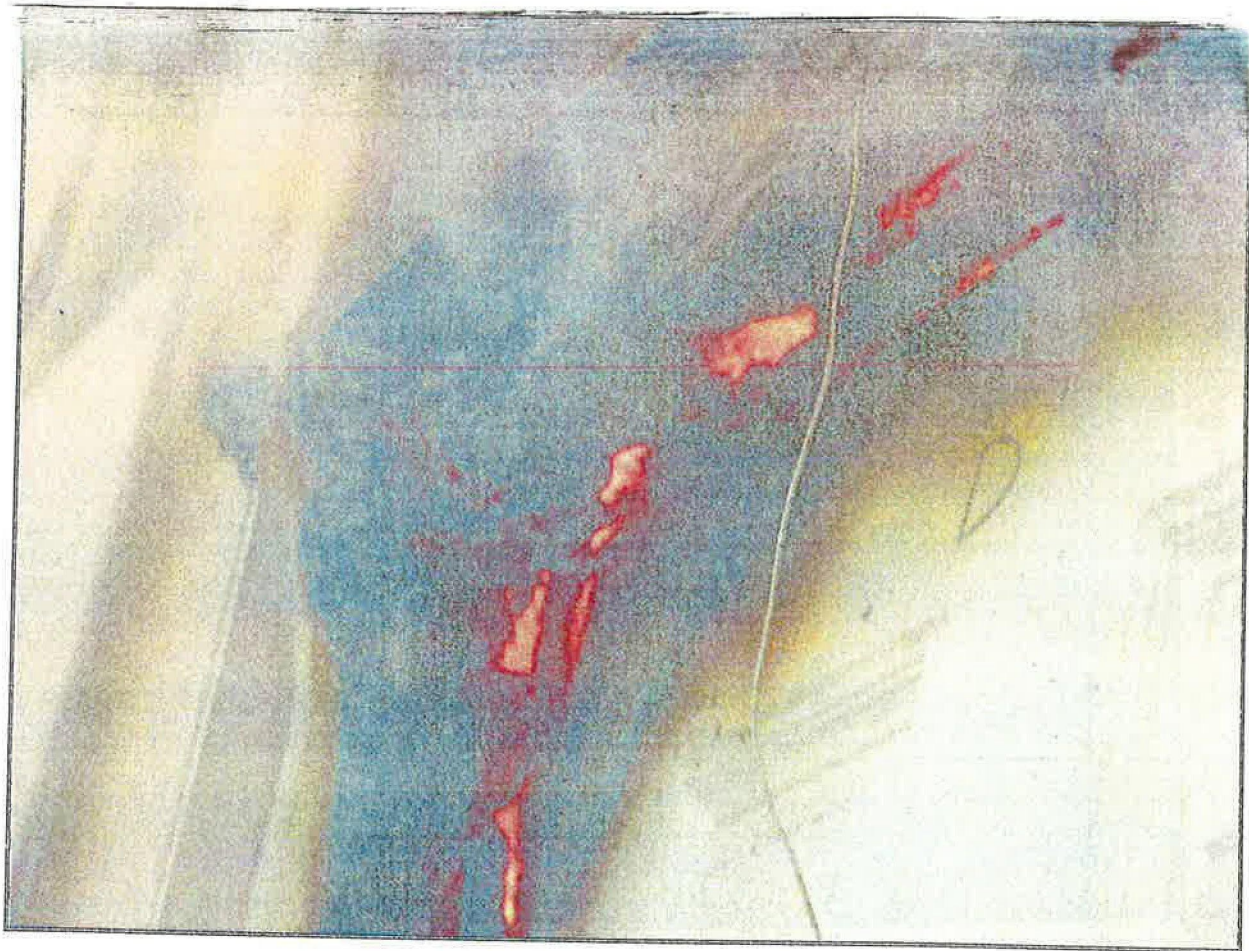
Photograph 27. Top hanging edge corner of door leaf at 33 minutes, showing activated intumescent.

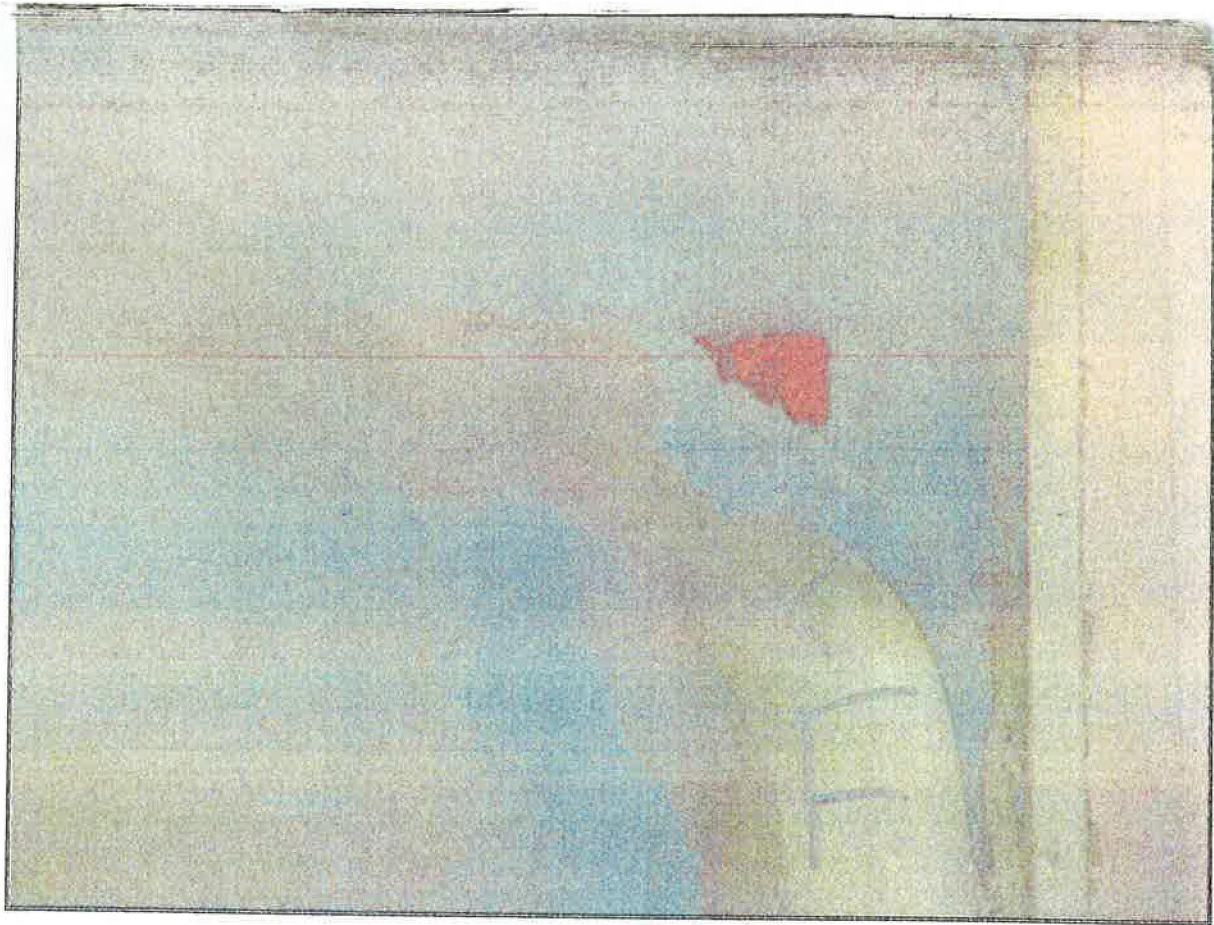
Photograph 29. Top closing edge corner at 35 minutes, showing position of integrity failure.

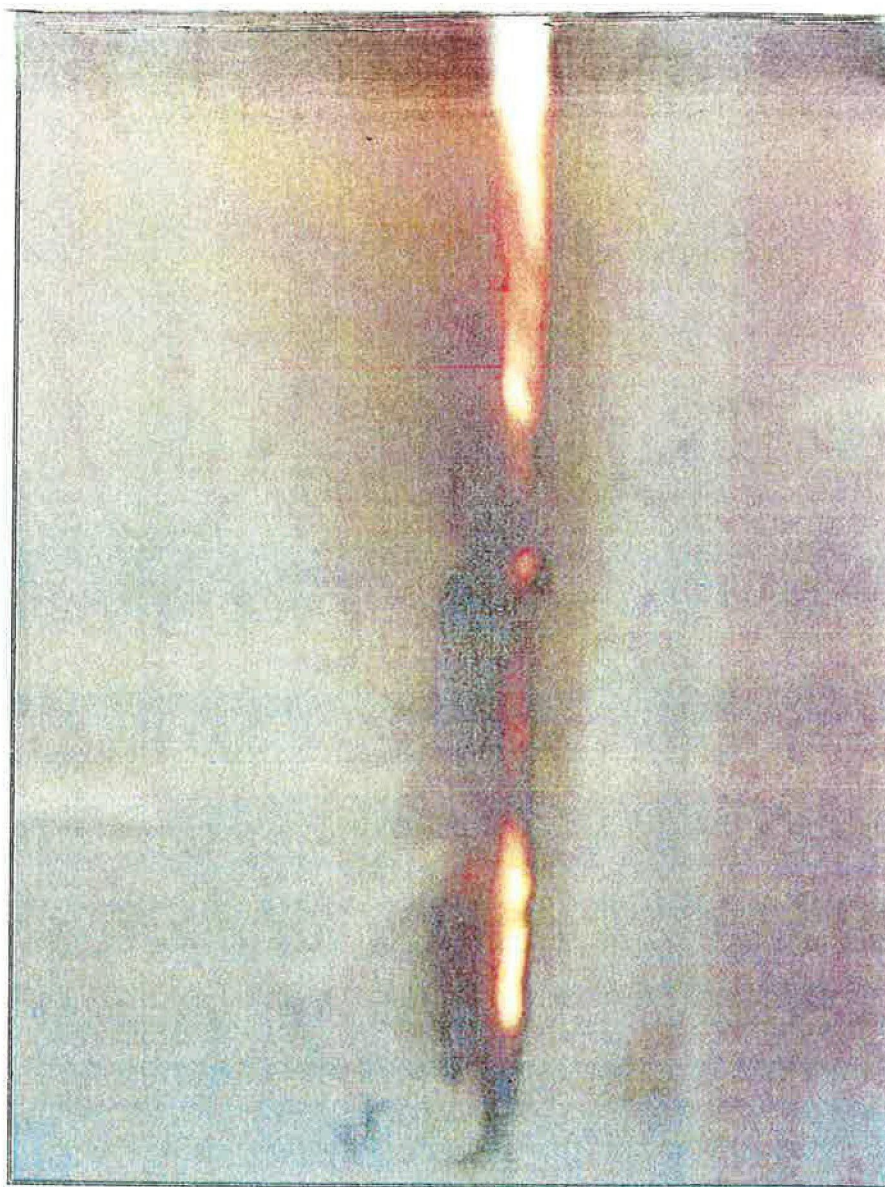
Photograph 30. Gap between door leaf and frame at 35 minutes.

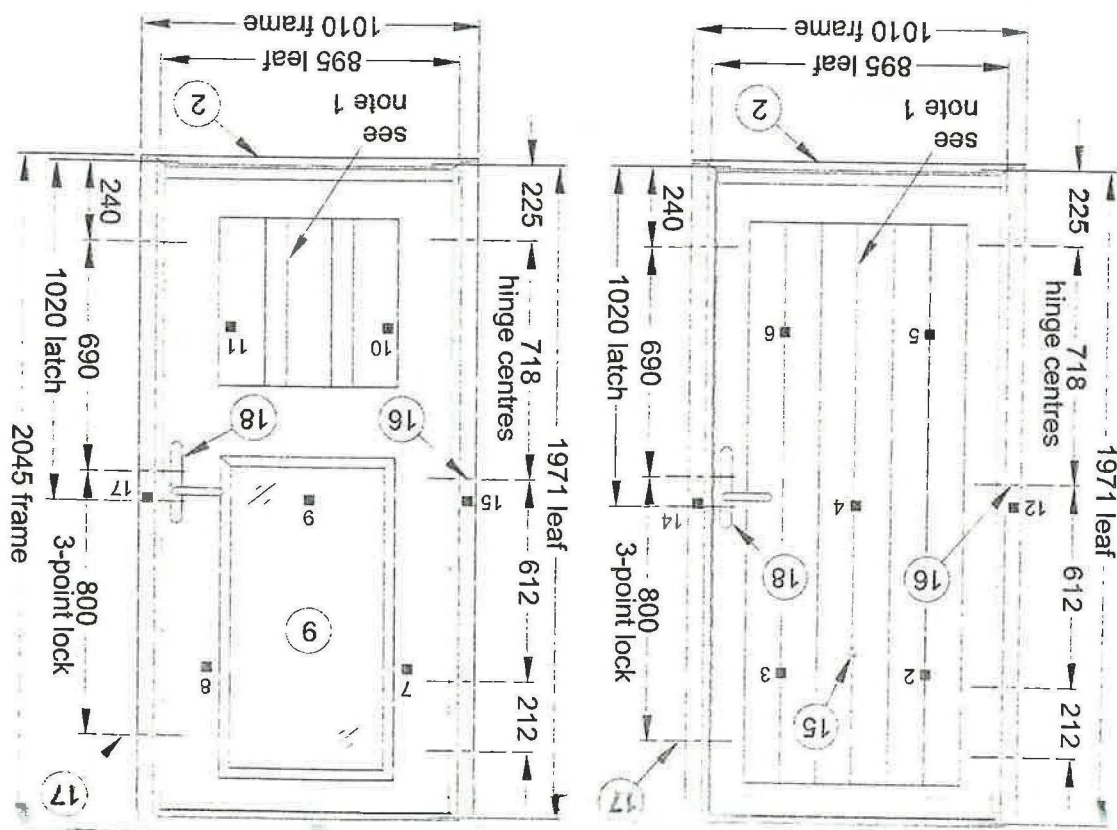
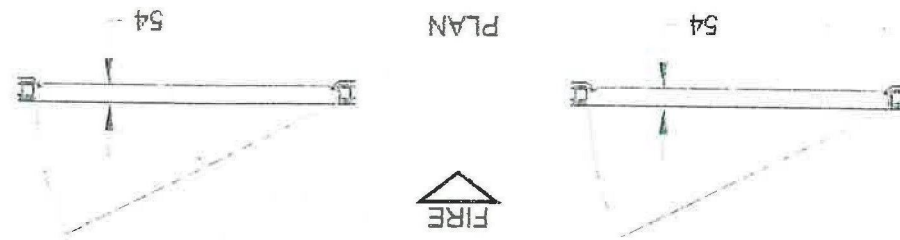
Figure 1 - General elevation of test specimens and unexposed face thermocouples

Refer to Figures 1 & 7

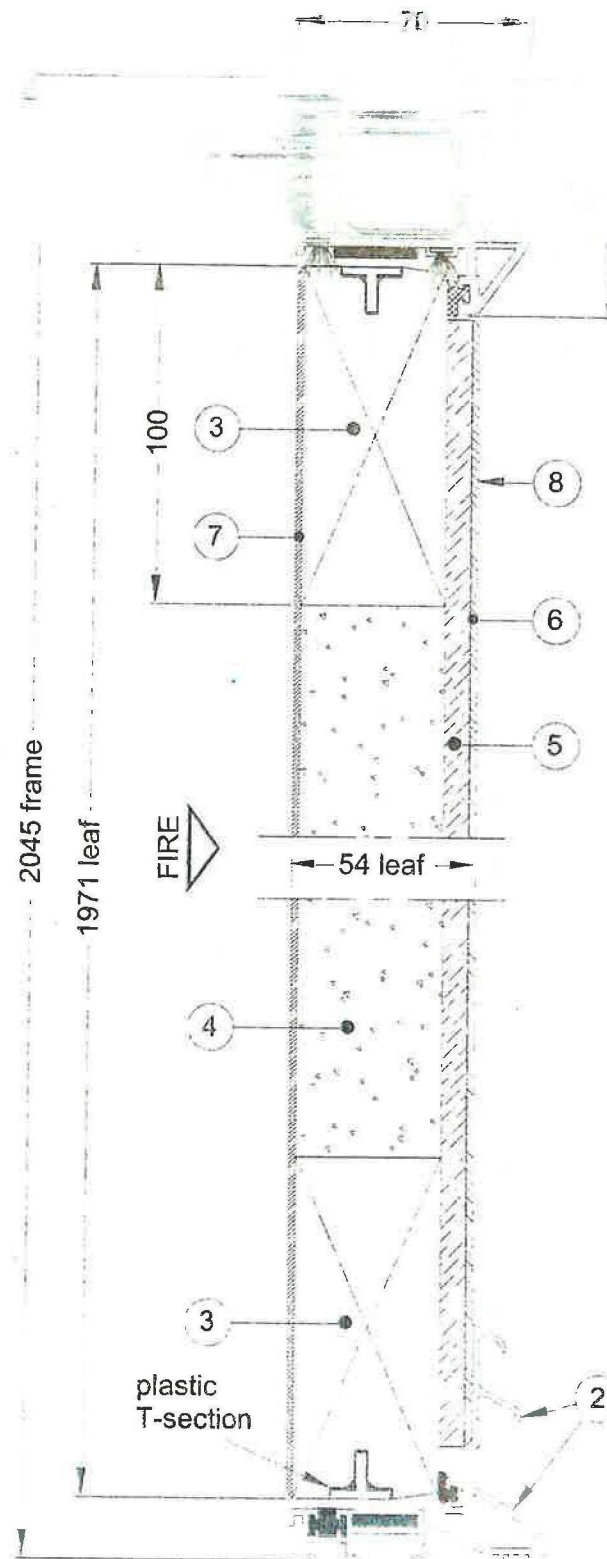
Figure 3 – Typical vertical section through both doorsets

: Stormguard  
 : Masterguard MK2  
 : Aluminium  
 : See Figure 3  
 : Screw fixed to base of door frame jambs

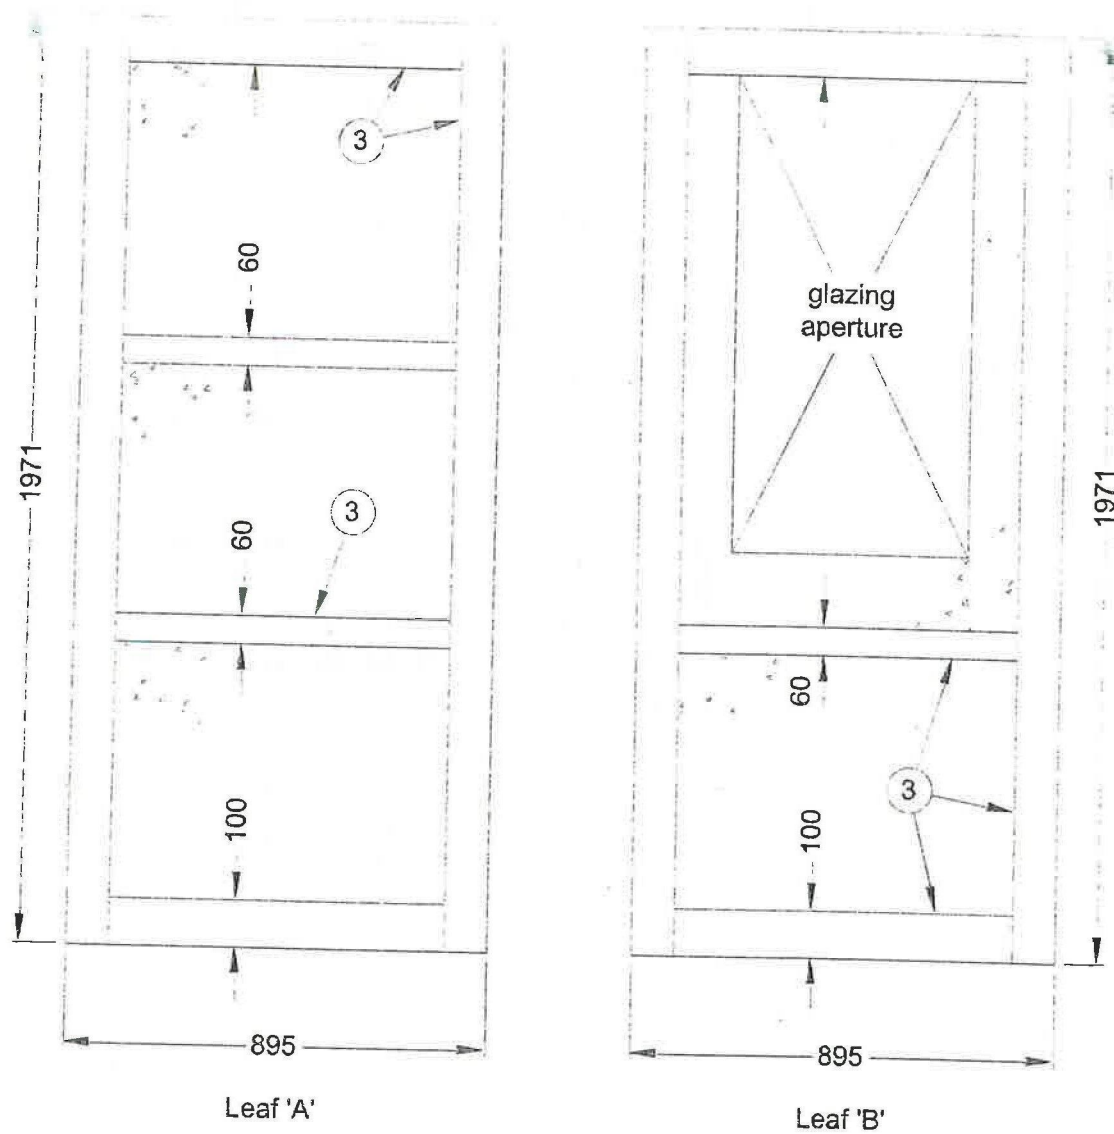
Figure 4 – Elevation view showing general layout of door leaf internal framework (item 3)

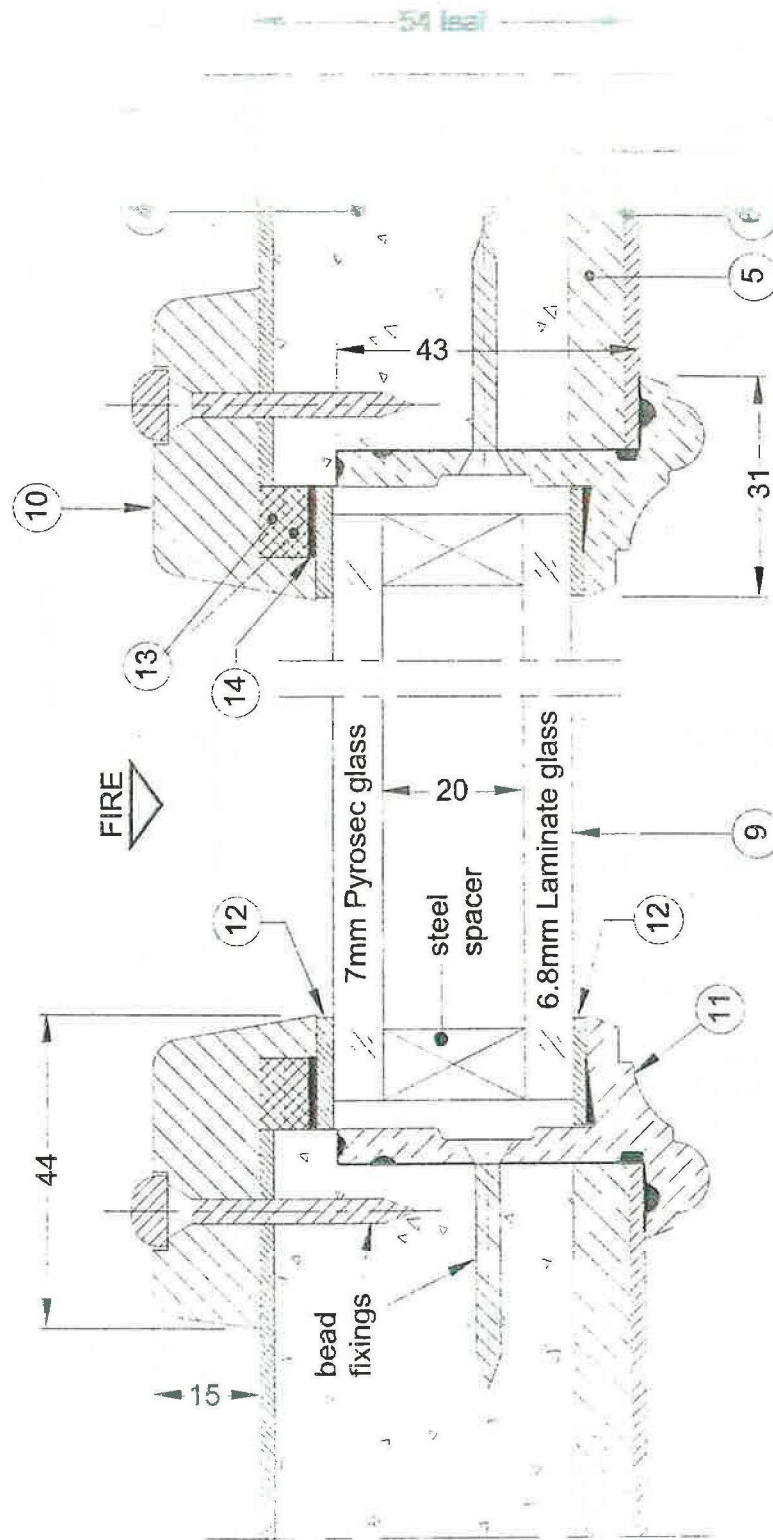
Figure 5 – Typical section through glazing for doorset 'B'

Item	Description
<b>9. Glass Unit</b>	
Manufacturer	: C3S Securiglass Limited
Overall thickness	: 33.6 mm (7mm Pyrosec ESD + 24mm clear glass)
<b>Density</b>	: 640 kg/m <sup>3</sup> (stated)
Overall section size	: See Figure 5
Details of Fixings

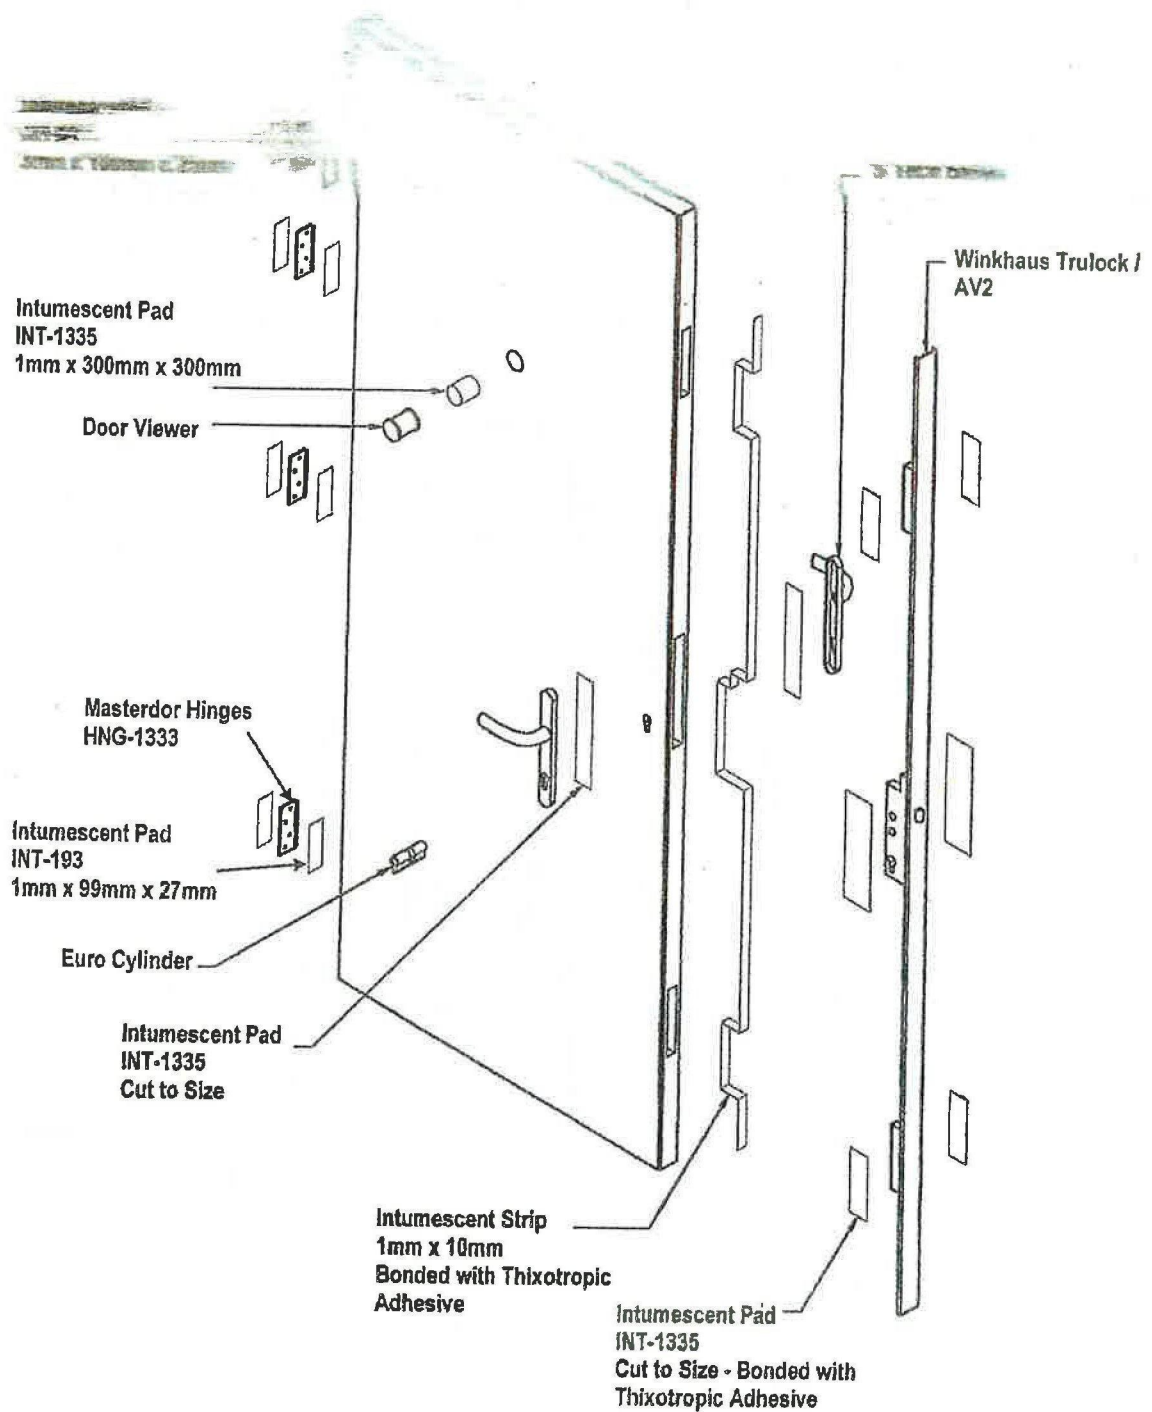
Figure 6 – Details of intumescent protection to hardware on both doorsets

v. top and bottom lock case	: 115 mm long x 40 mm deep
Operation of locks and latch	: Both engaged
Details of bedding material	: Intumescent strip/pads. See Figures 6 & 7.
<b>18. Lever Handleset</b>	
Manufacturer	: S-Tech
Reference	: Lever/lever SLD, with cylinder and thumb-turn
Material	: Aluminium handles, steel cylinder and thumb-turn
Overall sizes	: 245 mm long x 34 mm wide handle plate
Details of bedding material	: Intumescent pad. See Figure 6
