# The Building Test Centre

performance of a fully  
insulated doorset and a  
partially insulated, single-  
acting single-leaf doorset  
when tested in accordance  
with BS 476: Part 22:  
1987, Clause 6 and 7,  
respectively.

**WF Report No:**

To determine the fire resistance performance of two fire-rated doorsets and to determine the fire resistance performance of the doorsets in accordance with BS 476 Part 22: 1987, Class 3 and 4, respectively.

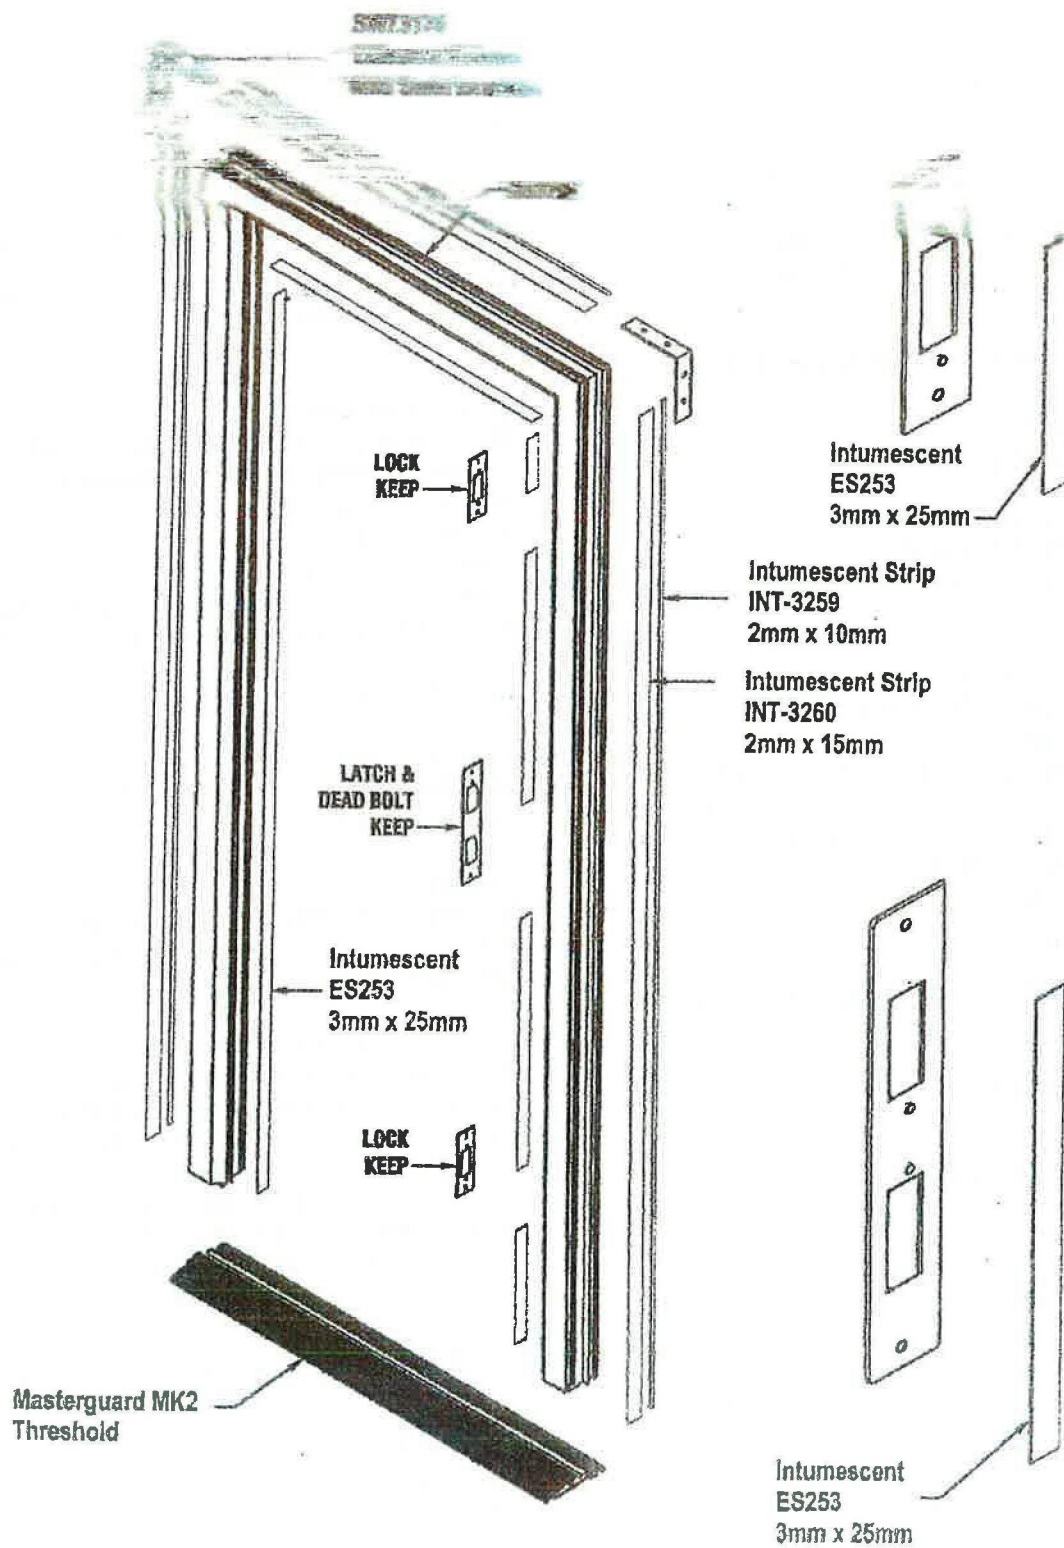
Figure 7 – Details of door frame assembly

Refer to Figures 1 & 7

: LB Plastics Limited  
 : Sheerframe profile SK77950 / S118 reinforcement  
 : Polyvinyl chloride (PVC) outer frame with steel box section internal reinforcement.  
 : 70 mm x 70 mm  
 : 1010 mm wide x 2045 mm high  
 : Mitred corners with steel angle bracket fixed to the steel reinforcement using 6 no. steel screws ref SW71574, per corner.  
 : See Figures 2 & 7

: Envirograf  
 : Seals fitted along door frame jambs and head.  
 : See Figures 2 & 7.

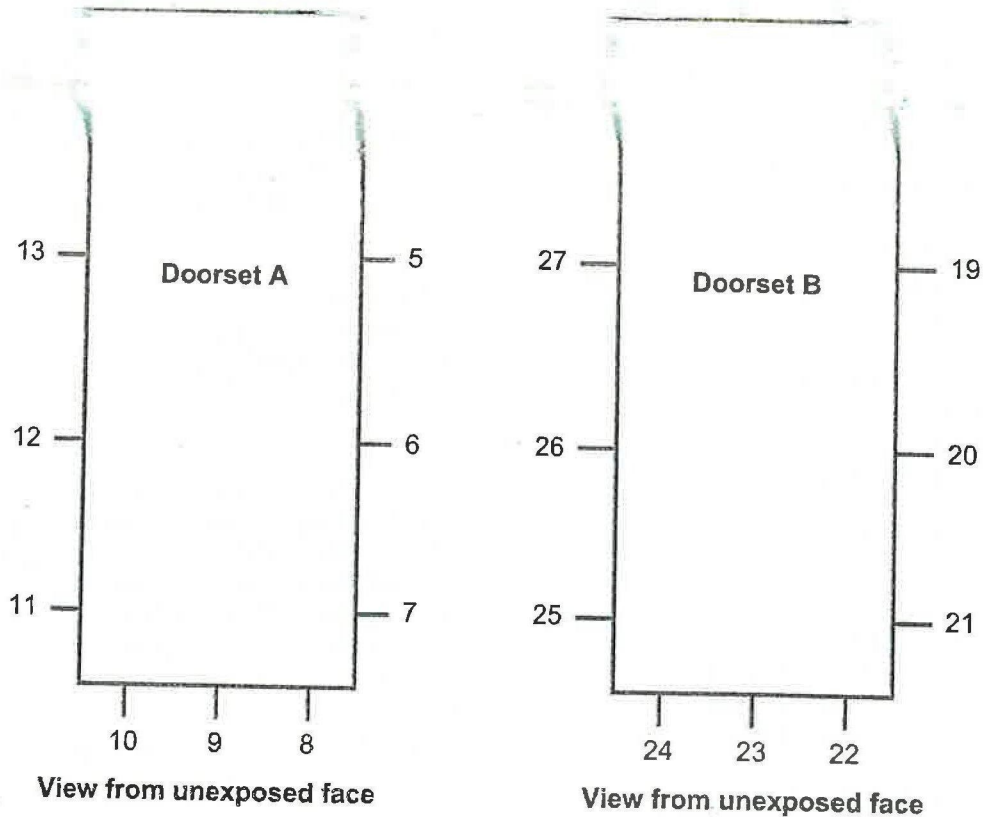
## Doorset Clearance Gaps

Door Ref	Gap Dimension in mm at Positions													
A	1	2	3	4	5	6	7	8*	9*	10*	11	12	13	14
	4.3	5.2	4.3	4.8	4.3	3.6	4.2	0	0	0	5.0	5.5	5.2	5.5
B	15	16	17	18	19	20	21	22*	23*	24*	25	26	27	28
	4.3	4.5	4.6	4.8	3.5	3.6	4.1	0	0	0	3.2	5	4.5	5.4
A	Mean			4.7		Maximum			5.5		Minimum		3.6	
B	Mean			4.3		Maximum			5.4		Minimum		3.2

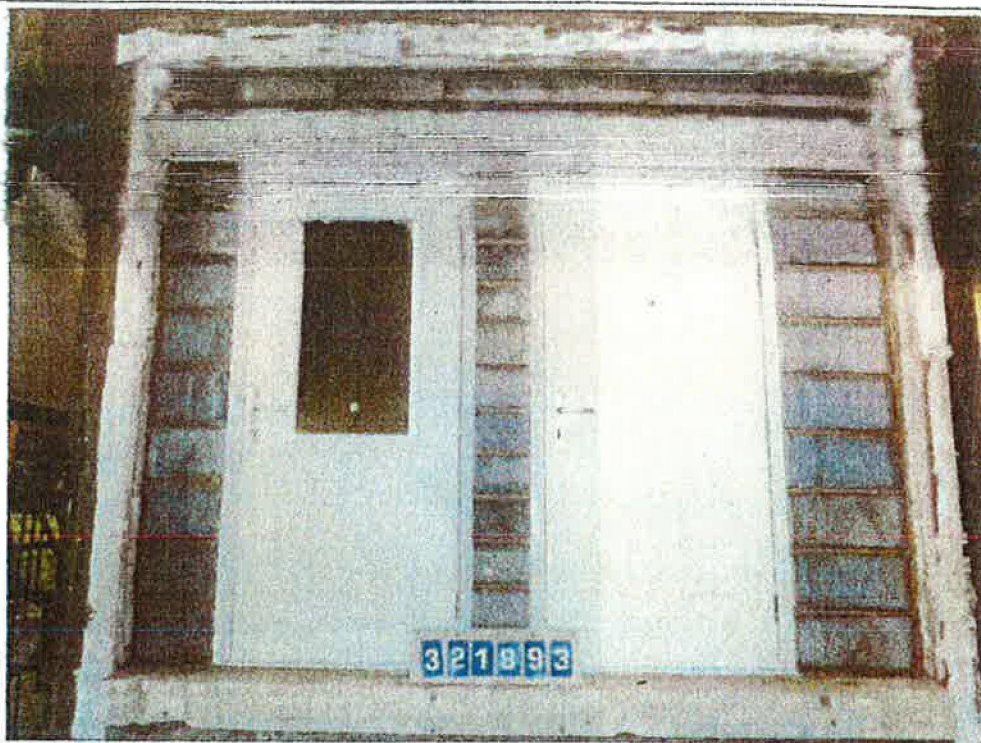
The exposed face  
of the doorsets  
prior to testing

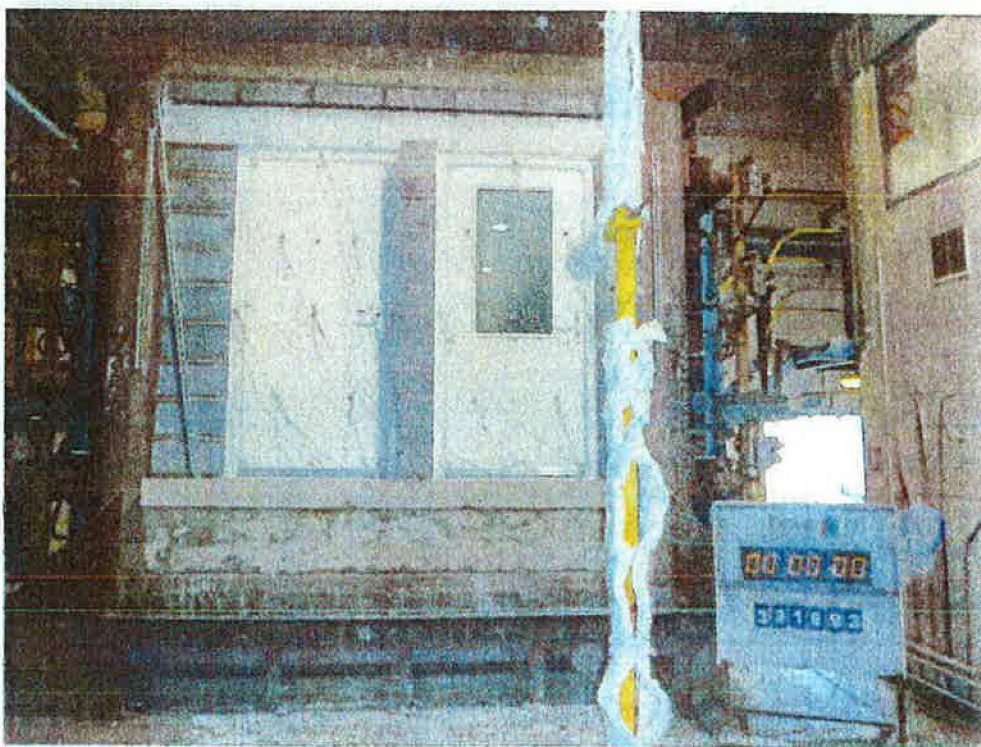
The unexposed  
face of the  
doorsets prior to  
testing

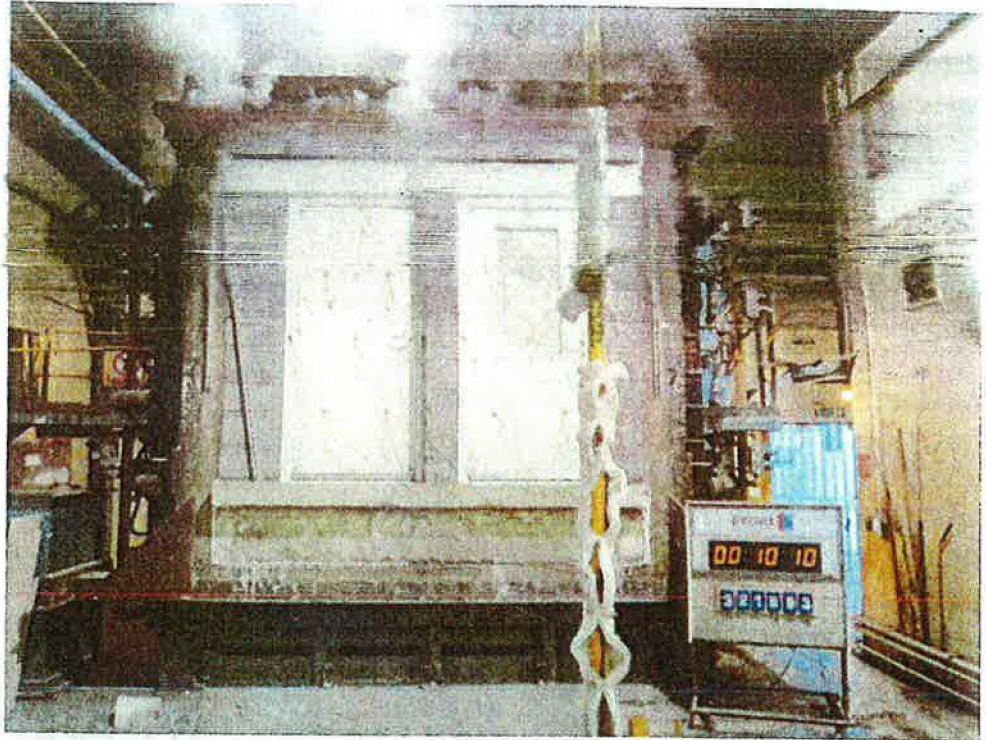
The unexposed  
face of the  
doorsets after 10  
minutes of testing

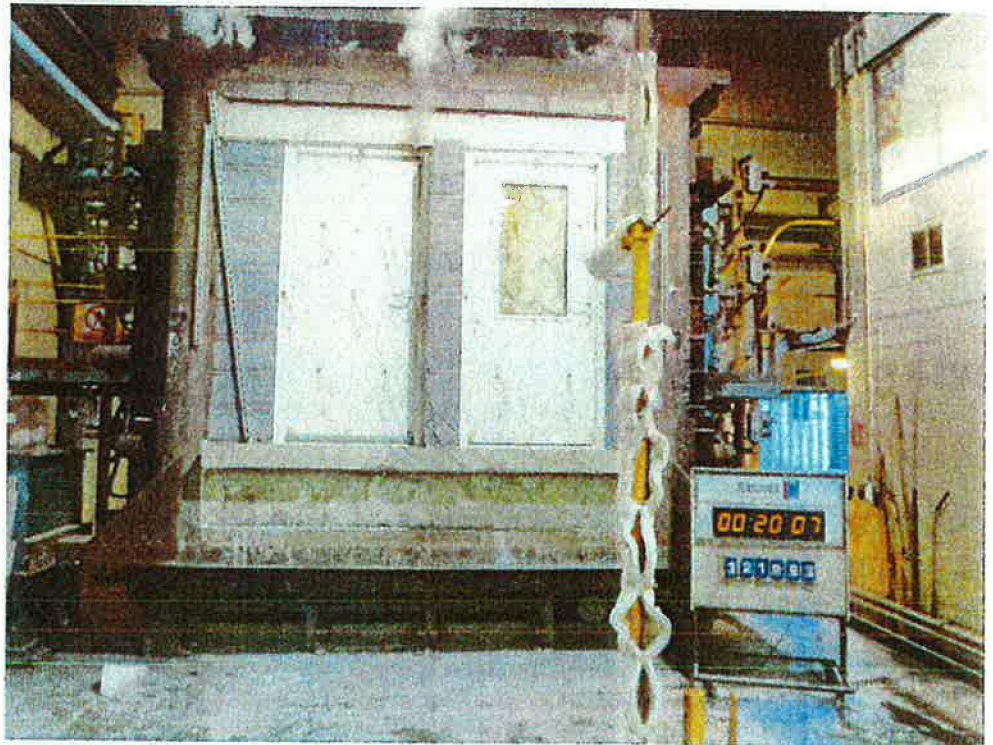
The unexposed  
face of the  
doorsets after 20  
minutes of testing

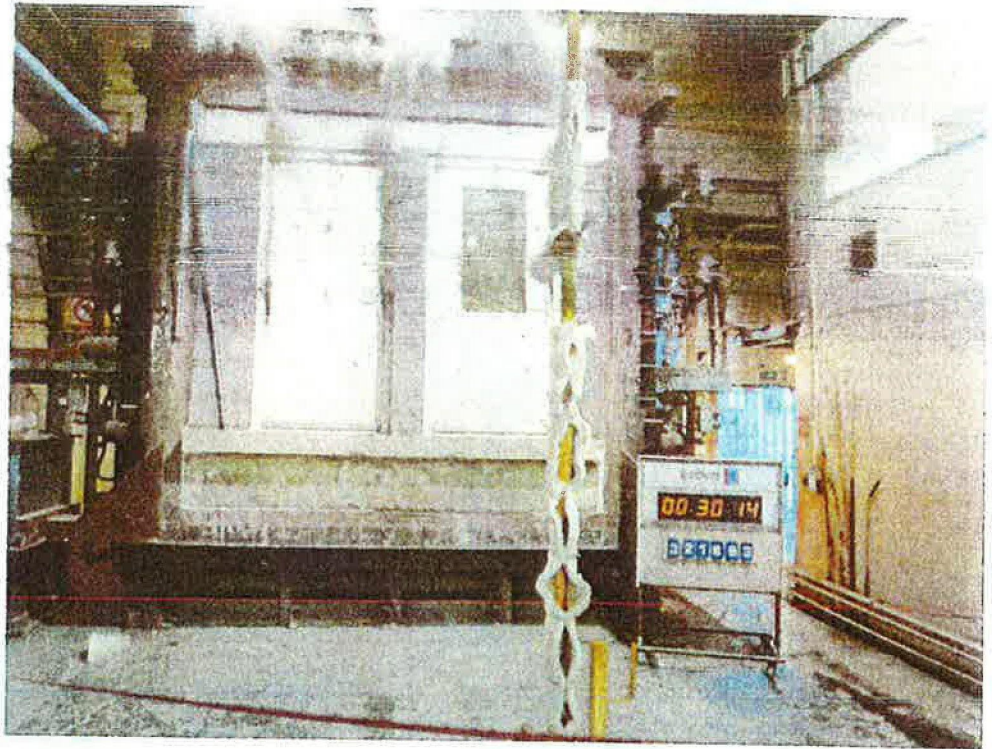
The unexposed  
face of the  
doorsets after 30  
minutes of testing

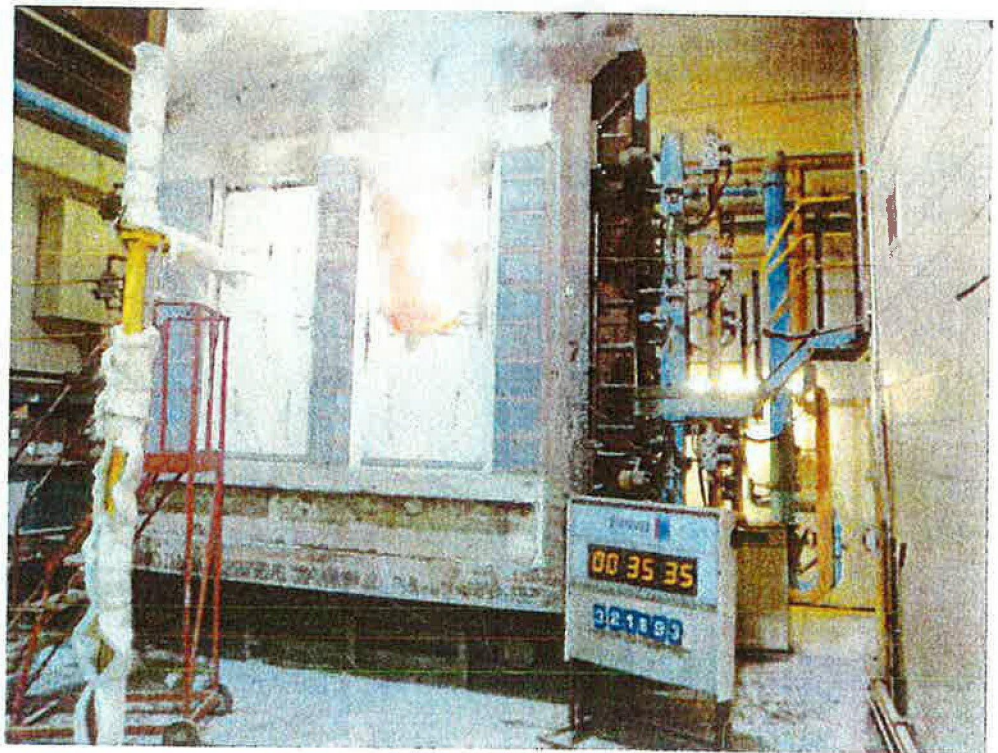
The unexposed  
face of the  
doorsets after 35  
minutes of testing

Time	All observations are from the unexposed face unless noted otherwise	
05	00	Glass pane of Doorset B begins to turn opaque.
06	00	Slight amount of smoke leakage is being released from the leading edge corner of Doorset A.
07	00	Slight amount of smoke leakage from the leading edge of Doorset B.
14	00	The glass pane on the exposed face is heavily cracked and the beading material of Doorset B is cracked also.
15	00	The GRP face of Doorset A is coming away on the lower right hand side of the specimen on the exposed face.
21	00	Smoke leakage continues at the position previously mentioned at 6 minutes.
28	00	The GRP face of Doorset A falls away completely; the material behind it is flaming on the exposed face. A cotton wool pad is applied over the door viewer. The pad only discolours.
29	00	A cotton wool pad is applied over the door viewer of Doorset A. The pad only discolours.
35	00	The vision panel of Doorset B suddenly falls away and the glass shatters. <b>Doorset B is no longer maintaining its integrity.</b>

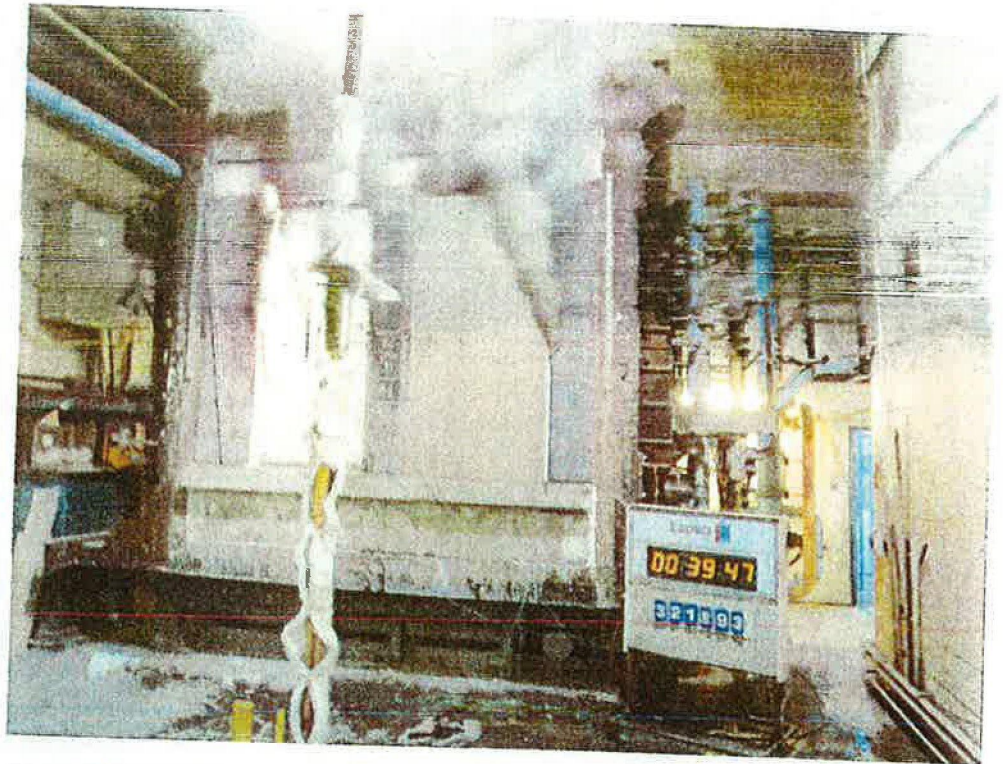
The unexposed  
face of the  
doorsets after 39  
minutes of testing

38	00	A cotton wool pad is applied over a lower area of Doorset A on the hinge side. The cotton wool pad ignites. <b>Integrity failure of doorset A occurs.</b>
40	00	At the request of the sponsor the test is discontinued.

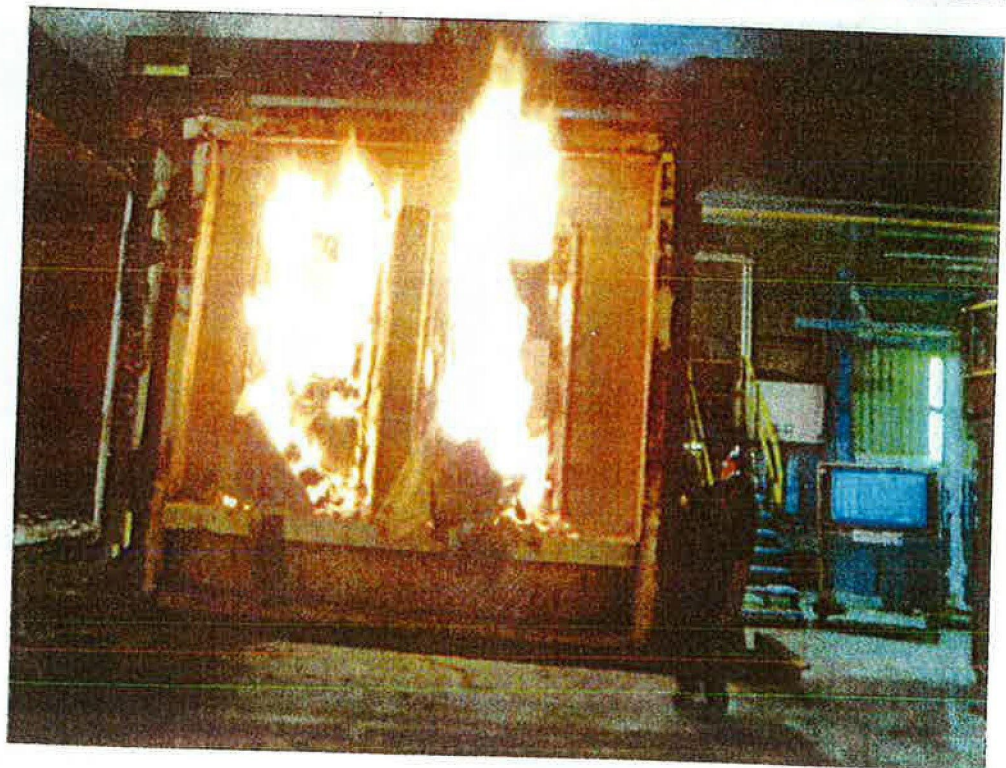
The exposed face  
of the doorsets  
immediately after  
testing

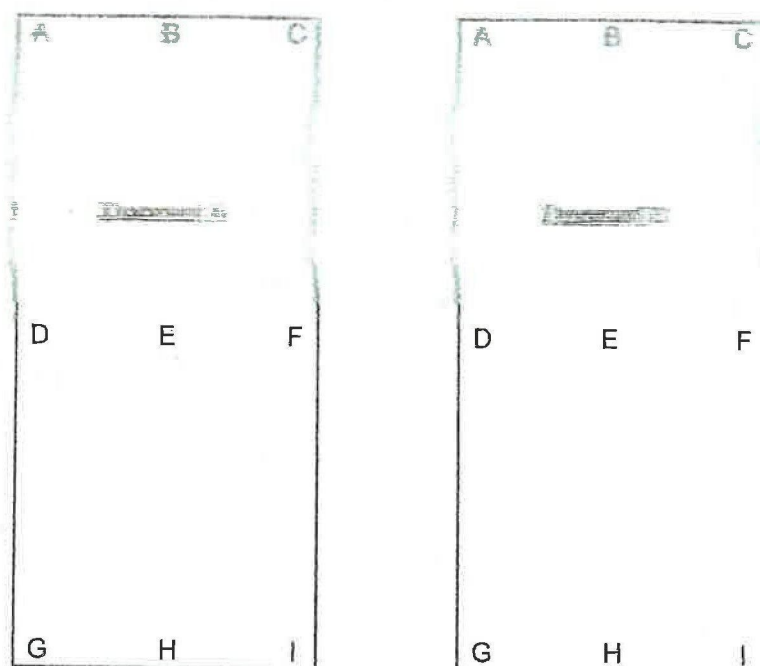
# Deflection Of The Door Leaves During The Test

Doorset A									
Deflections – mm									
Time Mins	A	B	C	D	E	F	G	H	I
0	0	0	0	0	0	0	0	0	0
10	-3	5	6	0	5	2	5	1	-1
20	-1	7	3	5	6	7	0	3	1
30	-3	4	7	1	8	7	1	4	2

Doorset B									
Deflections – mm									
Time Mins	A	B	C	D	E	F	G	H	I
0	0	0	0	0	0	0	0	0	0
10	-2	4	3	2	2	1	0	0	0
20	-1	2	3	2	1	2	1	2	1
30	1	3	4	2	-1	-2	2	5	0

Positive values indicate movement towards the furnace chamber

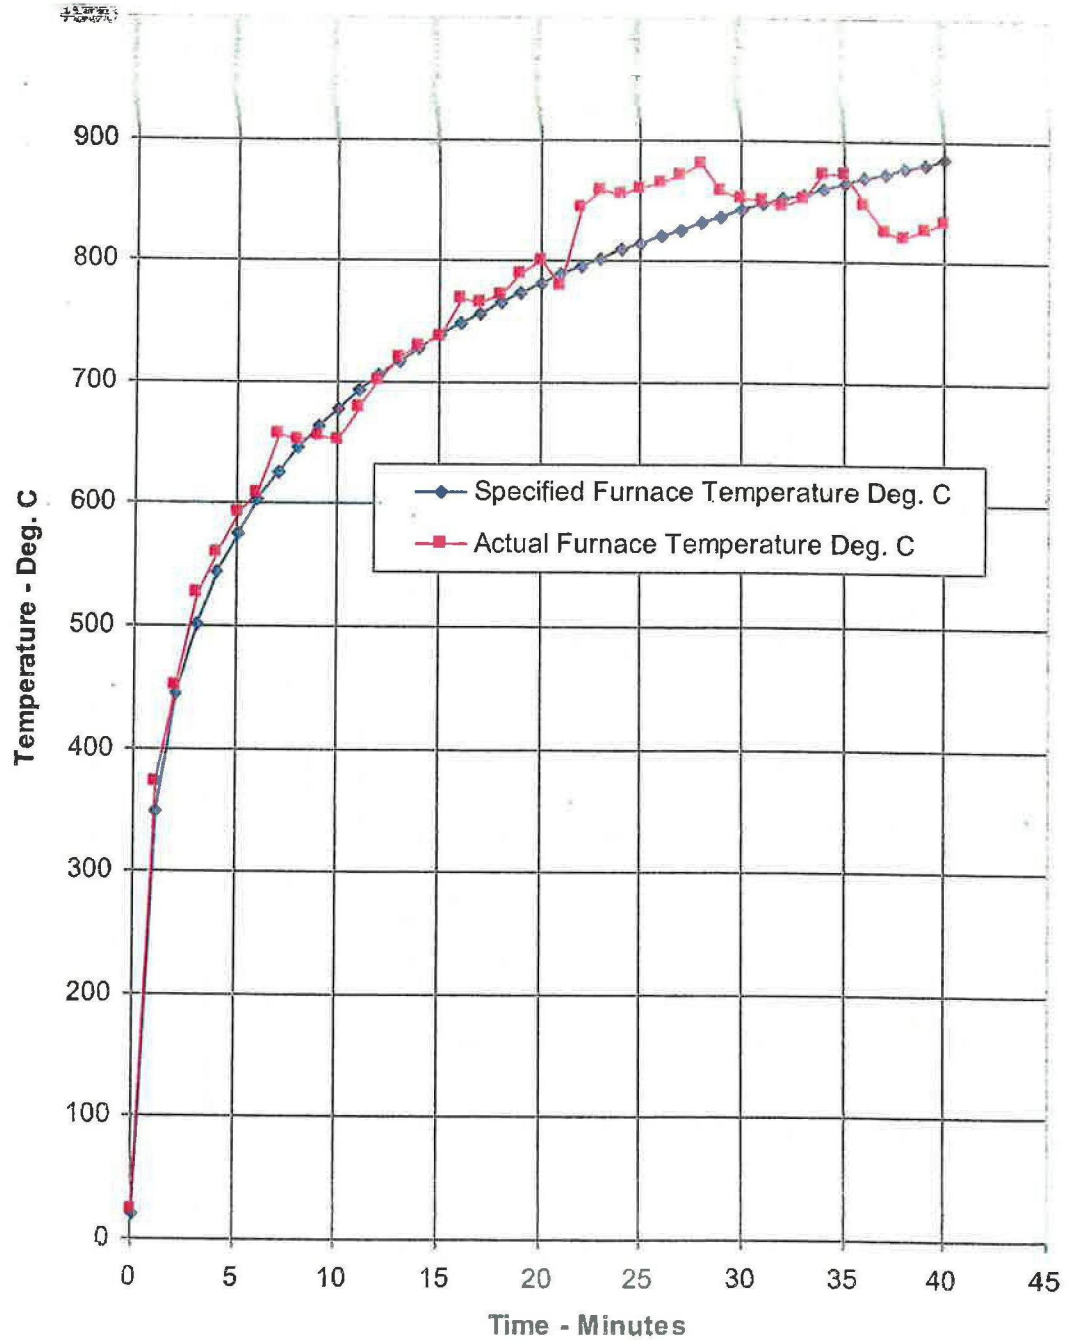
Graph Showing Mean Furnace Temperature, Together With The Temperature/Time Relationship Specified In The Standard

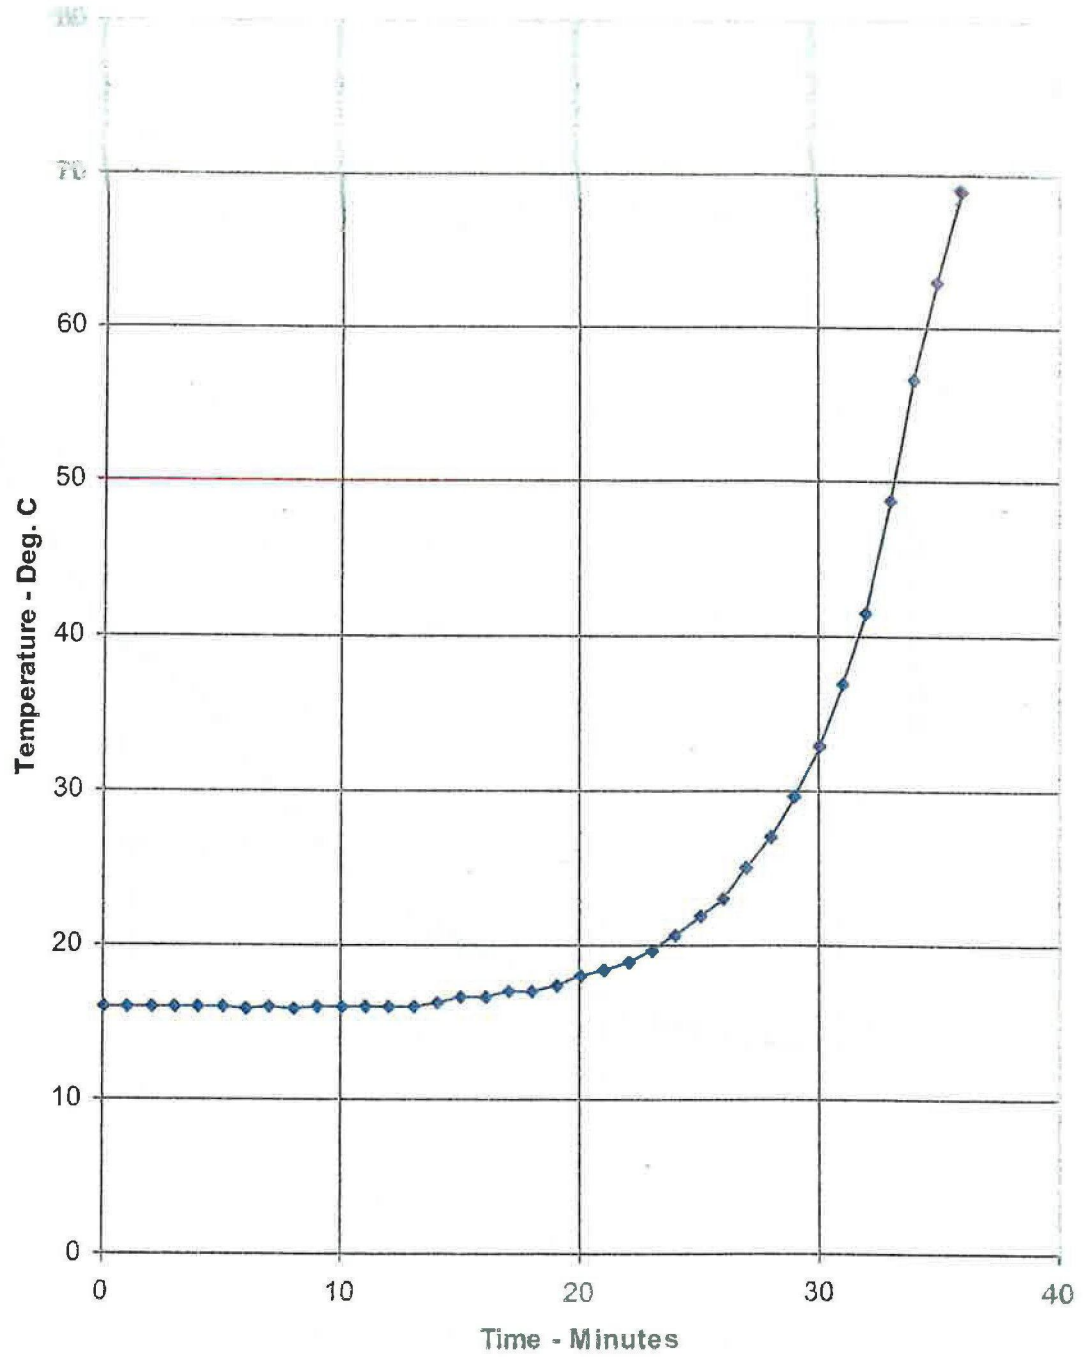
Graph Showing Mean Temperature Recorded On The Unexposed Surface Of Doorset A

It is required that the mean temperature rise of the unexposed surface shall not be greater than 140°C and that the maximum temperature rise shall not be greater than 180°C. Insulation failure also occurs simultaneously with integrity failure. These requirements were satisfied for a period of 32 minutes after which time thermocouple number 6 recorded a temperature increase in excess of 180°C.

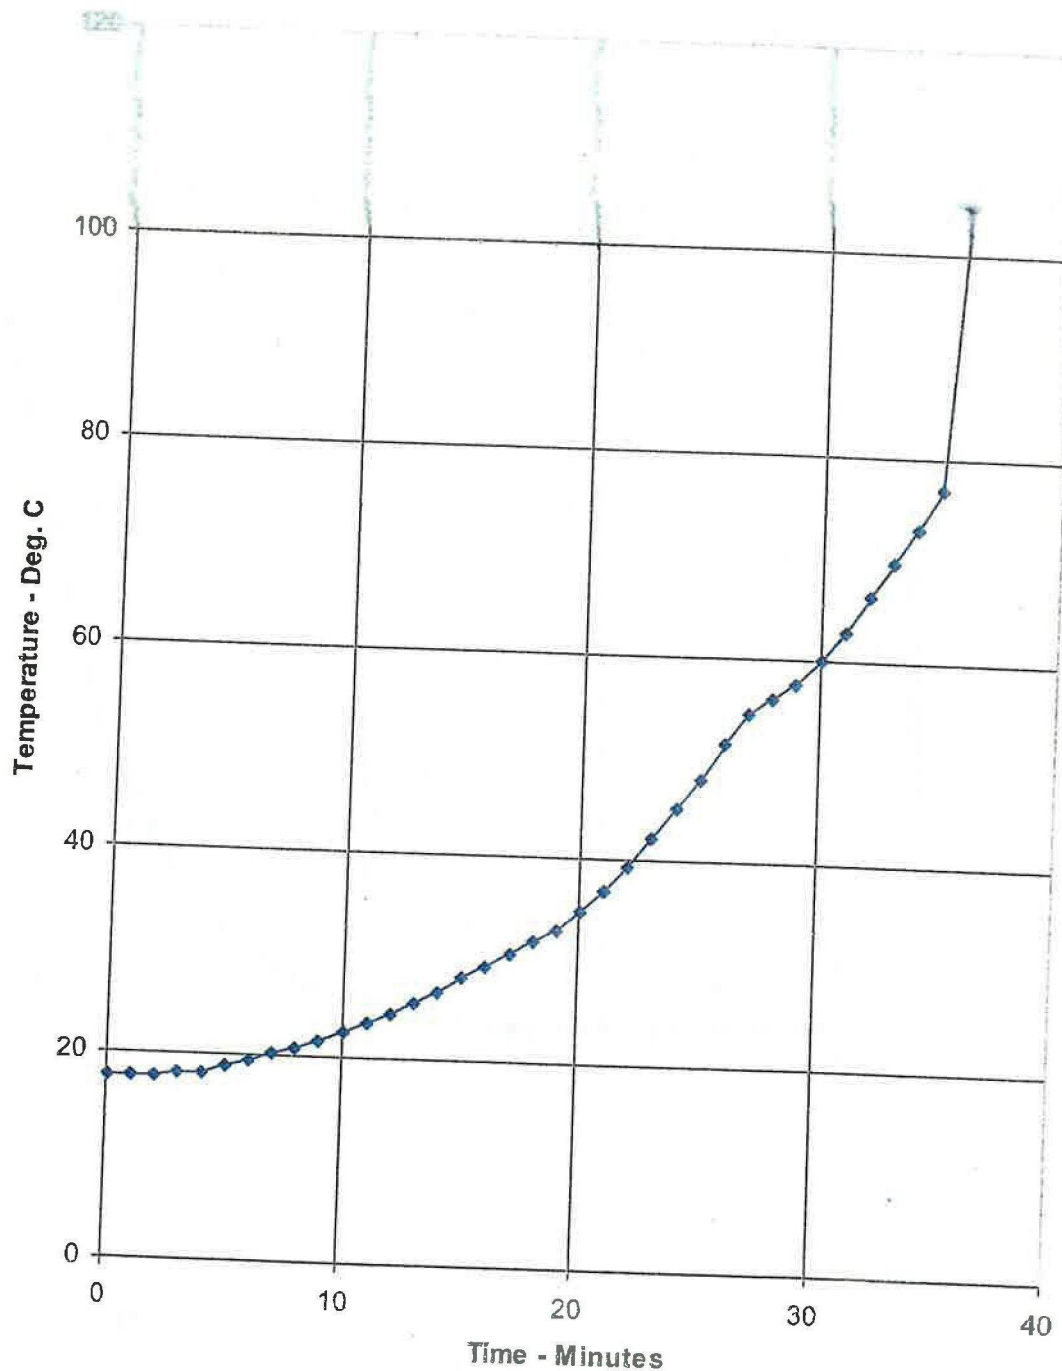
Graph Showing Mean Temperature Recorded On The Unexposed Surface Of Doorset B

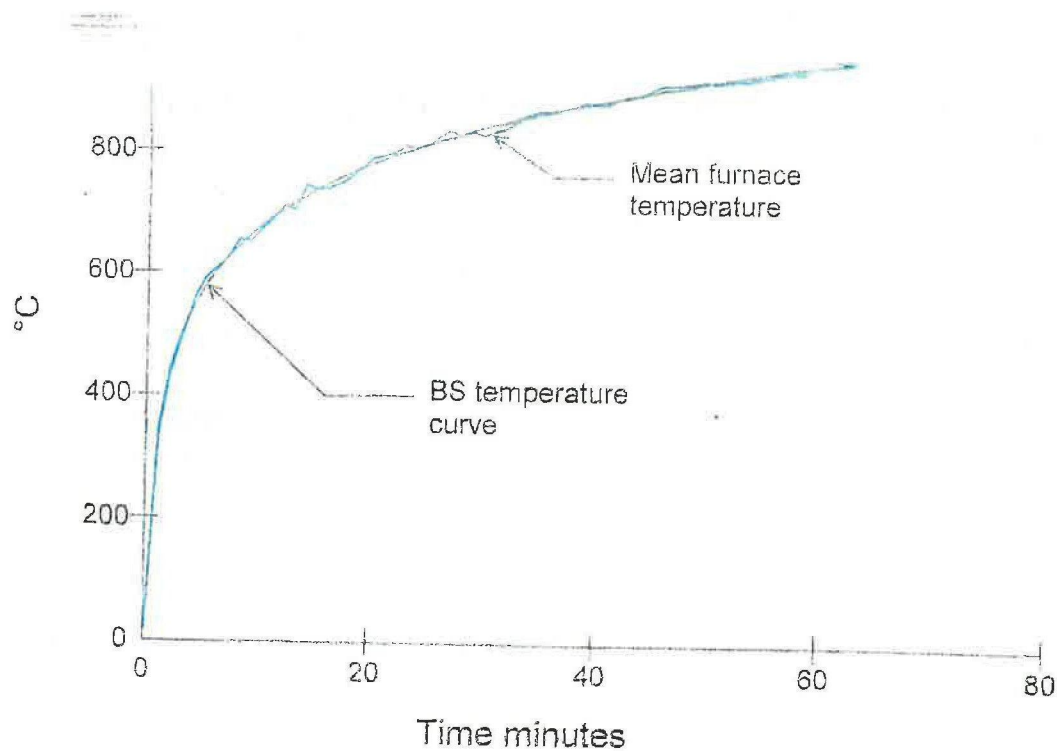
### 4.1 Furnace temperature curve

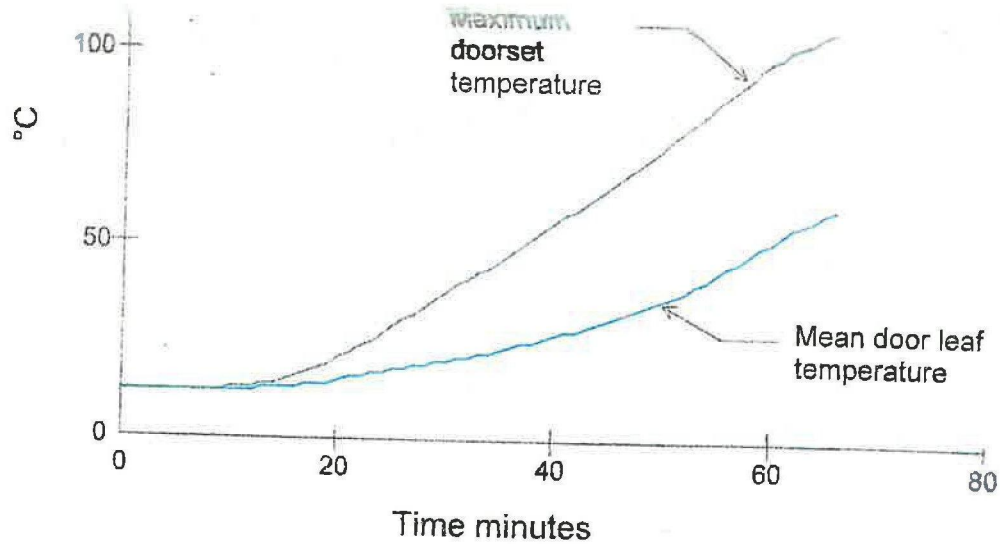
### Doorset A

## 4.2 Unexposed face temperature curves

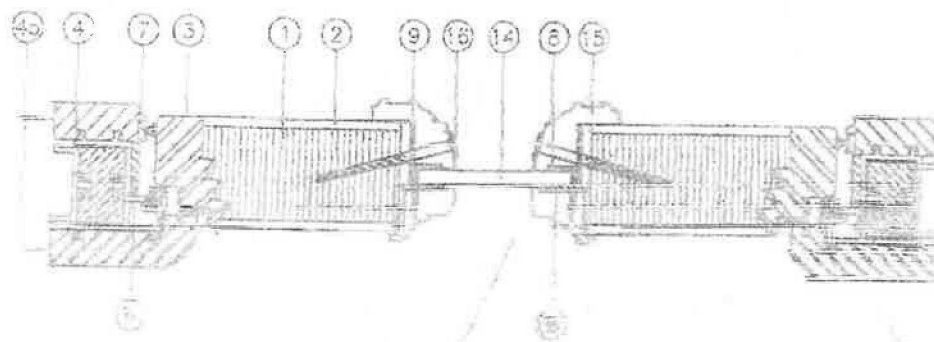
Section A-A

5 x 70 Steel Screws  
and Cup Washers  
175 mm Max Pitch  
Set at 15 degrees  
from vertical.

225 Dia. X 254 mm  
retaining rail.

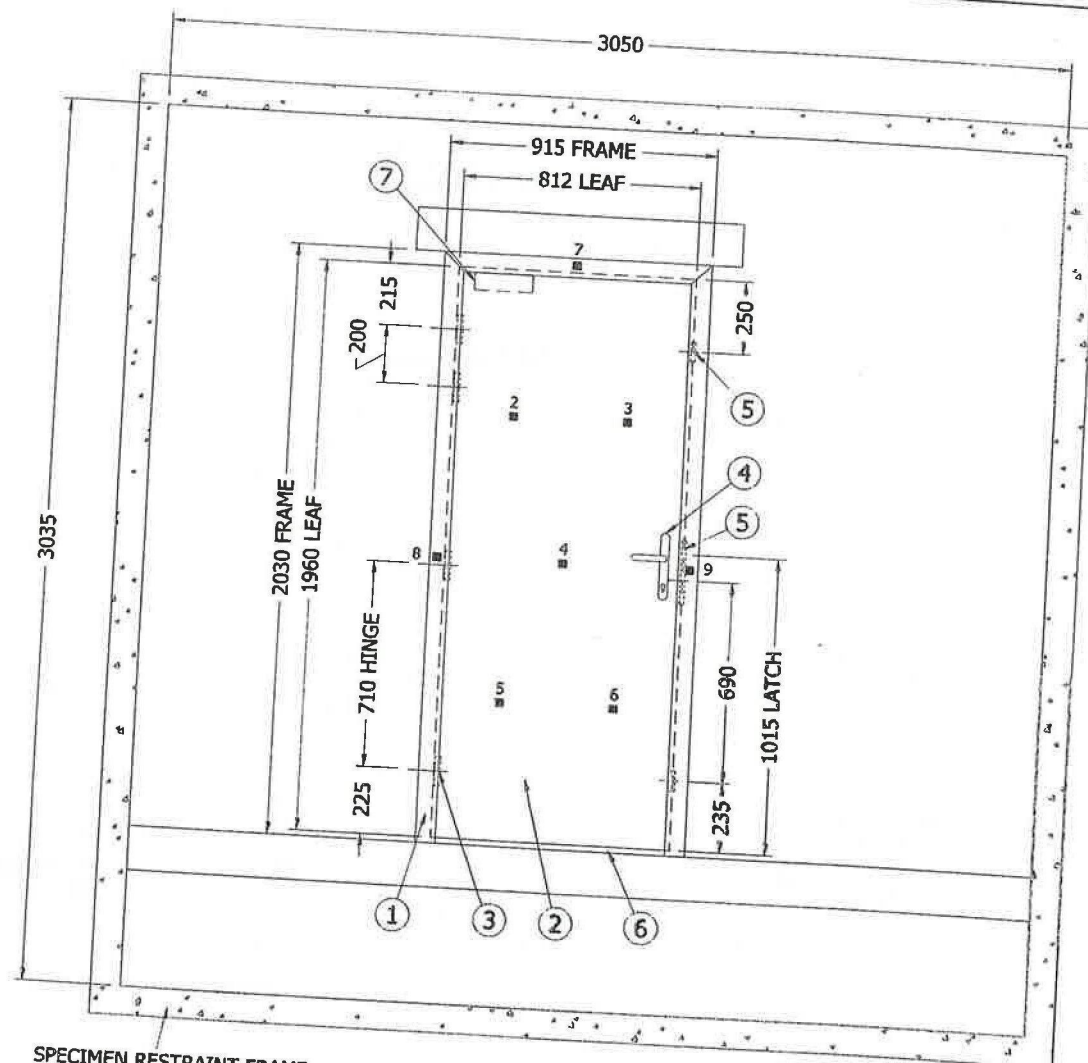
Figure 1 – Elevation of unexposed face of doorset built into a specimen restraint frame

SPECIMEN RESTRAINT FRAME

■ POSITIONS OF UNEXPOSED FACE THERMOCOUPLES.

SPECIMEN BUILT INTO A MASONRY WALL CONSISTING OF AAC (AUTOCLAVED AERATED CONCRETE) BLOCKWORK WALLS, LINTEL AND BASE, NOMINALLY 150 THICK. DOOR LEAF OPENS TOWARDS THE HEATING CONDITIONS OF THE TEST.
