## Doorset Clearance Gaps

Order number: <b>310387</b>	Document number: <b>FTCR/96/0089</b>
Client: <b>Manse Window Design Ltd Halfpenny Lane Knaresborough N. Yorkshire HG5 0PR</b>

**TEST  
REPORT**

**FIRE TESTING OF A FOUR PANELLED SOLID  
MANSE MASTERDOR AND A PARTIALLY  
GLAZED SOLID MANSE MASTERDOR  
TEST DATE: 23 AUGUST 1996**

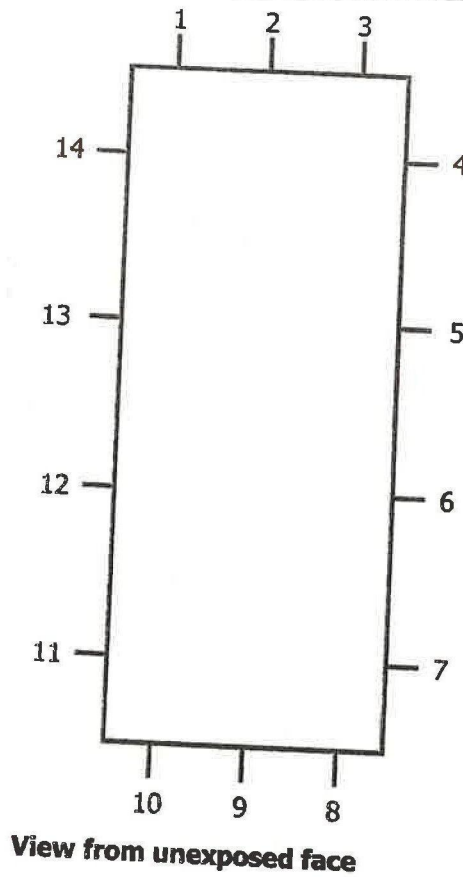
Gap Dimension in mm at Position													
1	2	3	4	5	6	7	8*	9*	10*	11	12	13	14
2.9	2.7	2.7	2.8	2.8	4.4	3.8	3.5	3.8	3.8	7.0	5.9	6.6	4.5
Mean		4.0		Maximum			7.0		Minimum			2.7

\* Dimension not included in calculations

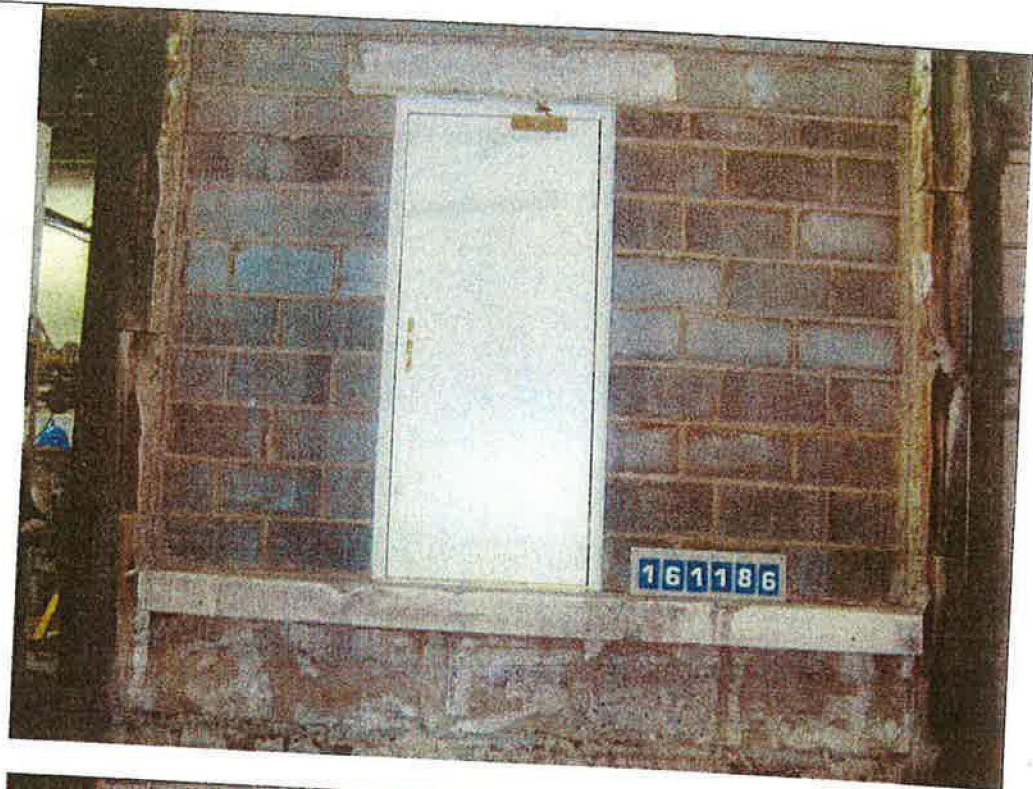
The exposed  
face of the  
doorset prior to  
testing

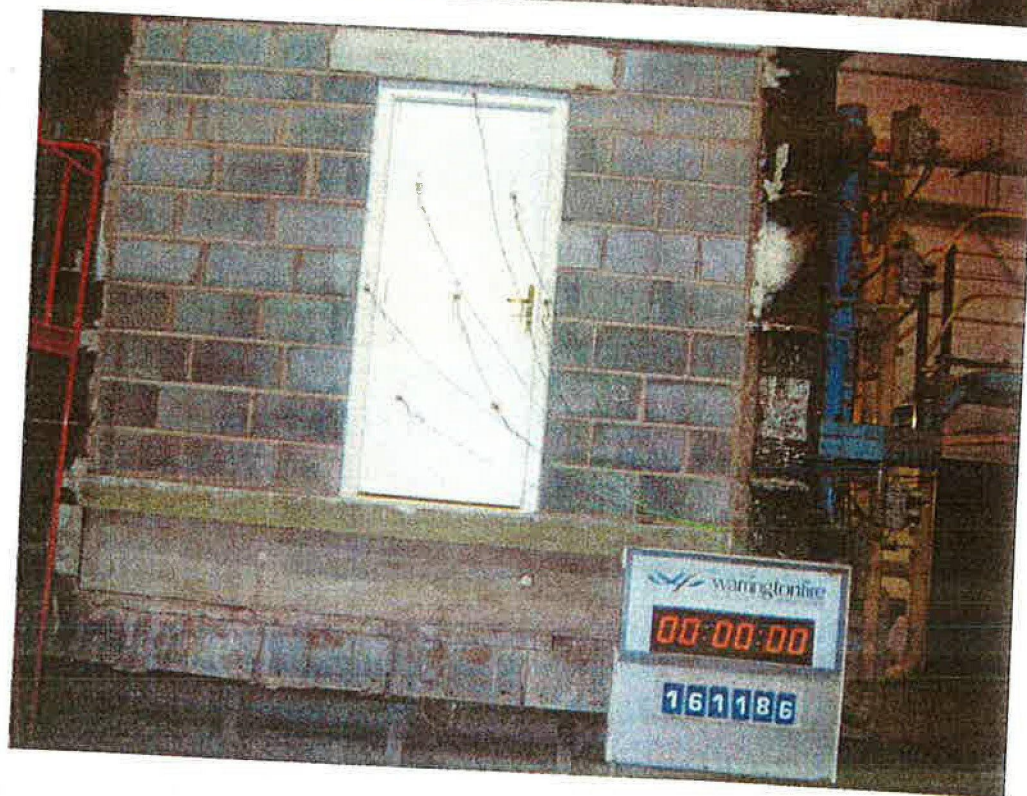
The unexposed  
face of the  
doorset prior to  
testing

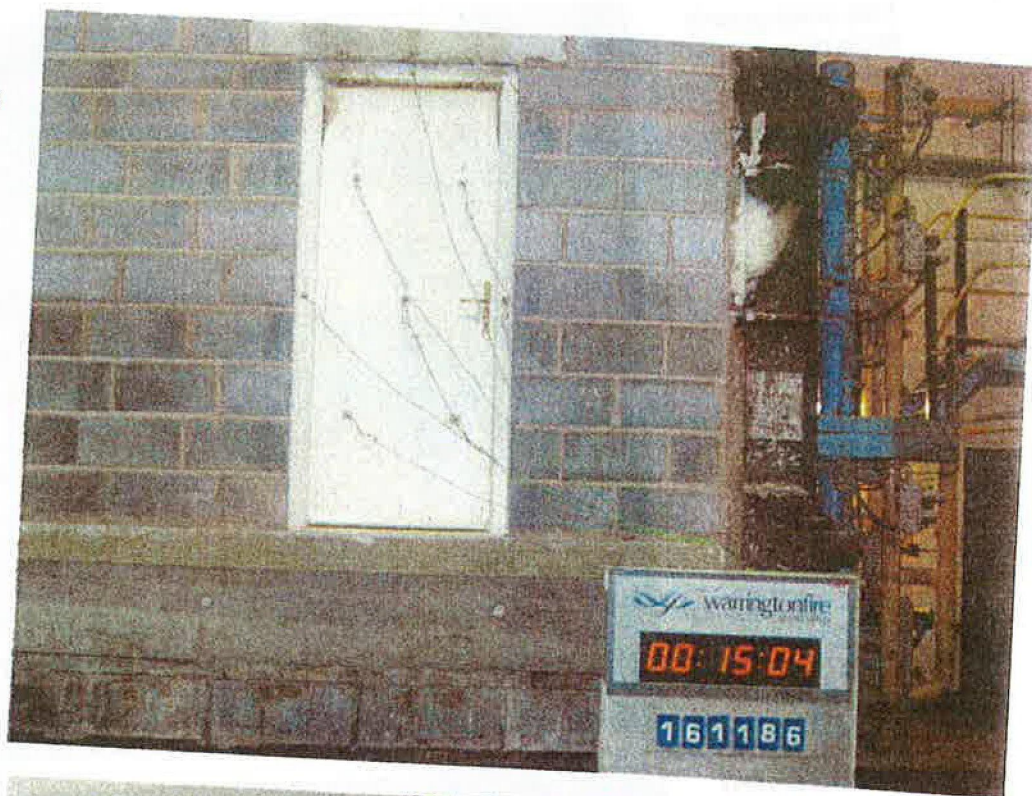
The unexposed  
face of the  
doorset after 15  
minutes of  
testing

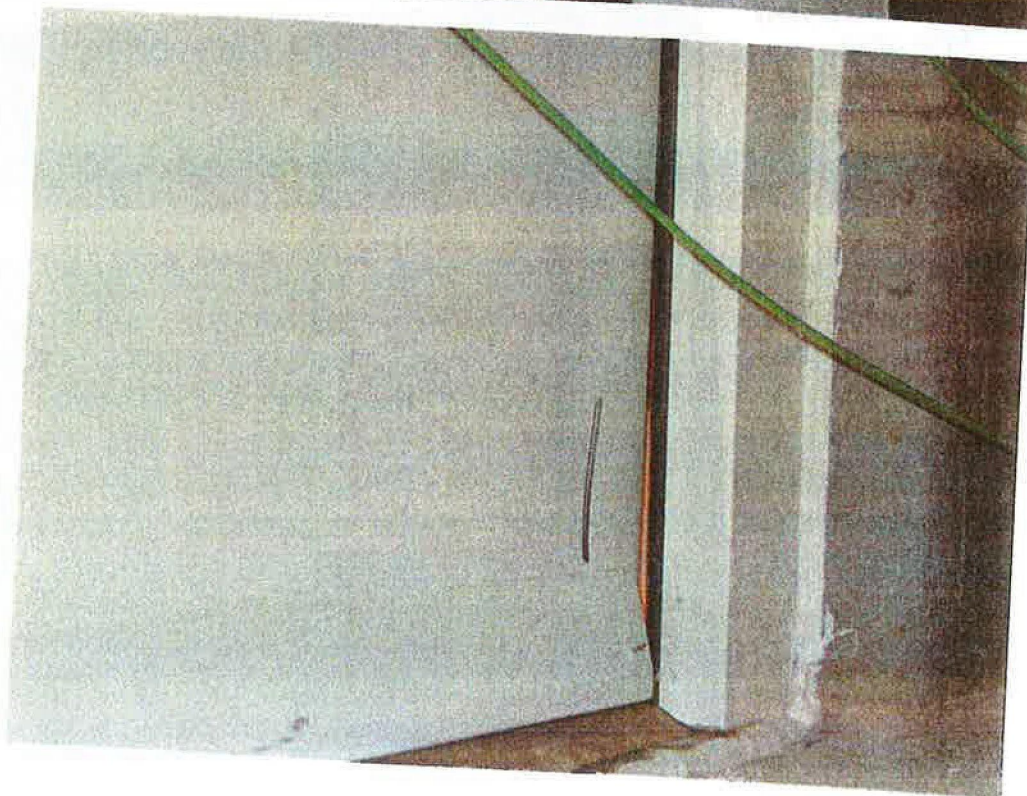
The unexposed  
face of the  
doorset during  
testing

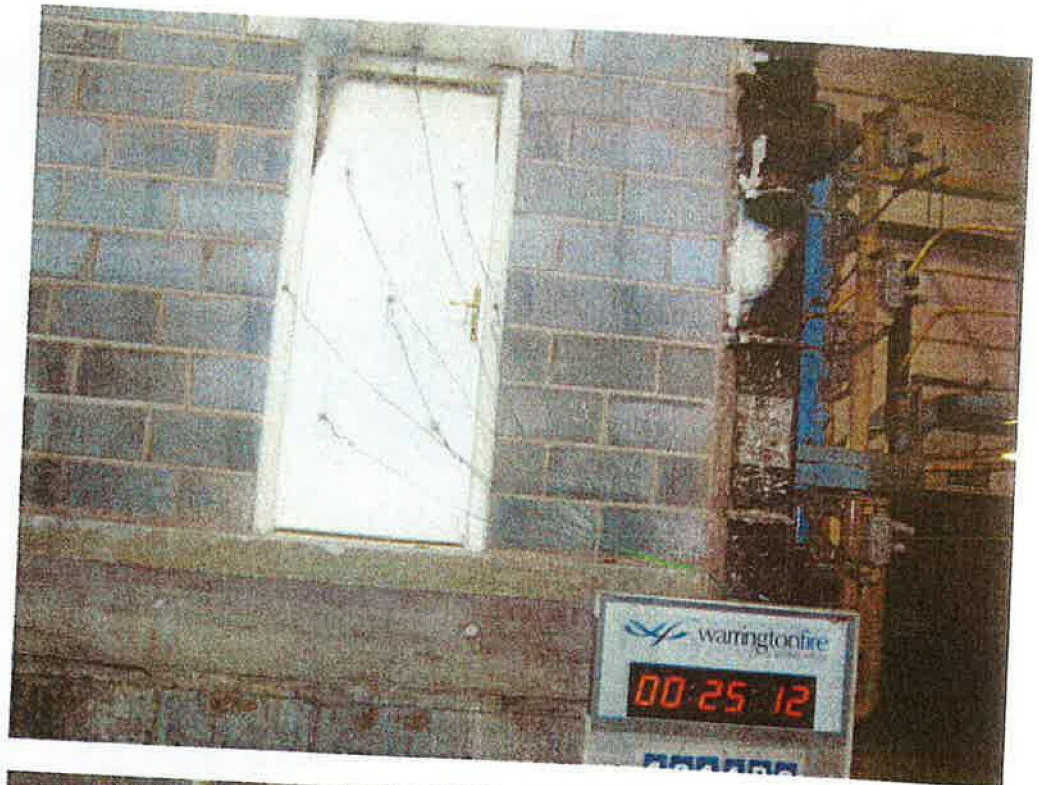
The unexposed  
face of  
Doorset B after  
25 minutes of  
testing

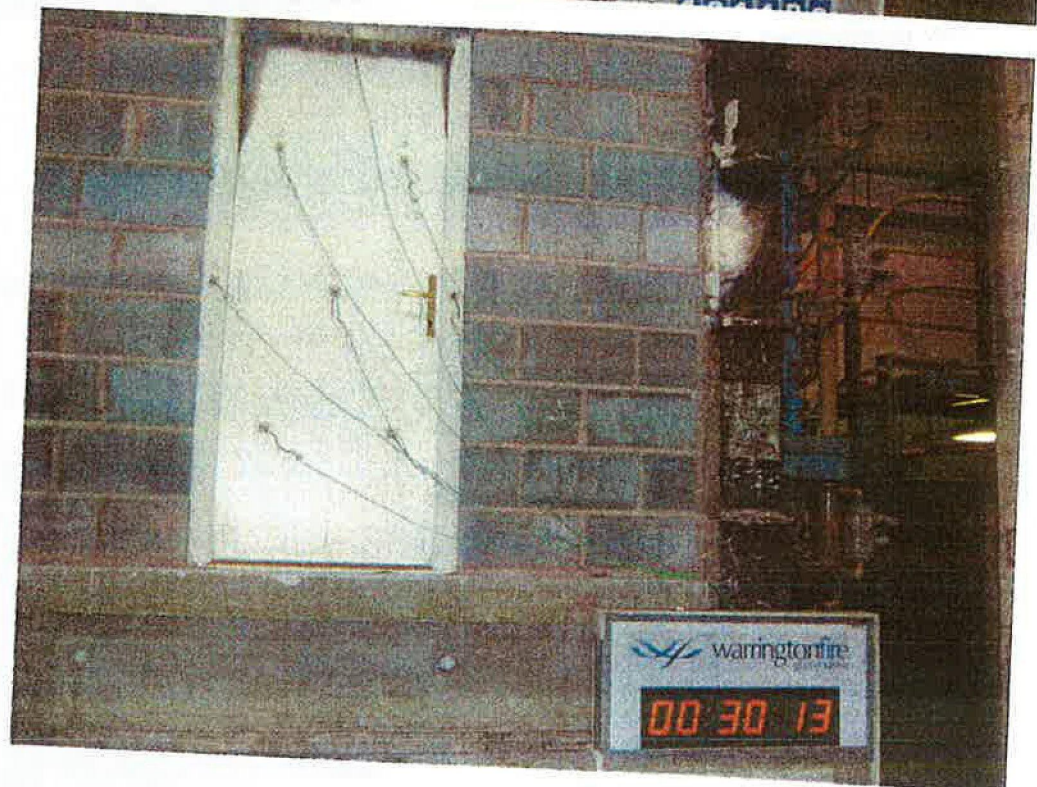
The unexposed  
face of the  
doorsets after  
30 minutes of  
testing

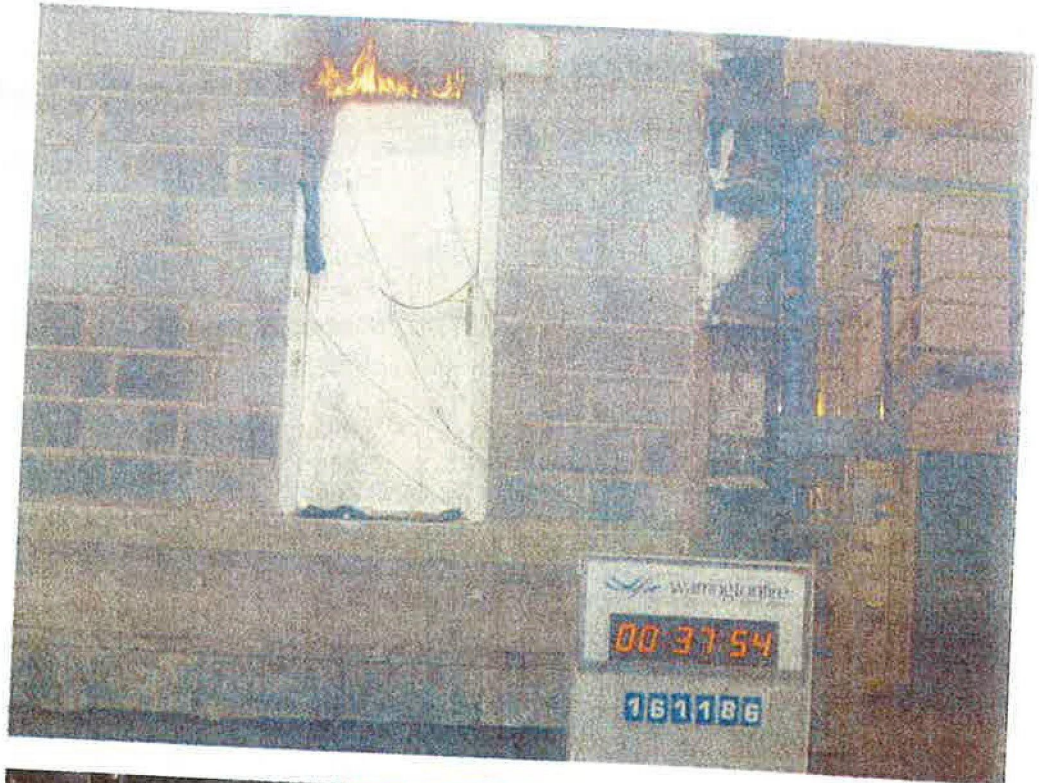
The unexposed  
face of the  
Doorset after  
37 minutes of  
testing

It is required that there is no collapse of the specimen, no sustained flaming on the unexposed surface and no loss of impermeability. These requirements were satisfied for a period of 35 minutes. Failure at this time was due to sustained flaming on the unexposed surface of the doorset.

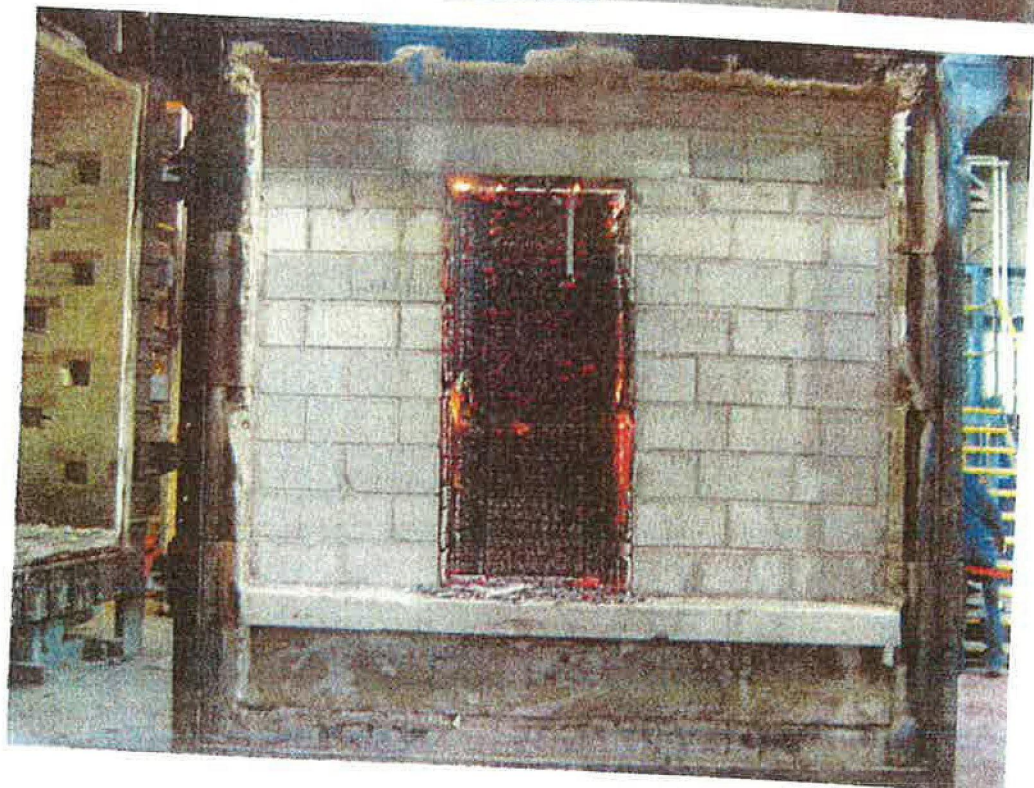
The exposed  
face of the  
doorset  
immediately  
after testing

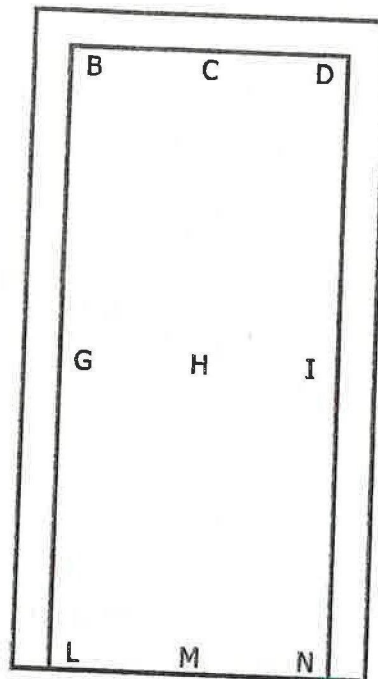
# Deflection Of The Door Leaves During The Test

TIME mins	Deflections - mm													
	A	B	C	D	E	F	G	H	I	J	K	L	M	N
0	0	0	0	0	0	0	0	0	0	0	0	0	0	0
5	-	2	0	0	-	-	2	1	1	-	-	0	3	3
10	-	1	3	3	-	-	2	1	1	-	-	3	1	3
15	-	5	4	5	-	-	2	3	4	-	-	3	4	3
20	-	6	7	5	-	-	4	5	6	-	-	7	6	3
25	-	2	0	5	-	-	5	6	6	-	-	8	6	6

Positive values indicate movement towards the furnace  
\* Measurements discontinued due to unsafe conditions

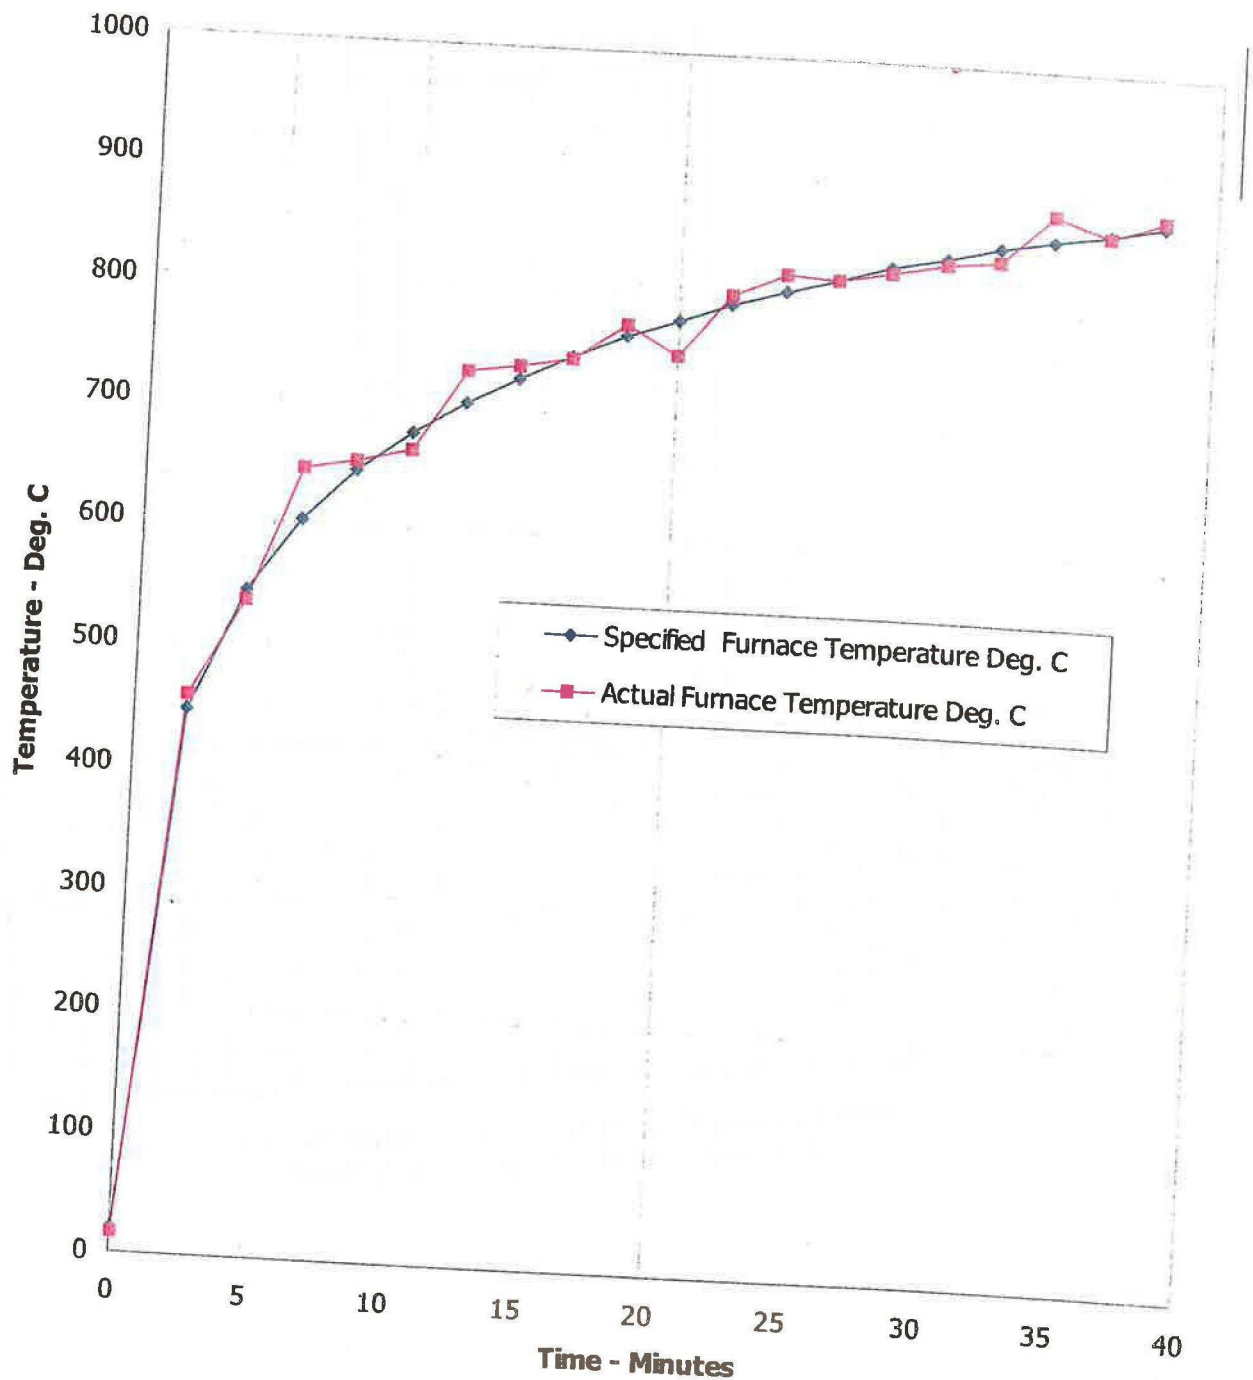
Graph Showing Mean Furnace Temperature, Together With The Temperature/Time Relationship Specified In The Standard

Time Mins	Specified Furnace Temperature Deg. C	Actual Furnace Temperature Deg. C
0	20	17
2	445	458
4	544	536
6	603	645
8	646	653
10	678	665
12	706	732
14	728	738
16	748	746
18	766	776
20	781	752
22	796	804
24	809	823
26	820	819
28	832	828
30	842	837
32	852	841
34	860	883
36	869	866
38	877	882

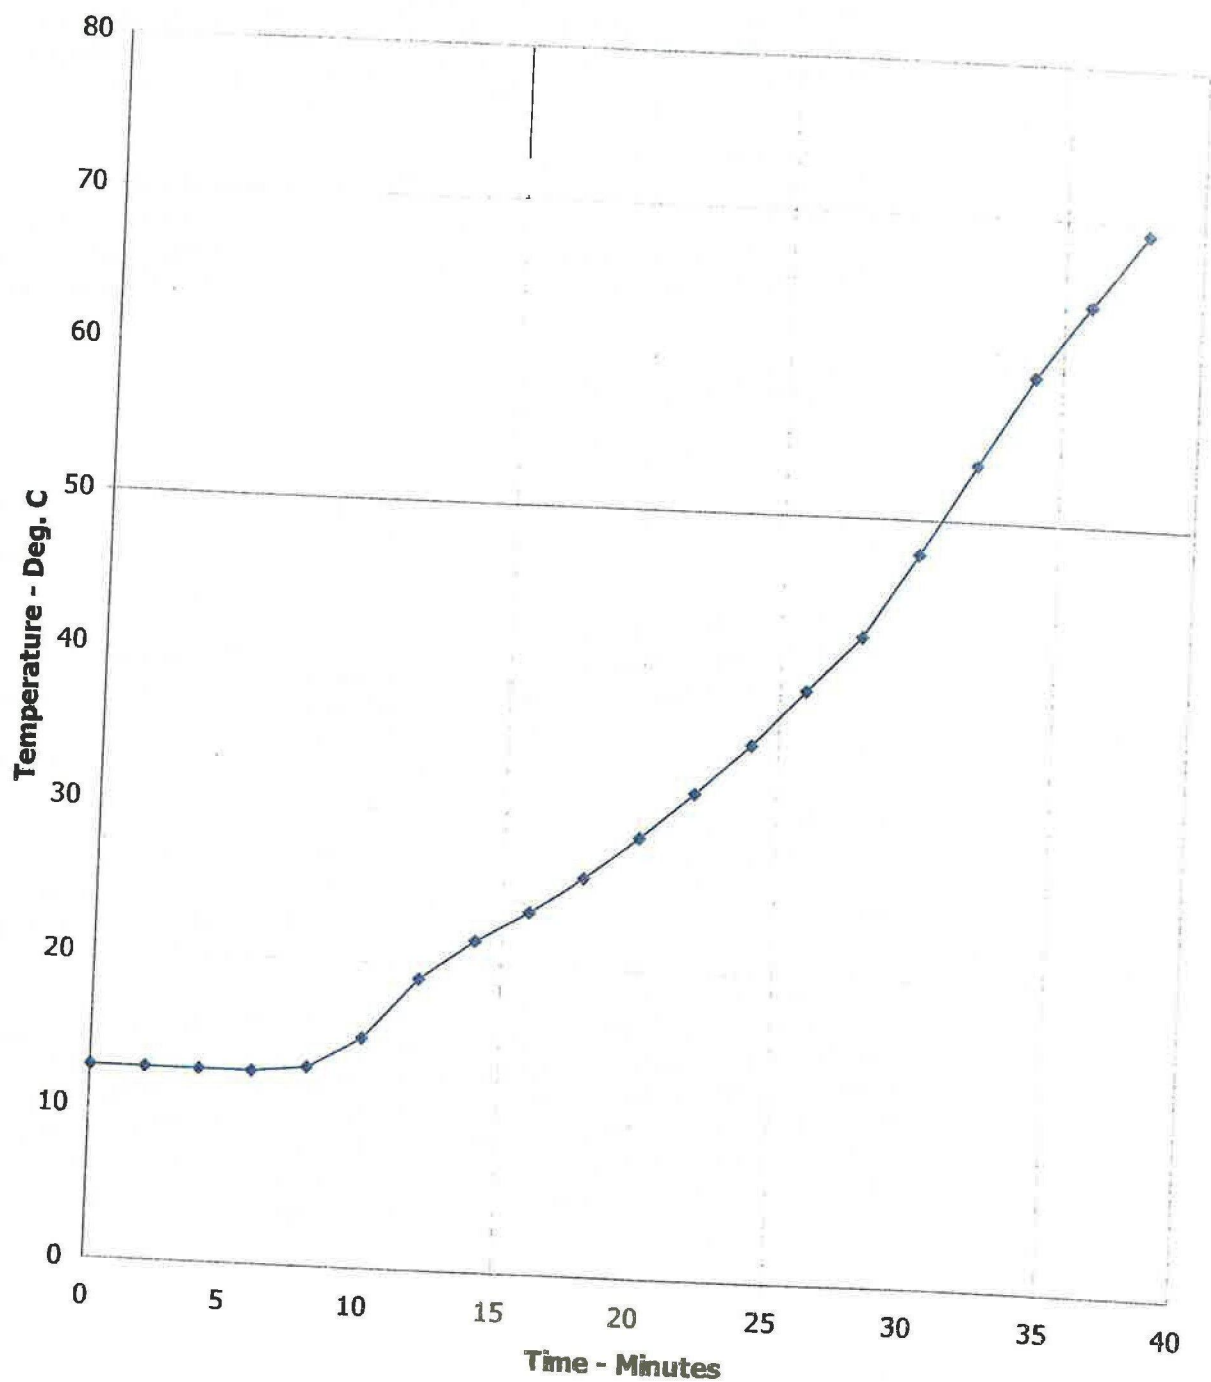
Graph Showing Mean Temperatures Recorded On The Unexposed Surface Of The Doorset

Time Mins	T/C Number 2 Deg. C	T/C Number 3 Deg. C	T/C Number 4 Deg. C	T/C Number 5 Deg. C	T/C Number 6 Deg. C	Mean Temp Deg. C
0	12	13	13	12	13	13
2	12	13	13	12	13	13
4	12	13	13	12	13	13
6	12	13	13	12	13	13
8	13	13	13	13	13	13
10	13	15	13	20	14	15
12	14	18	14	33	16	19
14	17	21	15	36	19	22
16	19	25	16	37	21	24
18	22	29	18	37	24	26
20	26	33	21	38	26	29
22	30	36	24	40	29	32
24	34	39	28	42	32	35
26	39	42	32	45	35	39
28	44	44	36	48	39	42
30	53	48	42	51	45	48
32	63	53	47	56	50	54
34	70	60	52	61	55	60
36	74	65	56	66	61	64
38	78	69	62	70	67	69

It is required that the mean temperature rise of the unexposed surface shall not be greater than 140°C and that the maximum temperature rise shall not be greater than 180°C. Insulation failure also occurs simultaneously with integrity failure. These requirements were satisfied for a period of 35 minutes after which time integrity failure occurred.

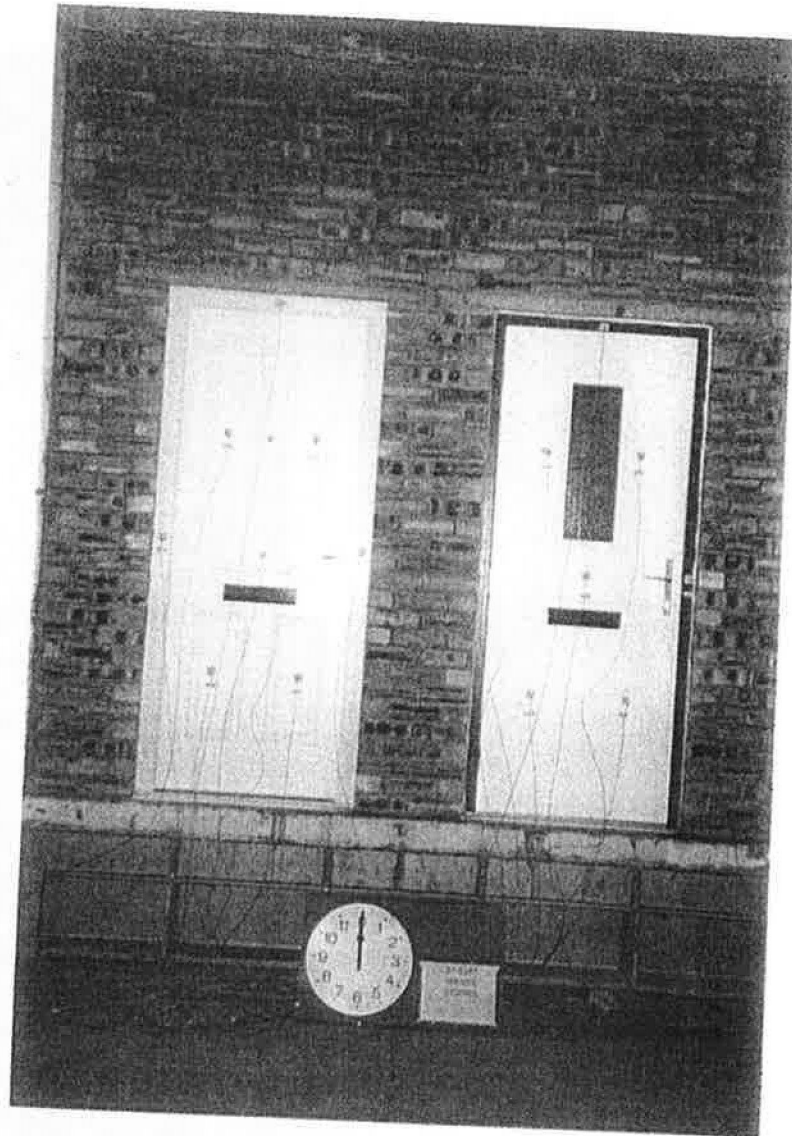
Frame 1 Unexposed side pre test

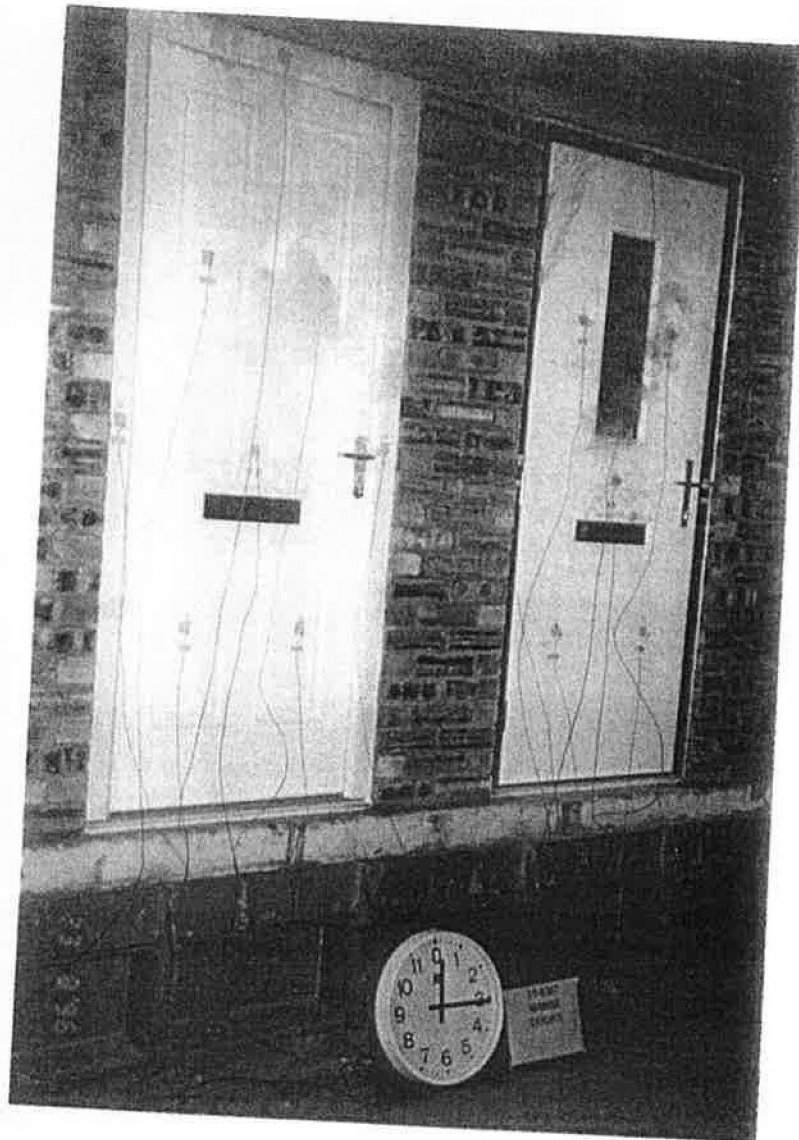
Frame 2 Unexposed side - after 15 minutes

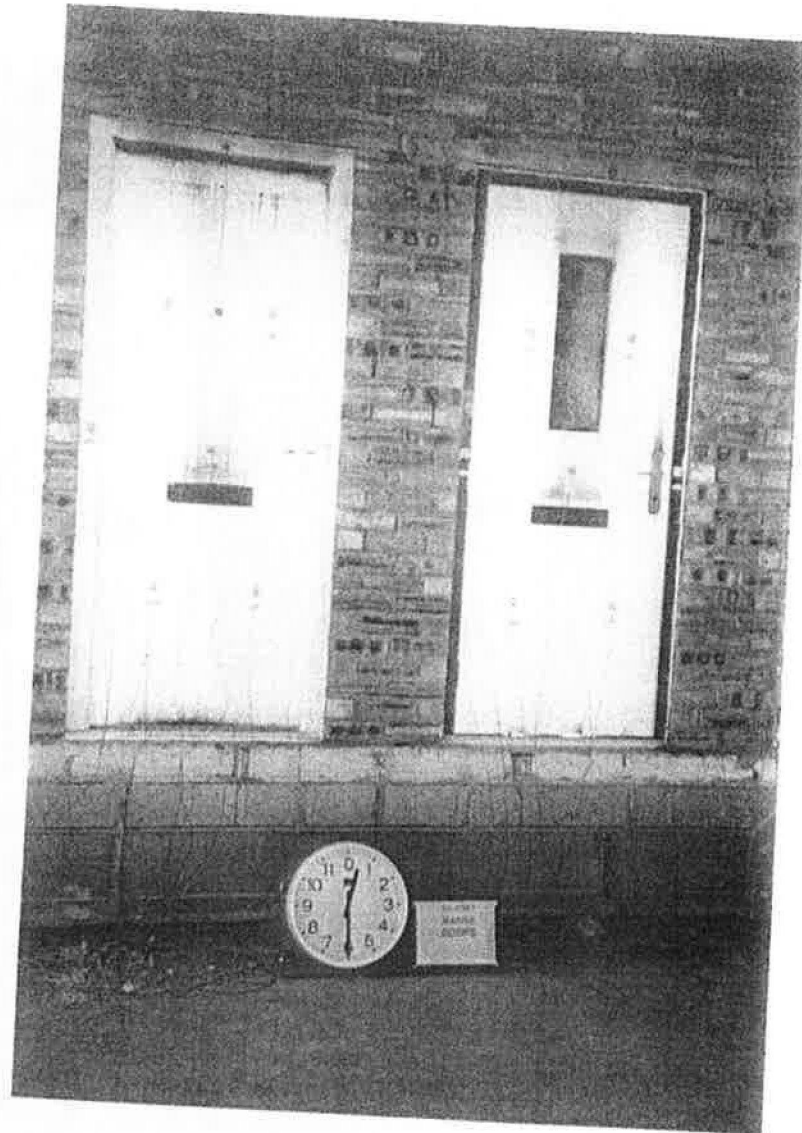
Frame 3 Unexposed side - after 30 minutes

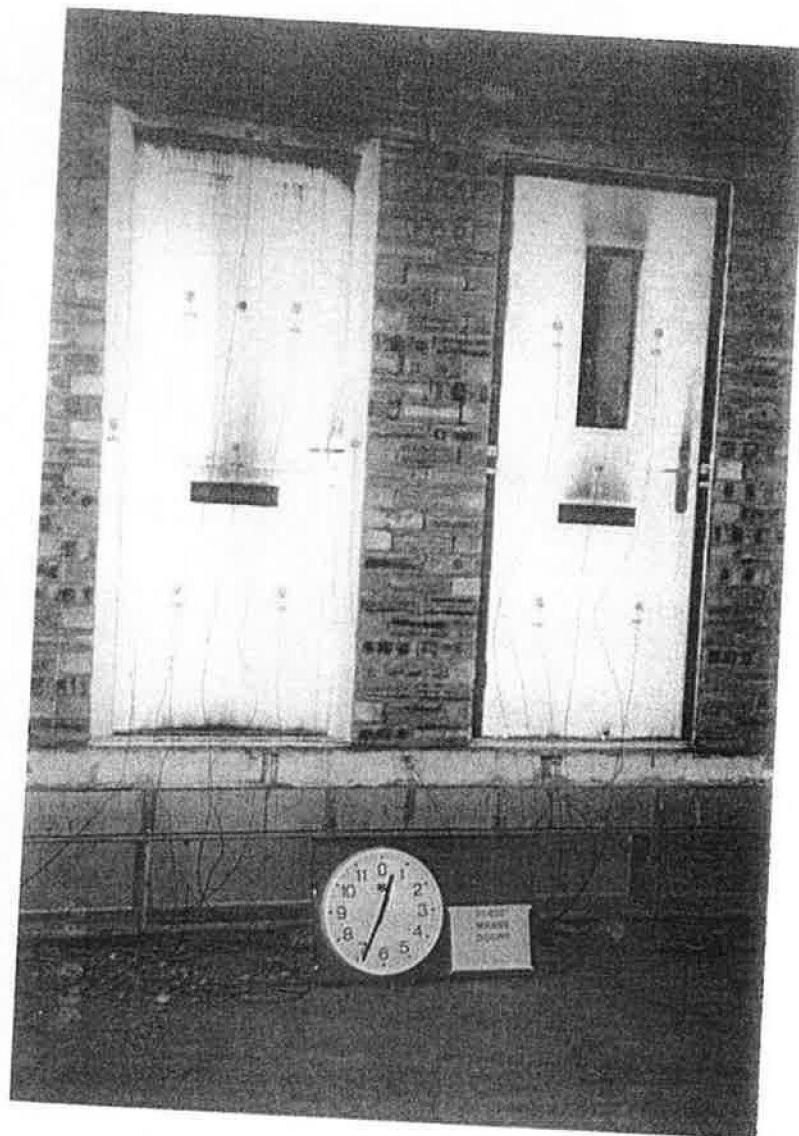
Frame 4 Unexposed side - after 34 minutes

2.4 The four panelled Marse Masteror satisfied the criteria for integrity and stability for 34 minutes when a cotton pad failure was found at the top of the door. The partially glazed solid Marse Masteror satisfied the criteria for integrity and stability for 36 minutes, when sustained flaming was observed at the bottom of the door. Both doors satisfied the criteria for insulation for 36 minutes, when the test was terminated.

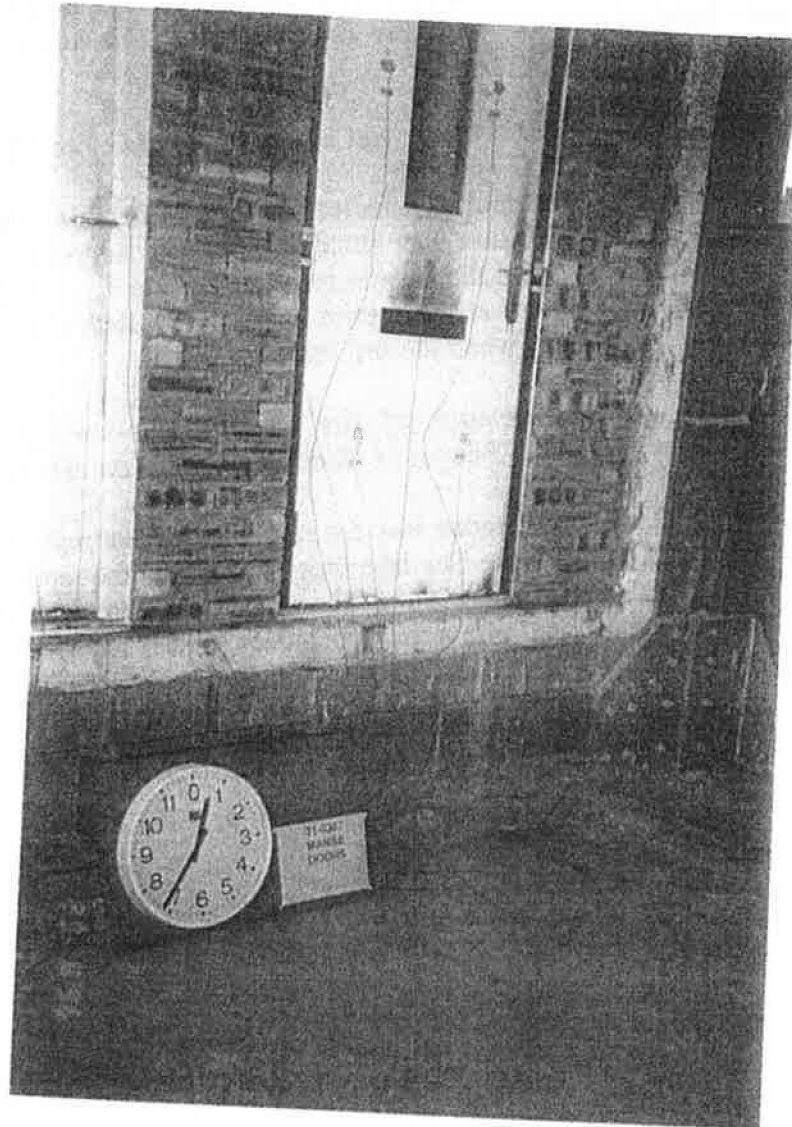
Frame 5 Unexposed side after 36 minutes
