**Test reference: BMT/FEI/F14030**

**Re: Indicative Fire Resistance Test utilizing the temperature and pressure conditions of BS 476: Part 20: 1987 and the principles of BS 476: 22: 1987 (and current FTSG Resolutions where applicable)**

Report on testing a single leaf, single acting doorset (inward opening) - within a British Gypsum steel stud partition in accordance with BS EN 1634-3

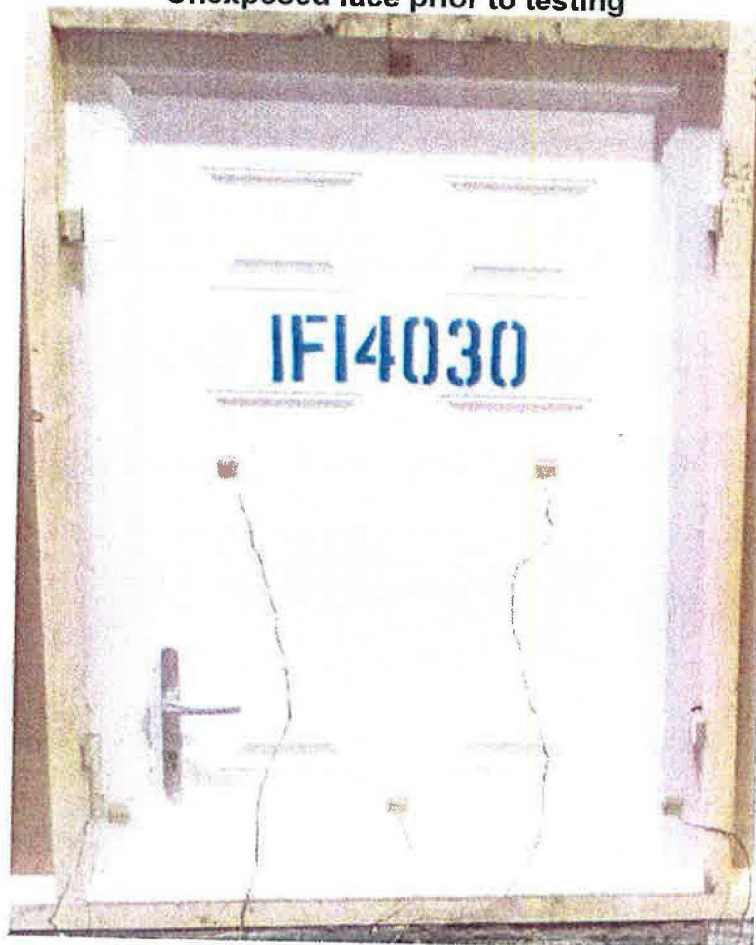
**Unexposed face prior to testing**

The leaf measured 1200mm high x 785mm wide x nominally 45mm thick

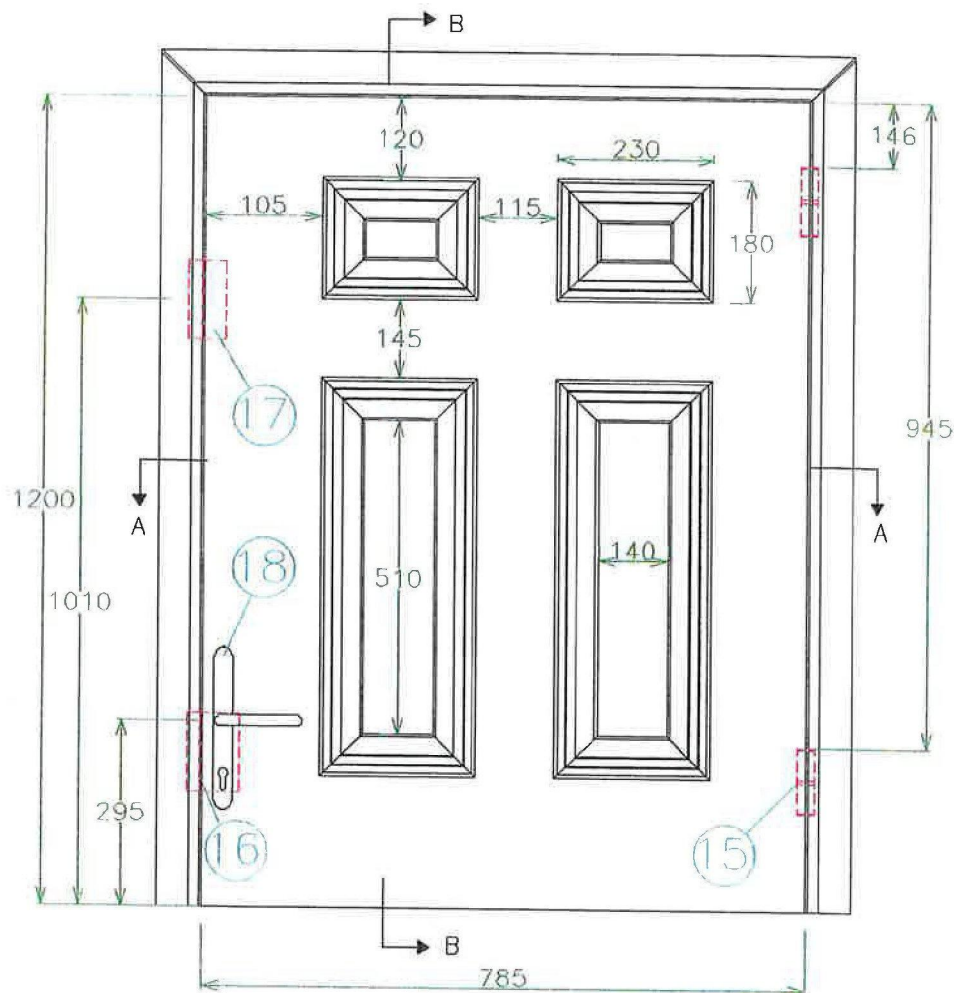
### Front elevation showing hardware positions

Leaf – identified as a trimmed Nan Ya FD60 door blank

Species/type	Dimensions (mm)	Density (kg/m³)	Key to figures
Stiles	Inner	#Mixed wood finger jointed lamels	30 wide x 40 thick	490 - 600*	1
	Outer – removed	-	-	-	-
Top rail (bottom rail removed)	Inner	#Mixed wood finger jointed lamels	30 wide x 40 thick	490- 600*	2
	Outer	#Mixed wood finger jointed lamels	70 wide x 40 thick	490- 600*	3
Core		Phenolic foam	41 thick reducing to 26 thick at fielded areas	90*	4
Facings		Interlocking GRP – 9mm wide interlocking detail	2 thick	-	5
Adhesive	Stiles and rails	PU	-	-	-
Lippings		None fitted – leaf edge trimmed back to the interlock of the facings	-	-	-

Make/type	Size (mm)	Location	Key to figures
Hinges	2 No. Masterdor bearing butt type stepped hinges	101 x 35 (blade size)	Fitted 146mm and 945mm from the head of the leaf	15
Closer	None fitted	-	-	-
Lock/latch – engaged	Winkhaus AV2 multi point lock/latch with Eurocylinder	1130 x 20 (forend size)	Latch fitted 295mm from the threshold of the leaf	16
		235 x 30 (latch keep size)	Fitted appropriate to the latch	
		230 x 25 (hook bolt keep size)	Fitted 1010mm from the threshold of the leaf	17
Furniture	Hoppe lever type handle	235 x 30 (footprint size)	Fitted appropriate to the lock/latch	18

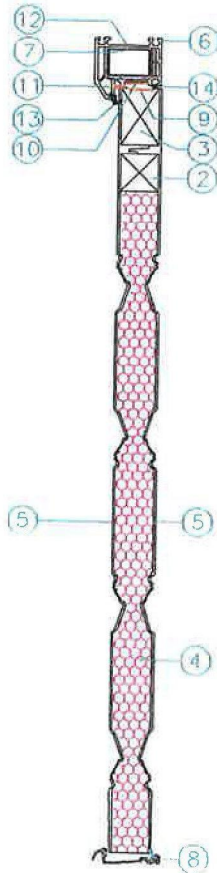
Section B-B

Species/type	Dimensions (mm)	Density (kg/m <sup>3</sup> )	Moisture (% w/w)	Key to figures
Head & jambs	PVCu LB Plastics 7000 range SR77950	70 wide x 70 deep including a 23 high x 21 wide integral stop	-	-	6
Frame reinforcement	Steel box section Product reference S119	30 x 35 x 1.5 thick	-	-	7
Stops – Integral	-	-	-	-	-
Frame corner jointing detail	Mitred – plastic welded	-	-	-	-
Frame to supporting construction fire stopping detail	Tightly packed rock mineral fibre capped with intumescent acrylic mastic	Nominally 5-10mm wide x 10-15 deep	-	-	-
Frame to supporting construction fixing detail	3 No steel wood screws per jamb	No 10 x 80 long at nominally 600-800 centres	-	-	-
Architrave	None fitted	-	-	-	-
Threshold	Stormguard Masterguard threshold	75 wide x 30 high	-	-	8

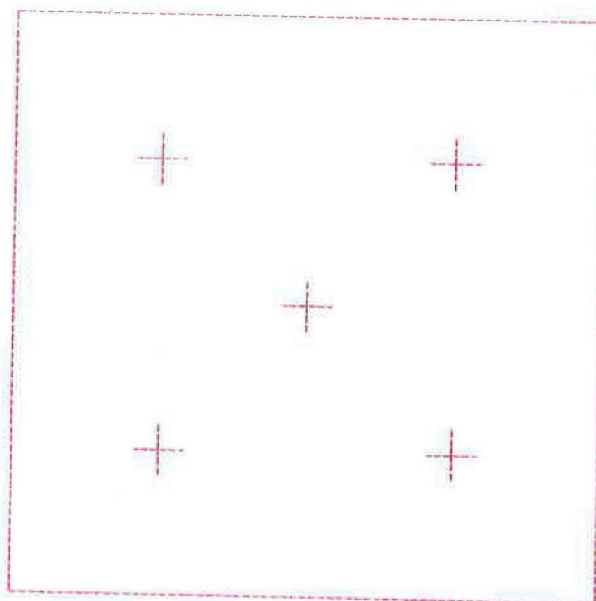
+ : Furnace Thermocouples

The furnace temperature was measured using the average of 5No furnace thermocouples. The temperature and pressure were controlled to the conditions outlined in BS 476: Part 22: 1987.

The furnace pressure was maintained at 5.75Pa, equating to 8.3Pa at the head of the specimen.

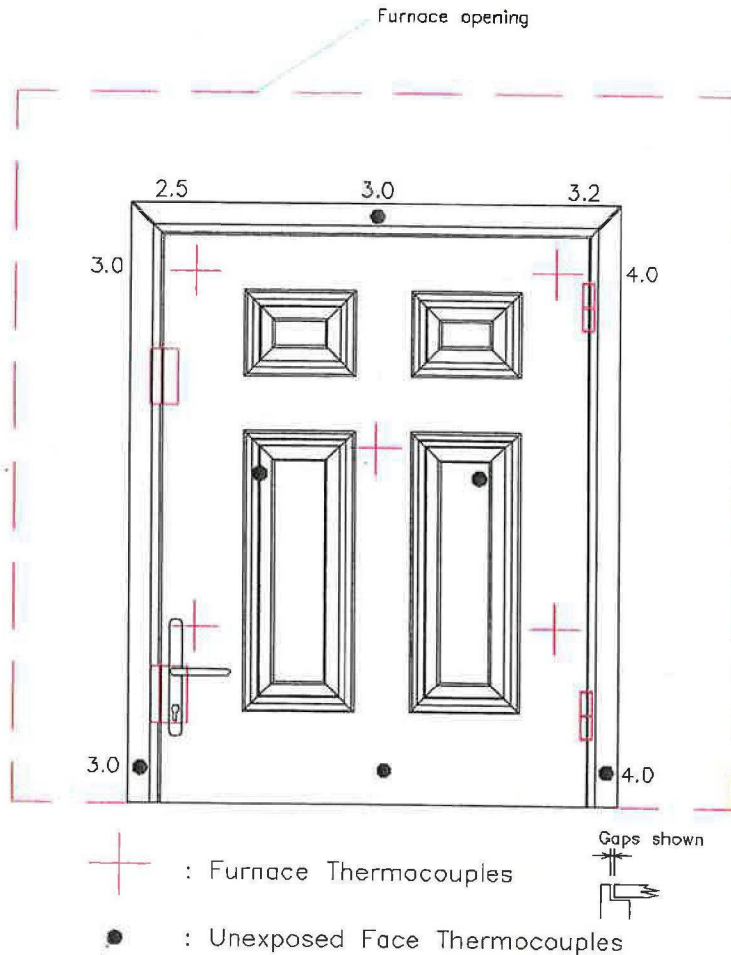
The temperature of the unexposed face of the doorset was monitored by means of three thermocouples fixed to the frame and three thermocouples fixed to the leaf. The locations of the thermocouples are shown below. The temperatures recorded are shown graphically below.

The leaf to frame gaps were measured prior to test, the measurements are shown below and are recorded in millimetres.

The manufacturer did not declare a working range so the door was installed to open and close freely, maintaining gaps, where possible, to a range of 2-4mm along all edges. The leaf to frame gaps were measured prior to test, the measurements are shown below.

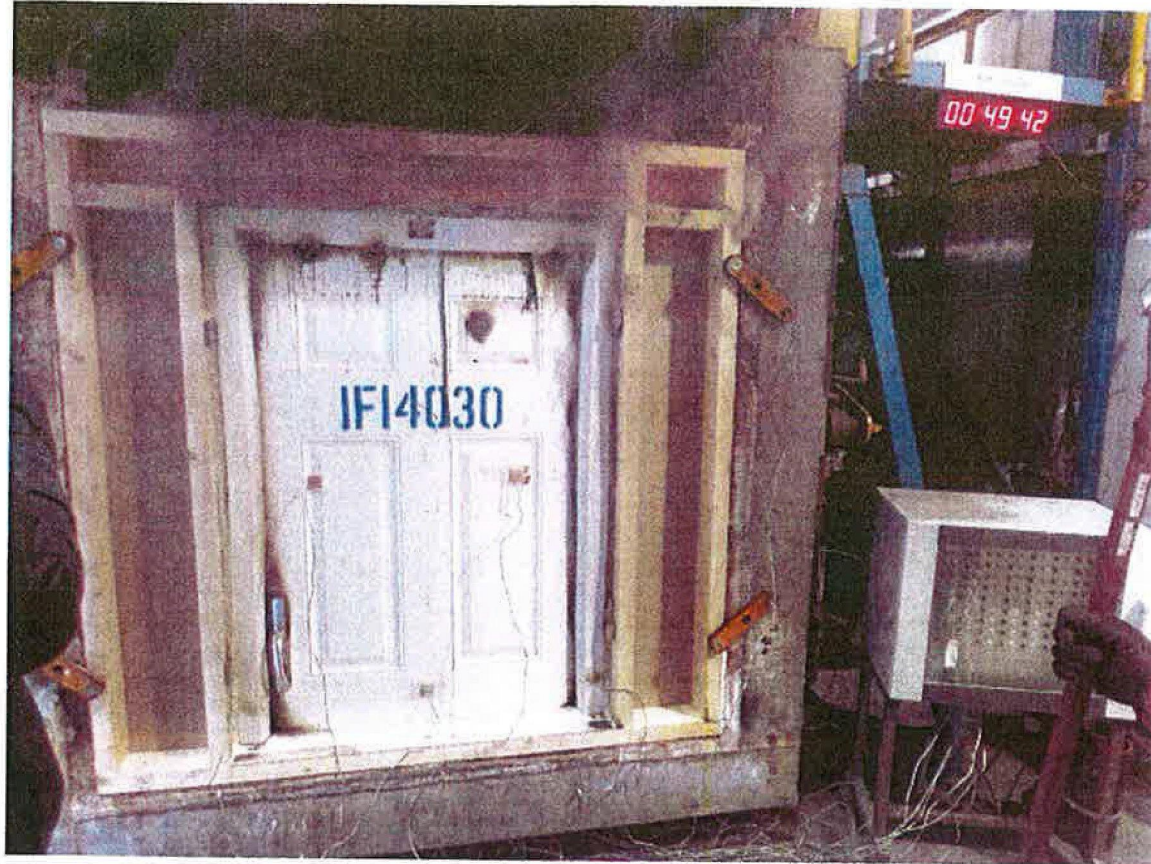
After 49 minutes

- 50.00 Charring is evident at the top right panel.
- 50.30 A glow is visible at the top right panel.
- 50.45 A cotton pad integrity test was carried out the top right panel. No failure is observed.

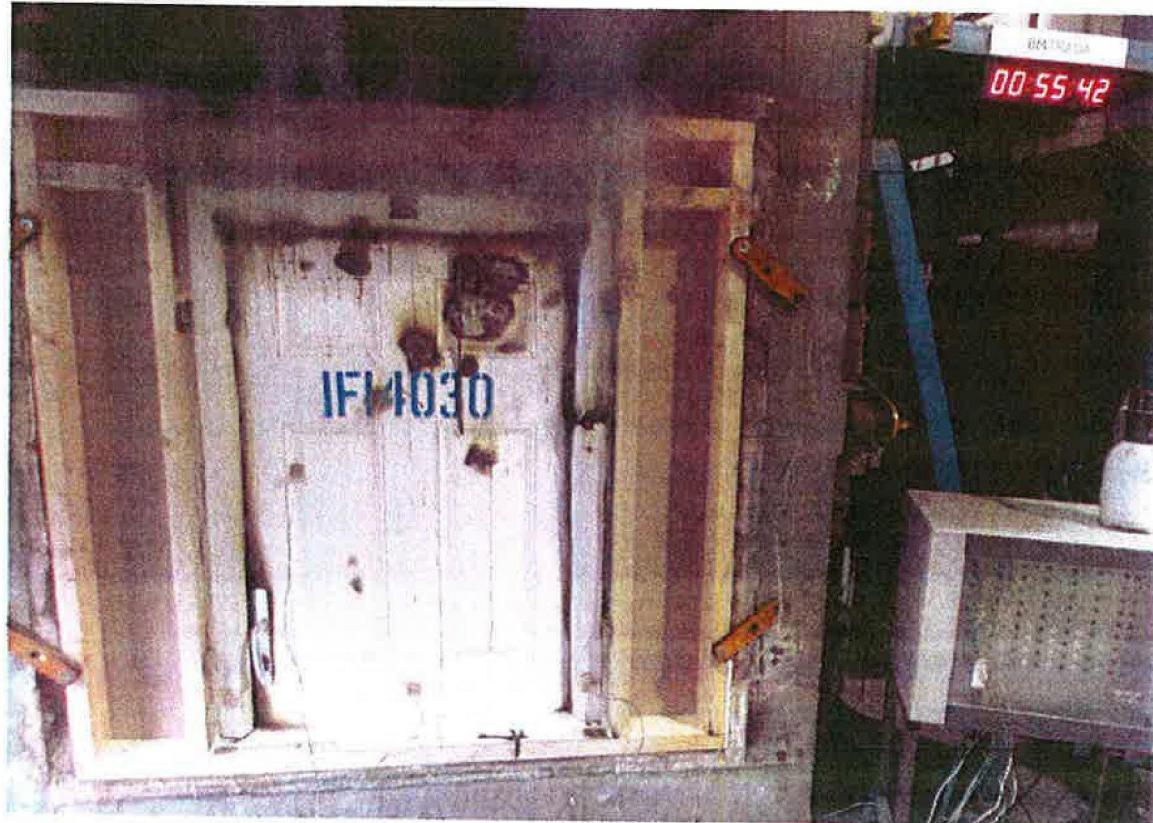
After 55 minutes

- 55.30 A cotton pad integrity test was carried out at the right jamb. No failure is observed.
- 56.00 There is a glow visible at the top hanging corner of the leaf.

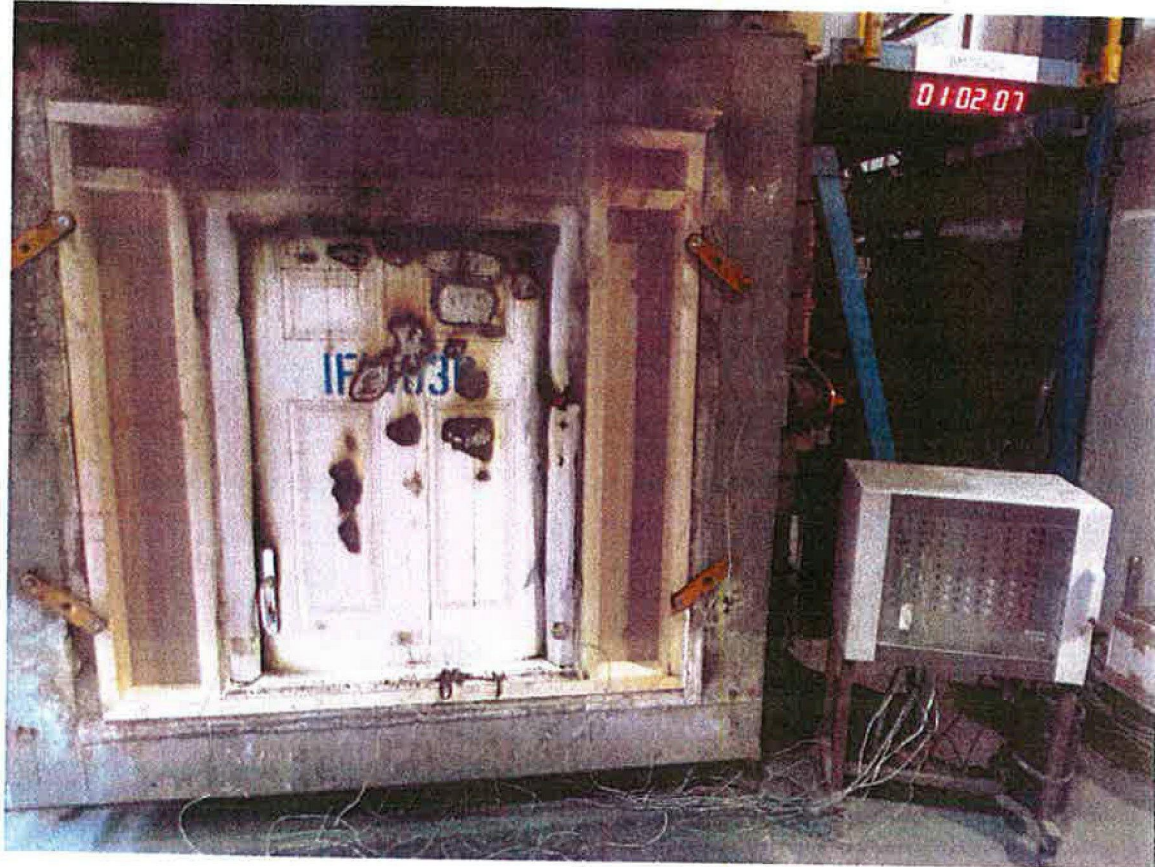
After 62 minutes

- 61.45 There is further discolouration across the face of the leaf.
- 62.50 There is intermittent flaming from the right frame jamb.
- 63.20 There is flaming in excess of 10 seconds from the right frame jamb.

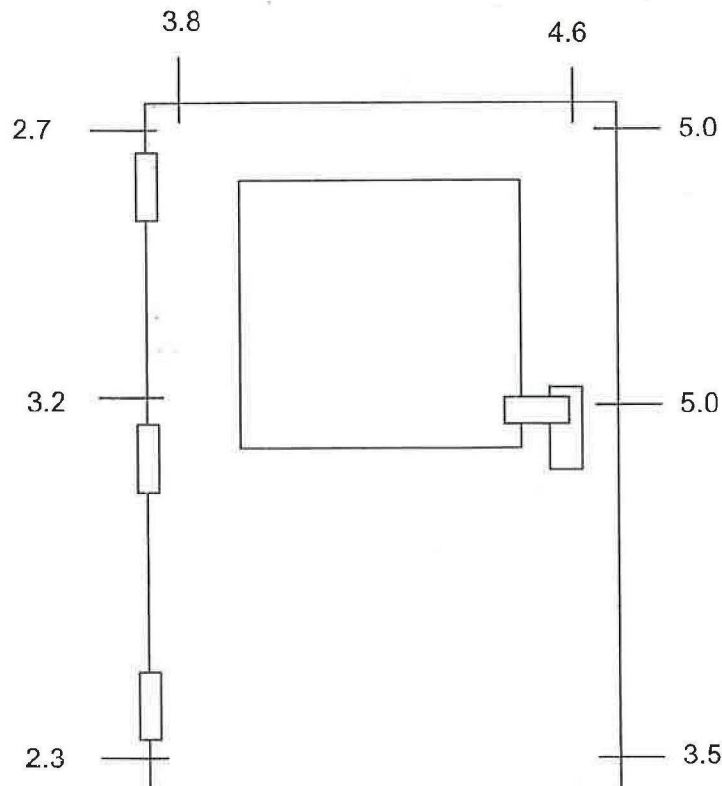
### 5.3 Door Gaps

The leaf/frame gaps and letter plate gaps were measured before testing commenced – See diagram below (Gaps were taken within 20mm from corners and centre of stiles).

The perimeter length of leaf/frame gap was 4.715m.

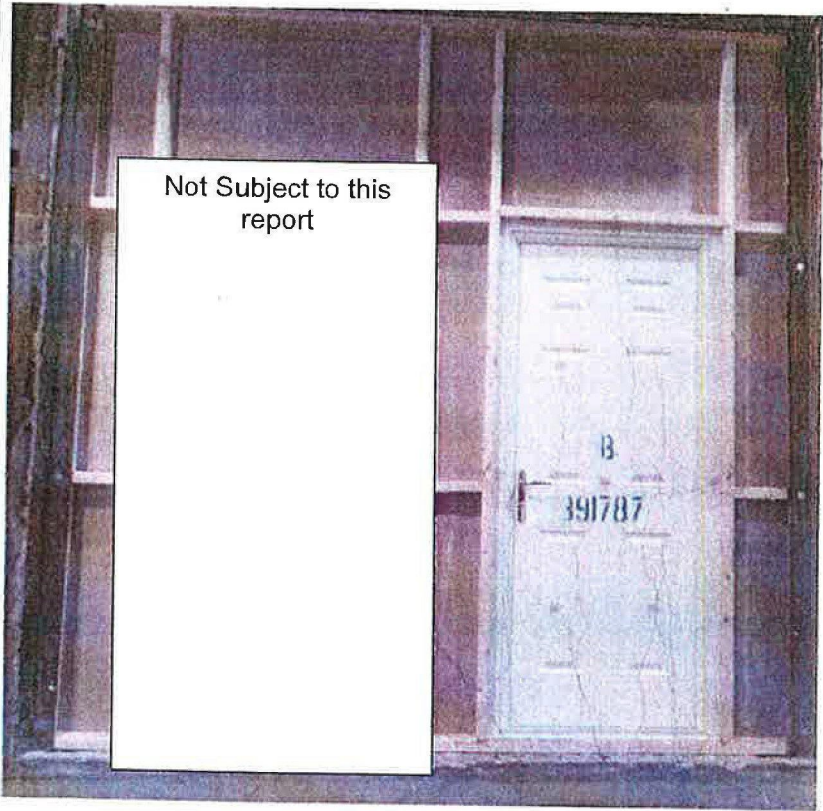
<p data-bbox="371 1077 604 1137">Not Subject to this report</p>	<b>Summary of specimens:</b> <p data-bbox="1066 994 1398 1106"><b>A latched single leaf single acting doorsets, hung opening in towards the furnace</b></p> <p data-bbox="1066 1176 1425 1301">The doorset on the left of the furnace was designated doorset A and is not subject to this report.</p> <p data-bbox="1066 1335 1425 1424">Leaf size: doorset B - 2015mm high x 785mm wide x 45mm thick.</p>
---	--

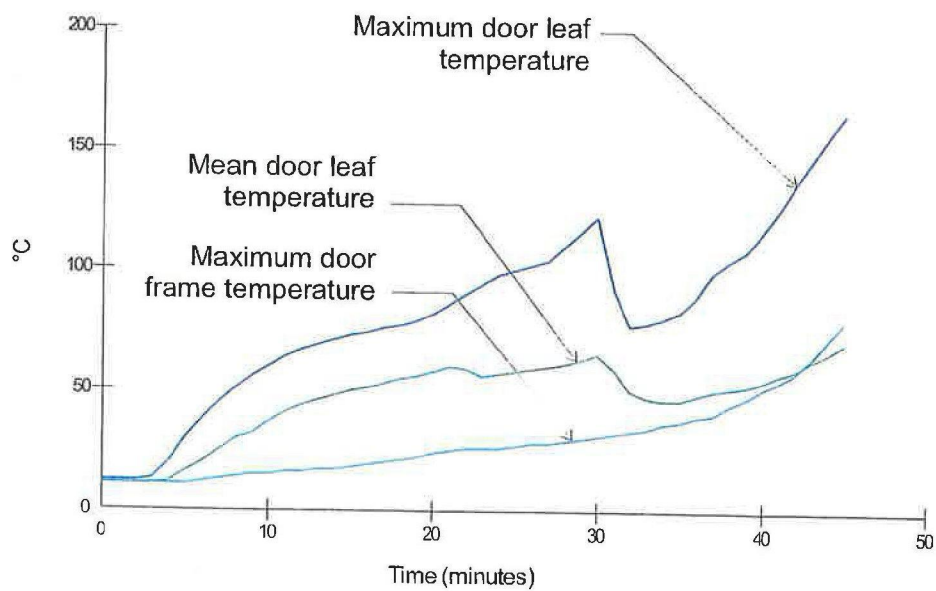
### 5.2 Unexposed Face Temperature Curves

Doorset B

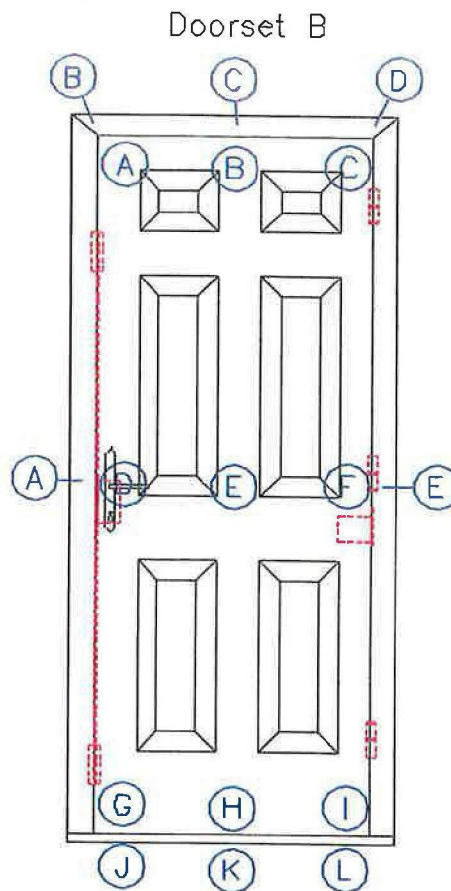
### 5.3 Frame and Door Distortion Data

The following tables show the distortion of the frame and door in mm with an accuracy of  $\pm 1\text{mm}$ .

A negative measurement indicates distortion away from the furnace.

J, K and L give vertical movement of the door, a negative reading indicates that the door has dropped.

Time	A	B	C	D	E
10	15	7	3	6	2
20	14	16	3	6	3
30	14	16	3	5	2
40	14	3	0	5	2

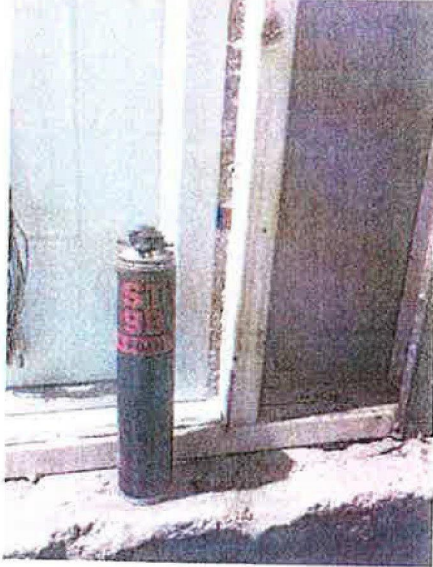
Fire Stopping to the rear of frame – Doorset B

Intumescent interruptions by hardware

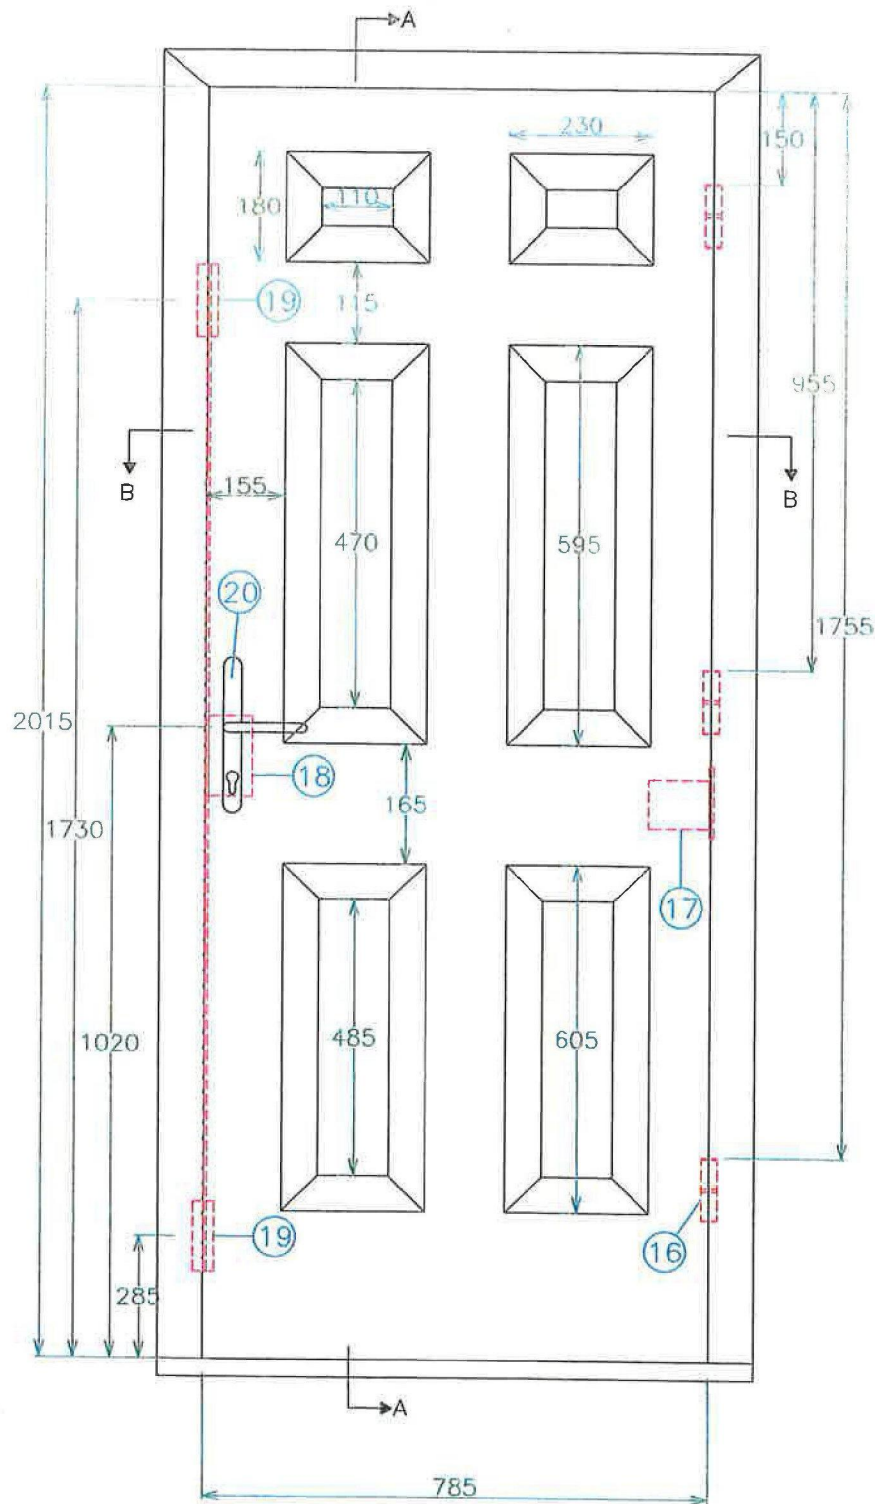
## Doorset B

-30 min fire rated door fiberglass reinforcement location-
