C S Stokes and Associates Limited

16th December 2015

Subject: HIU's within the hallways of some Grenfell Tower flats which are located on the existing electrical supply/distribution board cupboard.

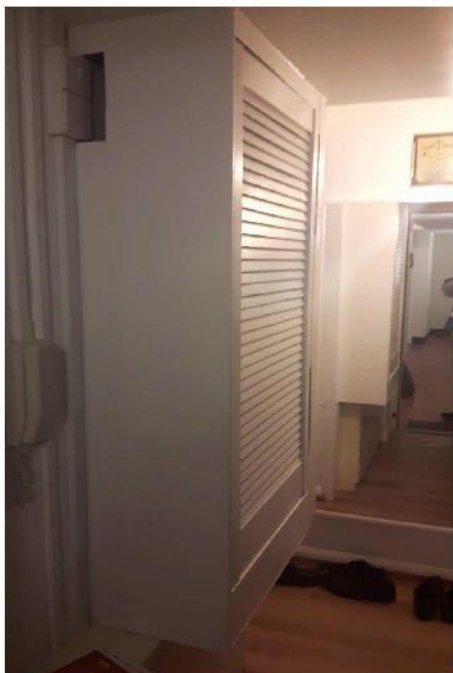
Photopgraph A

Please see a photograph on the left below, (A) this was taken on Tuesday the 15th December 2015 within one of the flats where the HIU is positioned on the wall just inside of the flat entrance door above the existing electrical cupboard. The local Authority Building Control Officer has agreed the location of this unit in the hallway of the flats concerned and this location complies with the requirements of the Building Regulations. This includes the Fire Safety aspects of the Regulations, so by complying with the requirements of the Fire Safety, Approved Document B of the Building Regulations the positioning also will comply with the requirements of the Regulatory Reform (Fire Safety) Order 2005.

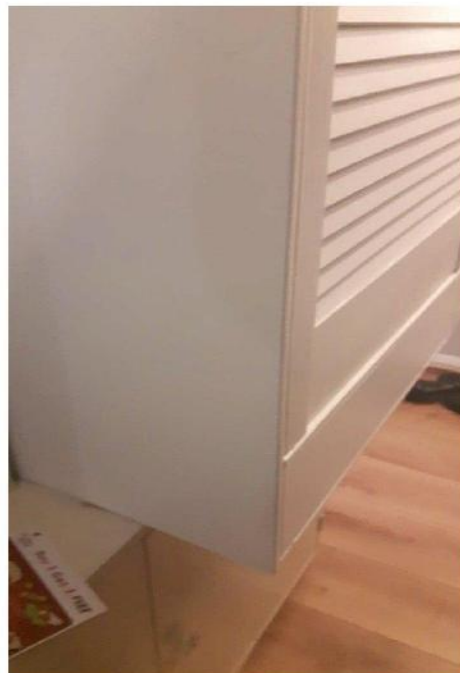
Photopgraph B

The photograph on the right (B) below shows the overhang of the timber constructed cupboard with a louvered door containing the HIU in comparison to the existing electrical supply/distribution board cupboard. The width of the hallway is 1170mm, the existing electrical supply/distribution board cupboard comes out from the wall 180mm and the HIU cupboard comes out from the wall 330mm. There is a 150mm overhang by the HIU cupboard into the hallway more that the electrical cupboard.

This leaves a clear width/gap of 840mm from the front face of the HIU cupboard to the other wall of the hallway. All of the above measurements were taken from one flat but the width of the hallways is the same within each dwelling and from what I have been told the HIUs have been positioned in similar locations. Photograph C below shows the HIU within the timber constructed cupboard with a louvered door open.

In Approved Document M (ADM) of the Building Regulations, "Access and use of Buildings", which includes disabled access arrangements it states in item 6.23 that the requirements of Part M will be satisfied if an external door providing access for a disabled person, to a dwelling, has a minimum clear opening width of 775mm. The clear width of the hallway within the flat I looked at had a clear width of 840mm, this is greater than the minimum width required by ADM for the entrance door. Again if the requirements of ADM are complied with then the requirements of the Regulatory Reform (Fire Safety) Order 2005, The Disability Discrimination Act 2005 (DDA) and the Equality Act 2010 are also met.
