**Grenfell Tower – fire safety investigation:  
The fire protection measures in place on the night of the fire, and conclusions as to:**

**the extent to which they failed to control the spread of fire and smoke;  
the extent to which they contributed to the speed at which the fire spread.**

**Phase 1 Report – Appendix J  
Smoke extract – requirements and provisions**

**Dr Barbara Lane FREng CEng**

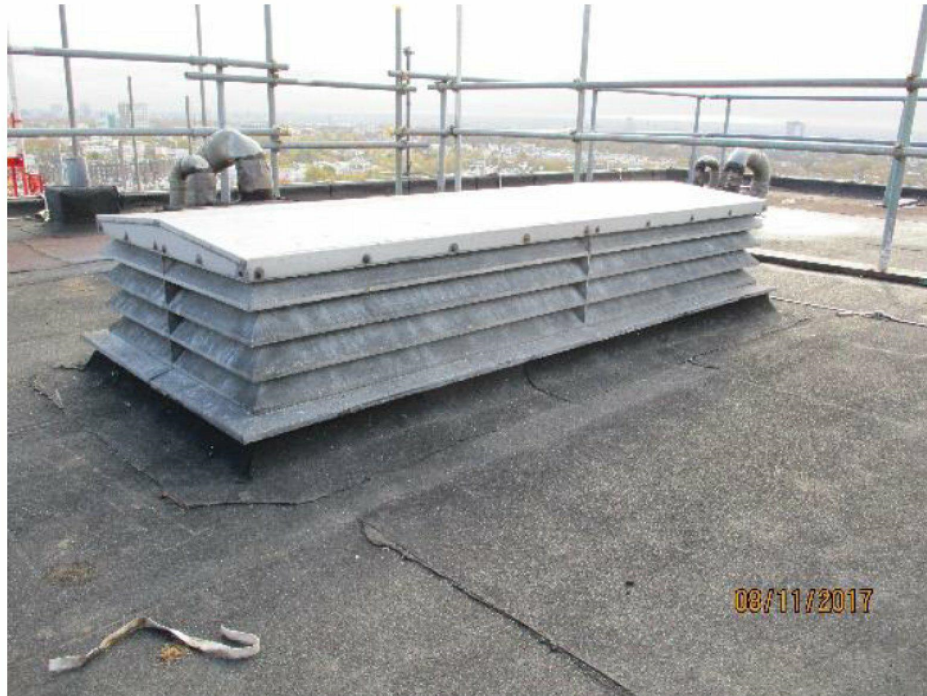
- J6.1.1** During my site inspection, I observed a permanently open vent to the stair at roof level shown in Figure J.9. The PSB technical submission states the measured free area of the vent was 1.0m<sup>2</sup>. I was not able during my site inspection to measure the free area of this vent.

Figure J.9: Permanently open vent at Roof Level.

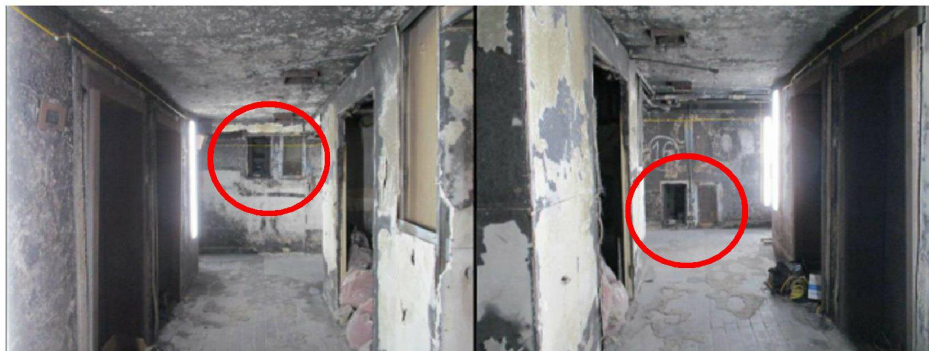
- J6.2.1** The positions of the AOVs within the lobby are shown in Figure J.10.

Figure J.10: Location of the AOVs in the Level 16 lobby. Left - North AOVs located at high level. Right – South AOVs located at low level.

- J6.2.2** The low-level location of the south AOVs is not ideal for smoke exhaust. Smoke exhaust vents should be located as high as practicable within the lobby. The location of the south AOVs was retained from the design of the original system in which these AOVs were located at low level for their function as a fresh air inlet. PSB00000214 did not comment on the location of the south AOVs or the effect of this location on the efficiency of smoke exhaust.

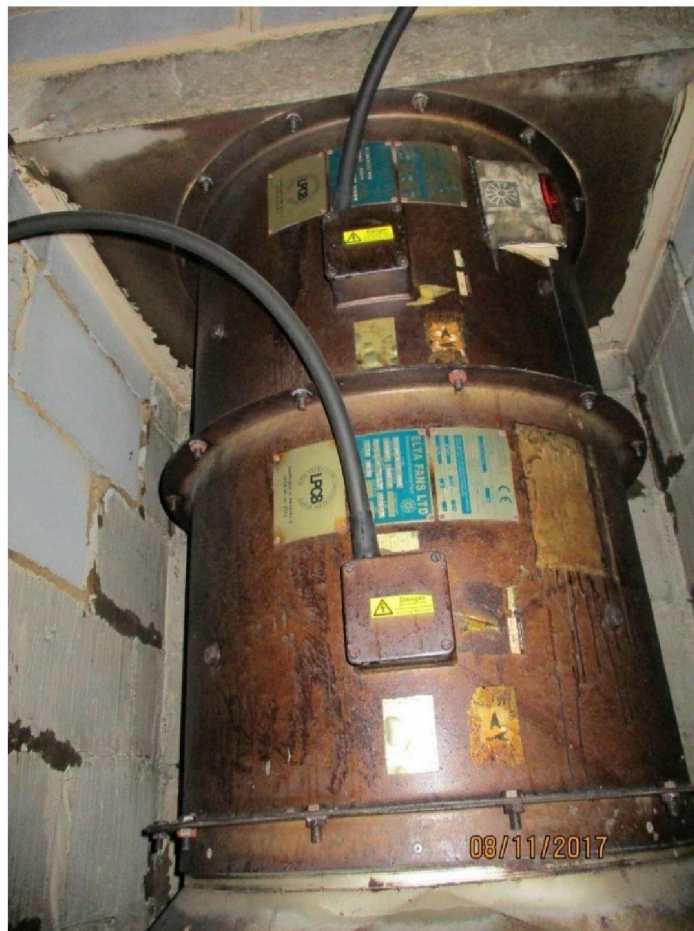
**J6.4.2** New run and standby extract fans were located at Roof Level and serve the pair of shafts serving the AOVs located on the north side of the lobbies.

**J6.4.3** I observed the new fans at Roof Level as shown in Figure J.12.

Figure J.12: Environmental / Smoke ventilation fans in the roof plant room

- J9.2.7** I understand from discussions with BRE on site that they found, immediately following the fire, that AOVs were open on more than one floor.
- J9.2.8** The top of the north shaft and the roof level smoke exhaust fan set show light smoke deposition.

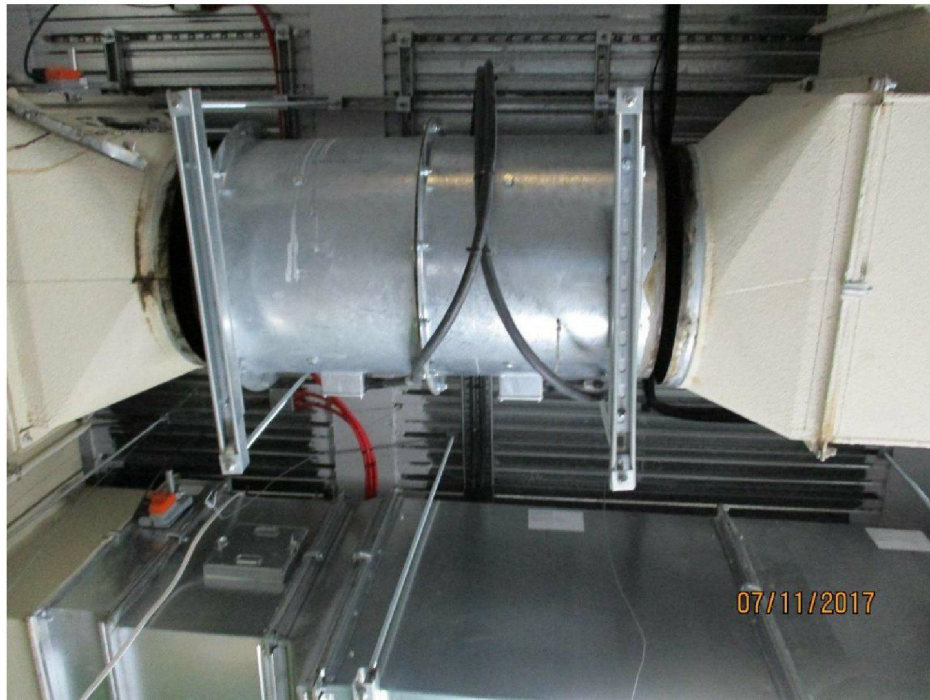
**J6.4.4** A second set of new run and standby extract fans were located on Level 2 serve the other pair of shafts serving the AOVs located on the south side of the lobbies.

**J6.4.5** I observed the smoke extract fans located at Level 2 as shown in Figure J.13.

Figure J.13: Smoke exhaust fans at Level 2

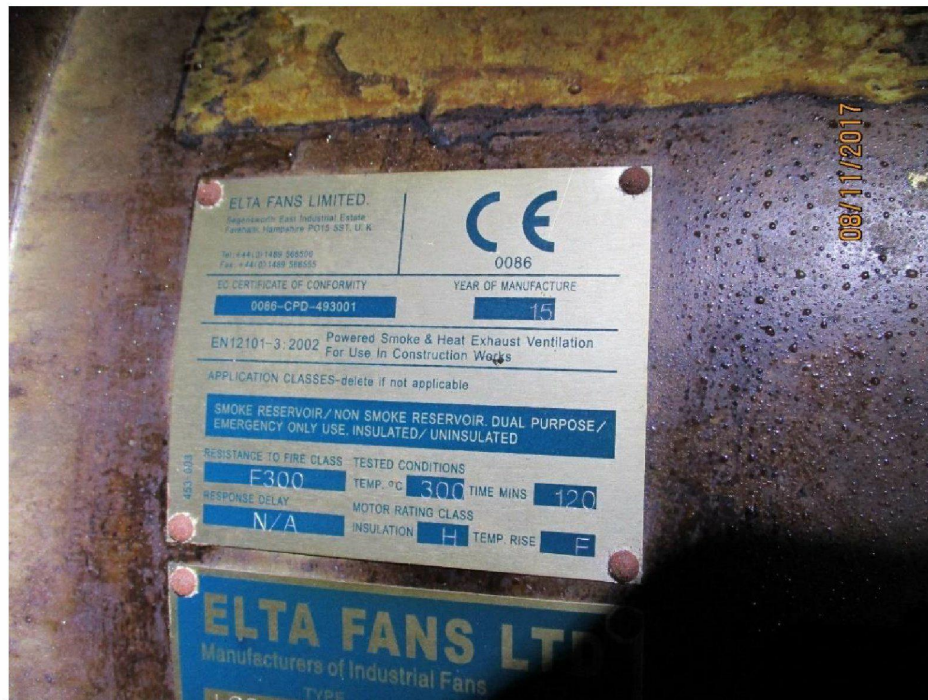
- J6.4.6** A single new environmental control fan was connected to the smoke ventilation system at Level 2.
- J6.4.7** The environmental fan at Level 2 was to be fitted with a bypass system to separate it from the extract system when the smoke extract fans are running.
- J6.5 Fire rating of fans**
- J6.5.1** The smoke extract fans are specified in PSB00000214 as being rated for operation for 2 hours when drawing smoke at 300°C.
- J6.5.2** I confirmed this performance rating of the roof fan set serving the north shaft by observation of the identification plate fixed to the fans, which I observed during a site visit between the 7<sup>th</sup> and 9<sup>th</sup> November 2017 (Figure J.14)

Figure J.14: Post fire inspection of fan information plates

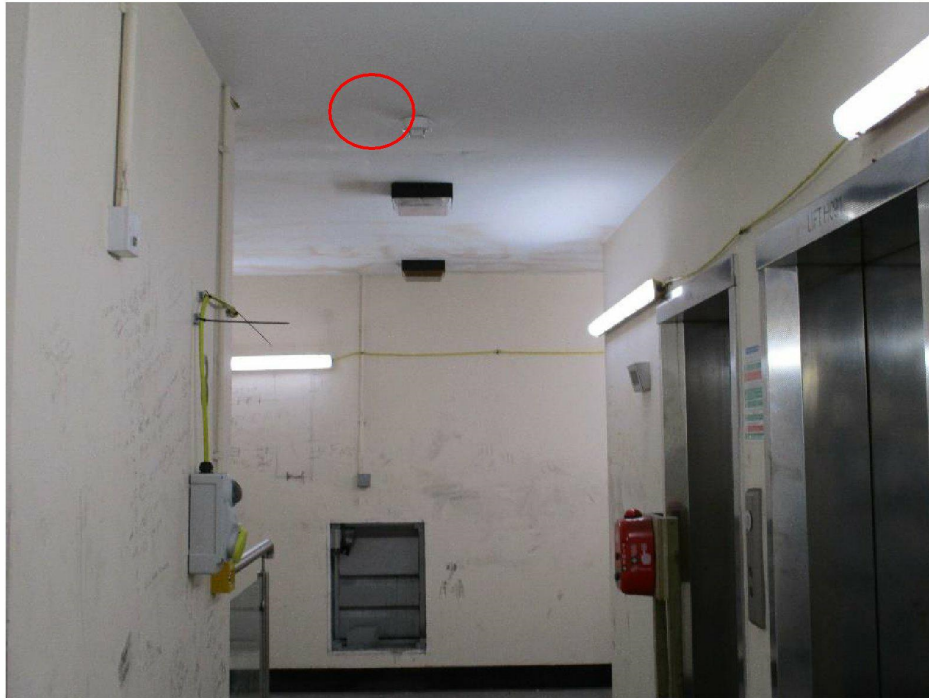
**J6.7.1** During the site visit I observed smoke detectors within the lobbies on levels Ground to 23 in Grenfell Tower during my site visit. An example from Level 3 is shown in Figure J.15.

Figure J.15: Smoke detector (circled) in Level 3 lobby.

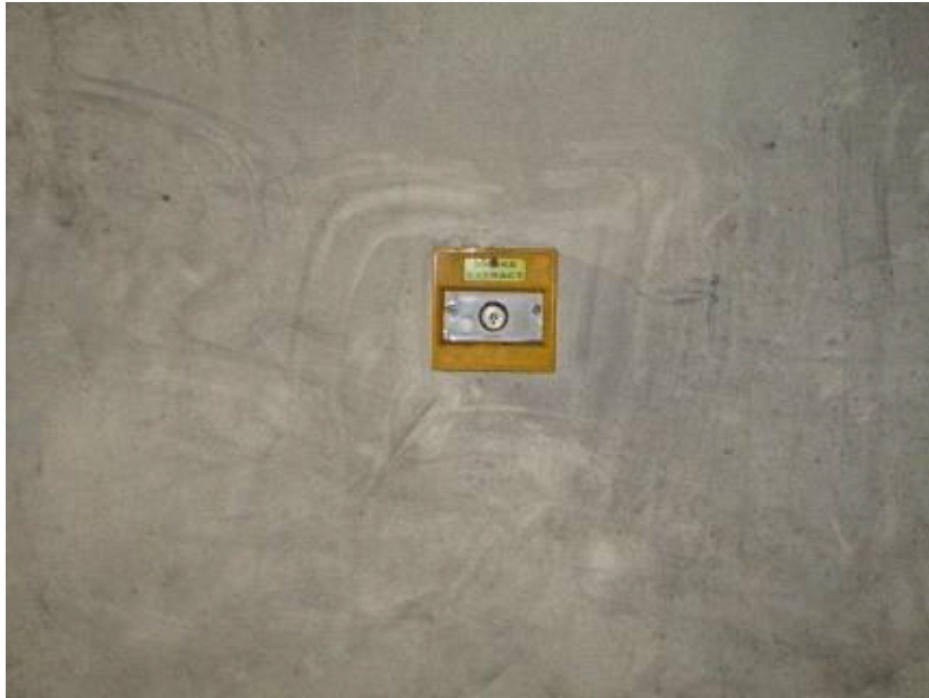
During the site visit I observed override switches for the smoke ventilation system in all lobbies on levels Ground to Level 23. These switches were located on the left-hand wall adjacent to the stair door, within the lobby. An example from Level 4 is shown in Figure J.16. I observed during my site visit that the override switches on Levels 5, 7 and 9 to 23 were badly damaged during the fire (Appendix C).

Figure J.16: Smoke ventilation system override switch on Level 4.
