Grenfell Tower – fire safety investigation:
The fire protection measures in place on the night of the fire, and conclusions as to:
the extent to which they failed to control the spread of fire and smoke;
the extent to which they contributed to the speed at which the fire spread.

Phase 1 Report – Appendix L

Lift installations – fire safety requirements and provisions

Dr Barbara Lane FREng FRSE CEng

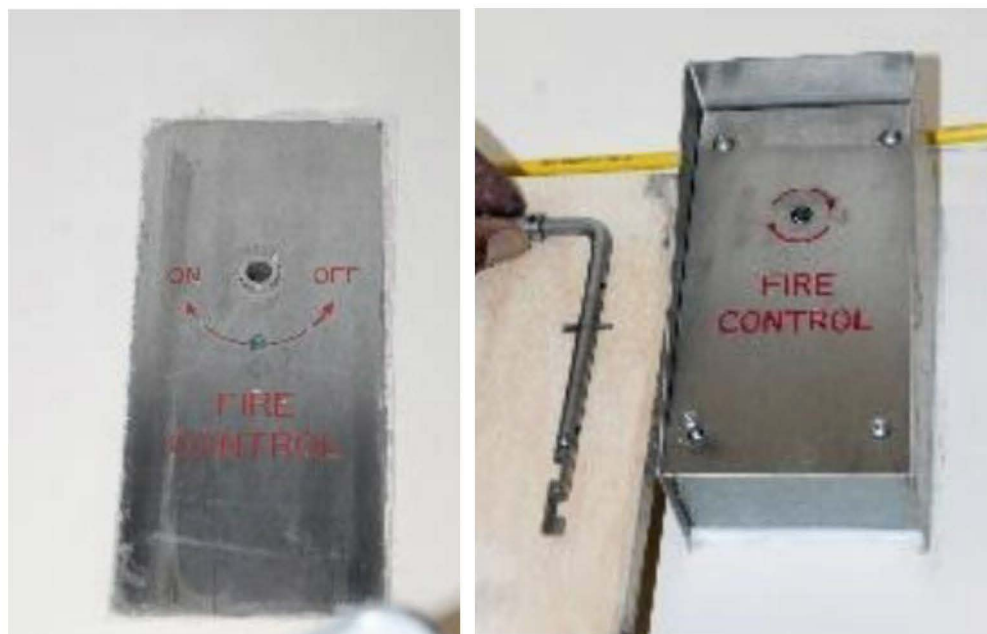
L4.2.24 The Apex evidence therefore conflicts with the Butler and Young 2005 lift specification (CST00000384) which included a 'Firemans Control:'. It also conflicts with my own observation of switches at ground and second floor level; with the latter control marked with the words "fire control" (See Figure L.11).

Figure L.11: Photographs from WSP site investigation report (MET00019973) showing both ground level (left) and level 2 (right) switches were embossed with 'FIRE CONTROL' in red lettering

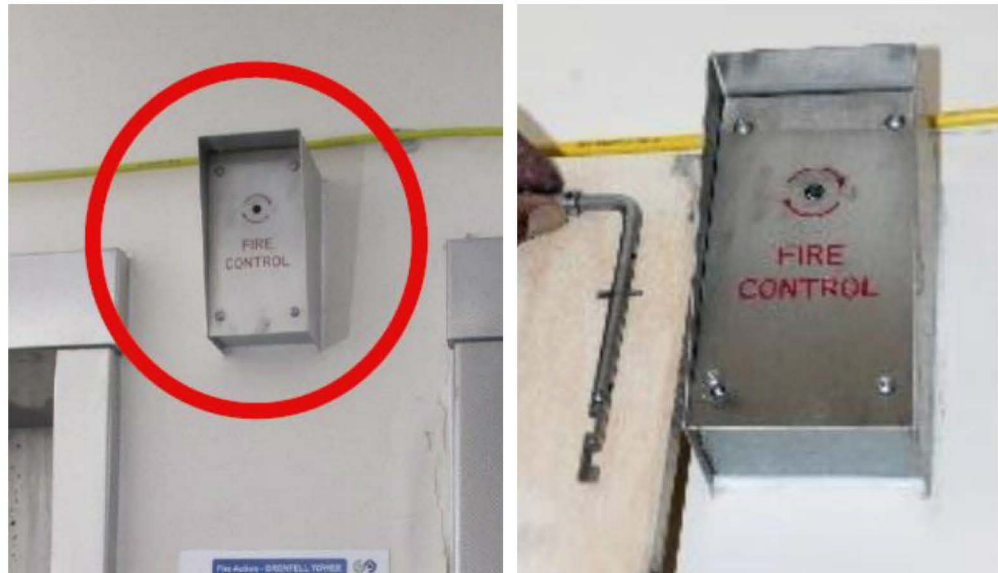
L4.4.2 In Figure L.16 below I show my photo of the lift control switch at Level 2, along with a close up photo taken by WSP (MET00019973).

Figure L.16: Fire control switch as noted on Level 2 lobby (left: my observations, right: WSP site inspection report)

L4.4.15 Therefore, the Level 2 switch could not be used to take any form of control of the lifts by LFB on 14th June 2017.

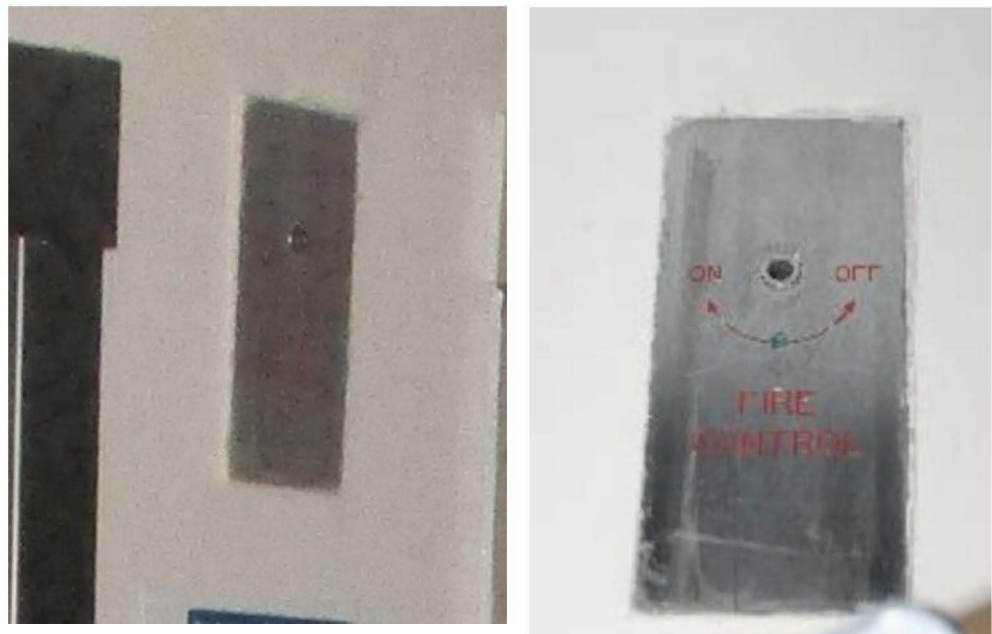
L4.4.3 On the Ground floor, the single control switch provided is clearly labelled “Fire Control” and with a green “flag” in the face plate (See Figure L.10 below). I do not know if it controls both lifts at Ground level or not.

L4.4.4 In Figure L.17 below I also show my photo of the lift control switch at Ground level, along with a close up photo taken by WSP.

Figure L.17: Fire control switch as noted on ground level lobby (left: my observations, right: WSP site inspection report)

- L4.4.8** Regarding the Ground level switch, they advise that the fireman’s switch was difficult to operate.
- L4.4.9** Therefore, WSP removed the faceplate to determine the reason for failing to operate the switch.

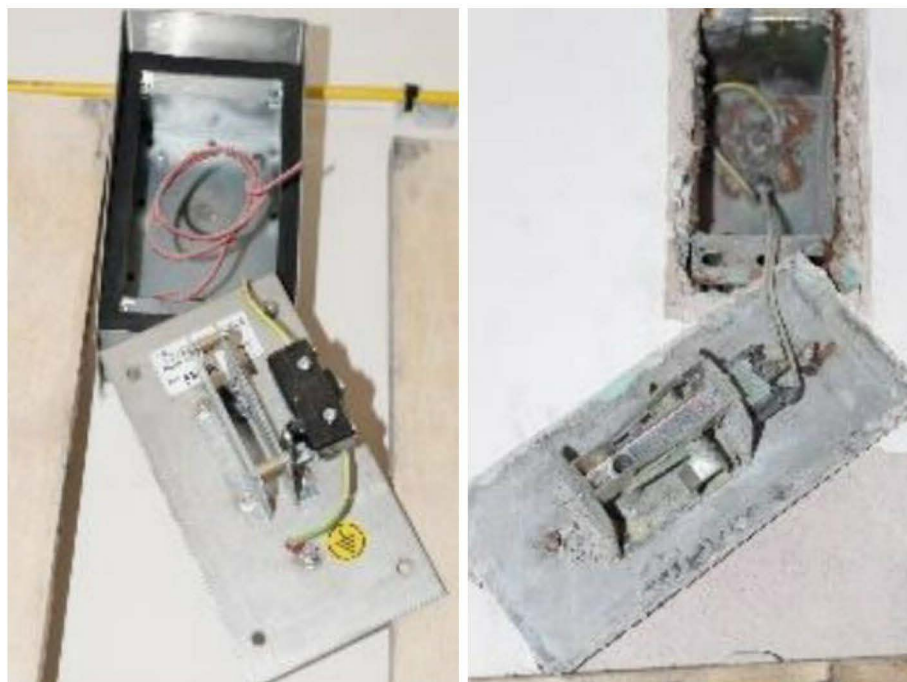
- L4.4.10** WSP discovered that the mechanism was seized and damaged/deformed (see Figure L.18).
- L4.4.11** This corresponds with the evidence given in the hearing on the 4th July 2018, by Secrett: “I’ve put my express lift key or drop key into the box that operates it and I’m trying to switch it on, which would engage the fire lift operation.” (see also his evidence, quoted above, from Transcript 4th July 2017 at p.192-193).

Figure L.18 left: Level 2 switch with faceplate removed. Right: Ground level switch with faceplate removed (MET00019973)

- L4.4.12** The single Ground floor switch and single Level 2 switch are not the exact same model of switch, as indicated by differences in their markings and presence of a ‘flag’ indicator on the ground floor switch only. Both switches installed at Grenfell Tower are clearly not the type operated using triangular type keys in accordance with BS EN 81-72.

- L4.4.13** Both switches feature the circular entry point for a drop/express type key instead, clearly visible on both faceplates. The WSP report confirms that a drop/express type key is used to operate these switches – which they physically checked at Grenfell Tower.

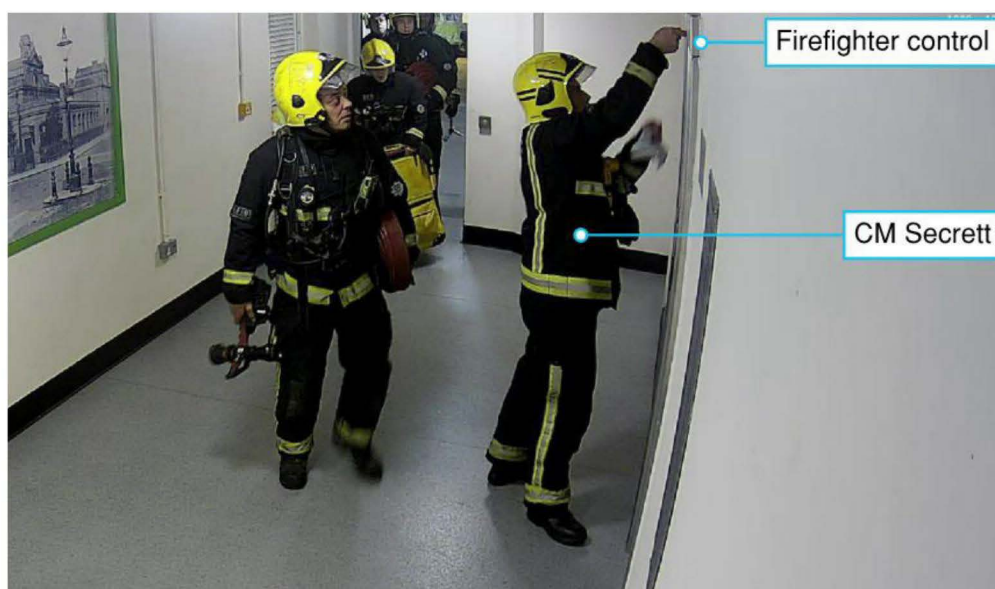
L5.1.1 According to the evidence given in the hearing on 4th July 2018, FF Secrett was first to use the firefighter control switch situated on the Ground floor lobby. He confirmed he was the firefighter shown entering the lobby and trying to operate the firefighting control function on the CCTV image (see Figure L.20) of the ground floor at 01:01. His evidence was:

Figure L.20: CCTV image of ground floor lobby at 01:01:35 (INQ00000138)

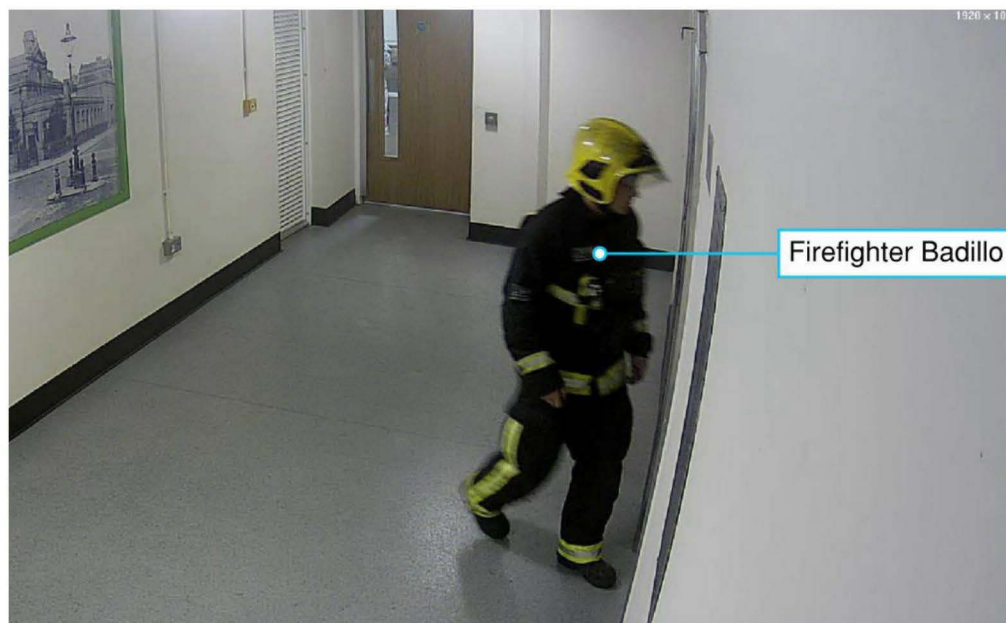
L5.2.3 This is confirmed by CCTV imagery showing firefighter Badillo entering a lift at ground level, as shown in Figure L.21:

Figure L.21: CCTV image of ground floor lobby at 01:27:39 (INQ00000103)

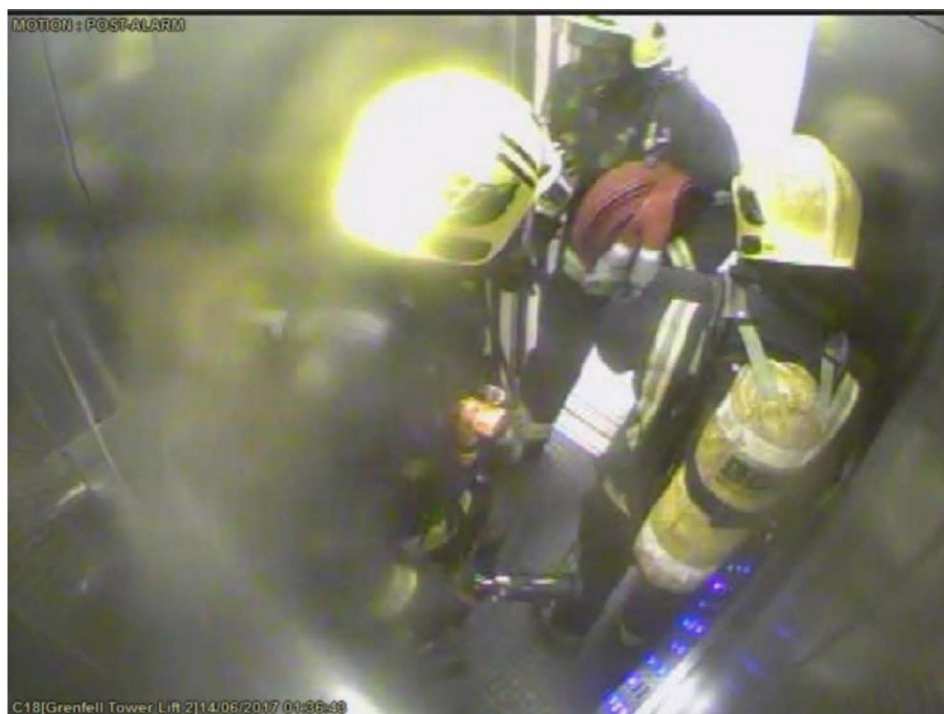
L5.2.6 In his evidence given on the 5th July 2018, Secrett describes how at approximately 01:35, he and firefighters Badillo and Dorgu used the lift to get further up in the tower (Transcript, 5th July 2018 p71 and Figure L.22):

Figure L.22: CCTV footage from South Lift of Secrett, Badillo and Dorgu entering lift at Level 2. Timestamp 01:36 (INQ00000141)

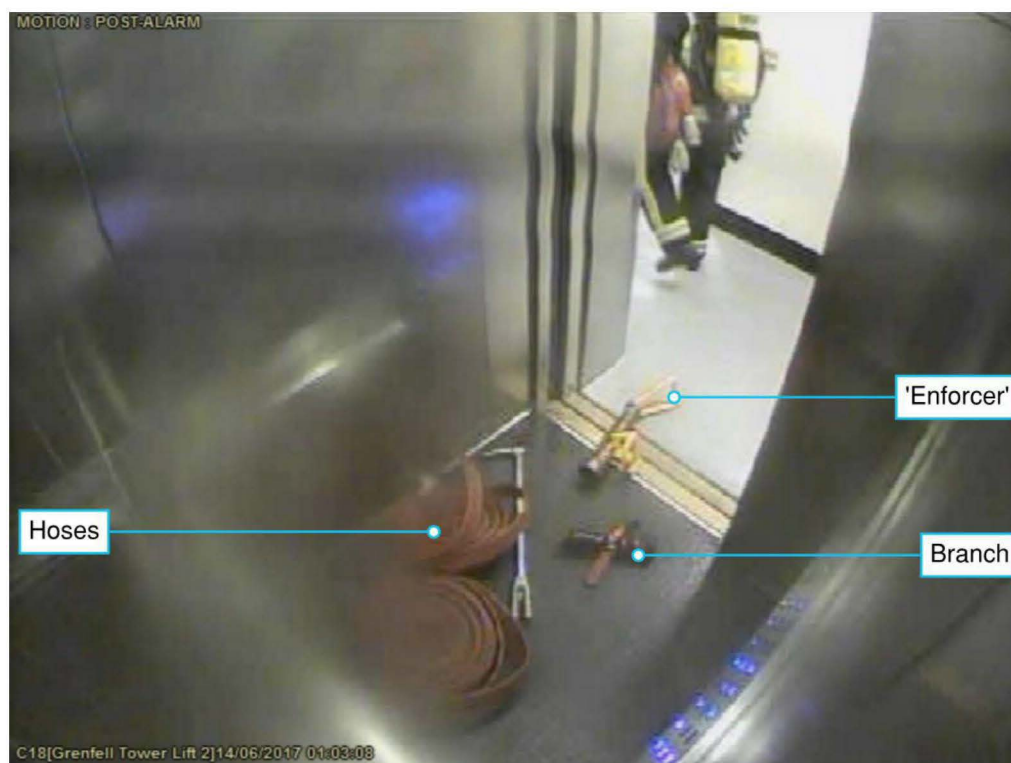
L5.3.1 When giving evidence on 4th July 2018, CM Secrett was shown a CCTV image from within lift 2 (see Figure L.23) and asked to explain what he saw.

Figure L.23: CCTV image from within lift 2 at 01:03:08 (INQ00000149)

“Yes. So it looks like we've all got out of the lift. That piece of equipment in the lift door is what we call the enforcer, which is breaking-in equipment, and someone's put that there on purpose to stop the lift going because we didn't have control over it. If they hadn't have put that there, the lift could've been called and subsequently all our equipment would've gone and we would've lost the lift. So it's been put there as a temporary measure to keep some sort of control over the lift.”

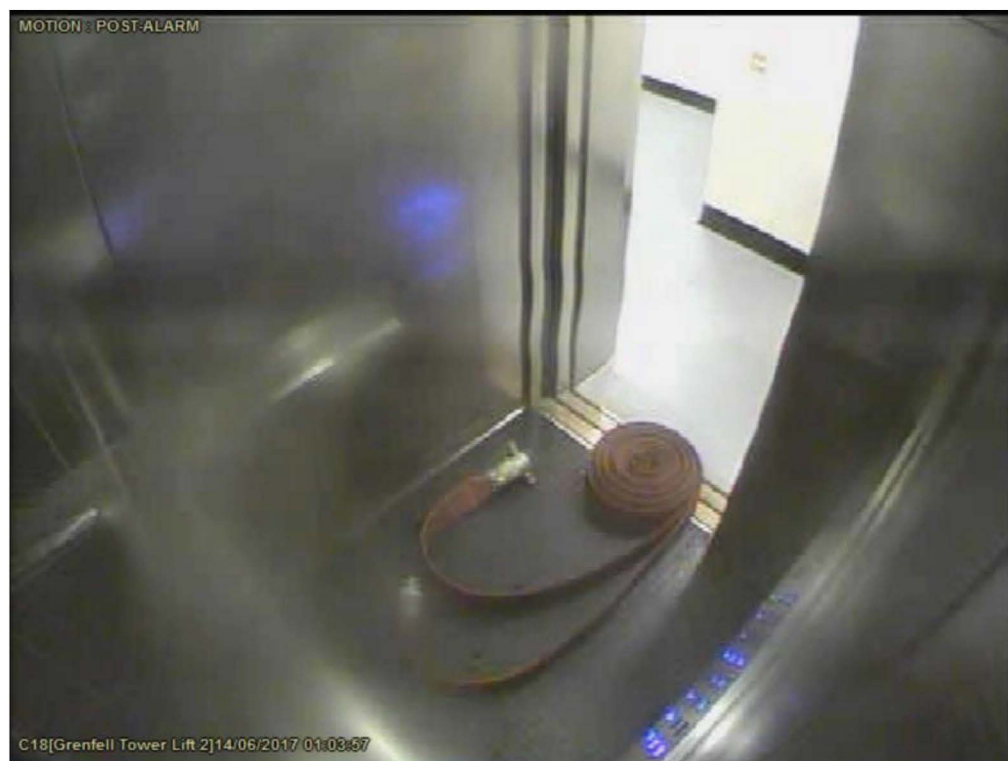
L5.3.3 Once the equipment has been removed from the lift, a single reel of hose is left in the lift doors to retain this control as indicated below:

Figure L.24: CCTV image of hose reel in lift doors. Timestamp 01:03 (INQ00000150)

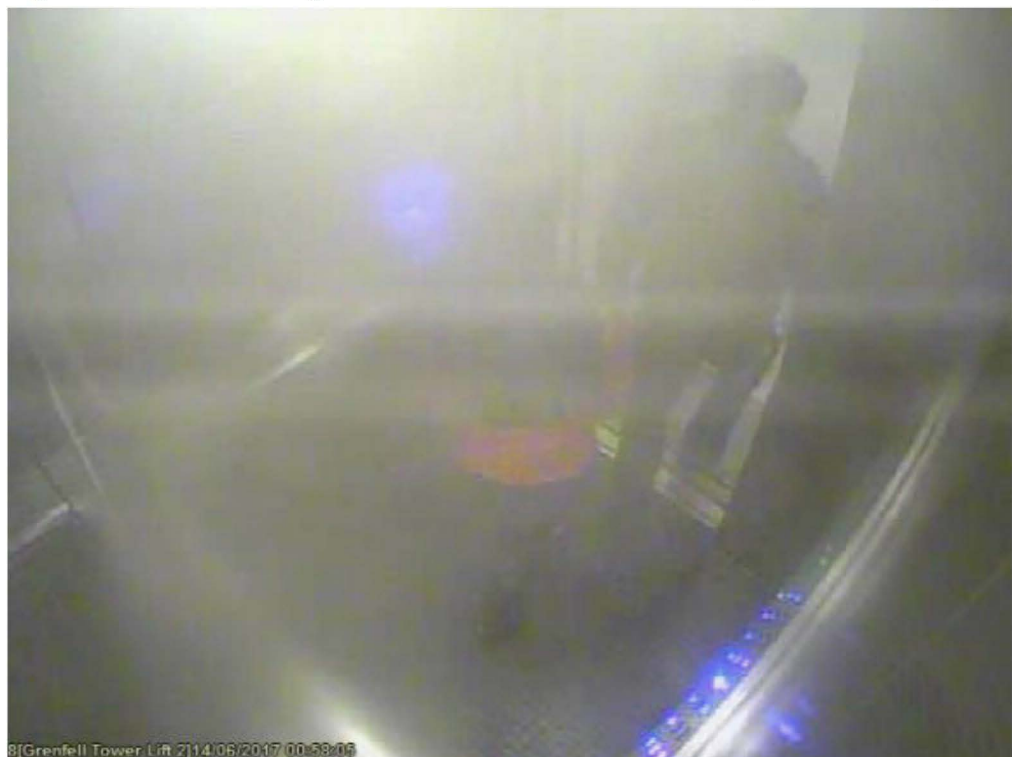
Figure L.26: Residents escaping the lift as it is affected by smoke at 00:58 (MET00012593)

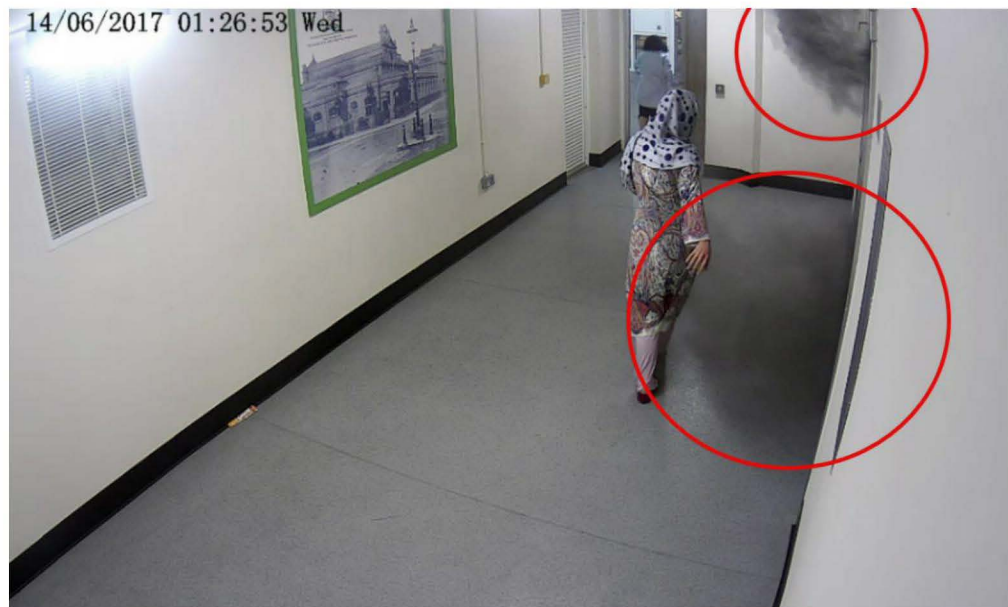
- L5.4.3** The footage at 01:26 (Figure L.27) also indicates significant amounts of smoke exiting one lift car as the residents exit the lift at ground floor.

Figure L.27: Residents escaping using the lift at 01:26 (Ground) (MET00012593)
Smoke leaking from lift doors circled in red

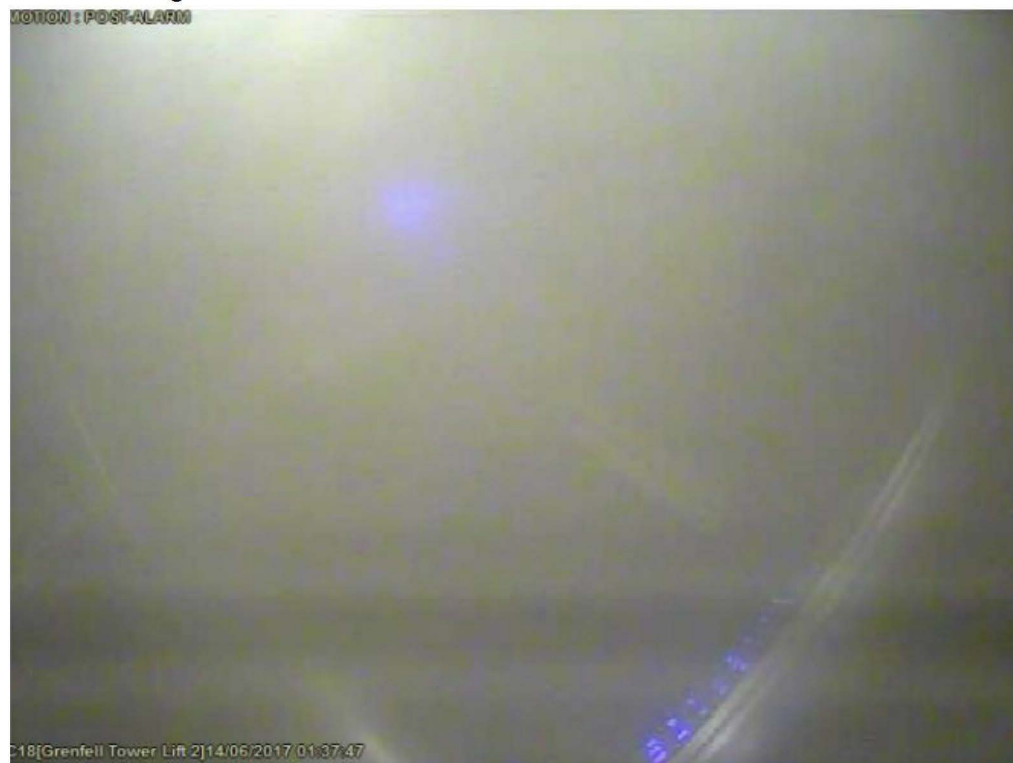
- L5.4.4** Shortly after this time, at 01:38, CCTV footage indicates heavy smoke logging within that lift car.
- L5.4.5** At some time during the fire, the lift moves to Level 10 where it appears to have been disabled by the fire.

Figure L.28: Conditions inside the lift at 01:37 (MET00012593)
