**Grenfell Tower – fire safety investigation:**  
**The fire protection measures in place on the night of the fire, and conclusions as to:**  
**the extent to which they failed to control the spread of fire and smoke;**  
**the extent to which they contributed to the speed at which the fire spread.**

**Phase 1 Report – Section 12**

**The significance of the building envelope fire**

**24<sup>th</sup> October 2018**

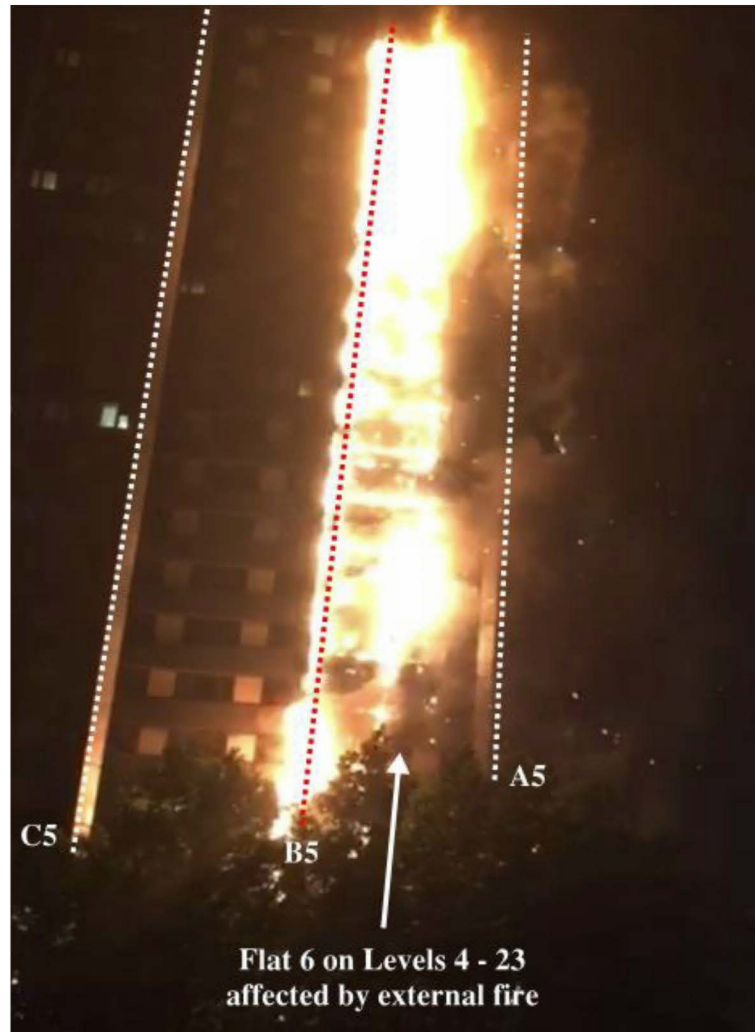
12.3.1 By 01:26, fire affected the external building envelope outside “Flat 6” from Level 4 through Level 23, as shown in Figure 12.6.

Figure 12.6: Flat 6 on Levels 4 - 23 affected by external fire at 01:26 (IWS00000046)

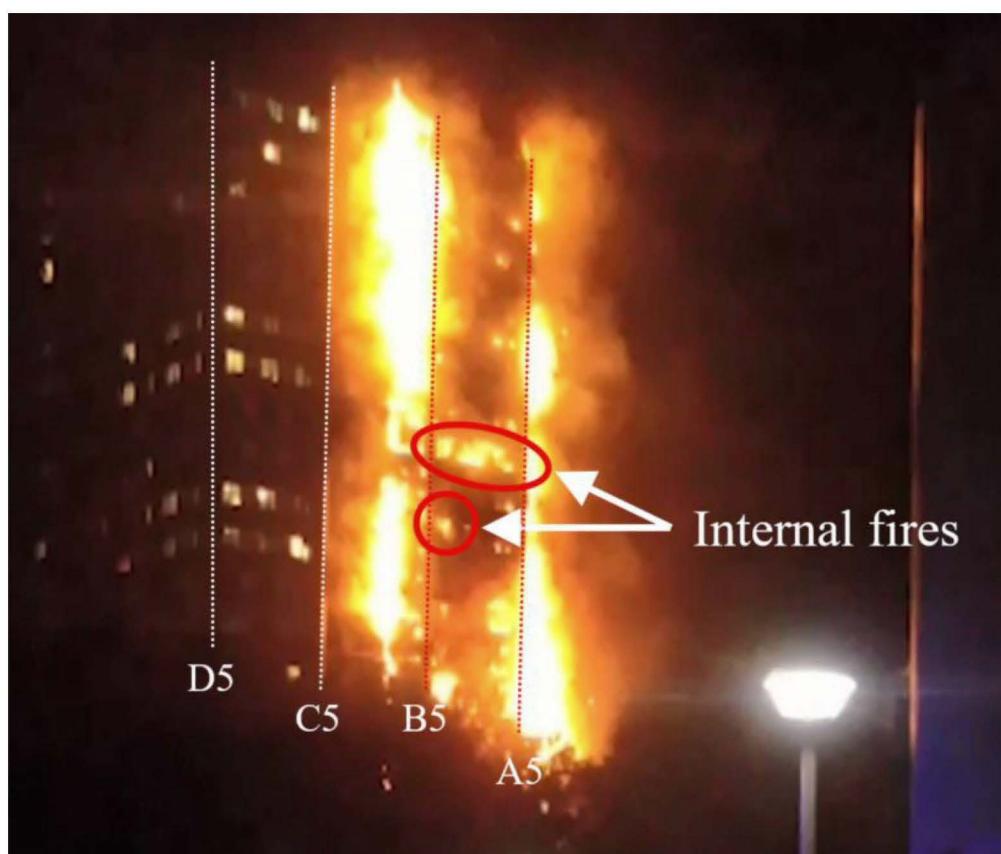
12.3.3 Figure 12.7 shows the earliest photographic evidence I have seen where internal fires are distinguishable, at 01:44.

Figure 12.7: My first observation of internal fires at 01:44 on the East elevation of building envelope (extract from Bisby Video 2 accompanying Luke Bisby's supplemental phase 1 Report)

- 12.2.11** There is evidence of multiple internal fires burning by 01:44 (refer to Figure 12.7), if not as early as 01:36 (see Figure 12.2 below).
- 12.2.12** This exposed more and more residents to the effects of fire and smoke.

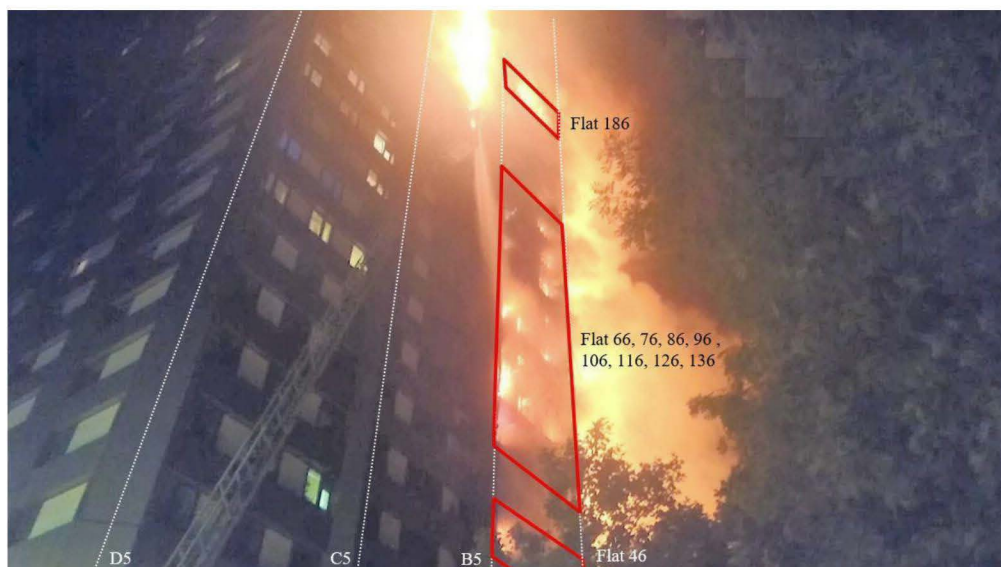
- 12.3.15** Based on the screenshot from a video of the external fire spread on the East elevation shown in Figure 12.10, at least 10 flats (Flats 46, 66, 76, 86, 96, 106, 116, 126, 136, 186) had internal fires by 01:57 (exact time of photograph is not known).

Figure 12.10: Internal fires, photograph of East elevation of building; exact time between 01:43 and 01:57 not known (extract from Video 2 accompanying Luke Bisby's supplemental phase 1 Report)

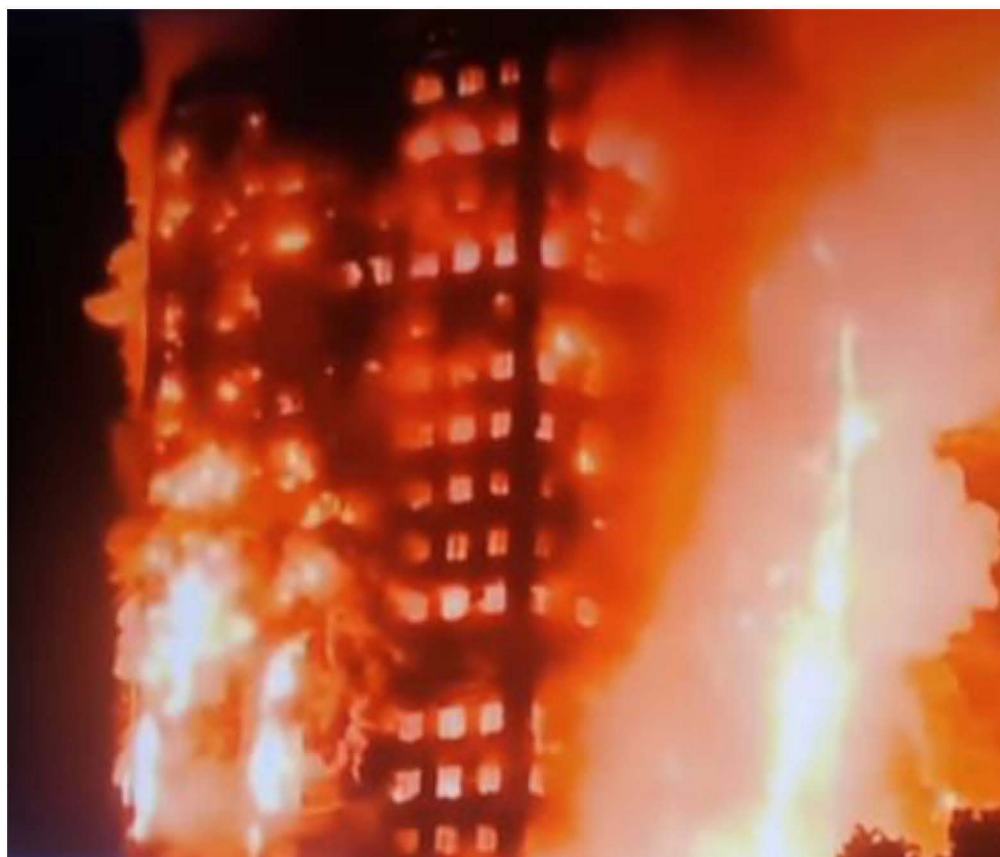
- 12.3.18** As the flame front spread across each elevation of the building envelope, an increasing number of internal flat fires were observed in its trail, as shown in Figure 12.12.13 through Figure 12.15 inclusive.
- 12.3.19** While it is difficult to identify the exact number of internal flat fires precisely, based on quality of these photographs, it is clear that internal fires burned in multiple flats on multiple elevations and compartmentation was breached in several locations. For example, Figure 12.12 shows the fire conditions on the East and North elevations of the building at 03:01. I calculate there are at least 16 internal flashover fires in this photograph. Based on my analysis, 61 flats were affected by the flame fronts by this time (Refer to Table 12.1 and Figure 12.3) and there were 106 occupants remaining in the building.

Figure 12.12: Internal and external fires on East elevation (left) and North elevation (right) at 03:01 on 14 June 2017; 106 number of people still in building at this time<sup>3</sup>

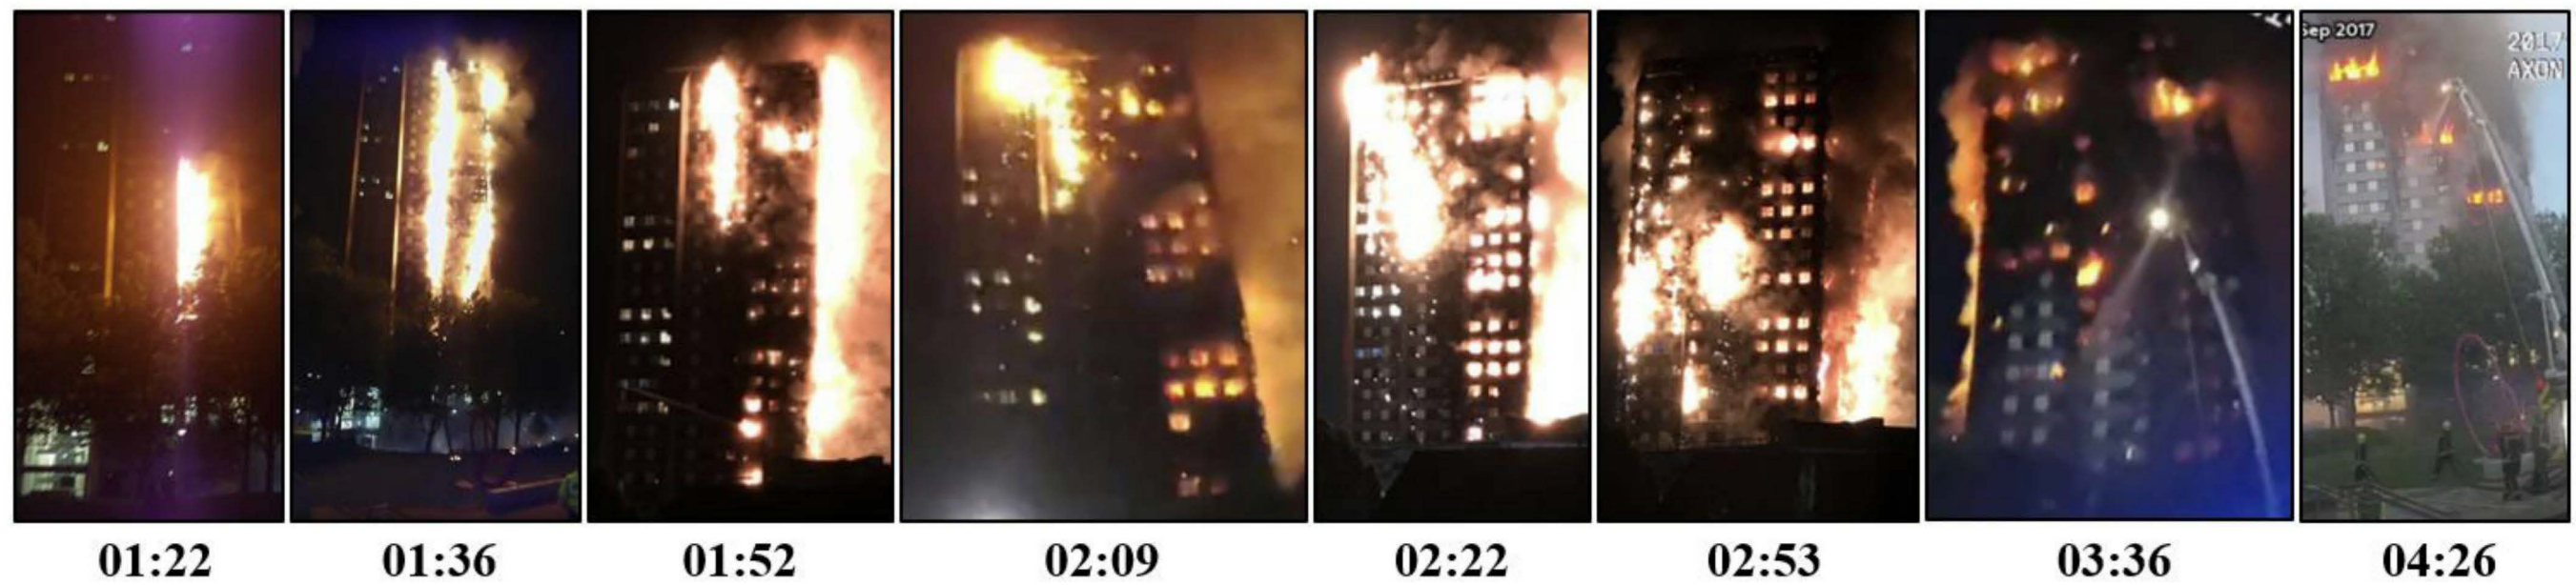
Figure 12.12.13: External flame front on East elevation of building envelope and increasing numbers of internal fires on East building elevation, between 01:22 and 04:26 (MET00012593) <sup>4</sup>

- 12.1.20** A critical consequence was the contribution the external fire made to creating multiple internal fires. Based on Figure 12.2, internal fires were visible on at least 4 no. storeys by 01:52, and these progressed around the building – refer to the series for each elevation in Figure 12.12.13 through Figure 12.15 inclusive.

- 12.3.24 There is evidence of flats affected by smoke as early as 01:20 (MET00012593) and evidence of multiple internal fires by 01:40 (Table 12.2).
- 12.3.25 These internal fires were also continuing to spread – refer to Figure 12.12.13 for photographs showing a significant number of internal fires on the East elevation of the building between 02:22 and 02:53. And I also provide a series for every elevation in Figure 12.12.13 through Figure 12.15 inclusive.

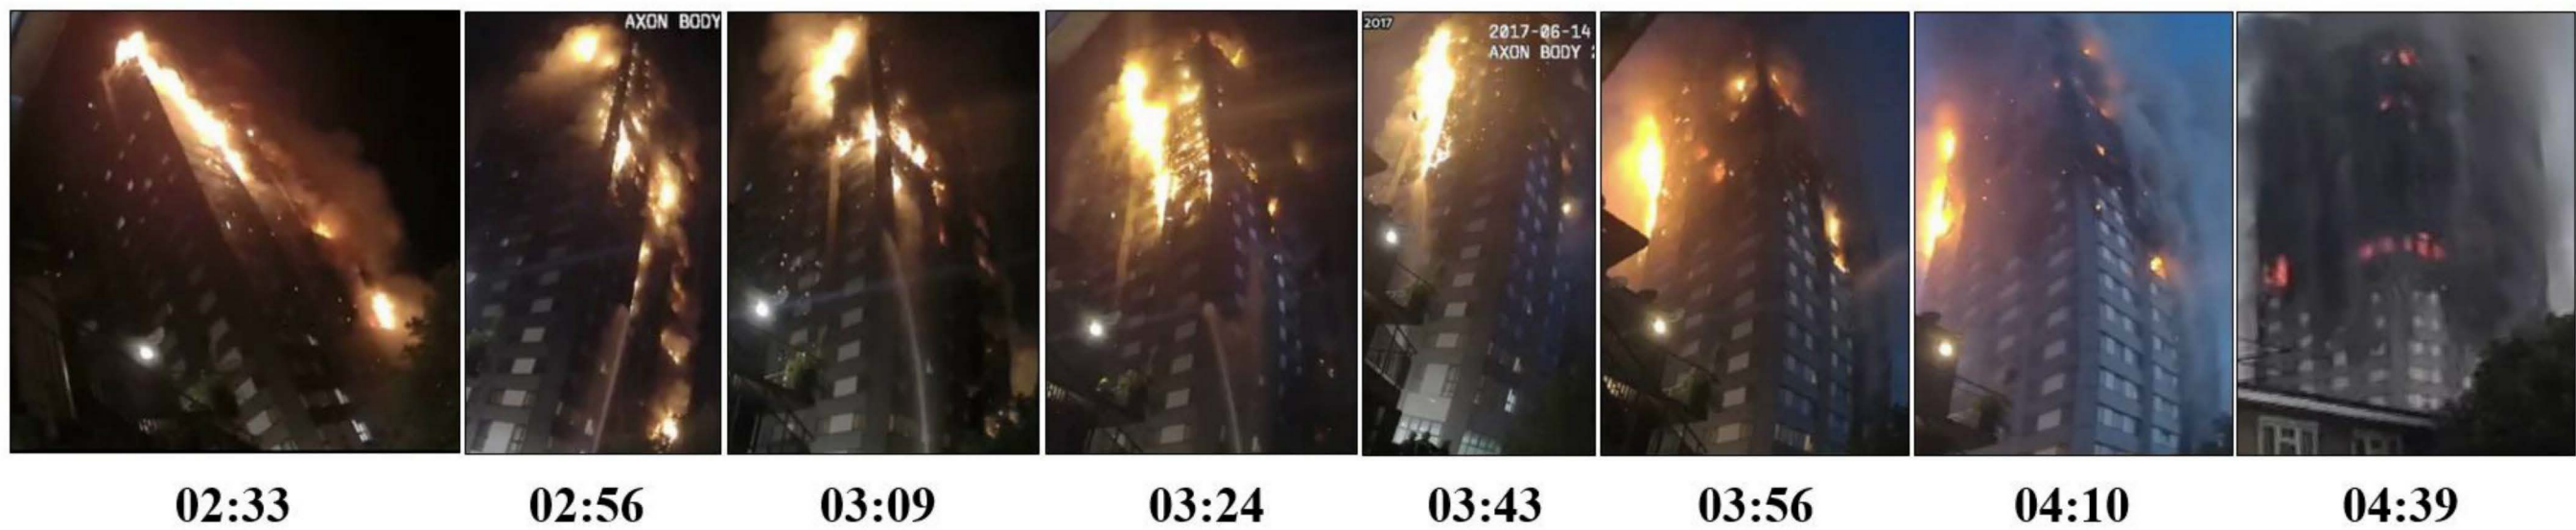
Figure 12.15: External flame front on South elevation (left) and East elevation (right) of building envelope and increasing numbers of internal fires on both building elevations, between 02:33 and 04:39 (MET00012593)

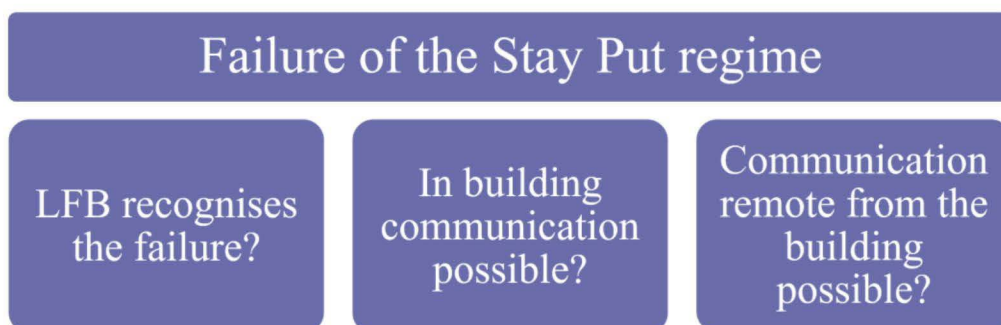
Figure 12.17: Diagram demonstrating the investigations required due to the failure of the Stay Put regime

- 12.4.4** Please refer to Figure 12.17 and Figure 12.18 for diagrams demonstrating the investigations required into the failures of the Stay Put regime and the Defend in Place regime at Grenfell Tower.
