**APPENDIX A12**

**EXHIBIT SCM/1: BELIEVED CAPACITOR (MELTED)**

**EXHIBIT MJD/61: WIRING FROM WALL TO LEFT OF SINK**

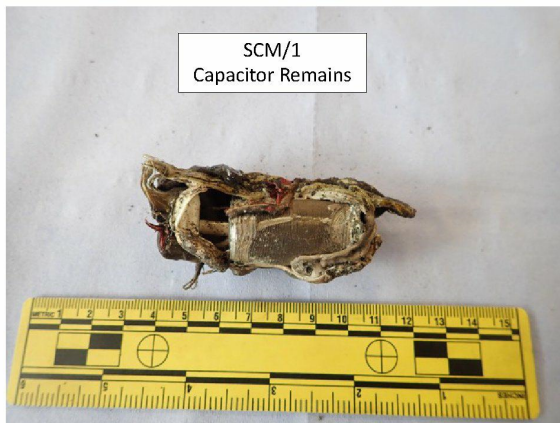
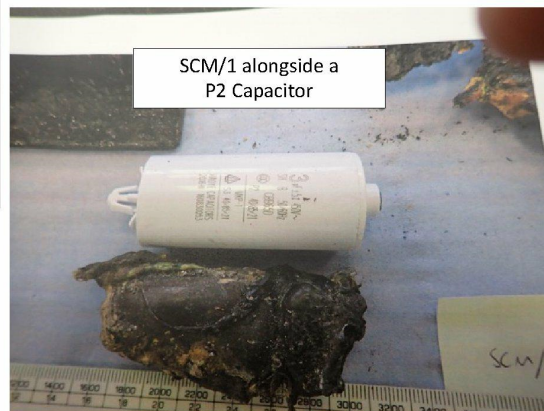
**Figure A12-1: SCM/1 – Capacitor Remains [J.D. Glover Photo – 26 September 2018]**

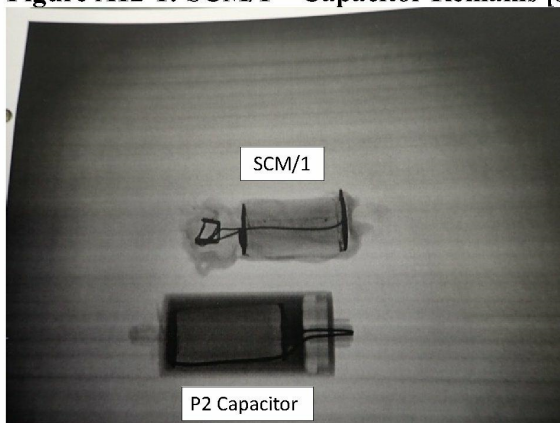
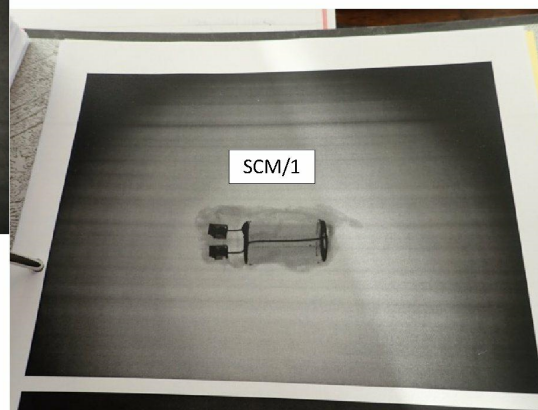
**Figure A12-2: X-Rays of SCM/1 and P2 Capacitor [J.D. Glover Photo – 21 September 2018]**

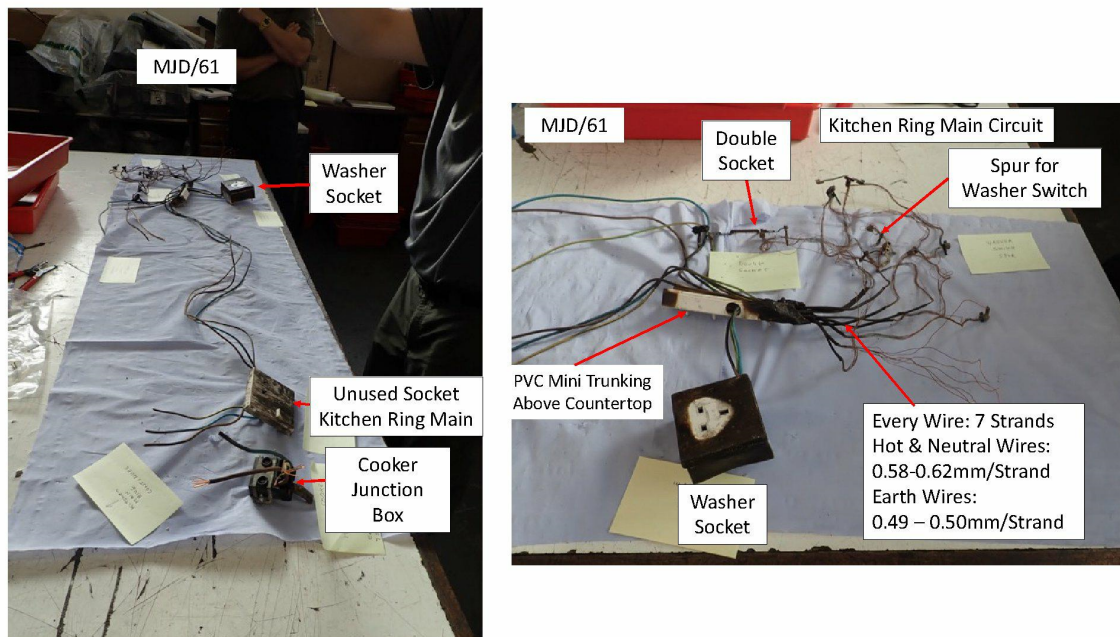
**Figure A12-3: MJD/61: Wiring from Wall to Left of Sink [J.D. Glover Photo – 21 September 2018]**
