3.1 Initiation of the fire event

3.2 Fire breakout

3.3 Interaction with the external envelope

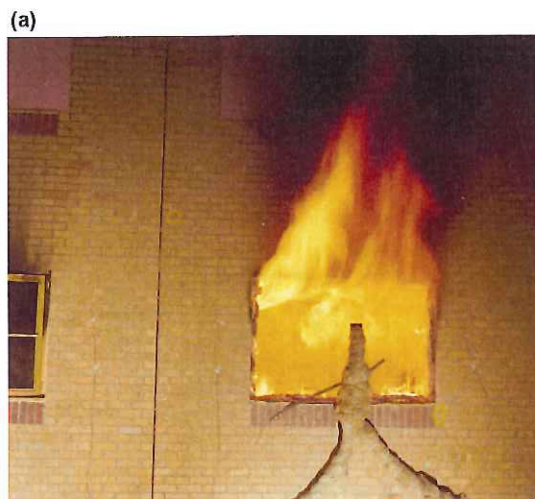
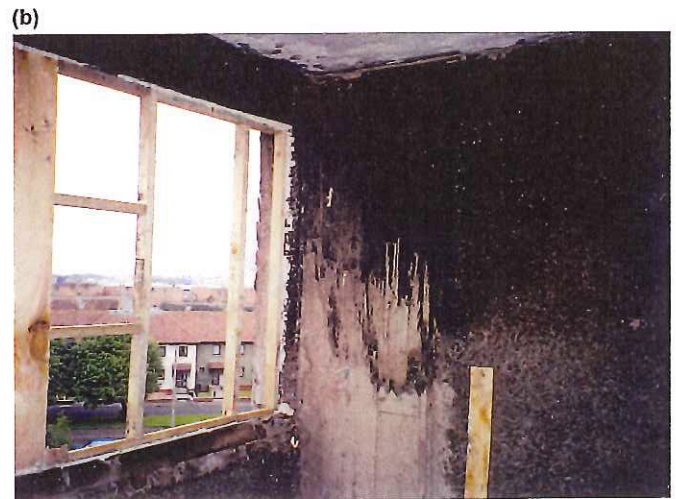
Figure 4: (a) Fire breakout from a post-flashover room on a masonry facade, (b) result of the flashover

Following the initiation of a fire inside the building, if no intervention occurs, the fire may develop to flashover and break out from the room of origin through a window opening or doorway (Figure 4). Flames breaking out of a building from a post-flashover fire will typically extend 2 m above the top of the opening prior to any involvement of the external face, and this is therefore independent of the material used to construct the outer face of the building envelope (eg Figures 4 and 5).
