Grenfell Tower – fire safety investigation:
The fire protection measures in place on the night of the fire, and conclusions as to:
the extent to which they failed to control the spread of fire and smoke;
the extent to which they contributed to the speed at which the fire spread.

**Phase 1 Report – Master file
incorporating Section 1, 2,3 and 4
&
Summary, Conclusions and Next Steps**

Dr Barbara Lane FREng CEng

12th April 2018

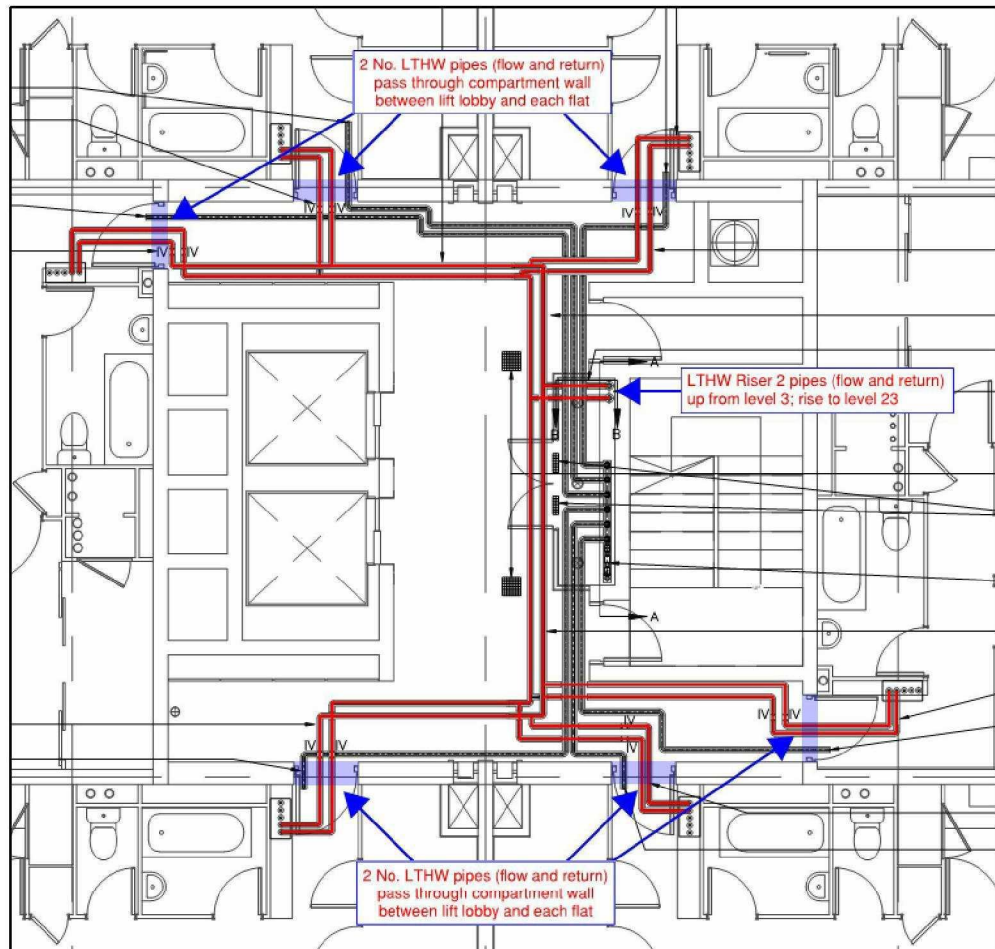
Figure 4.22: LTHW lateral distribution piping through typical residential level common lobby (RYD00000577)

- 4.7.51 On the Studio E Employers Requirements and As-Built drawings the new cupboards were not identified as requiring to be made of fire resisting construction, in contrast to the new partitions being introduced on Levels 1, 2 and 3. Therefore, there is no evidence that the cupboards on levels 4 – 23 were specified to be made of fire resisting construction.

- 4.7.52 On each level from level 4 – 23, the LTHW pipes leave the riser cupboard and distribute laterally through the common lobby to each flat. As shown in Figure 4.22, a flow and return pipe enters each flat above the flat entrance door (RYD00000577).

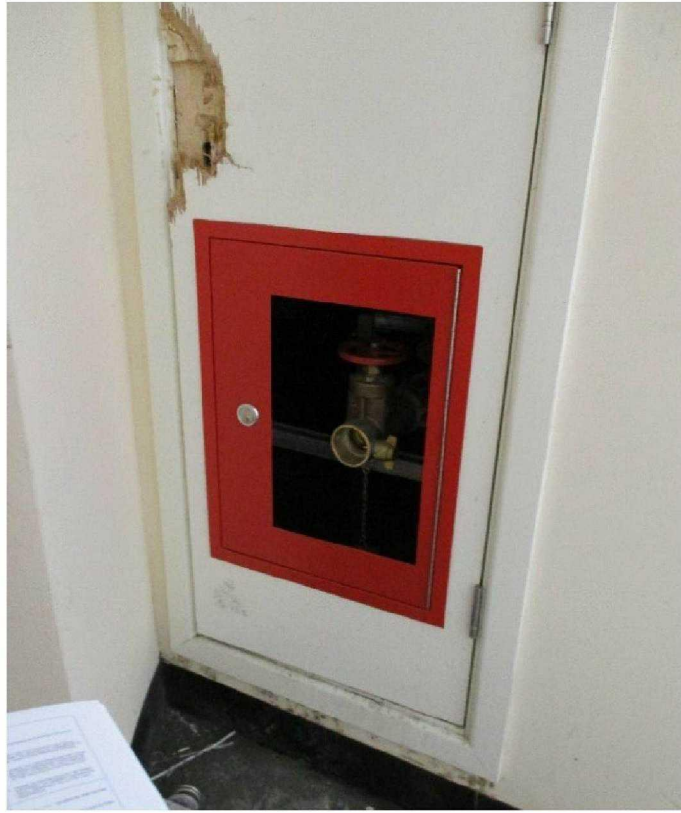
Figure 4.32: Example new dry rising fire main outlet at Level 2

4.7.134 A schematic of these modifications is shown in Figure 4.33 (RYD00000577). The revised outlet location on Level 2 is indicated in Figure 4.34, with a photograph of it from my post fire inspection provided in Figure 4.32.

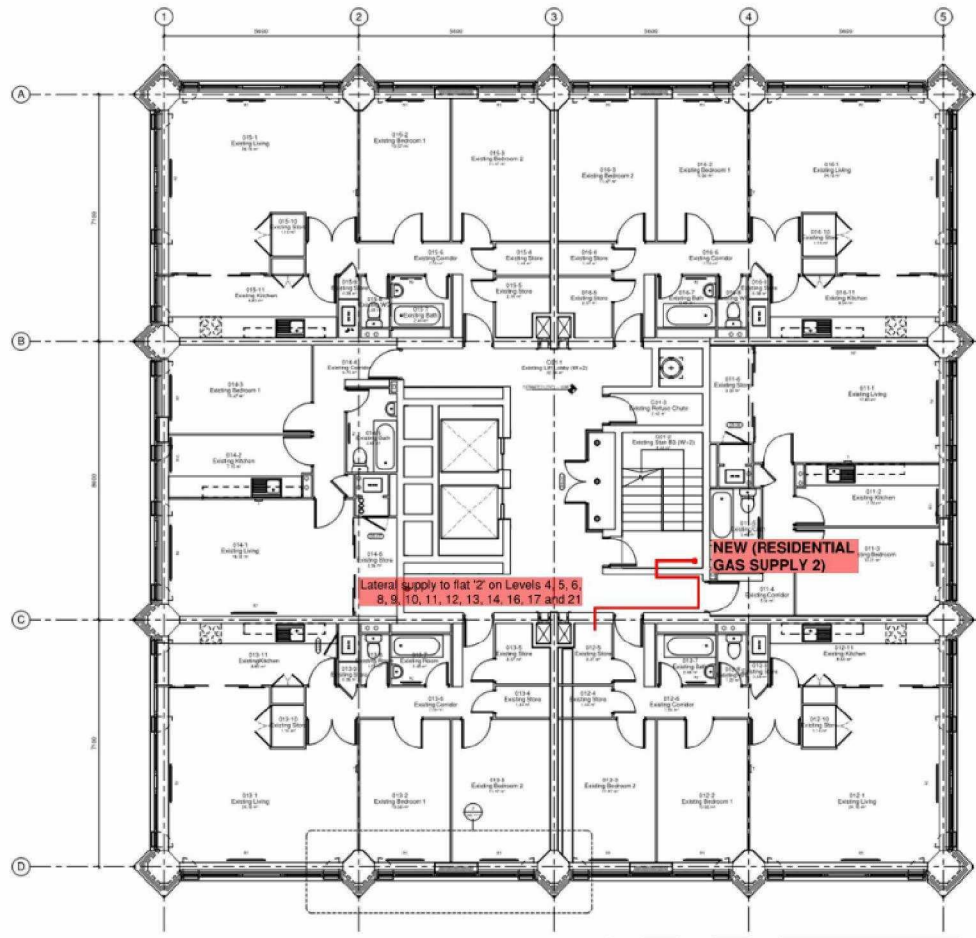
Figure 4.38: Gas works on typical residential level (SEA00010474)

4.7.154 At the abovementioned levels, a lateral gas pipe passes out through the stair wall across the lobby at ceiling level and enters flat '2' at the right-hand side of the flat entrance, as shown in Figure 4.38. This pipe is also shown in outside Flat 12.

4.7.155 Within the stair the riser was enclosed in construction that was complete from levels 4 to 22 at the time of the fire on 14 June 2017, but was not fully enclosed to the roof vent. The construction separating the lateral distribution pipes on each of the floors (where provided) was not installed at the time of the fire. As described in Appendix K, the fire resistance performance of the enclosing construction is currently unknown.

4.7.156 The arrangements for ventilation of the enclosure to the riser within the protected stair were not complete at the time of the fire on 14 June 2017.

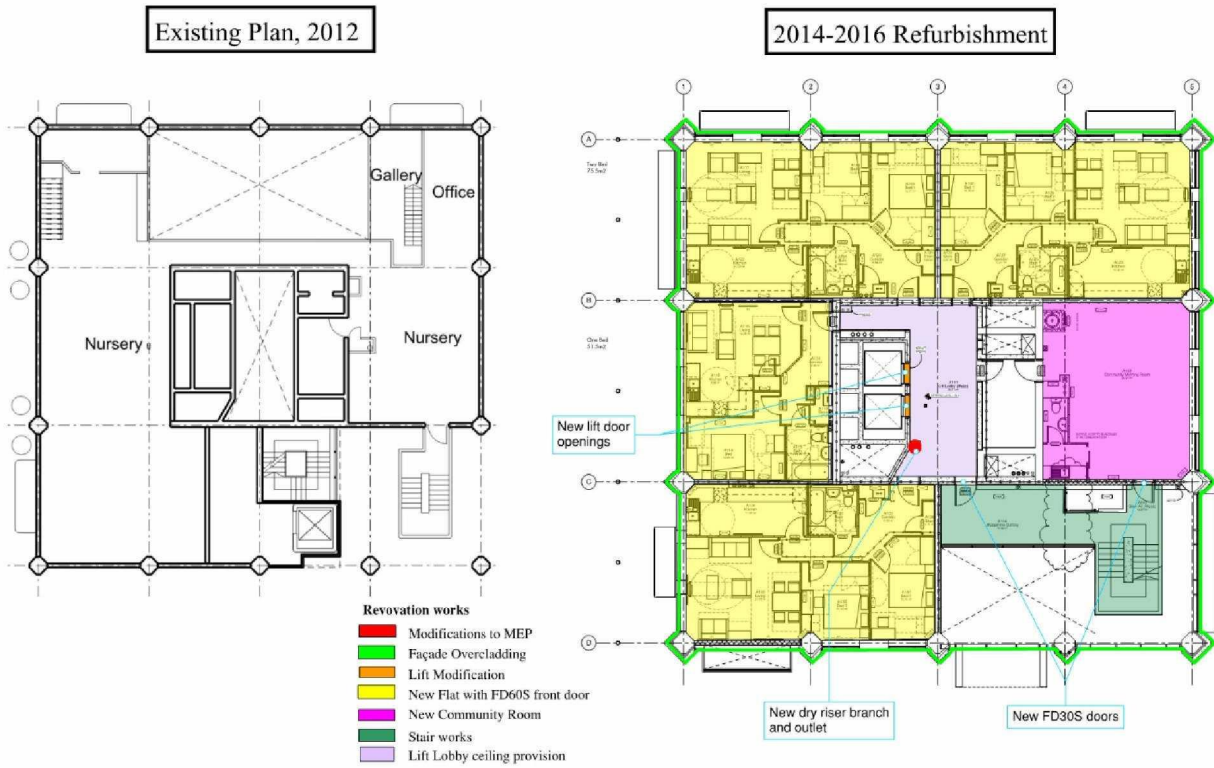
Figure 4.41: Level 1 – refurbishment plan and existing 2012 plan (MAX00000879, SEA00003231)

- 4.7.19 These changes are reflected in the Studio E As-Built drawings as indicated in Figure 4.41.
- 4.7.20 These changes also involved the installation of new services and connections for hot and cold water and for heating.
