**Grenfell Tower – fire safety investigation:
The fire protection measures in place on the night of the fire, and conclusions as to:**

**The extent to which they failed to control the spread of fire and smoke;
The extent to which they contributed to the speed at which the fire spread.**

Phase 1 Report – Section 9

Dr Barbara Lane FREng FRSE CEng

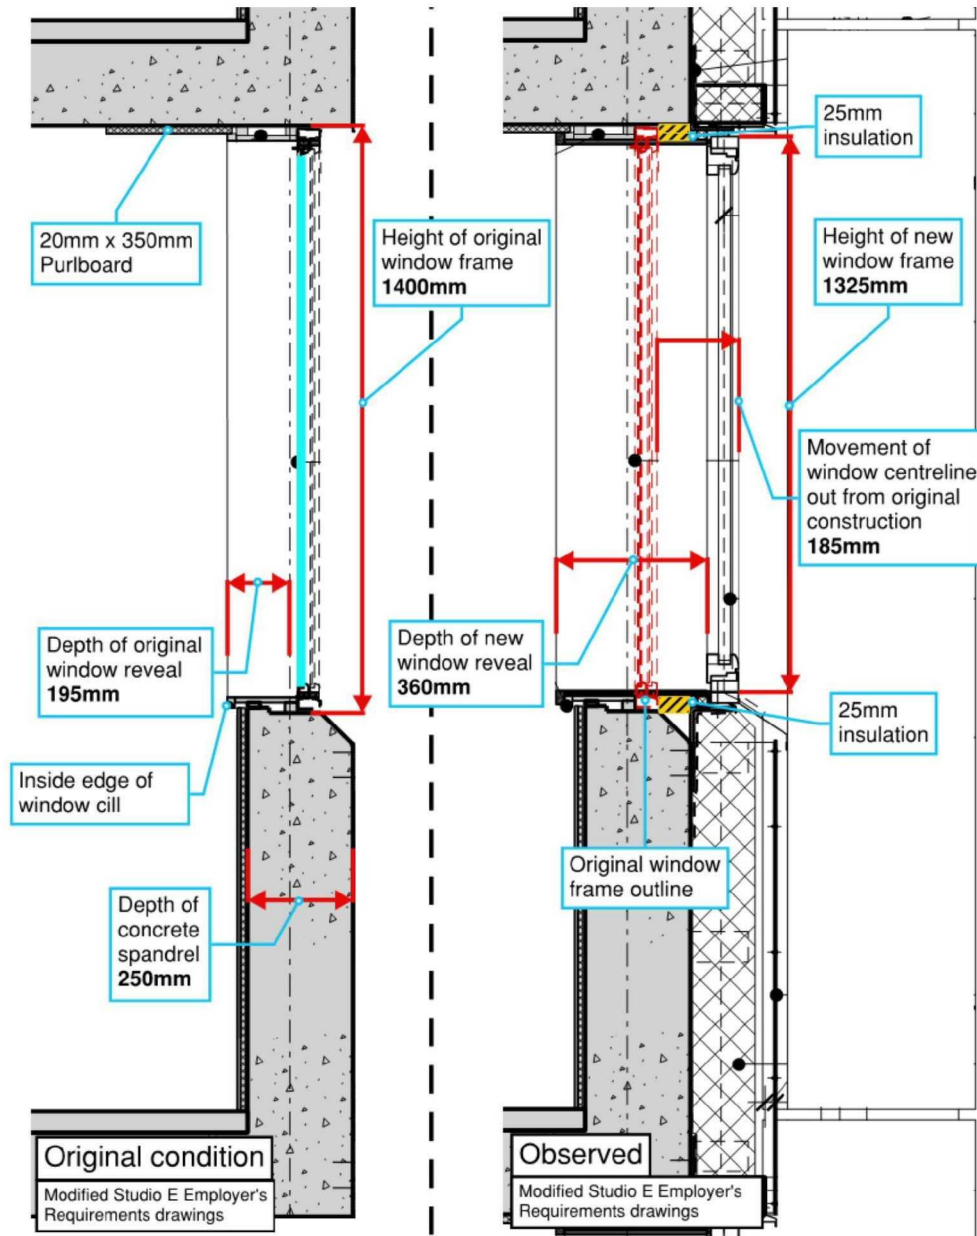
Figure 9.6: Vertical section view of original [left] and post refurbishment [right] window openings (Based on SEA00013045)

9.2.12 I have reproduced Figure 8.3 from Section 8 here (Figure 9.6 below) as a reminder of the location of the new window, relative to both the old and new external wall, and this is the reason for the creation of these cavities, in behind the window reveal linings.

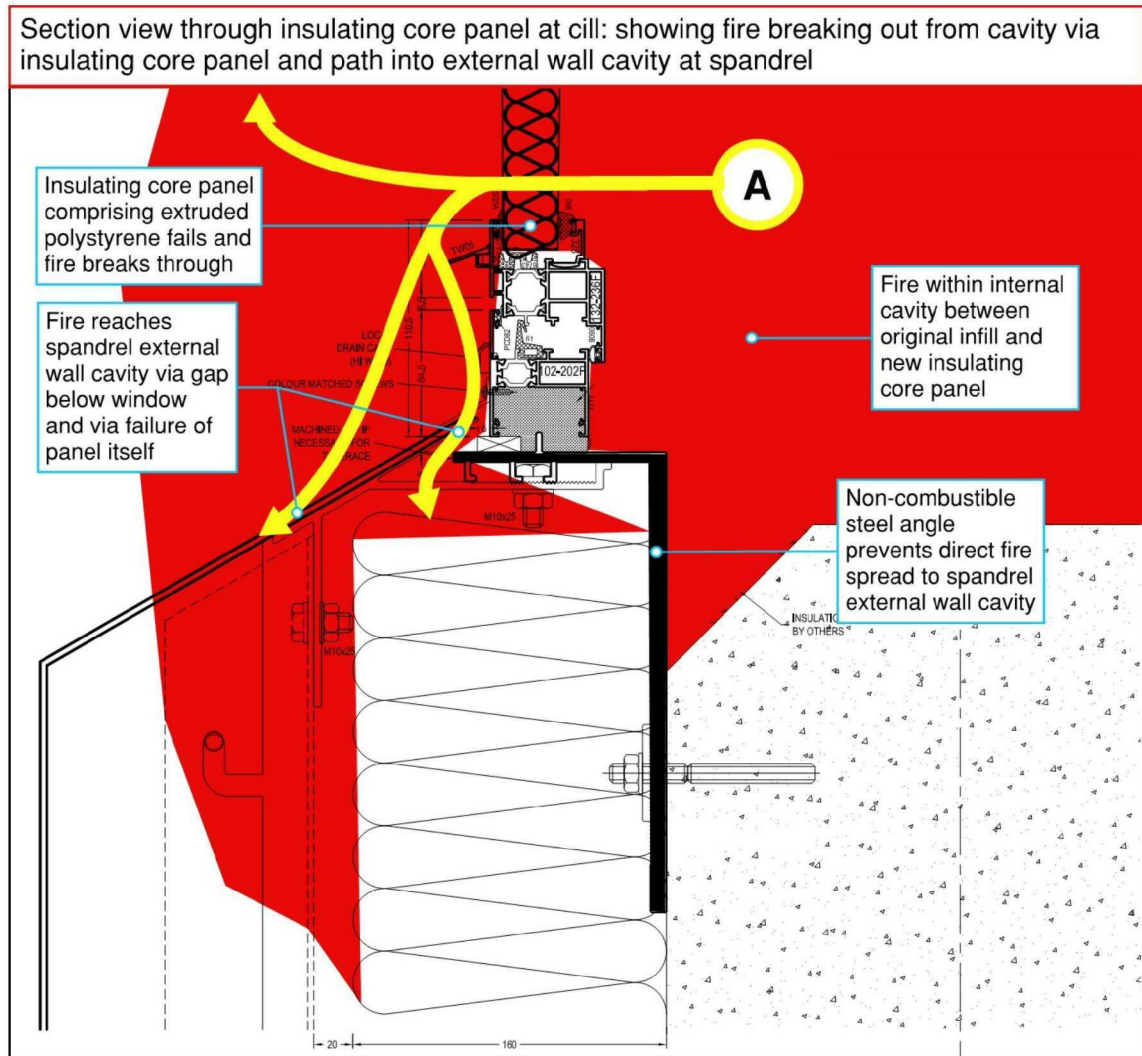
Figure 9.12: Diagram of route A also showing further route into external wall cavity on spandrel panel at cill of window (HAR00008879)

9.3.11 Figure 9.12 shows the ACP cassette where it is folded in towards the insulating core panel, below the window at cill level.

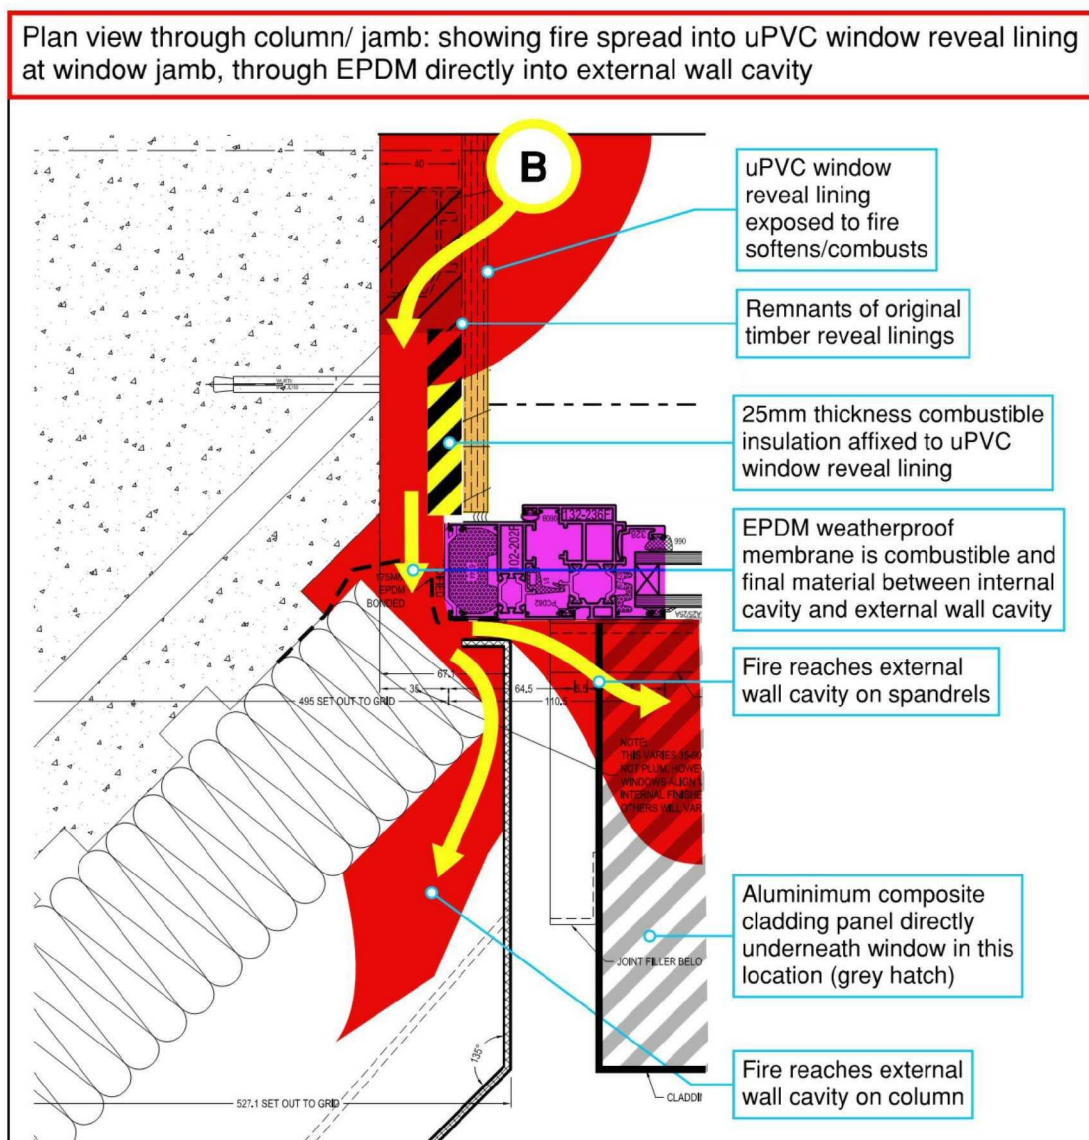
Figure 9.14: Diagram of route B originating from a localised fire adjacent to window jamb (HAR00008902).

9.3.15 In Figure 9.14 I have illustrated the route of fire spread from a localised fire at or near the column side of the window and the external wall column cavity.

9.3.16 In this position, radiative heat, hot gases or burning particles from the fire could impinge on the vertical materials lining the window jamb. First the uPVC surface lining, then the 25mm combustible insulation affixed to the underside of the uPVC and the retained timber batons from the original window frames.

9.3.17 Once the fire is within the vertical cavity behind the window jamb it can spread directly to the column external wall cavity through the combustible EPDM weatherproof membrane?

9.4.7 The horizontal section diagram through the column-window jamb featured in Figure 9.14 (route B) shows the same route, which allows the fire to break back into the flat by reversing the direction of the arrows. In the event of a fire in the building envelope around a column, the only material separating the interior of the flat from the façade cavity is a thin layer of combustible EPDM (behind the window reveal lining).

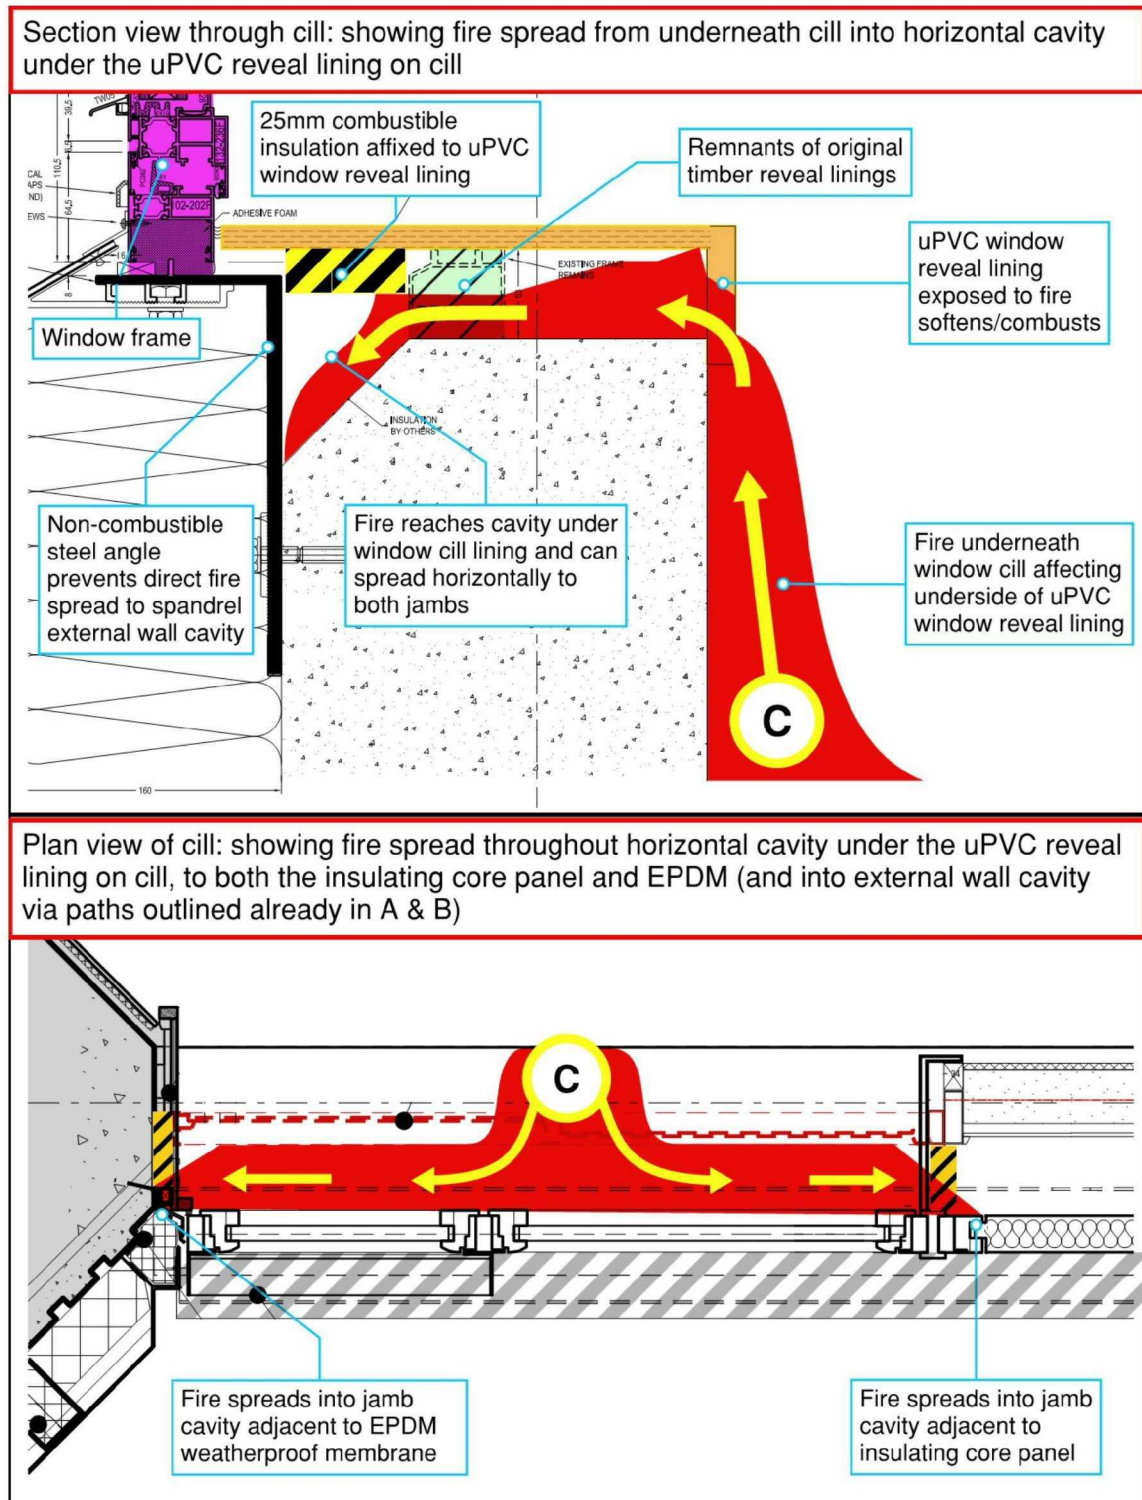
Figure 9.15: Diagram of route C (in two parts) originating from a localised fire underneath cill and spreading into cill internal cavity, with onward spread to behind both jambs and using the remainder of routes A & B to reach the external wall cavity (HAR00008879, SEA00013045).

- 9.3.19** In Figure 9.15 I have provided a marked up drawing of the route of fire spread from a fire under or near the window cill into the column cavity of the external wall.

- 9.3.20** In this position radiative heat, hot gases and/or burning particles from the fire could impinge directly upon the combustible materials of the window cill. First the uPVC surface lining, then the 25mm combustible insulation affixed to the underside of the uPVC surface lining. Any gaps between the uPVC surface lining and horizontal wall would increase in size.

- 9.3.22** If the fire spread laterally along the cavity beneath the window cill towards the column it could then spread through the combustible EPDM to the column external wall cavity. (Figure 9.15)

- 9.3.24** As per route A, once failure of the insulating core panel occurs the fire can spread into the external wall cavity on the spandrel above, and below. This route is illustrated in Figure 9.15.

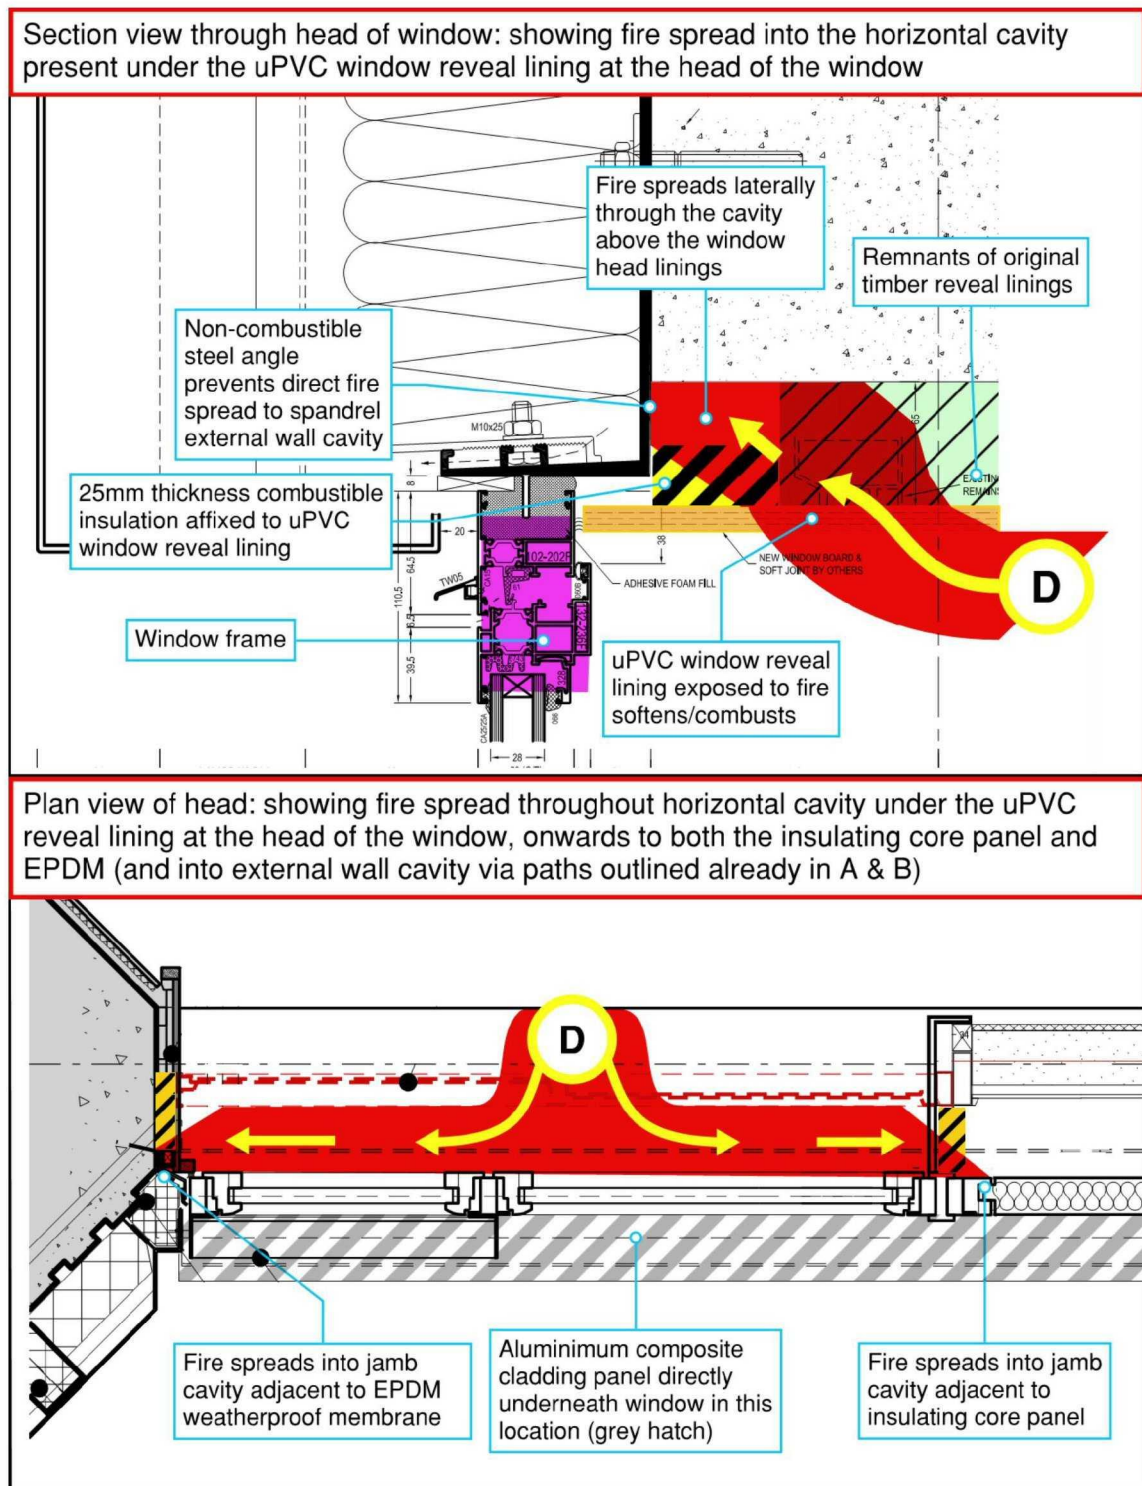
Figure 9.16: Diagram of route D (in two parts) originating from a localised fire on or adjacent to cill, or from a fire remote to window with ceiling plume. Onward spread to behind both jambs and using the remainder of routes A & B to reach the external wall cavity. (HAR00008901, SEA00013045).

9.3.26 In Figure 9.16 I have illustrated the route of fire spread where a localised fire is at or near the head of the window and travels to the column external wall cavity. In this position radiative heat, hot gases or burning particles from the fire could impinge on the horizontal materials lining the window jamb. First the uPVC surface lining, then the 25mm combustible insulation affixed to the underside of the uPVC.

9.3.27 Additionally, the original construction of the building included a section of “Purlboard” as a filler strip between the original head reveal lining and the concrete ceiling soffit. This material consists of a layer of plasterboard with a combustible fronting. This provides further combustible material, within the flat, that would promote rapid fire spread near the window head reveal lining.

9.3.28 As for a localised fire at or adjacent to the window cill, once a fire is within the window head cavity, it is separated from the external wall cavity by a non-combustible steel shelf angle. The fire must therefore spread laterally towards either the column or the new insulating core panels. Once the fire is in the head cavity it could spread laterally along the cavity until it reaches the EPDM weatherproof membrane at either the column jamb or the XPS filled insulating core panel located between the windows.

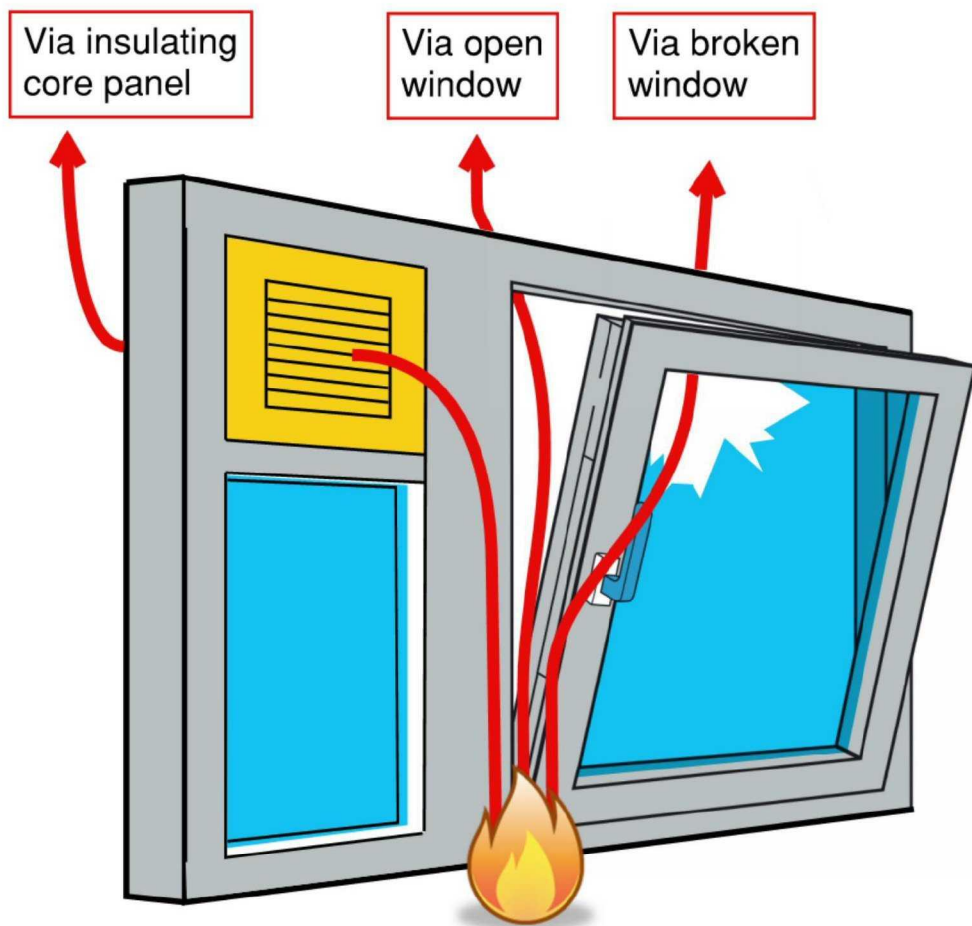
Figure 9.17: Routes for fire spread directly through a window

9.3.31 As displayed in Figure 9.17 there are three ways a fire could break out of the flat via the window directly:

- a) Via the combustible insulating core panel in the window that houses the ventilation fan for the kitchen;
- b) Via an open window;
- c) Via broken glazing in the window.

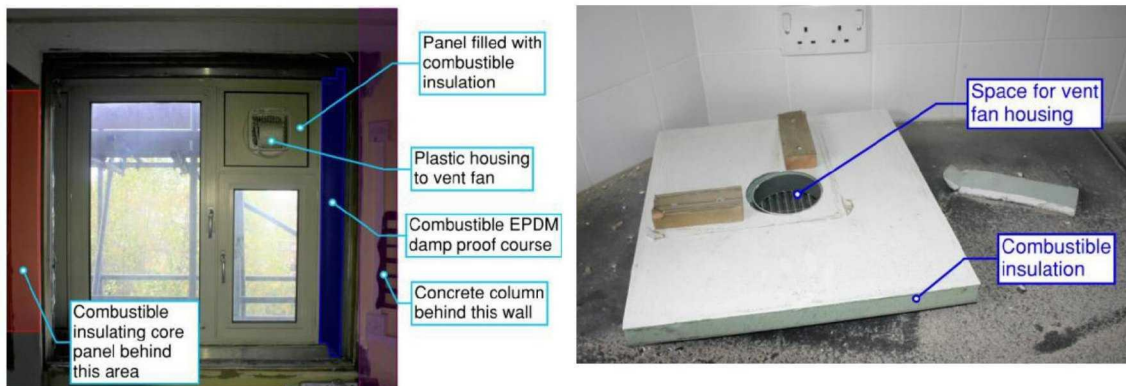
Figure 9.18: (a) Example kitchen window from Flat 13, (b) Evidence of window insert construction

9.5.7 Flat 46 has the same configuration of the kitchen window as flat 16, and Figure 9.18, thus the ‘left hand side’ of the window is the side opposite the column and kitchen vent insulating core panel. This therefore represents evidence in support of route A, fire spreading via the window reveal lining covering the cavity between the infill panel and insulating core panel.

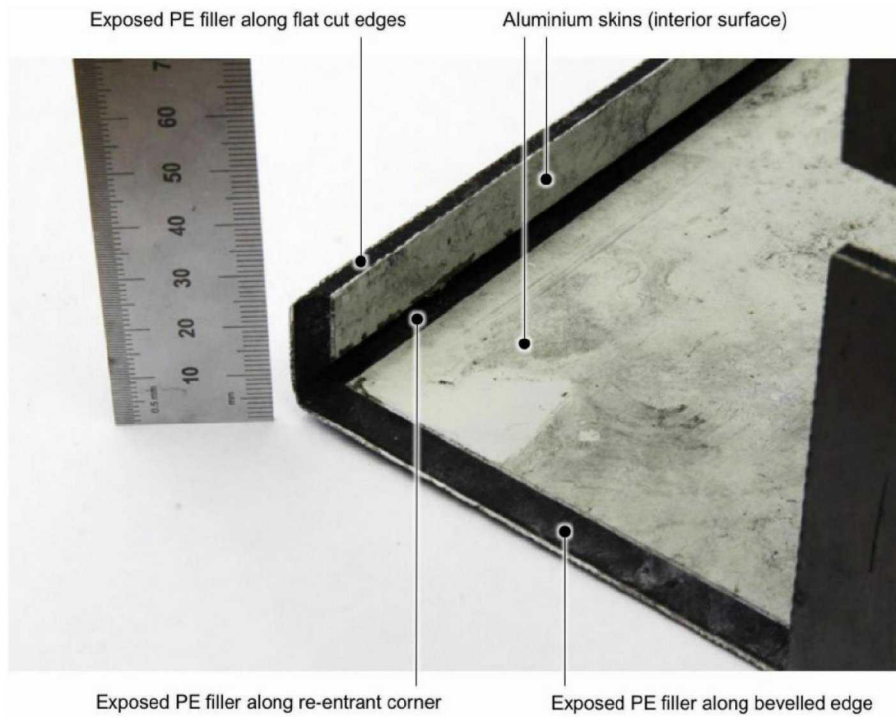
Figure 9.20: Prof. Bisby's phase 1 report, figure 20 showing photograph of spandrel cladding panel sample provided by MPS

9.3.33 The polyethylene core was exposed along the sides of the panels in this location, as indicated by Figure 9.20. My onsite observations confirm it was exposed and also that it had melted, as shown in Figure 9.21:

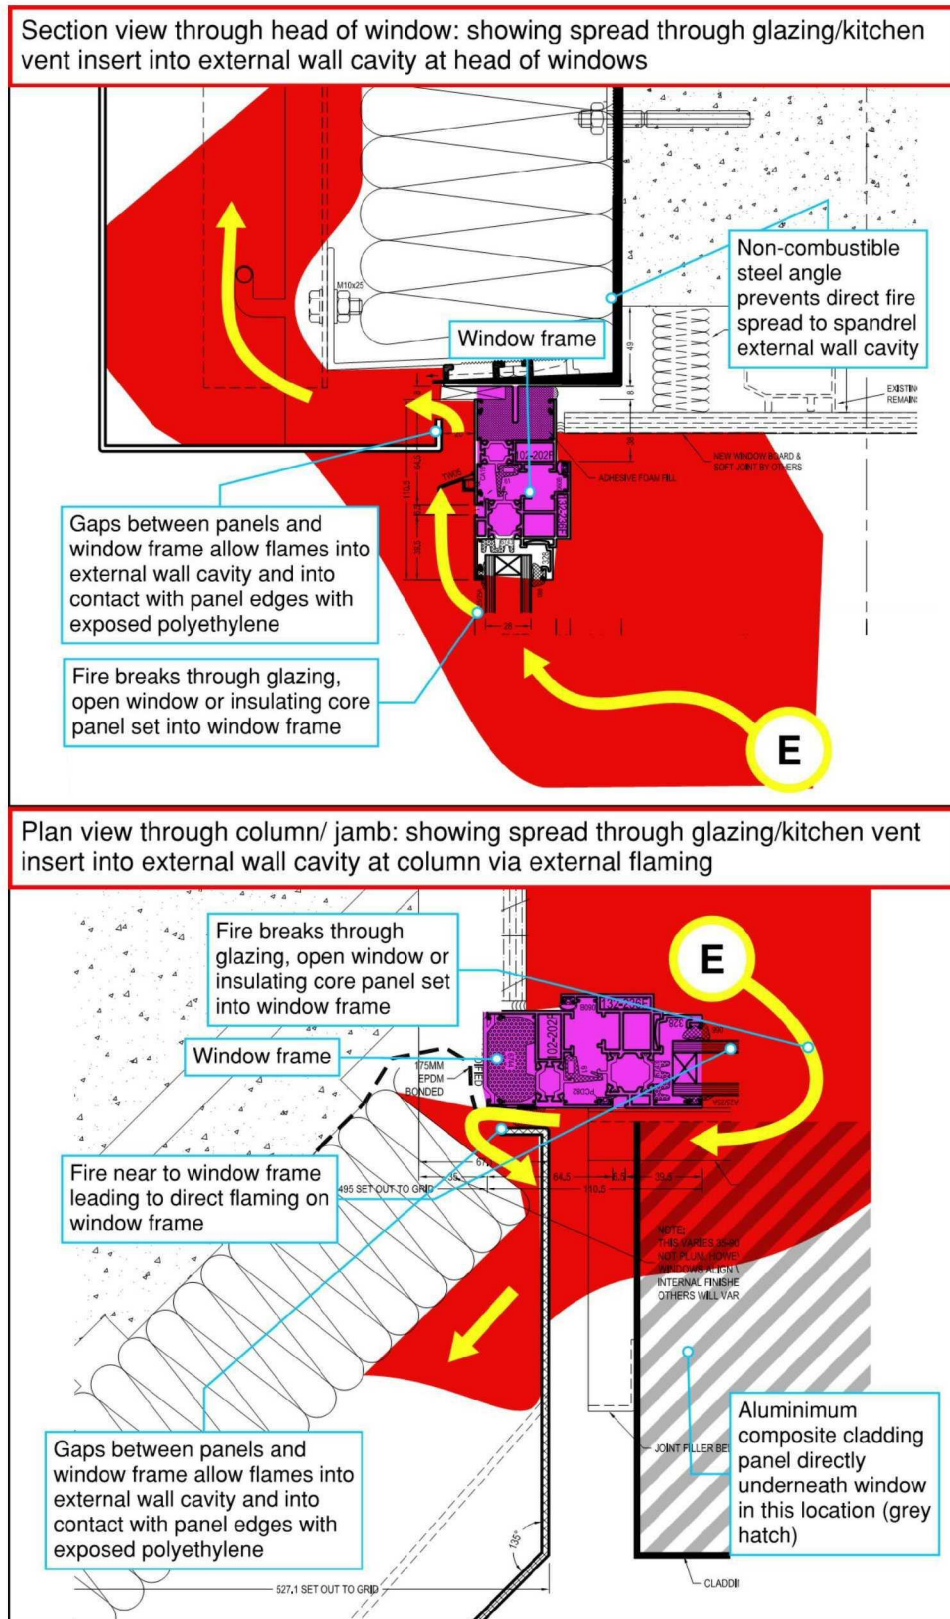
Figure 9.22: Diagram of route E originating from a localised fire on or adjacent to cill, or from a fire remote to window with ceiling plume. External flaming resulting

Once flames from the fire are able to penetrate the window by any one of the three scenarios described above, the heat and smoke from the fire could impinge directly on the ACP overlapping on the vertical column and also on the ACP overlapping located above and below the window. Flames can enter both the horizontal and vertical rainscreen cavities through ventilation gaps between the aluminium composite rainscreen panels (Figure 9.22) and also cause ignition of the exposed PE core, shown in Figure 9.19.

in fire spread to the external wall cavity at both the column (above) and the head of the window (below) (HAR00008901, HAR00008902).

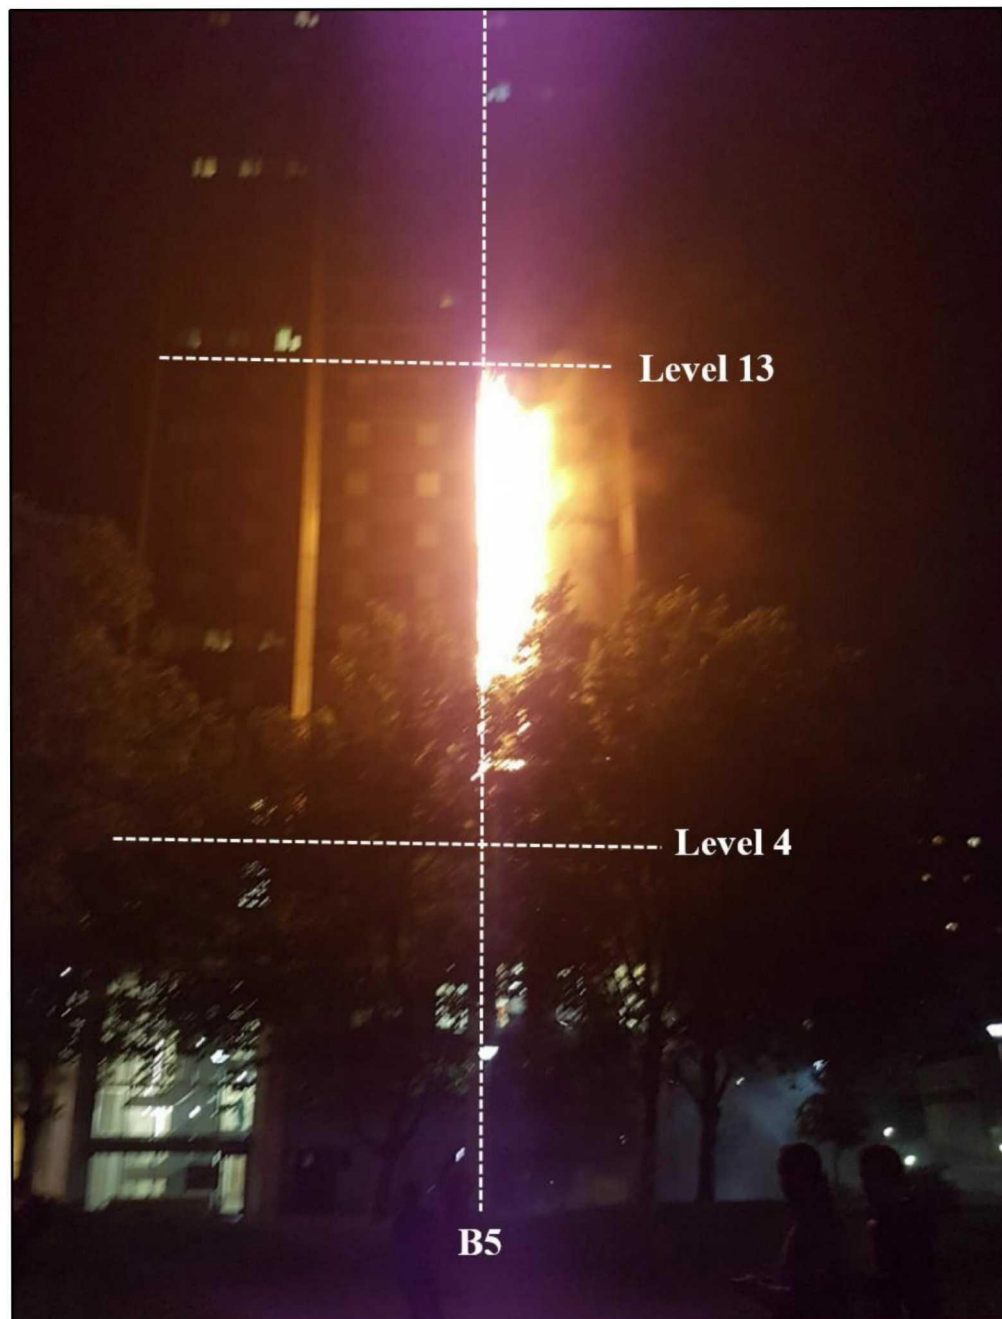
Figure 9.23: Evidence of flame spread up column at 01:22 (approx)¹

9.4.6 As I have explained in Section 5 of my report, there was rapid flame spread observed up the columns of Grenfell Tower on the 14th June 2017. Figure 9.23 is replicated from Section 5 to visualise this spread.

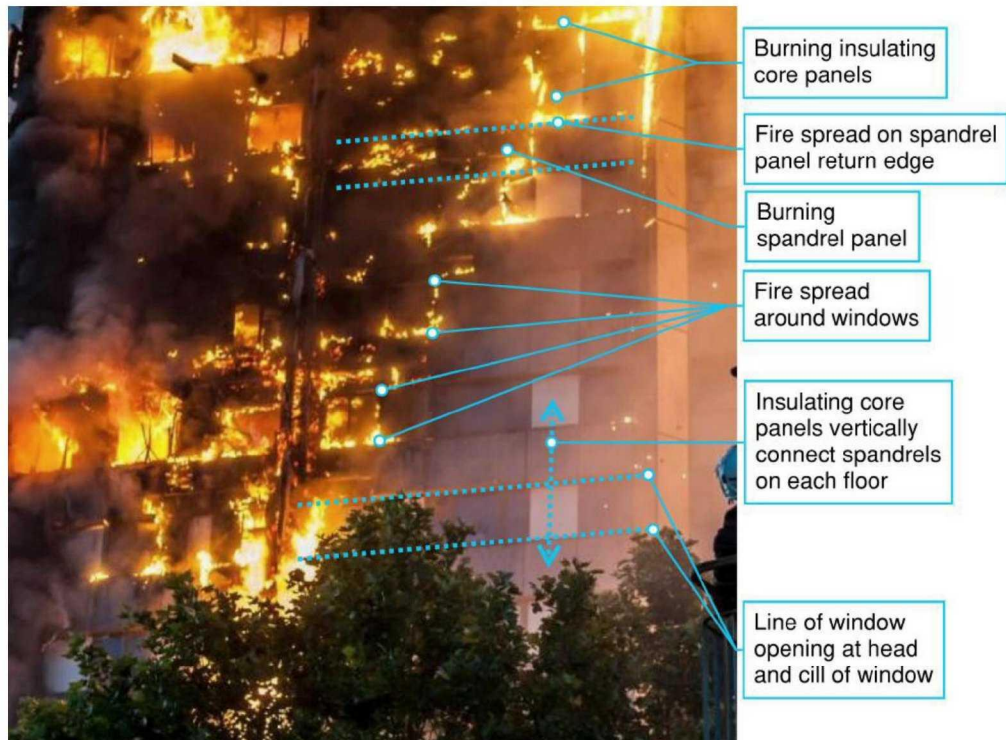
Figure 9.25: Example of Pathway C (replicated from Section 10)⁴

9.4.16 Figure 9.25 below, presents evidence from the fire on the 14th June 2017 of horizontal fire spread along the head and cills of the windows.

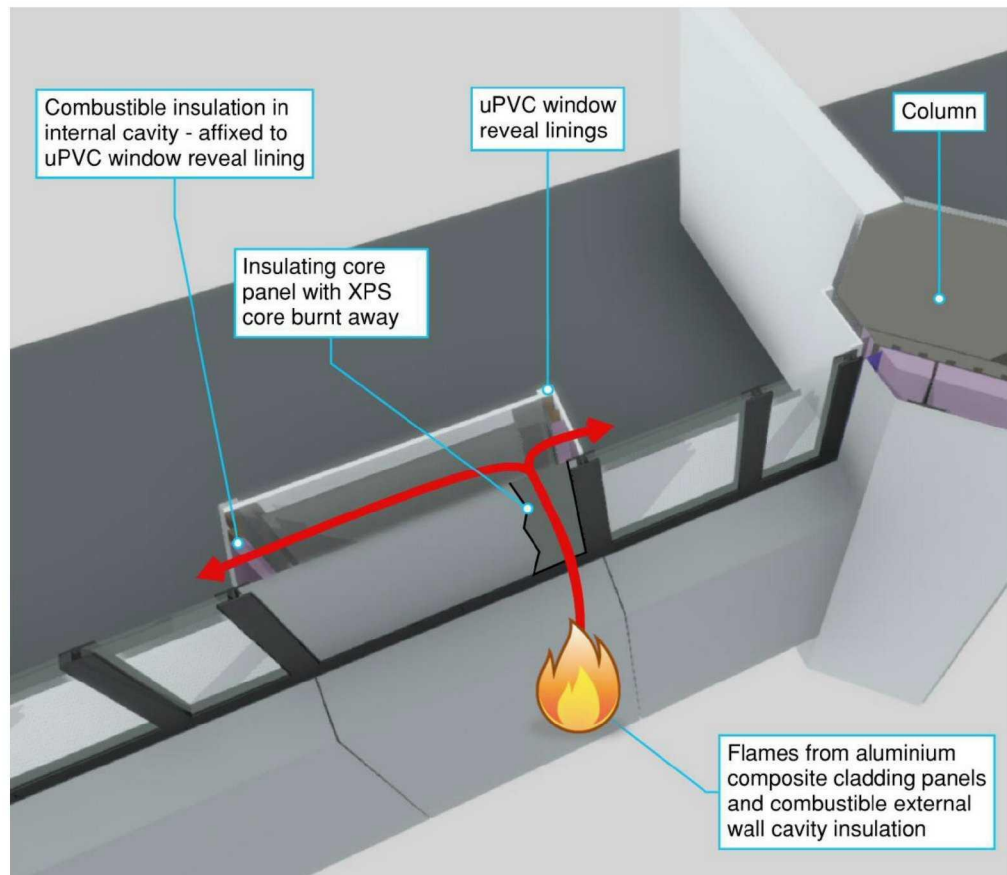
Figure 9.27: 3D model indicating routes of fire spread into flats via combustible seal either side of the new Styrofoam XPS insulating core panels, or via a failed panel itself.

- 9.4.18** What this also means is that the insulating core panel (extruded polystyrene core sandwiched between aluminium skin) is the only material separating the external flames from the spandrel cladding panels and from extending into the network of internal cavities (see Figure 9.25 below).
- 9.4.19** It also provides a route of fire spread back into the flats.

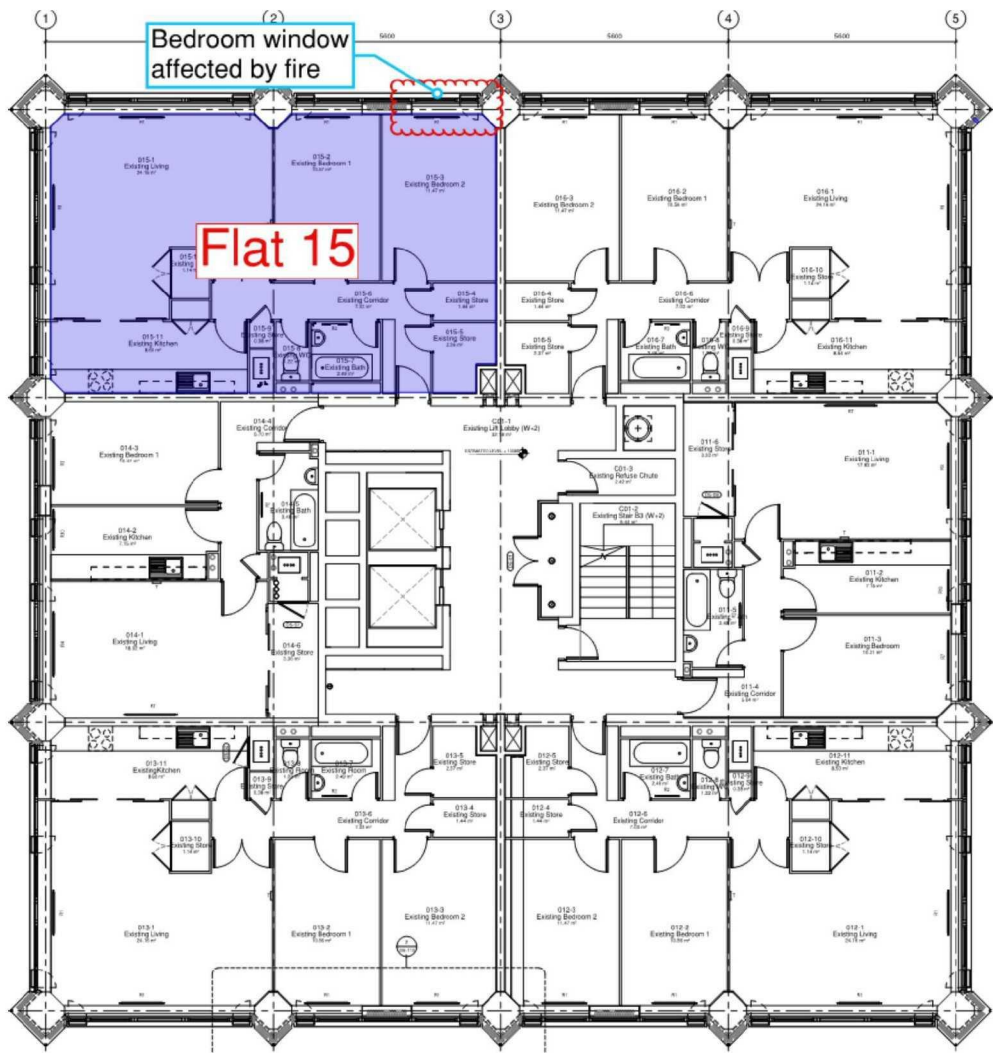
Figure 9.28: Marked up Studio E drawing indicating location of Flat 15, and the window shown in Figure 9.29 (Based on SEA00010474)

9.5.2 In my inspection of Flat 15 on Level 4 (Figure 9.28), I observed that there was a window exhibiting evidence of fire spread from outside the building to the inside, shown in Figure 9.29. The evidence of fire spread showed that the entry route for the fire was in the top corner of the window, adjacent to the column, consistent with the mechanism of fire spread presented in Section 9.4. That is a fire being able to penetrate from outside the building, into the cavity behind the new uPVC reveal linings via the EPDM weatherproof membrane (route B).

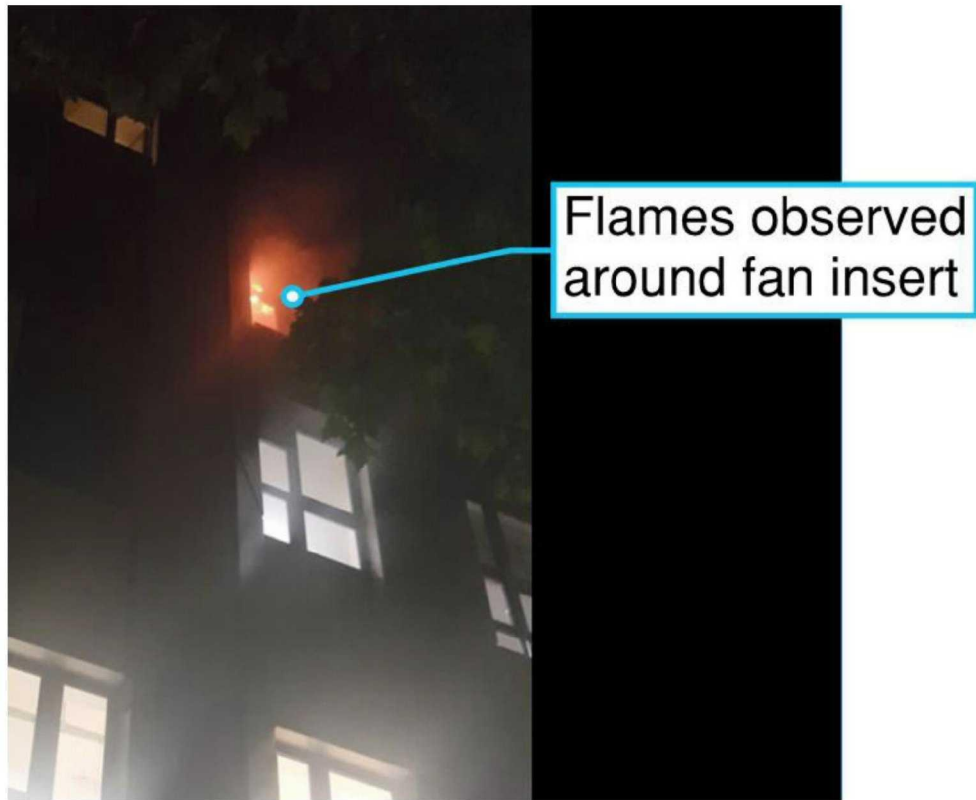
Figure 9.34: Still No.1 from video footage - (MET000083356)

9.5.14 Figure 9.34, Figure 9.35 and Figure 9.36 show how flames are present at the head of the Flat 16 kitchen window.

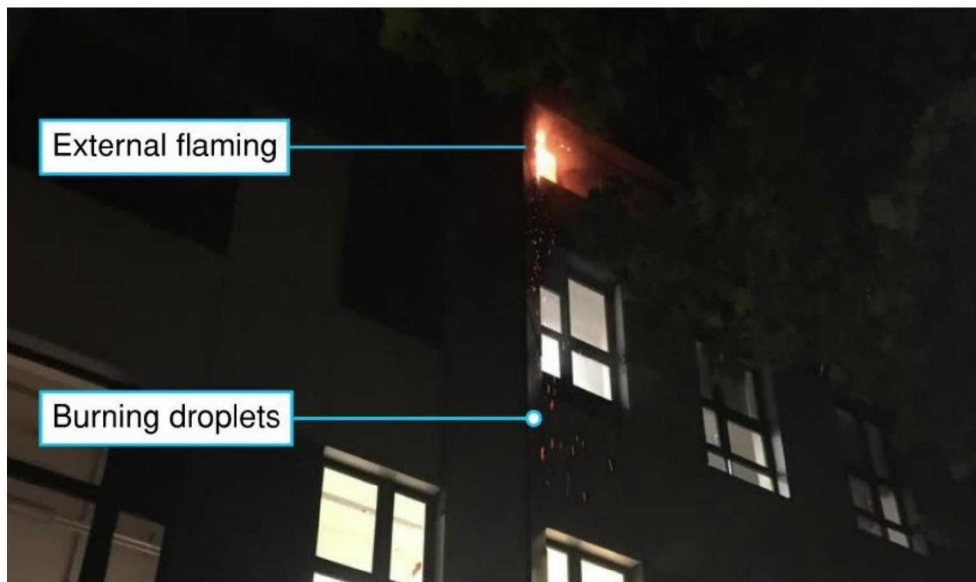
Figure 9.35: Photograph at 01:08 submitted by witness (IWS00000051)

9.5.15 Additionally, Figure 9.35 identifies that burning droplets began falling outside the building at around 01:08.

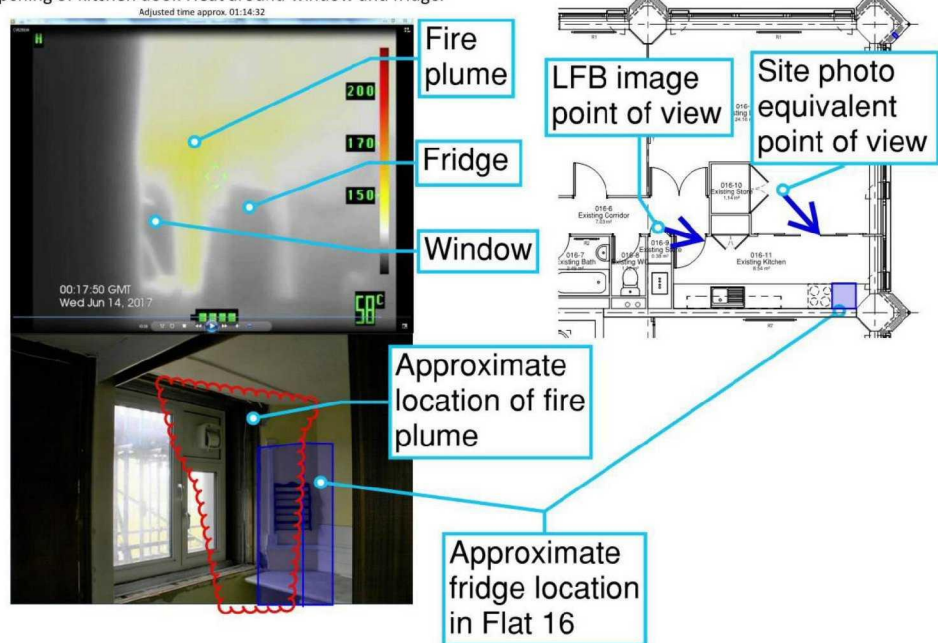
Figure 9.37: LFB thermal imaging camera footage - 01:14 (MPS document JRB TIC 01, MET00006109) above a marked up site photograph of Flat 13, where the kitchen

9.5.16 Figure 9.37 is a video still from LFB thermal imaging footage of the first fire fighters entering the kitchen in Flat 16 (MET00006109). This footage is taken at approximately 01:14 and also identifies flames at the top corner of the window, behind the side of the fridge freezer (please refer to Professor Niamh Nic Daoid’s report regarding the Flat 16 kitchen and the fire), and in the region near the fan insert.

9.5.17 The LFB footage does not indicate that a post flashover fire had occurred at that time (01:14). It is clearly a localised fire beside the window opening only.

2nd opening of kitchen door. Heat around window and fridge.

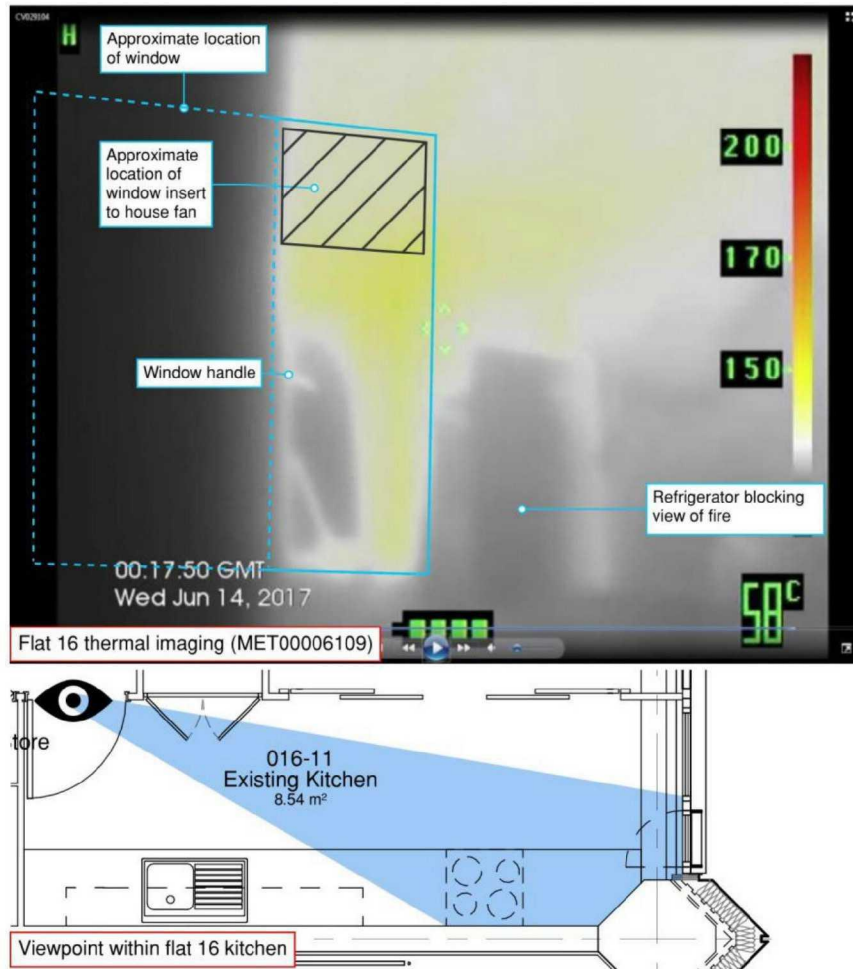
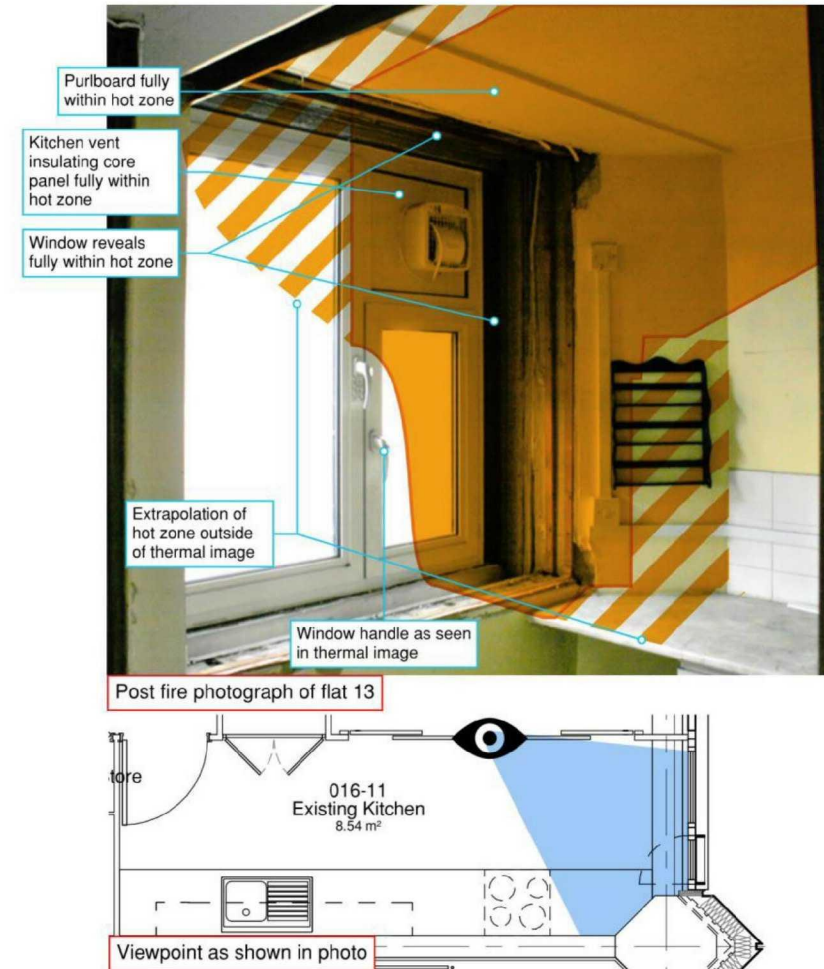
Figure 9.38: Comparison figure of the area exposed to the hot fire plume observed in thermal imaging from flat 16 (plans: SEA00010474)

- 9.5.18** Figure 9.38 shows the extent of the area that was subjected to the hot plume observed within the flat 16 thermal imaging camera footage. This therefore also shows the extent of materials that were exposed to the heating from the initial fire, and the possible routes available for fire spread into the external wall cavity.

9.5.19 Therefore, using Figure 9.38, the exposure from the hot zone could lead to the fire reaching the external wall cavity **by either routes B (via jamb/EPDM), or E (directly through the window glazing/kitchen vent panel):**
