**Grenfell Tower – fire safety investigation:
The fire protection measures in place on the night of the fire, and conclusions as to:**

Phase 1 Report – Section 9

Routes for fire spread out through the window openings

24th October 2018

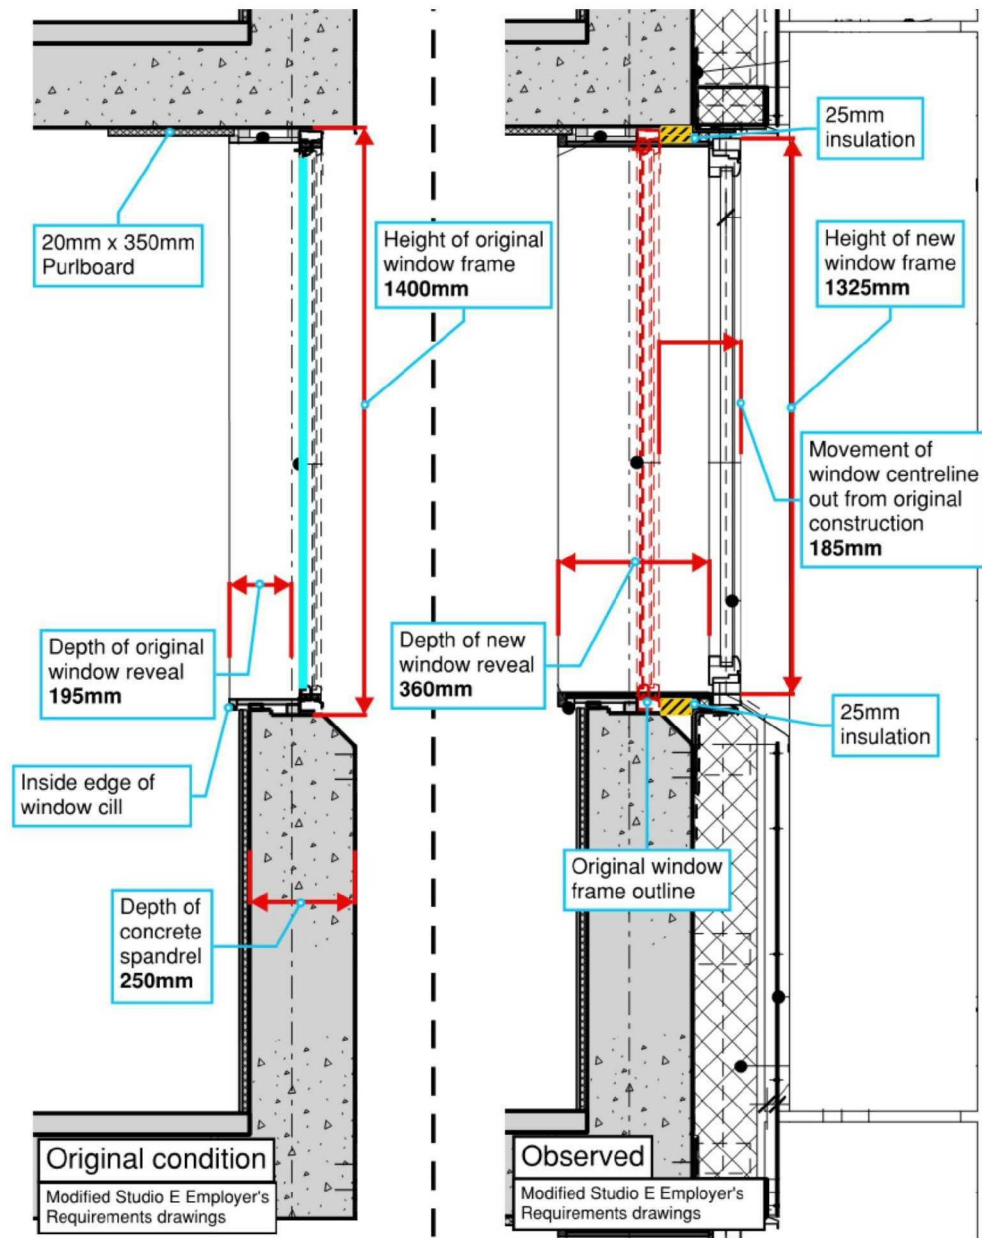
Figure 9.6: Vertical section view of original [left] and post refurbishment [right] window openings (Based on SEA00013045)

- 9.2.11 The relationship of that external wall cavity to the internal cavity at the jamb is also shown. It is clear in Figure 9.5 that the EPDM weatherproof membrane is the only thing separating these two spaces.
- 9.2.12 I have reproduced Figure 8.3 from Section 8 here (Figure 9.6 below) as a reminder of the location of the new window, relative to both the old and new external wall, and this is the reason for the creation of these cavities, in behind the window reveal linings.

9.2.13 Each of these cavities contained combustible insulation. In the internal cavities (a) to (d) above, these were localised insulation materials attempting to seal the window (Figure 9.1). In the main external wall cavity this was the Celotex/Kingspan product attached to the original concrete wall.

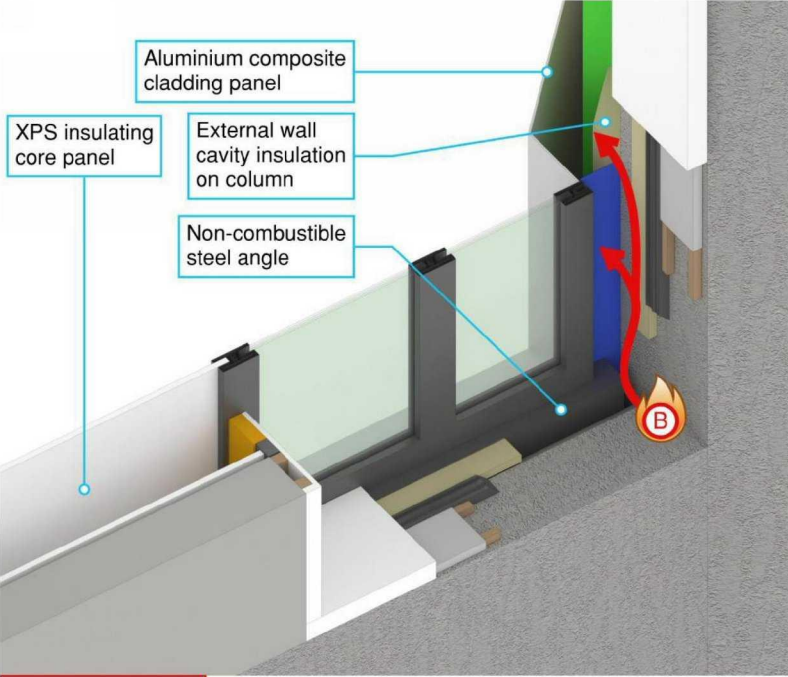
Fire Scenario	Route of fire spread through the window to the extensive external wall cavities
<p>B</p> <p>A fire starts on the column side of the window, it could break through the window reveal lining there and into the external wall cavity via the gap at the window jamb which is sealed with a damp proof membrane only.</p> <p>Fire source: Combustible flat contents stored/positioned on the window cill or near the window jamb</p>

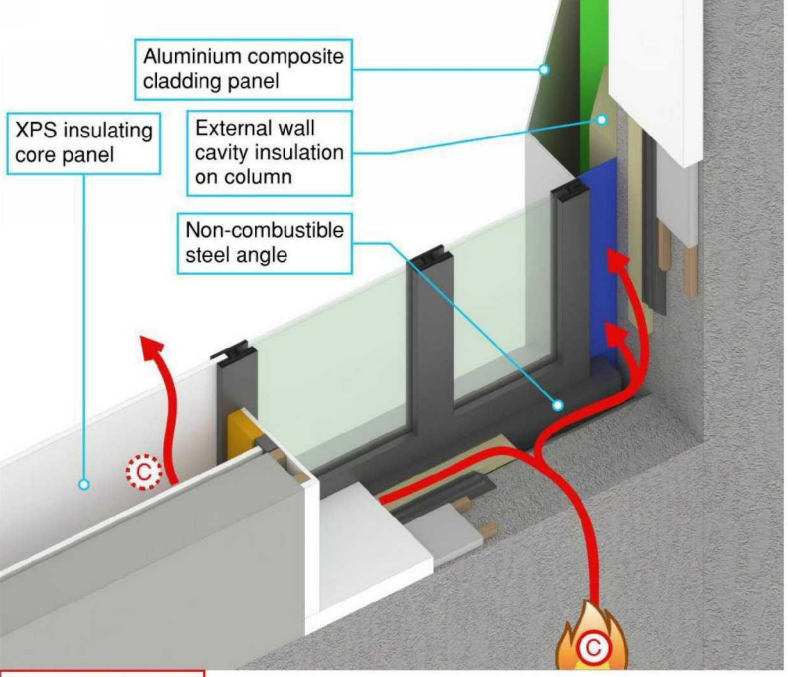
<p>Aluminium composite cladding panel</p> <p>XPS insulating core panel</p> <p>External wall cavity insulation on column</p> <p>Non-combustible steel angle</p> <p>Window cill view</p>
<p>C</p> <p>A fire starts under or next to the window cill, it could break into the materials forming the window reveal there and spread through those materials into the external wall cavity. This could occur via the gap between the window cill and window jamb. And also via the gap into the insulating core panel cavity.</p> <p>Fire source: Combustible flat contents stored/positioned next to the window</p>

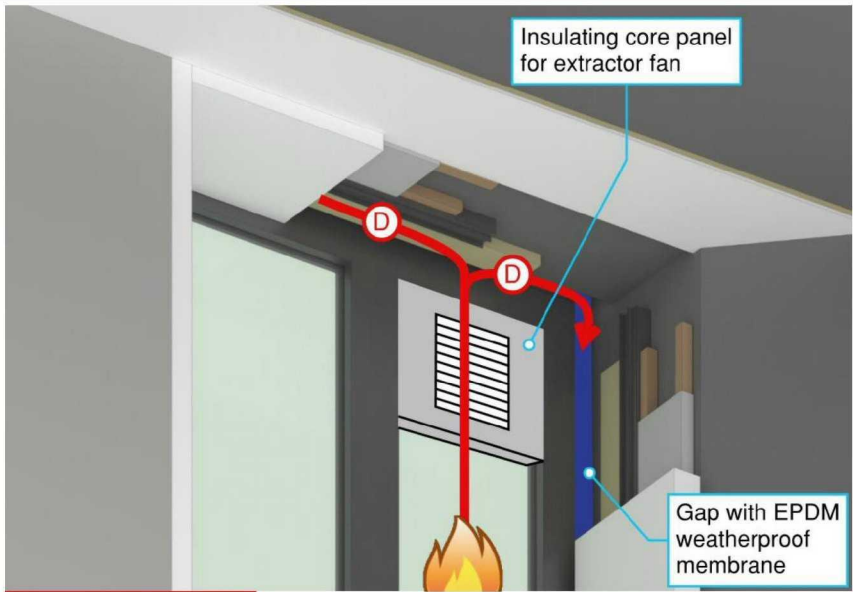
Fire Scenario	Route of fire spread through the window to the extensive external wall cavities
<p>D</p> <p>A fire could spread into the cavity at the head of the window, and onwards into the external wall cavity via the gap at the window jamb and via the insulating core panel.</p> <p>Fire source: Ceiling jet from fire within the kitchen or from combustible flat contents positioned/stored next to window</p>

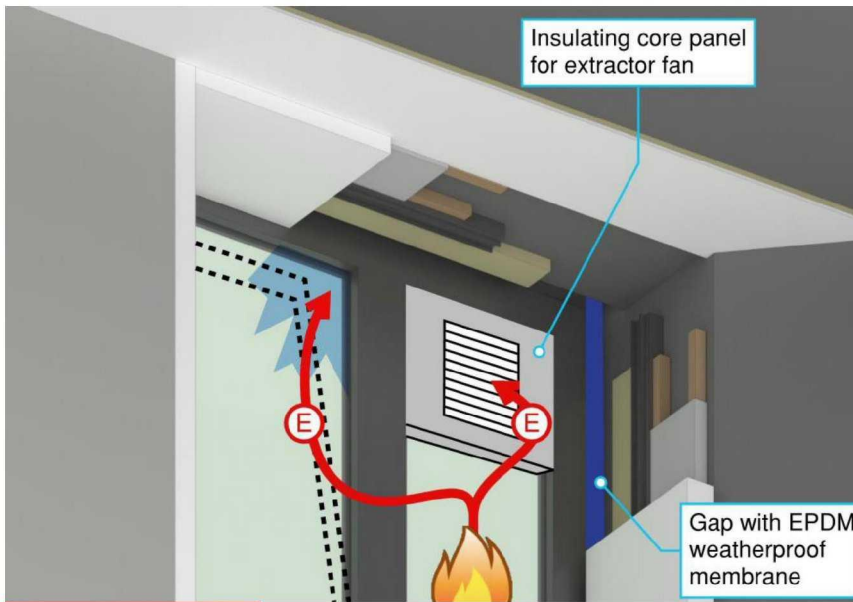
<p>Insulating core panel for extractor fan</p> <p>Gap with EPDM weatherproof membrane</p> <p>Window head view</p>
<p>E</p> <p>A fire could break through the window frame via the insulating core panel which houses the extractor fan, or via broken or open glazing and into the external wall cavity above and adjacent.</p> <p>Fire source: Ceiling jet from fire within the kitchen or from combustible flat contents positioned/stored next to window</p>

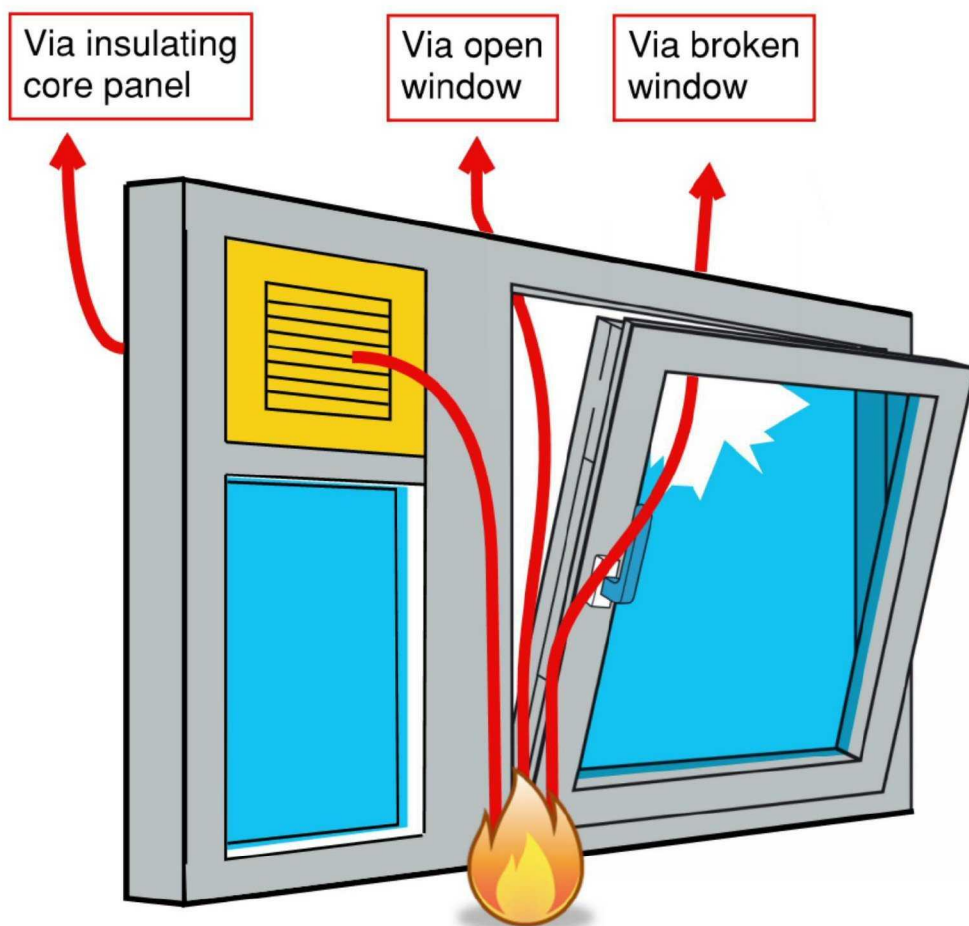
Figure 9.17: Routes for fire spread directly through a window

9.3.31 As displayed in Figure 9.17 there are three ways a fire could break out of the flat via the window directly:

- a) Via the combustible insulating core panel in the window that houses the ventilation fan for the kitchen;
- b) Via an open window;
- c) Via broken glazing in the window.

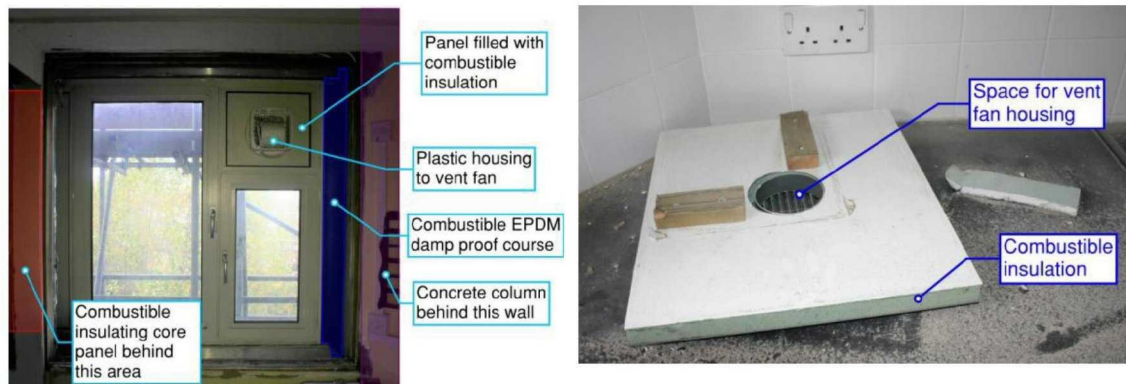
Figure 9.18: (a) Example kitchen window from Flat 13, (b) Evidence of window insert construction

9.5.7 Flat 46 has the same configuration of the kitchen window as flat 16, and Figure 9.18, thus the ‘left hand side’ of the window is the side opposite the column and kitchen vent insulating core panel. This therefore represents evidence in support of route A, fire spreading via the window reveal lining covering the cavity between the infill panel and insulating core panel.

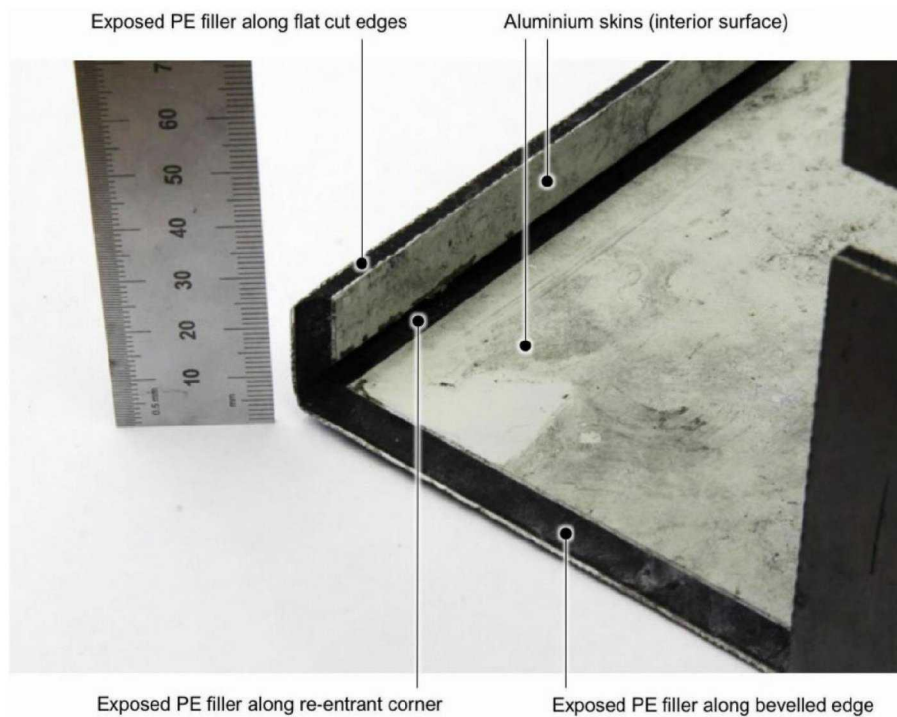
9.3.33 The polyethylene core was exposed along the sides of the panels in this location, as indicated by Figure 9.20. My onsite observations confirm it was exposed and also that it had melted, as shown in Figure 9.21:

Figure 9.20: Prof. Bisby's phase 1 report, figure 20 showing photograph of spandrel cladding panel sample provided by MPS

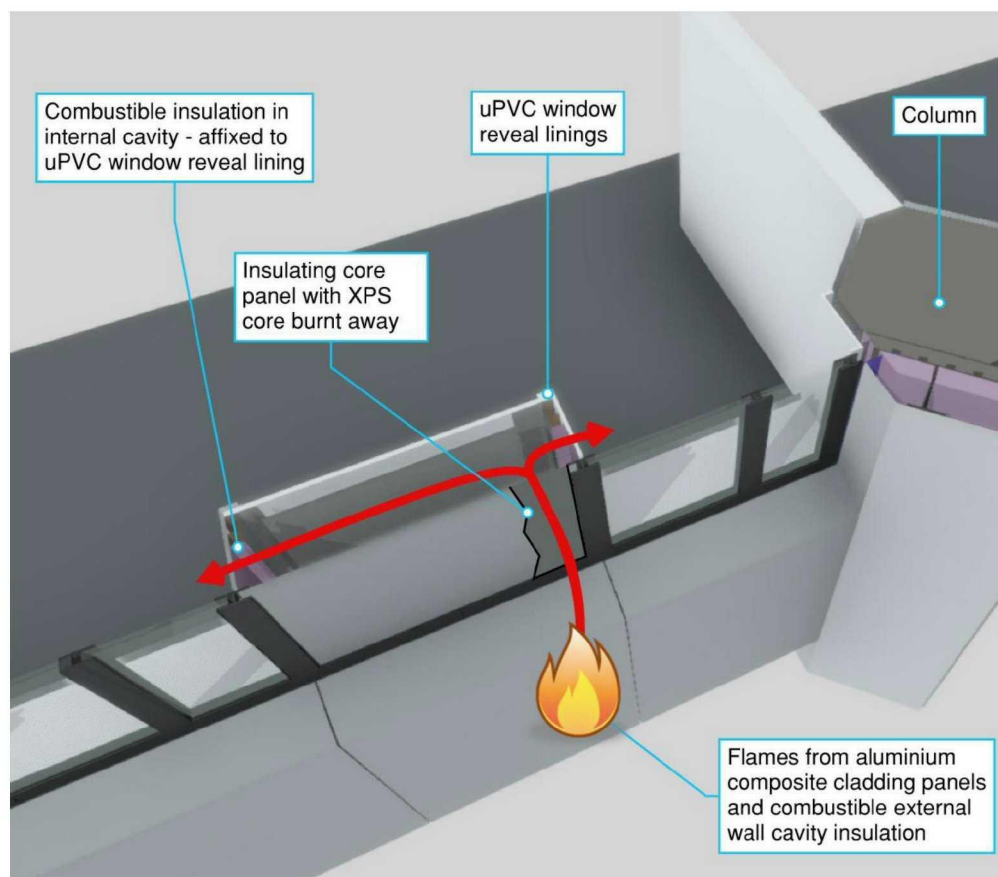
Figure 9.27: 3D model indicating routes of fire spread into flats via combustible seal either side of the new Styrofoam XPS insulating core panels, or via a failed panel itself.

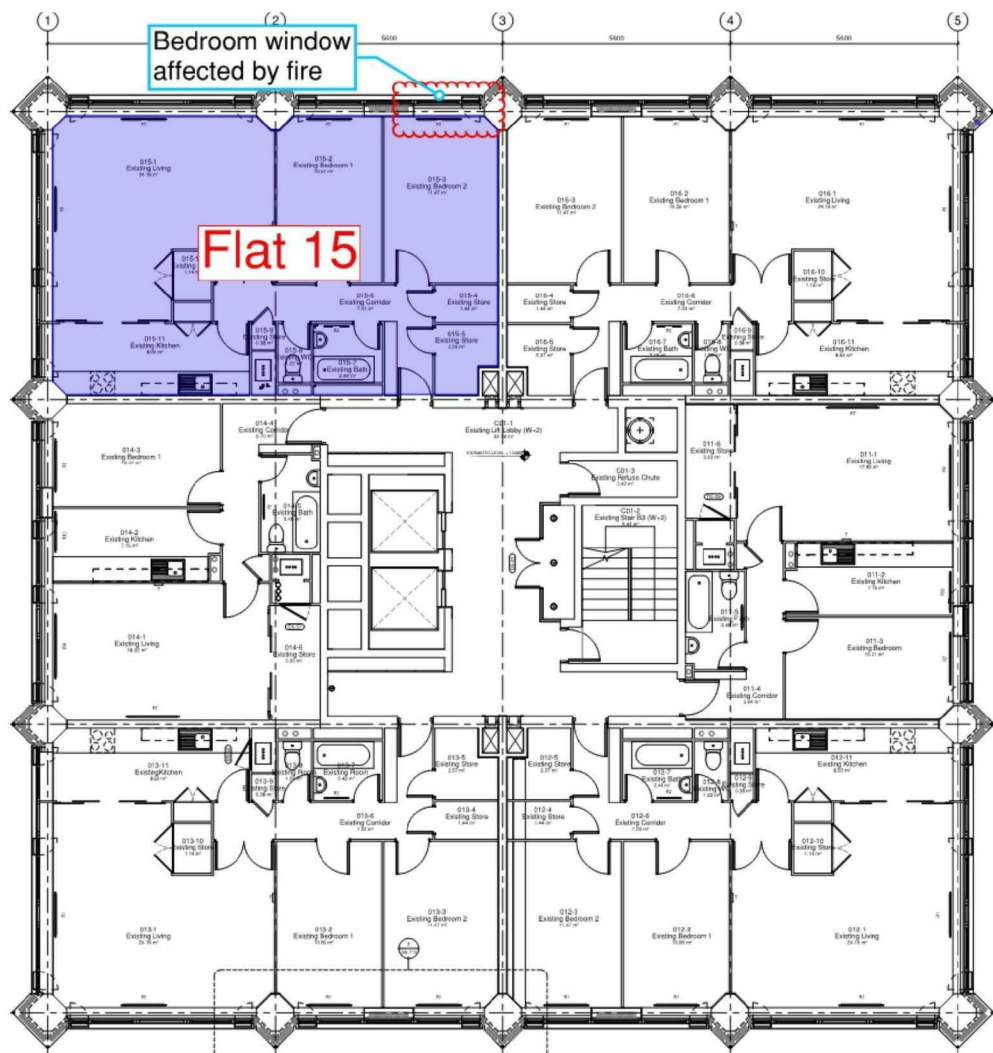
9.5.2 In my inspection of Flat 15 on Level 4 (Figure 9.28), I observed that there was a window exhibiting evidence of fire spread from outside the building to the inside, shown in Figure 9.29. The evidence of fire spread showed that the entry route for the fire was in the top corner of the window, adjacent to the column, consistent with the mechanism of fire spread presented in Section 9.4. That is a fire being able to penetrate from outside the building, into the cavity behind the new uPVC reveal linings via the EPDM weatherproof membrane (route B).

Figure 9.28: Marked up Studio E drawing indicating location of Flat 15, and the window shown in Figure 9.29 (Based on SEA00010474)

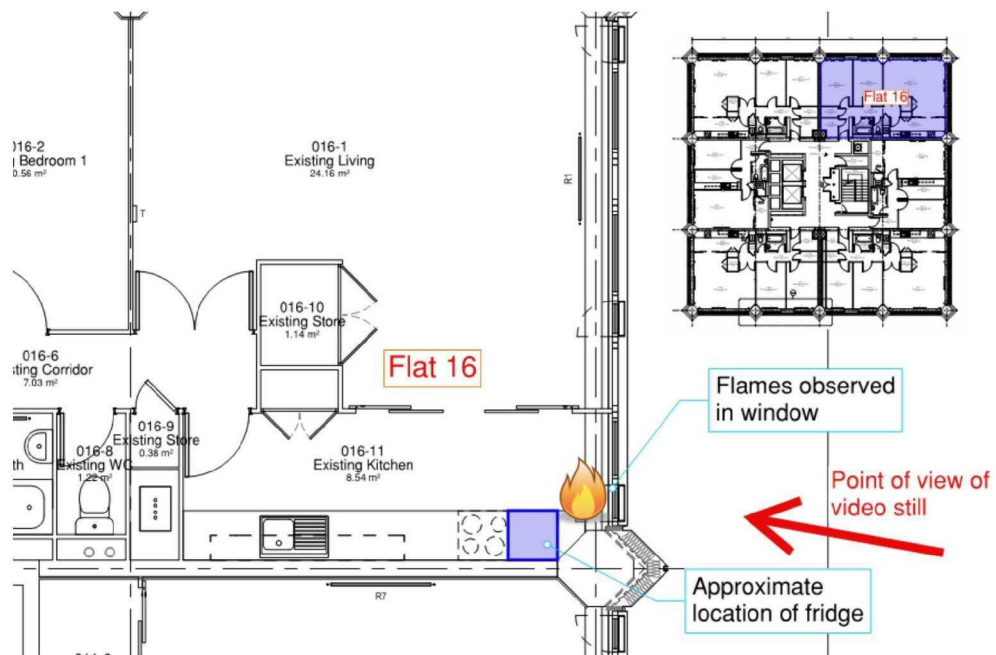
9.5.13 The following images are stills extracted from videos taken by the resident of Flat 16 on his mobile phone and a photograph submitted to the inquiry by a witness (MET000083356, MET000083357 and IWS00000051). Whilst the precise time of the videos is not known, the file name would suggest that the videos were taken at approximately 01:08 and 01:09 respectively. The precise time will depend on the accuracy of the timings on the mobile phone. The footage has been shot from the direction indicated in Figure 9.33. The photograph in Figure 9.35 is estimated to have been taken at 01:08.

Figure 9.33: Marked up Studio E drawing indicating location and orientation of resident camera footage (Based on SEA00010474)

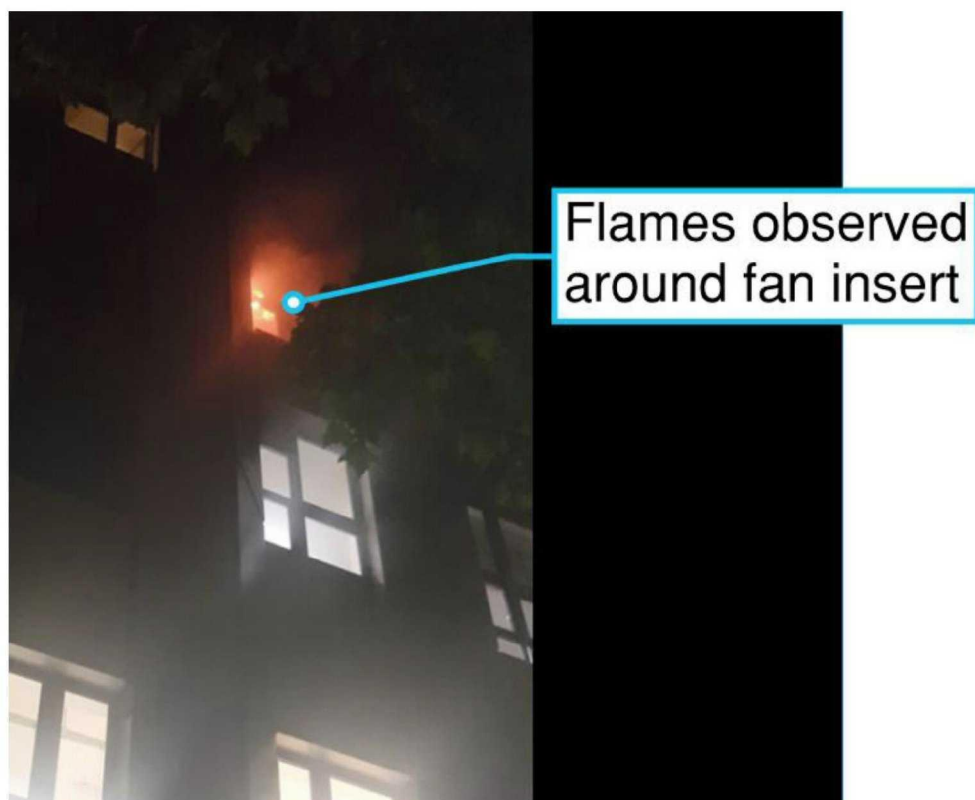
9.5.14 Figure 9.34, Figure 9.35 and Figure 9.36 show how flames are present at the head of the Flat 16 kitchen window.

Figure 9.34: Still No.1 from video footage - (MET000083356)

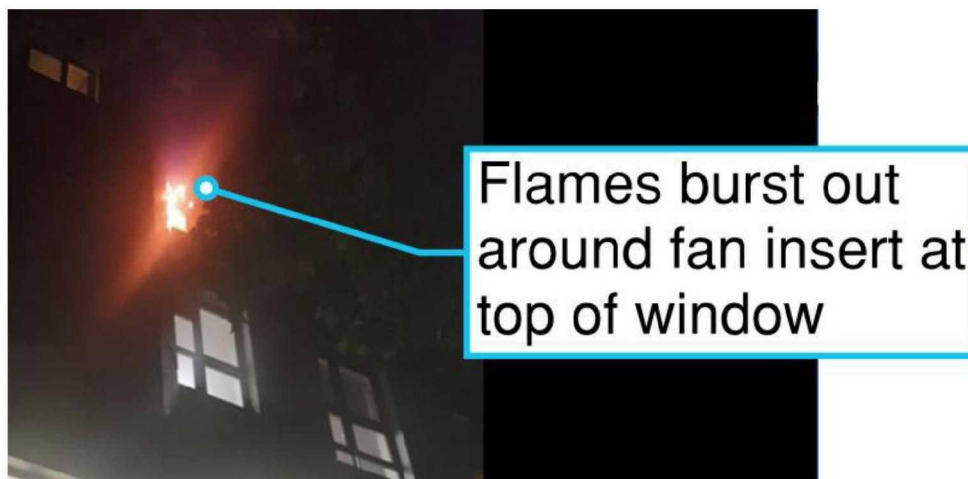
Figure 9.36: Still No.2 from video footage – (MET000083357)

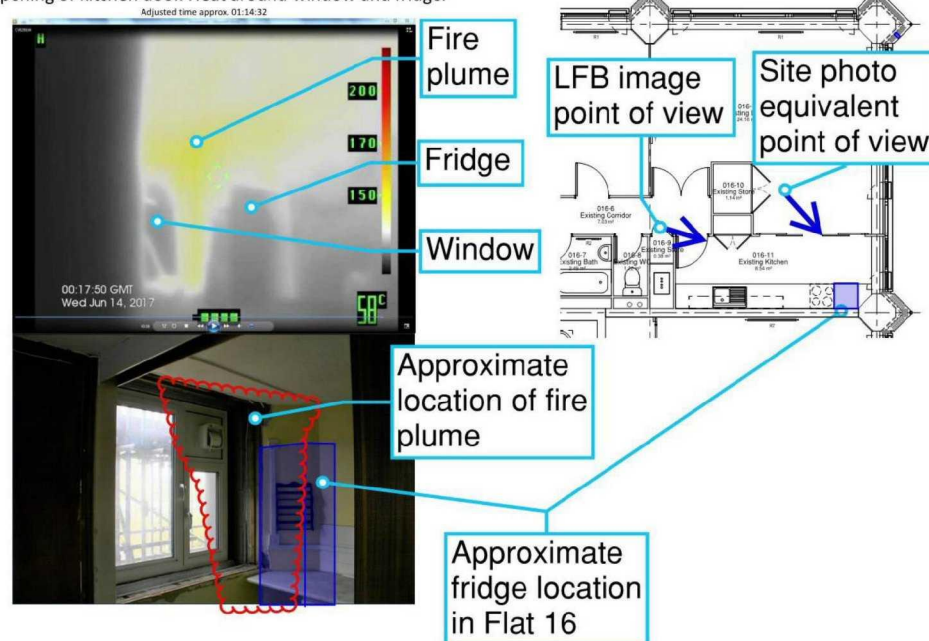
9.5.16 Figure 9.37 is a video still from LFB thermal imaging footage of the first fire fighters entering the kitchen in Flat 16 (MET00006109). This footage is taken at approximately 01:14 and also identifies flames at the top corner of the window, behind the side of the fridge freezer (please refer to Professor Niamh Nic Daoid's report regarding the Flat 16 kitchen and the fire), and in the region near the fan insert.

9.5.17 The LFB footage does not indicate that a post flashover fire had occurred at that time (01:14). It is clearly a localised fire beside the window opening only.

2nd opening of kitchen door. Heat around window and fridge.

Figure 9.37: LFB thermal imaging camera footage - 01:14 (MPS document JRB TIC 01, MET00006109) above a marked up site photograph of Flat 13, where the kitchen
