Grenfell Tower – fire safety investigation:
The fire protection measures in place on the night of the fire, and conclusions as to:
the extent to which they failed to control the spread of fire and smoke;
the extent to which they contributed to the speed at which the fire spread.

Phase 1 Report – Section 10

Routes for vertical and horizontal fire spread throughout the building envelope

Dr Barbara Lane FREng FRSE CEng

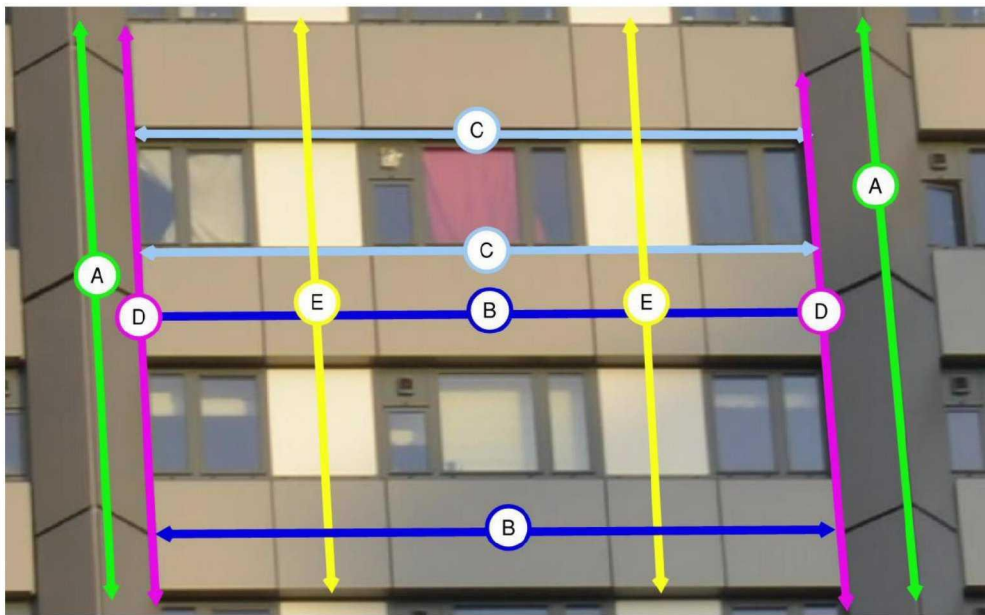
Figure 10.2: Pathways A to E identified on undamaged façade (SEA00000350)

- Pathway E: Vertically by means of the insulating core panels which connect between spandrel panels;
 - Pathway F: Around the crown of the building.
- 10.1.7** Figure 10.2 identifies Pathways A to E on an undamaged portion of the façade of Grenfell Tower. These Pathways are also indicated on a rendered schematic of the building envelope in Figure 10.4.

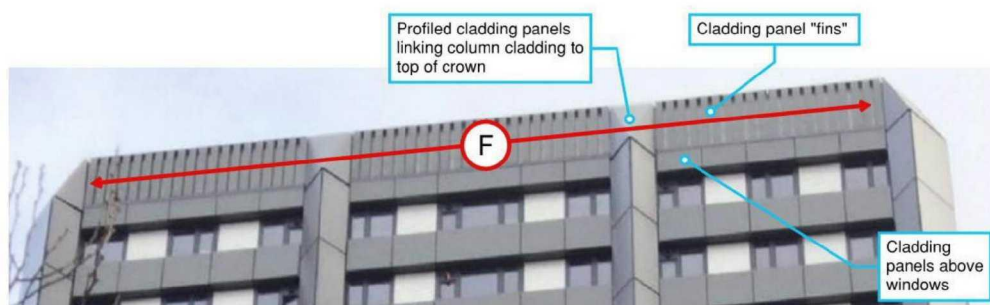
Figure 10.3: Pathway F identified on undamaged façade (SEA00000322)

10.1.8 Figure 10.3 identifies Pathway F on an image of the façade from before the fire.

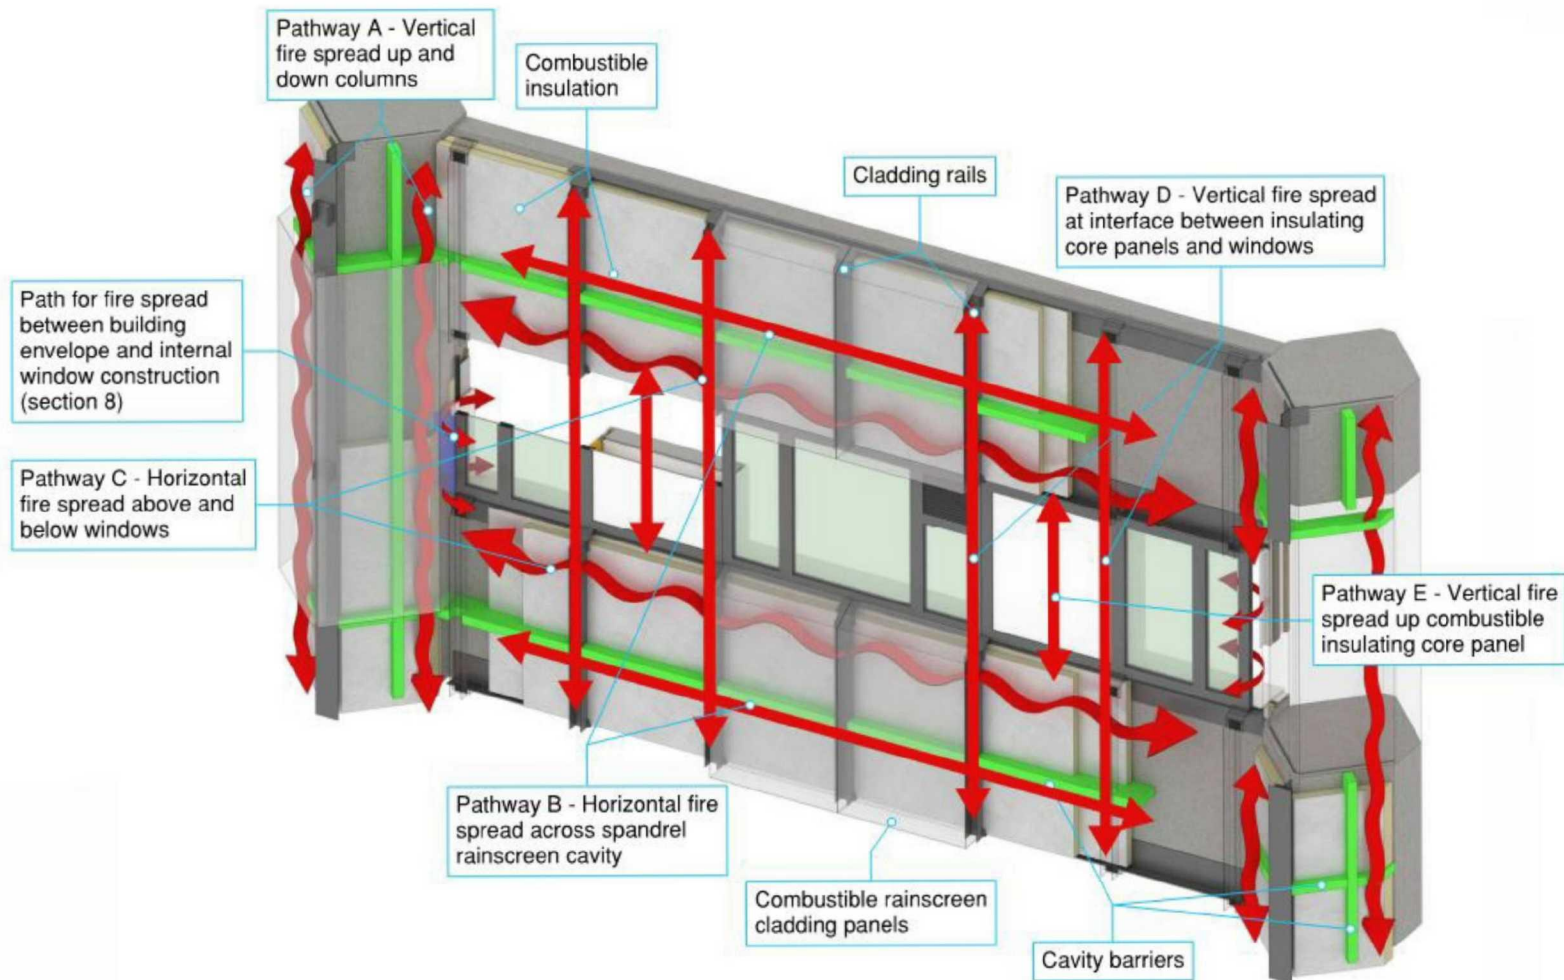
Figure 10.4: Pathways A, B, C, D and E shown on a rendered representation of rainscreen cladding installation based on design drawings and observations from post fire inspection

- 10.1.9** These pathways are shown on a rendered representation of the rainscreen cladding installation based on design drawings and observations from my post fire inspection in Figure 10.4.
- 10.1.10** These pathways are also demonstrated on photographs of external fire spread on the West elevation of Grenfell Tower in Figure 10.5.
- 10.1.11** In the following sections I will describe how the construction materials present at Grenfell Tower enable each of these Pathways, with reference to footage of the fire.
- 10.1.12** Please note it is not my intention to create a very detailed fire spread map in this part of my report. It is an analysis to understand general flame front routes, and importantly overall timescales where individual building elevations became fully involved in the fire. The very fine detail of the

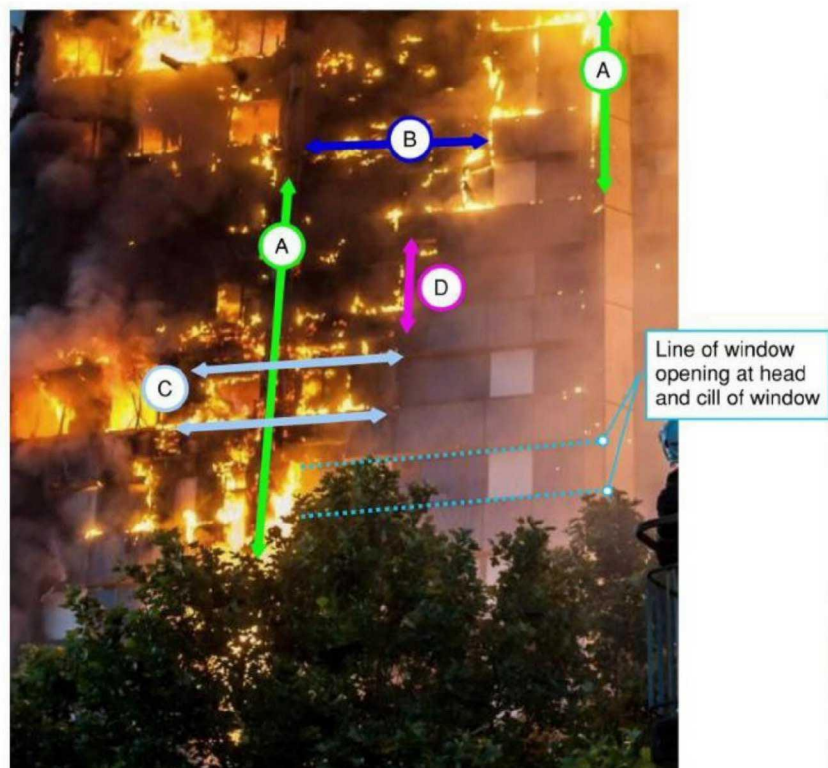
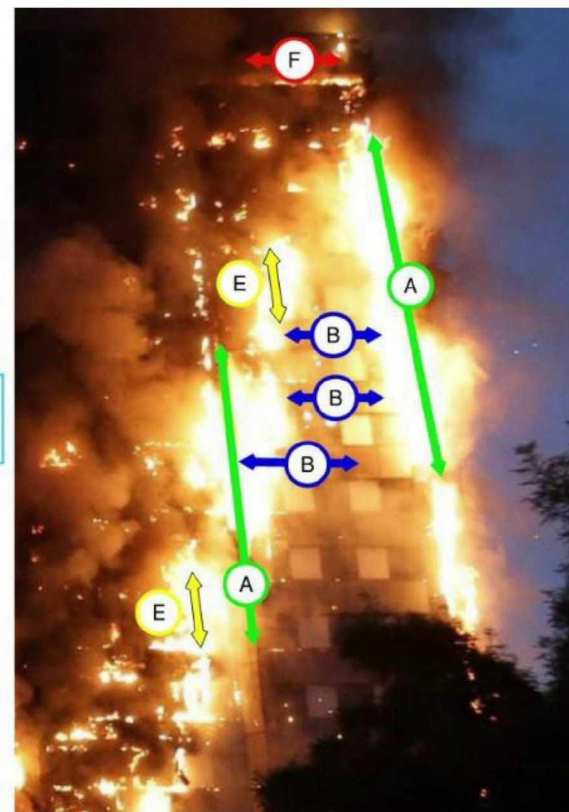
Figure 10.5: Fire spread on West elevation of Grenfell Tower

(a) Photographic evidence of Pathways A, B, C and D¹

(b) Photographic evidence of Pathways A, B and E²

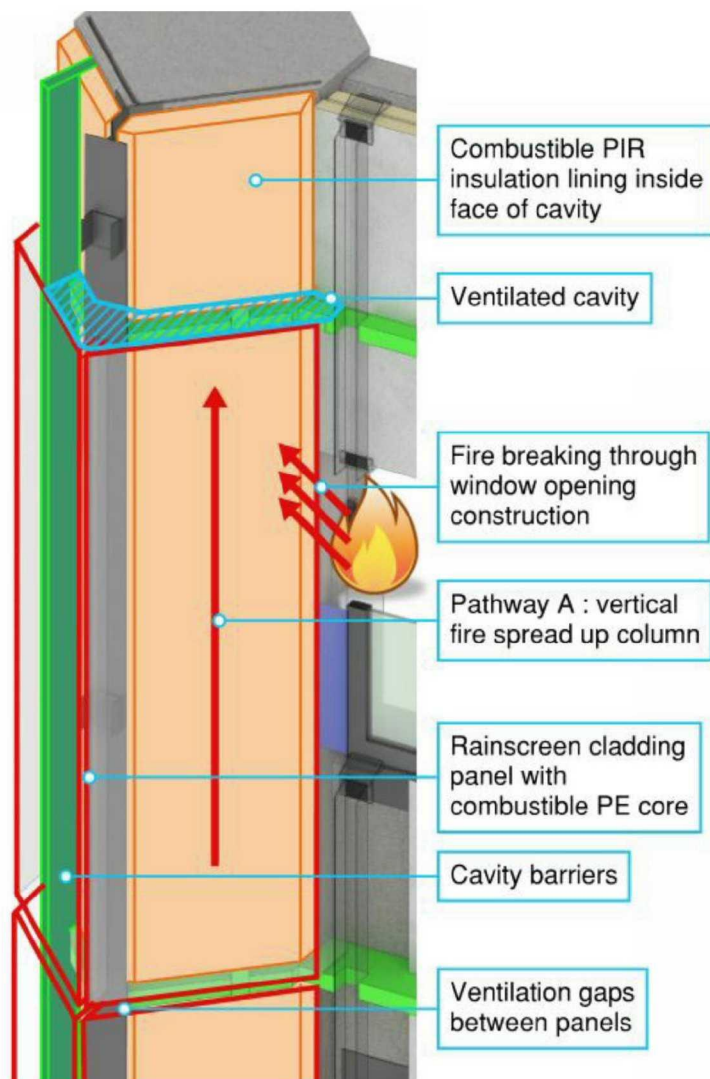
Figure 10.13: 3D image of the fuel, ventilation and heat available within the column cavity of Grenfell Tower to support combustion

10.3.26 In summary, the vertical fire spread observed up and down the columns, was caused by:

- The presence of fuel (the combustible polyethylene core of the Reynobond panels, the combustible Celotex insulation and the combustible EPDM weather proof membrane);
- The presence of oxygen entering the rainscreen cavity through the specifically designed air gaps;
- Heat from a fire within a flat passing into the cavity via the window construction described in Section 9; and
- Polyethylene from the Reynobond panels melting and running down the building, while ignited.

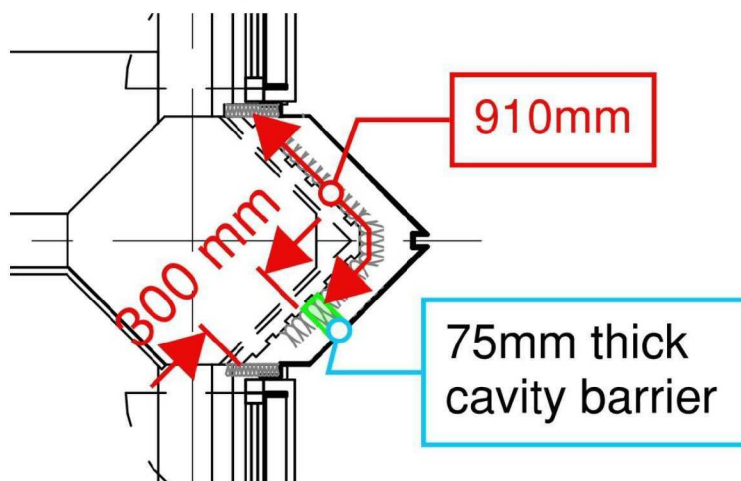
Figure 10.15: Horizontal extent of column cavity where a vertical fire stop is provided (based on SEA00010474 and thickness of barrier from Harley specification HAR00008991)

- 10.3.34** Please see Figure 10.15 demonstrating the horizontal extent of the column cavities either side of the vertical cavity barrier. The vertical spacing between horizontal cavity barriers was approximately 2.6m. This means an approximate area of column cavity (between fitted barriers) beside one window of 0.78m², and 2.7m² on the other side.

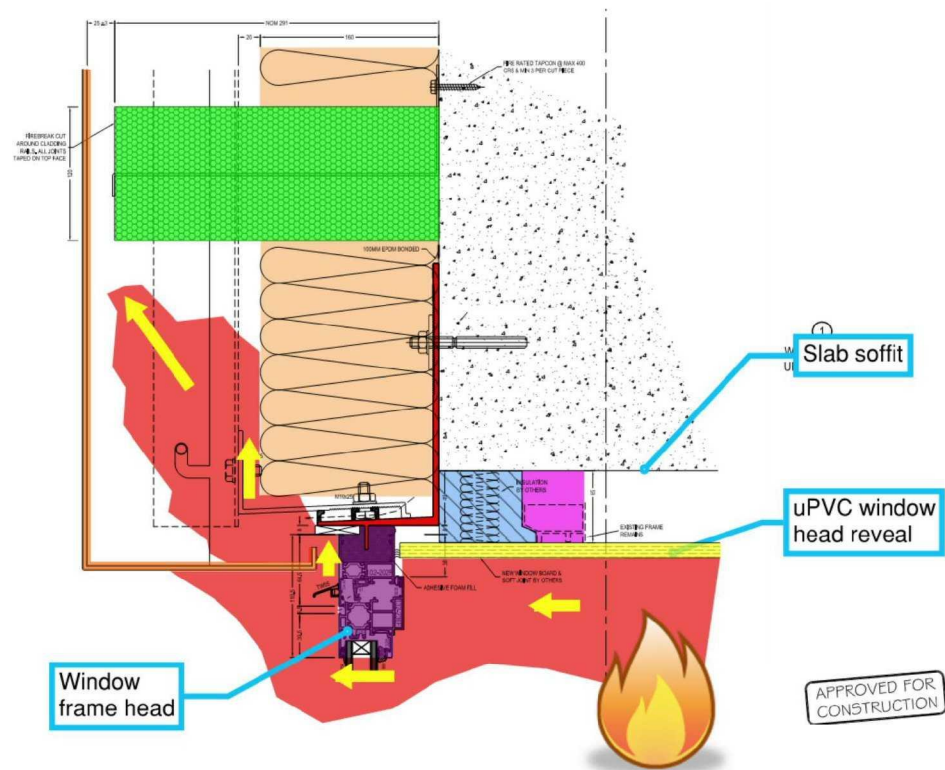
Figure 10.27: Mechanism for fire to enter spandrel cavity at window head (replicated from Section 9) (HAR00008901)

- 10.4.9** Fire can penetrate into the spandrel cavity either via Pathway A or by flames from internal fires breaking out of windows, passing into the cavity by the ventilation gap provided directly above the window head as identified in Figure 10.27.

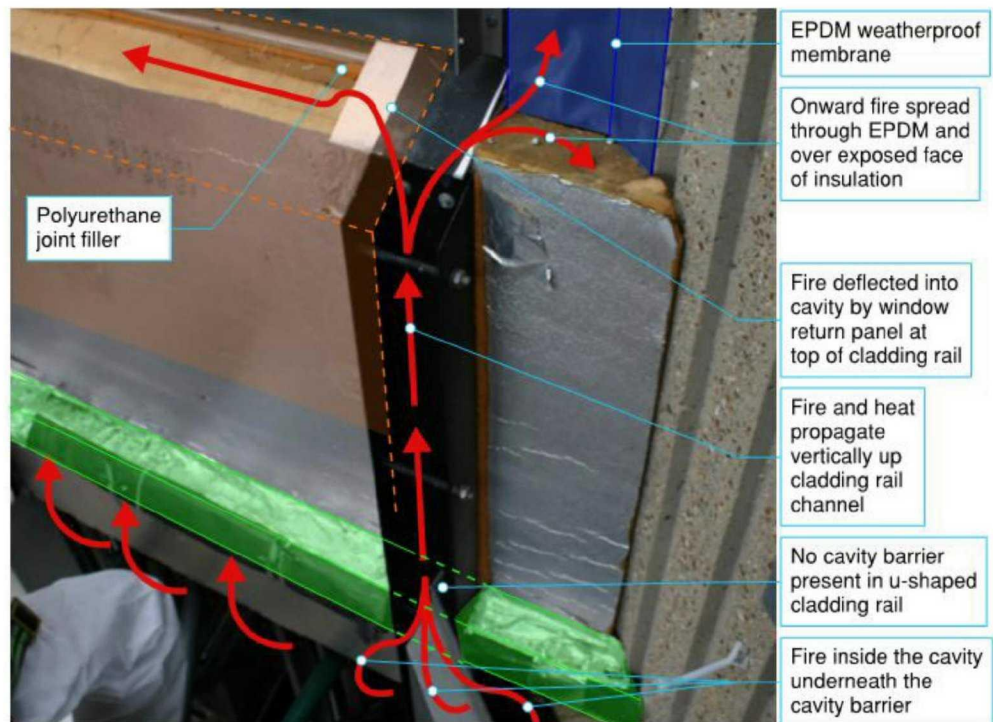
Figure 10.29: Schematic of possible fire spread via cladding support rail (External Flat 14)

- 10.4.20** Additionally, the cladding rails installed on the spandrels as the supporting structure of the Reynobond cladding panels contribute to vertical fire spread by providing a route through the horizontal cavity barriers as shown in Figure 10.29. As can be seen in Figure 10.35 and in Figure 10.4, these cladding support rails are provided at the junction with the column, and directly below each end of the new combustible insulating core panel.

- 10.4.21** Therefore, the construction of the spandrel panel provided no effective means of preventing fire spread via Pathway B.

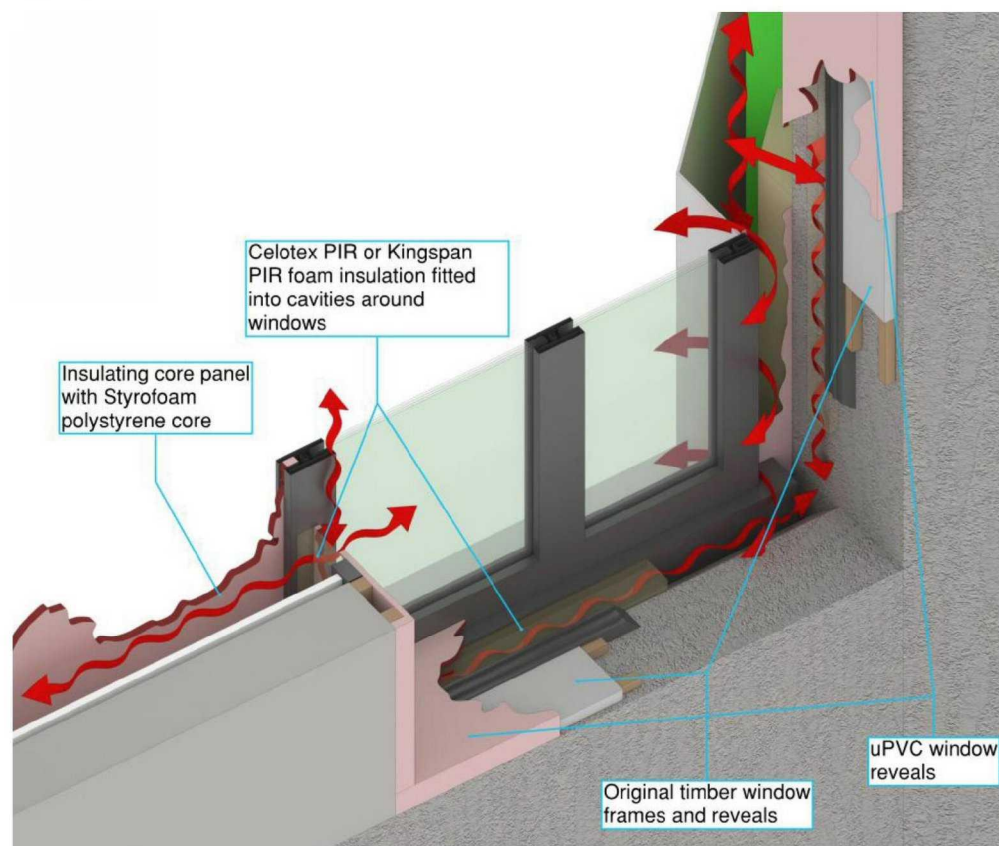
Figure 10.31: Materials making up the window surround

10.5.7 Please refer to Figure 10.31 for a diagram indicating the materials in the window surrounds.

10.5.8 This creates specific linear runs of combustible materials at the head and cill of each window.

10.5.9 Whilst no insulation appears to have been fitted within the head or cill cavity between the original non-combustible in-fill panel and the Aluglaze insulating core panel, the presence of the Aluglaze panel in this form, provides a source of fuel which connected the cill and head of each window, vertically via the Panel (as seen in Figure 10.30). (These panels also connect each storey of spandrel rainscreen cladding panels between windows – See Section 10.7 of my report).

- a) The presence of fuel (the combustible new uPVC window reveals, the original timber window frames and reveals, the combustible Celotex PIR or Kingspan therma PIR insulation behind the new uPVC cill and head reveals and the new Aluglaze extruded polystyrene insulating core panels) as shown in Figure 10.31 & Figure 10.32 ;
- b) The presence of oxygen from the outside atmosphere, or from within the flat; and
- c) Heat from a fire within a flat or in the external building envelope directly impacting the fuel identified in a) above.
- d) The presence of the Reynobond panel - either the cassette condition above a window or the cassette conditions below a window also provides a fire spread route (part of Route B).

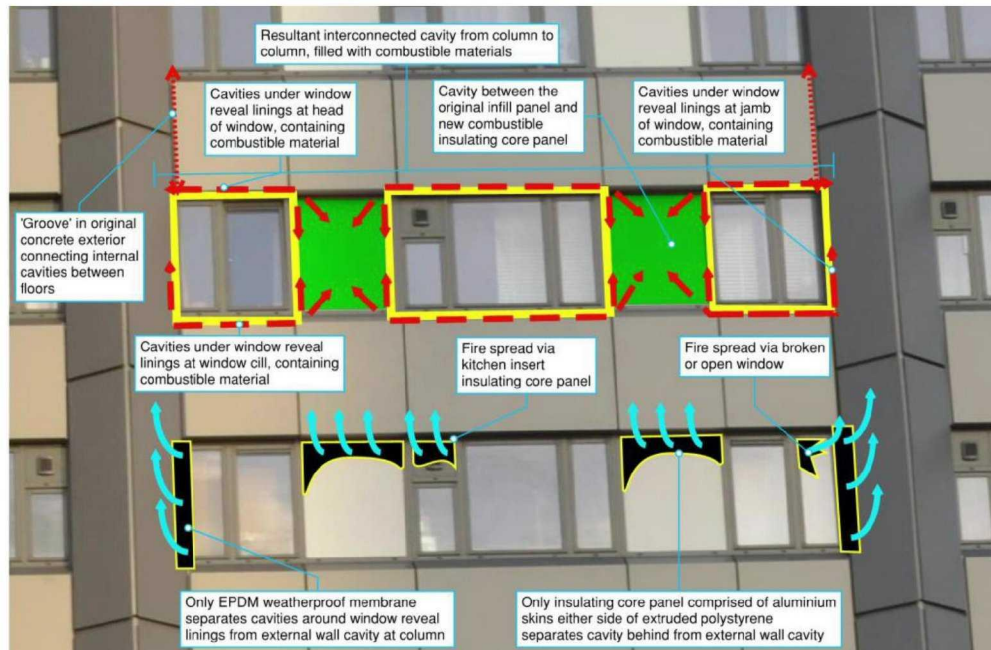
Figure 10.33: Network of window cavities superimposed on exterior of the building and routes into external wall cavity (SEA00000350)

10.5.14 In Section 9 I found multiple pathways for fire to spread through the window construction and into the external rainscreen cavity. In Figure 10.33, I have replicated from Section 9 an external perspective showing how fire can spread from within flats to the external rainscreen.

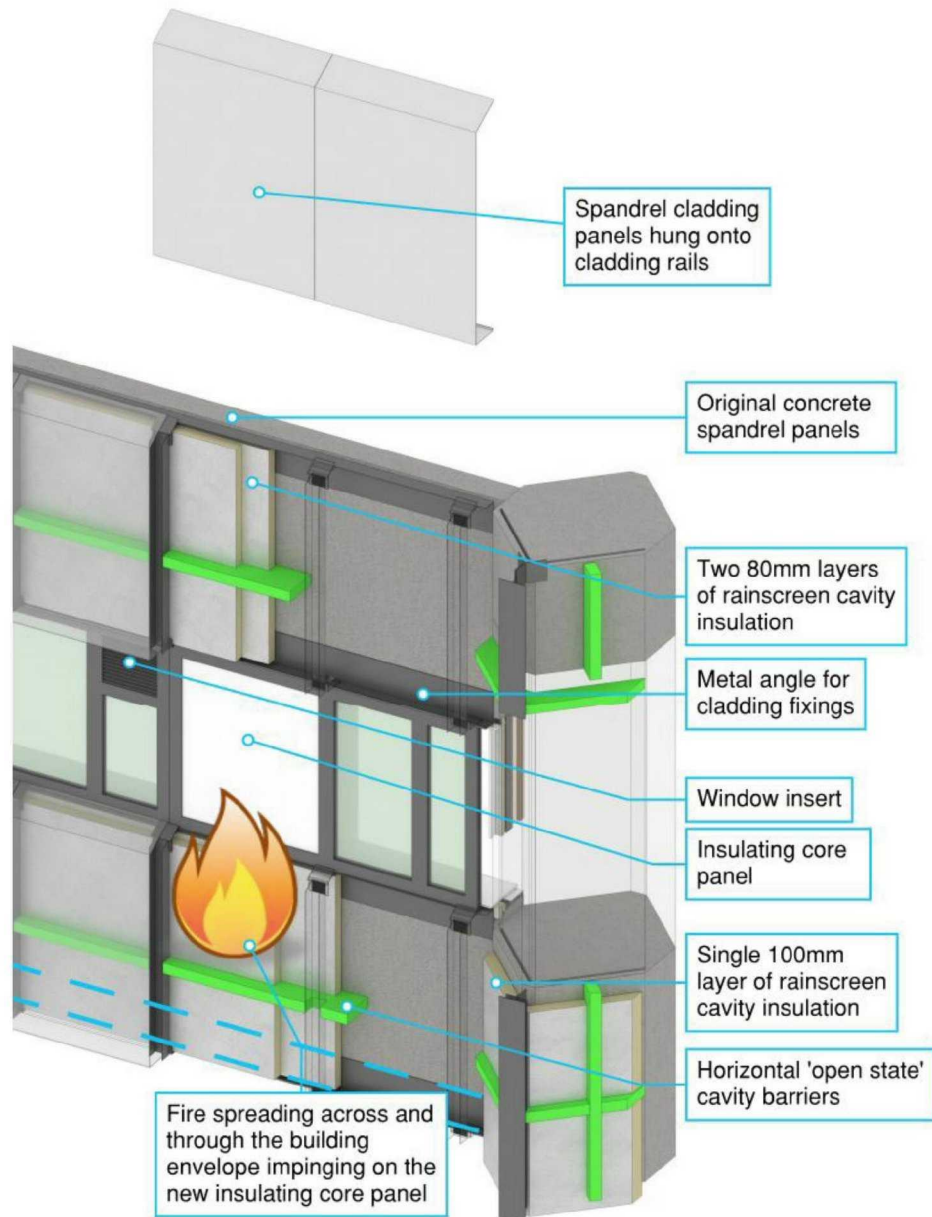
Figure 10.38: Materials of the facade around the new combustible insulating core panels

Styrofoam XPS core of the Aluglaze insulating core panels installed in between the windows, and the combustible Reynobond, Celotex and Kingspan materials fitted to the face of the spandrels. Please see Figure 10.38

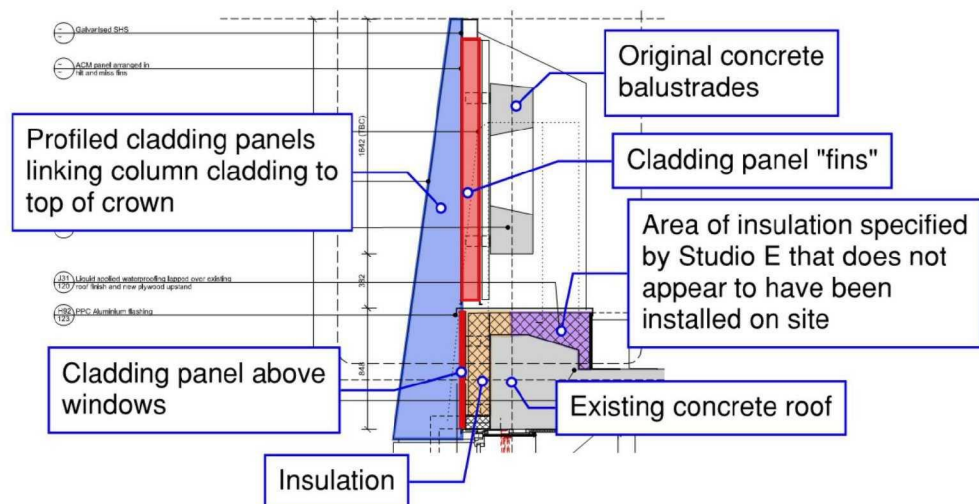
Figure 10.46: Materials used in construction of the crown cladding (based on SEA00002551)

10.8.14 Figure 10.46 presents a section through the crown construction based on the Studio E “As-Built” drawings (SEA00002551).

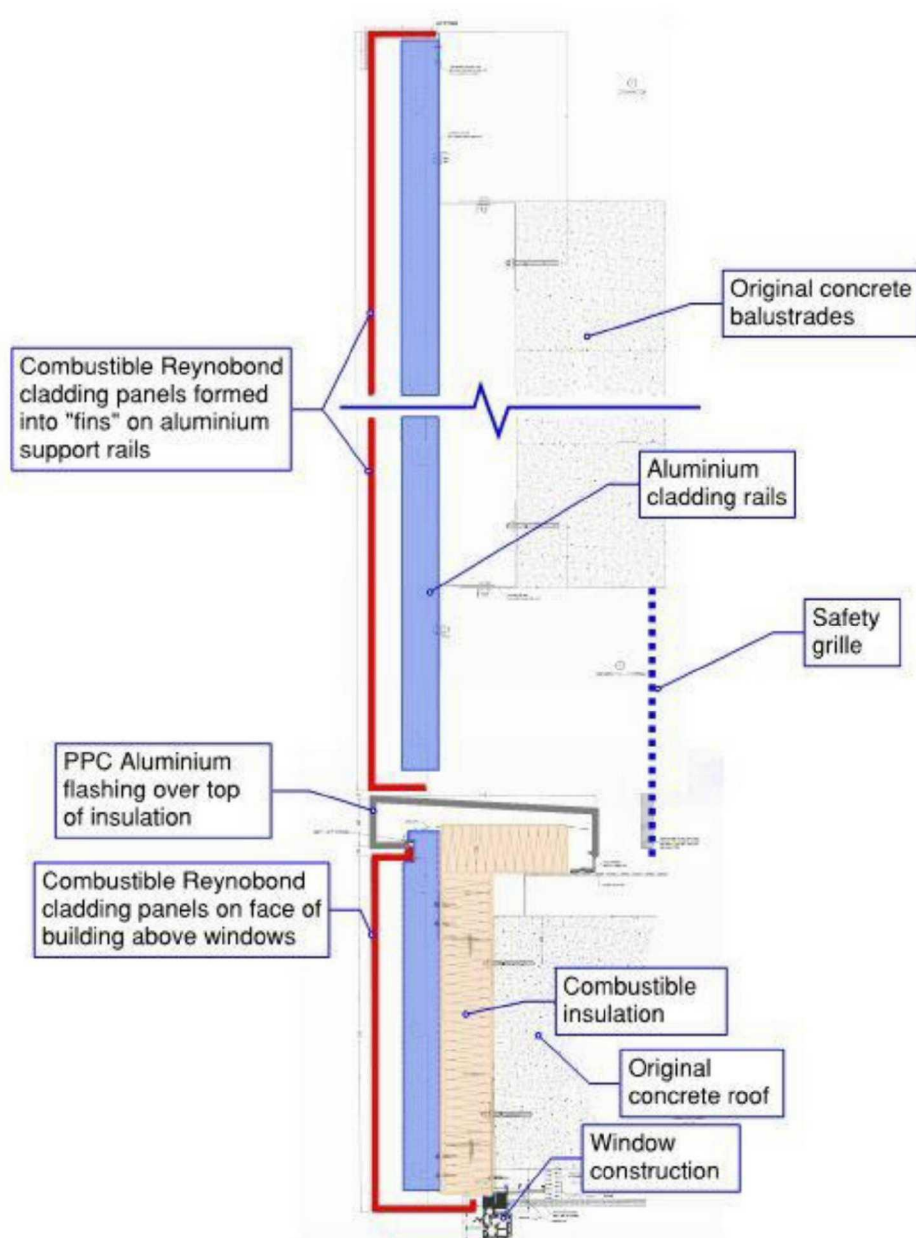
Figure 10.47: Materials used in balustrade sections of roof (excerpted from SEA00003242 and SEA00013263)

10.8.15 Figure 10.47 presents the specific materials used at the balustrade sections, based on Harley’s design drawings (excerpted from SEA0003242 and SEA00013263).

10.8.16 This drawing shows that the crown design adds cladding panels arranged as “hit and miss” fins to obscure the original concrete balustrades at the roof edge. Additionally, profiled cladding panels are added above the columns to terminate the column cladding in the crown cladding.

- 10.8.19 The safety grille indicated in Figure 10.47 was a steel mesh used to cover the gap between the bottom of the original concrete balustrade and the surface of the roof top, and was intended to be used as edge protection.

10.8.25 As indicated in Figure 10.47 and Figure 10.48, the Harley drawings did not appear to include a requirement for a horizontal cavity barrier/fire stop above the Level 23 windows. Therefore, no provision was made to prevent vertical fire spread from level 23 up to the roof area, including the Crown.

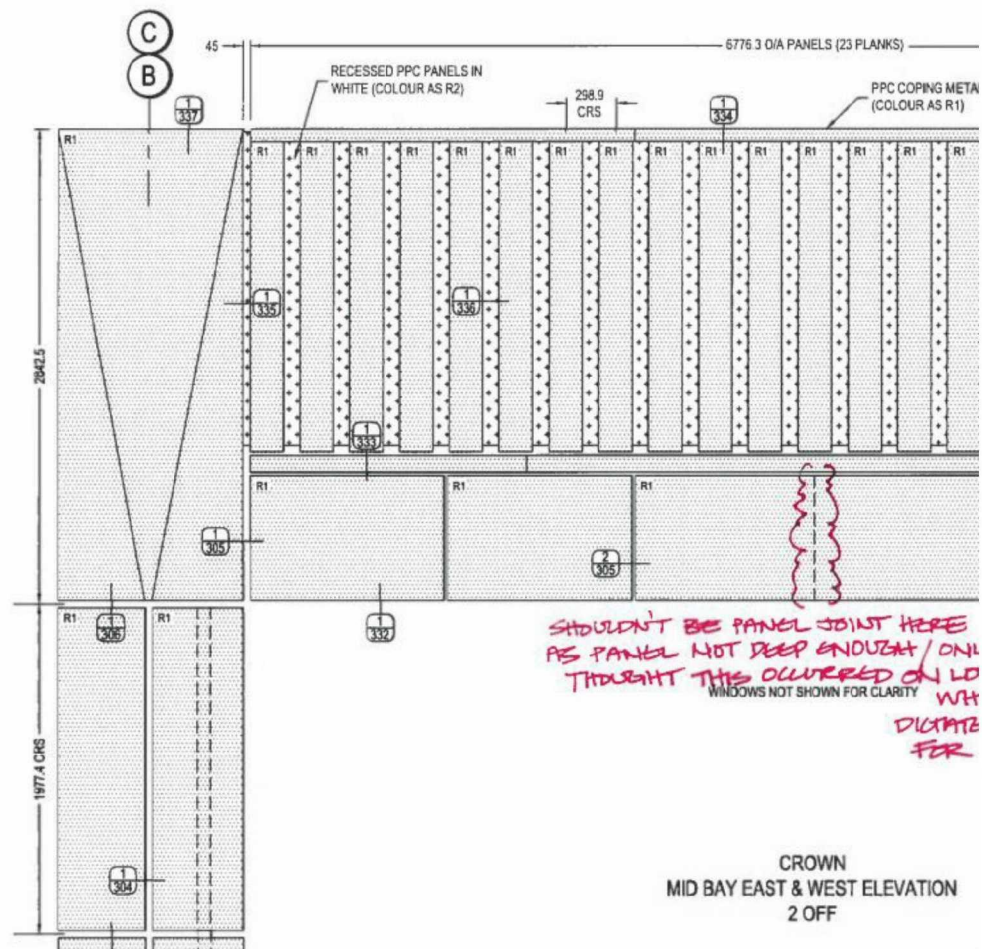
Figure 10.48: Excerpt from Harley drawing C1059-216 – red over-marks from original document (SEA00003242)

10.8.17 Figure 10.48 is an excerpt from the crown details in the Harley design drawings (SEA00003242) showing the panel types to be used in specific locations around the crown construction. As can be seen in this diagram, all of the panels for use in the crown construction were to be type R1. In accordance with the Harley specification (HAR00008991) the R1 type panel is for aluminium composite panels. As I have presented in Appendix E, this panel type was the Reynobond 55 PE product.

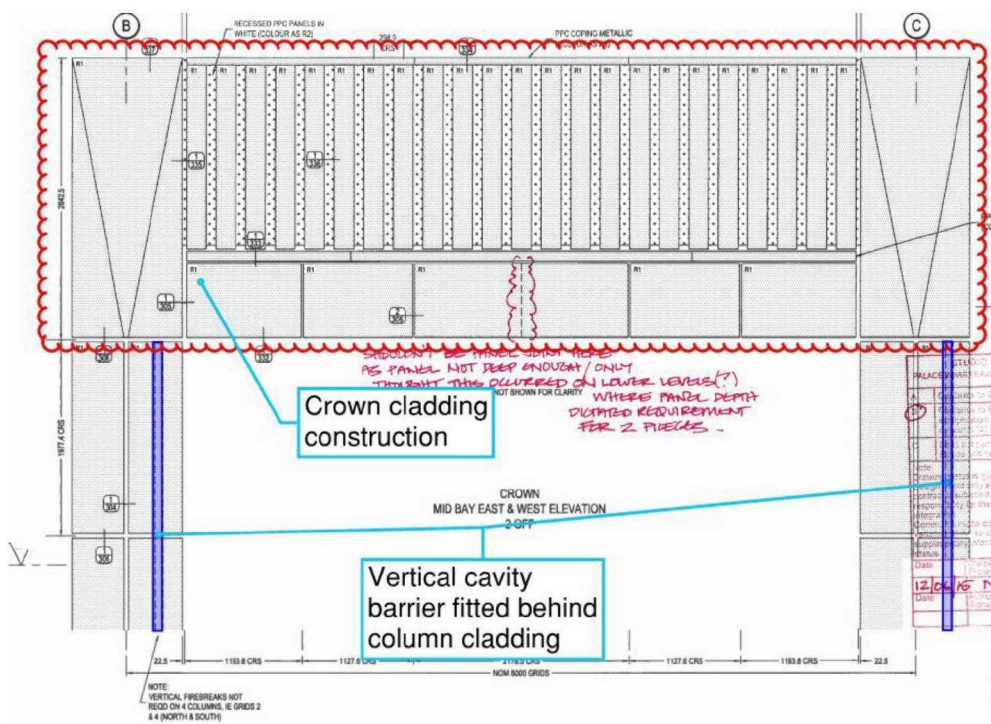
Figure 10.49: Harley “approved for construction” design drawings showing vertical cavity barrier extent (based on SEA00003242 red writing from original document)

10.8.24 There is no evidence currently available that any provisions were made to prevent horizontal fire spread around the crown cladding. The Harley “approved for construction” drawings (Figure 10.49) indicate that the vertical cavity barriers provided behind the new column cladding were to terminate at the level of the top of the windows at Level 23. This would allow fire to spread over the top of the cavity barrier.

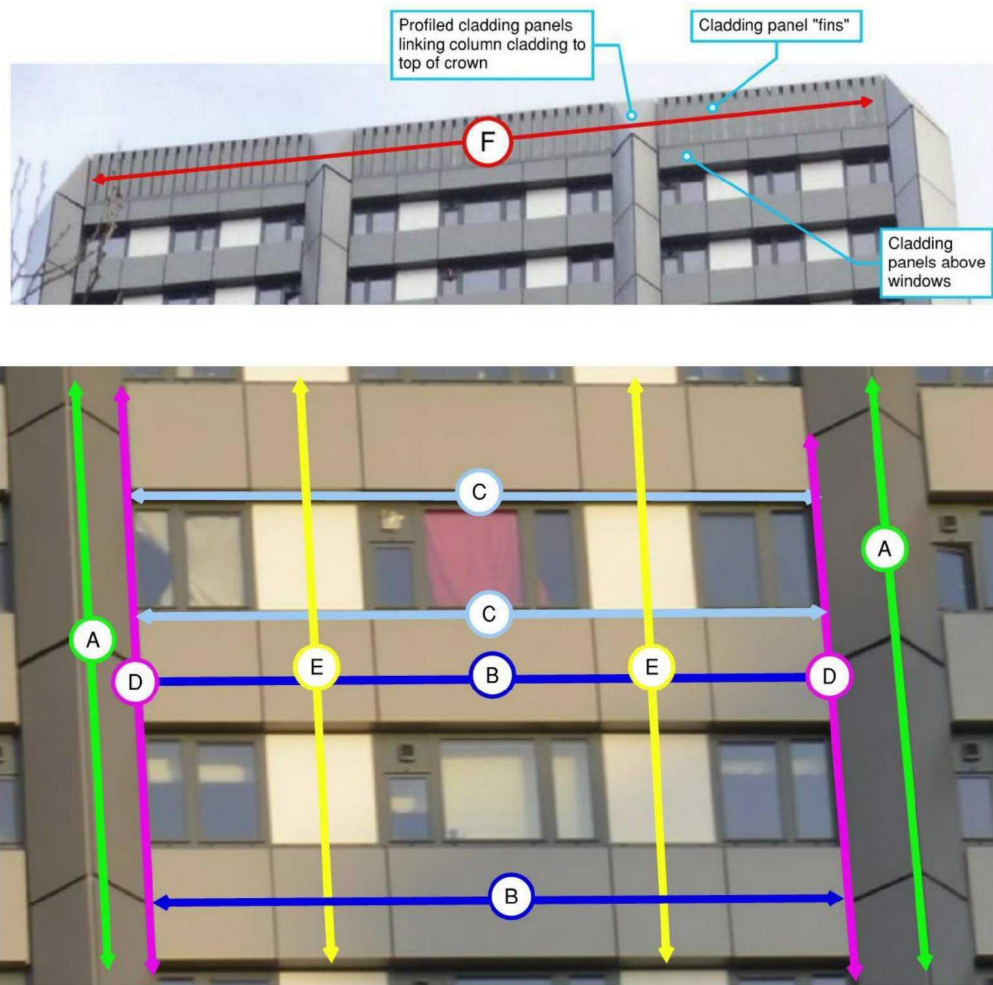
Figure 10.57: Pathways A to E (lower image) and F (Crown) identified on undamaged façade (SEA00000350; SEA00000322)

- 10.10.1** I have explained the 6 Pathways (A, B, C, D, E and F) shown in Figure 10.57 and how they permit vertical and horizontal fire spread along the building envelope.

- 10.10.4** Observations of the fire from the night clearly demonstrate the resulting geometric grid formed by multiple Pathways for fire spread over the external wall. This is due to the interconnection of all the Pathways via the rainscreen cladding panels, combustible insulation, combustible materials around the windows and insulating core infill panels.

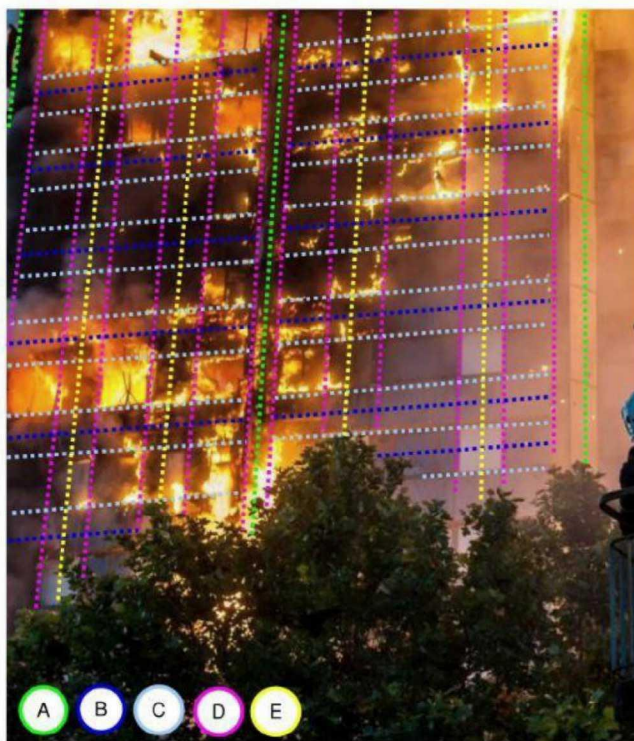
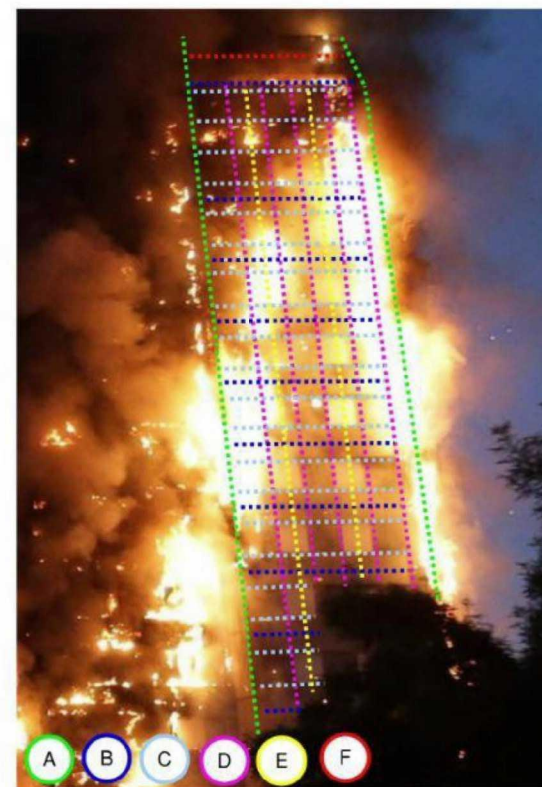
Figure 10.58: Fire spread on West elevation of Grenfell Tower

10.10.6 This fully connected grid facilitated fire spread in both the vertical and horizontal directions on all elevations of the building and between elevations, connecting the entire building envelope of Grenfell Tower. Figure 10.58 shows photographic evidence of fire spread via each of the six pathways on the West elevation of Grenfell Tower.

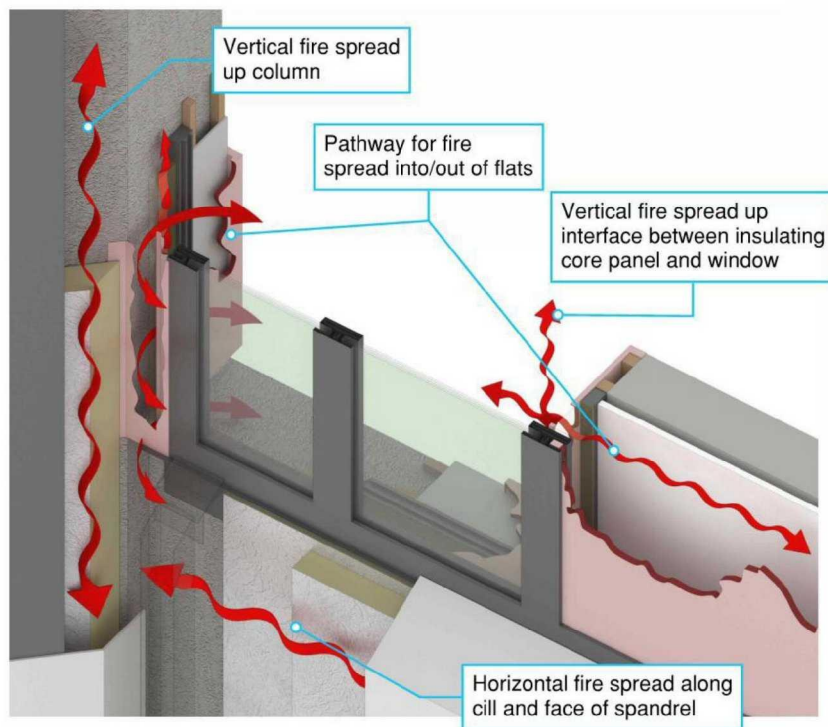
Figure 10.59: Pathway between external wall cavity and inside of flats

- 10.10.7** These six pathways and their connections permitted the fire to encompass the whole of the façade and penetrate inwards to the majority of the flats. I have presented in Section 9 the specific routes that I have identified that could permit fire to spread from inside a flat into the building cladding, but importantly fire could spread from the outside of the building back inside, as shown in Figure 10.59.

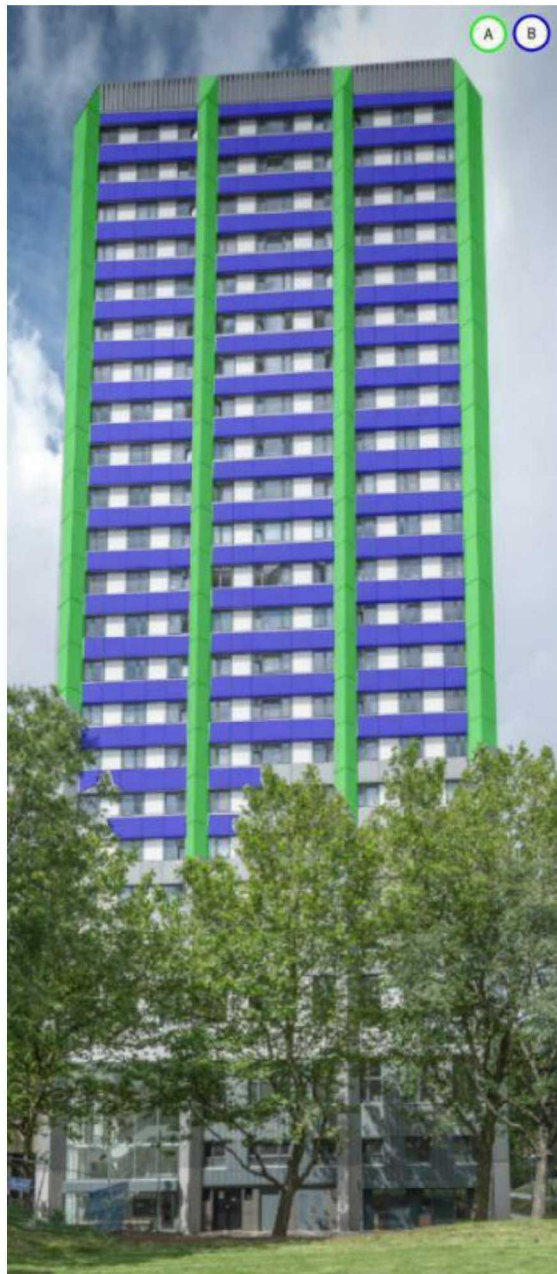
Figure 10.61 Pathways for external fire spread: pathway A and B (SEA00000387)

10.10.11 In this section I have considered the two pathways relevant to the external rainscreen cladding system only (Figure 10.61), that is:

- a) Pathway A: Vertically via the Reynobond 55 PE and Celotex RS5000 insulation attached to the columns; and
- b) Pathway B: horizontally via the Reynobond 55PE and Celotex RS5000 or Kingspan K15 thermal insulation attached to the spandrels.

- 10.10.12** In Figure 10.61 I have over-marked a photograph of Grenfell Tower before the fire on 14th June 2017. The vertical and horizontal connection between the columns and spandrels creates a grid and therefore resultant pathway for fire to spread over the full extent of the exterior of Grenfell Tower.
- 10.10.13** Figure 10.62 shows photographic evidence of fire spread via Pathways A and B on the West elevation of Grenfell Tower. The installation of Reynobond 55PE ACM panels and Celotex RS5000 or Kingspan K15 thermal insulation along the columns and spandrel panels in the rainscreen system created a grid covering all parts of the external wall in isolation.

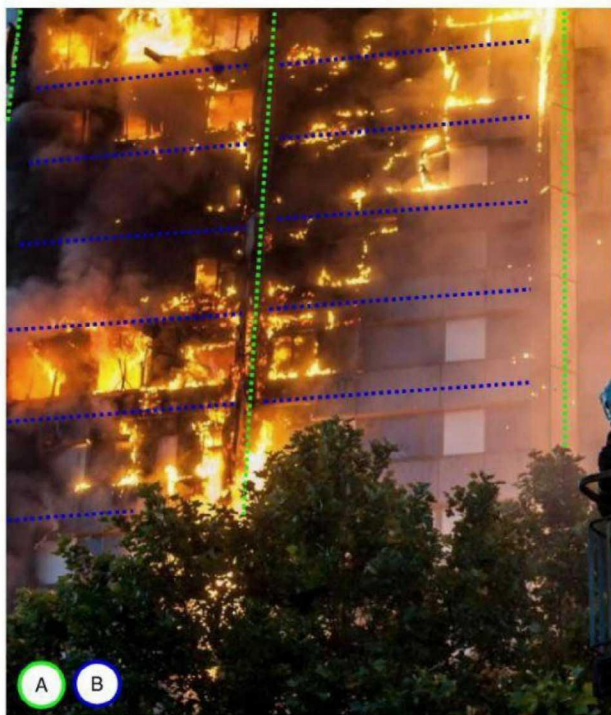
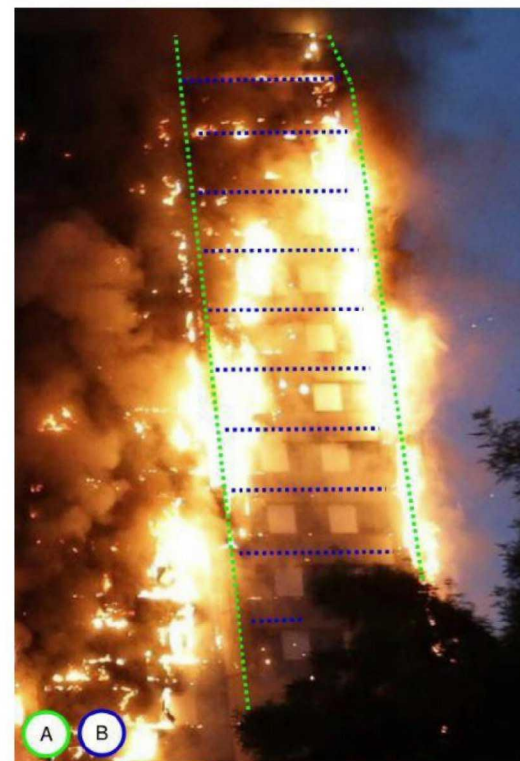
Figure 10.62: Fire spread on West elevation of Grenfell Tower

(a) Photographic evidence of Pathways A, B, C and D¹⁴

(b) Photographic evidence of Pathways A, B and E¹⁵

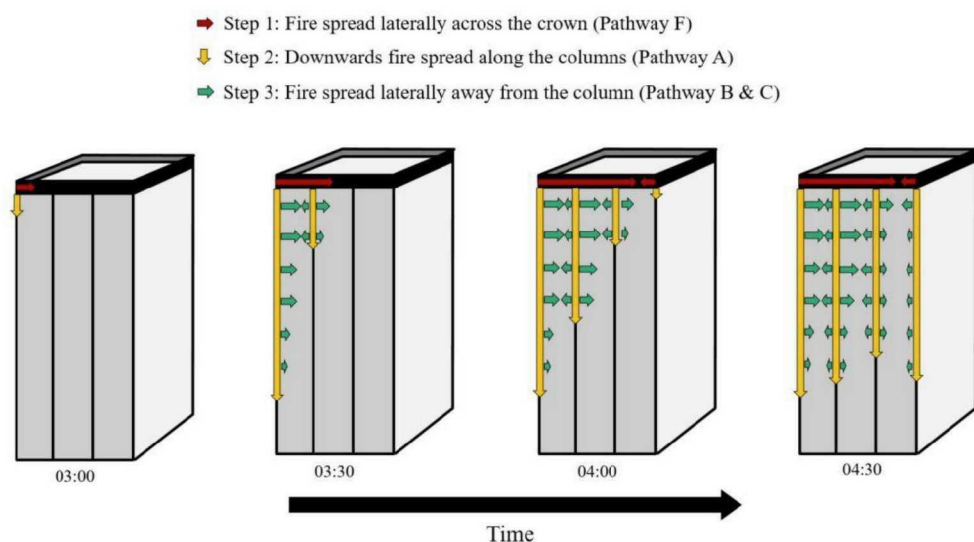
Figure 10.72: Schematic demonstrating the effect of fire spread along the architectural crown on lower levels of the building over time, on the West elevation of Grenfell Tower (MET00012593) (see Videos 2-5 accompanying Prof. Bisby's supplemental Phase 1 report.)

- 10.10.26** In Figure 10.72, I provide a schematic of these three steps of external fire spread caused by the crown, as I observe them to be, to demonstrate the effect of fire spread along the architectural crown on lower levels of the building over time.
- 10.10.27** This schematic is based on photographic and video evidence of external fire spread on the West elevation of Grenfell Tower.

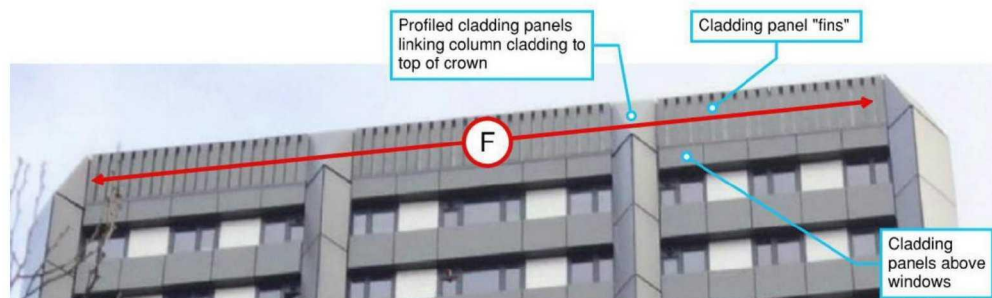
Figure 10.73: Pathway F (Crown) identified on undamaged façade (SEA00000322)

- a) Fire spread from combustible cladding panel “fins” on the architectural crown to the combustible cladding panels, insulation and cavity above the Level 23 windows (refer to Figure 10.73) – see photographic evidence in Figure 10.74; and
- b) Polyethylene from the Reynobond 55 PE panels on the crown melting and running down the building, while ignited – see photographic evidence in Figure 10.75.
