External fire spread – Part 1 Background research

By Ciara Holland, Dr David Crowder and Martin Shipp

External fire spread – Part 2 Experimental research

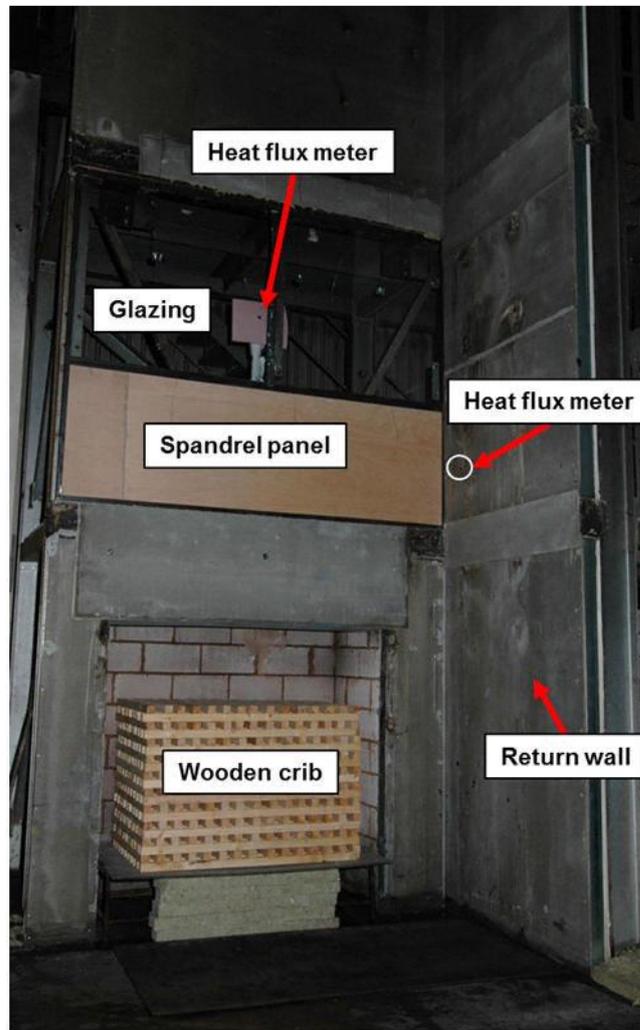
Figure 1 – Annotated image showing the front elevation of experimental set up

An experimental rig was designed and installed (Figure 1). This utilised one of the existing BRE Global BS 8414 test rigs [3]; a schematic of the BS 8414 test rigs can be found in BR 135 [5]. The intention of this experimental work was to evaluate potential fire spread from one building storey to another and therefore it was unnecessary to clad the entire height and return wing of the BS 8414 test rig.

A steel frame, 2850 mm wide by 2300 mm high was fabricated using 30 mm steel channel with 3 mm thick steel. This frame was installed onto the test rig, as shown in Figure 2, at the level directly above the fire source, approximately 2.7 metres from the ground and 700 mm from the top of the hearth. The frame was fitted to the leading edge of the concrete lintel resting on top of the lintel (see Figure 1) representing an external façade which is flush with the floor slab below. The frame was designed with two sections; the lower section contained the spandrel panel to be tested and the upper section contained the double-glazed units.

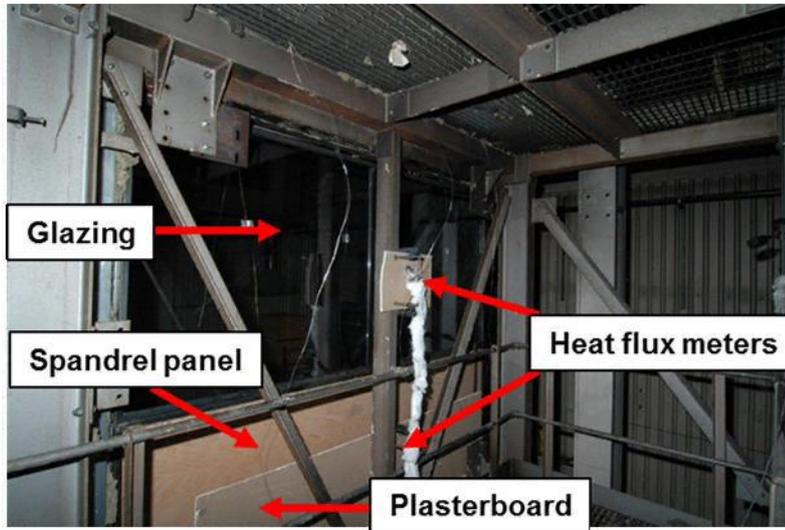
Figure 2 – Image of rear elevation behind the steel frame on level one of the test rig i.e. the level above the hearth

The spandrel panels were sealed into the frame by packing the channel with stone fibre wool insulation and the glazing units were sealed with glazing gasket, where necessary. Approximately 200 mm behind the spandrel panel, a sheet of standard 12.5 mm plasterboard (~ 500 mm x 2400 mm wide) was installed for mounting instrumentation on but also as a target to assess the potential damage (if any) from radiant heat or fire (Figure 2).

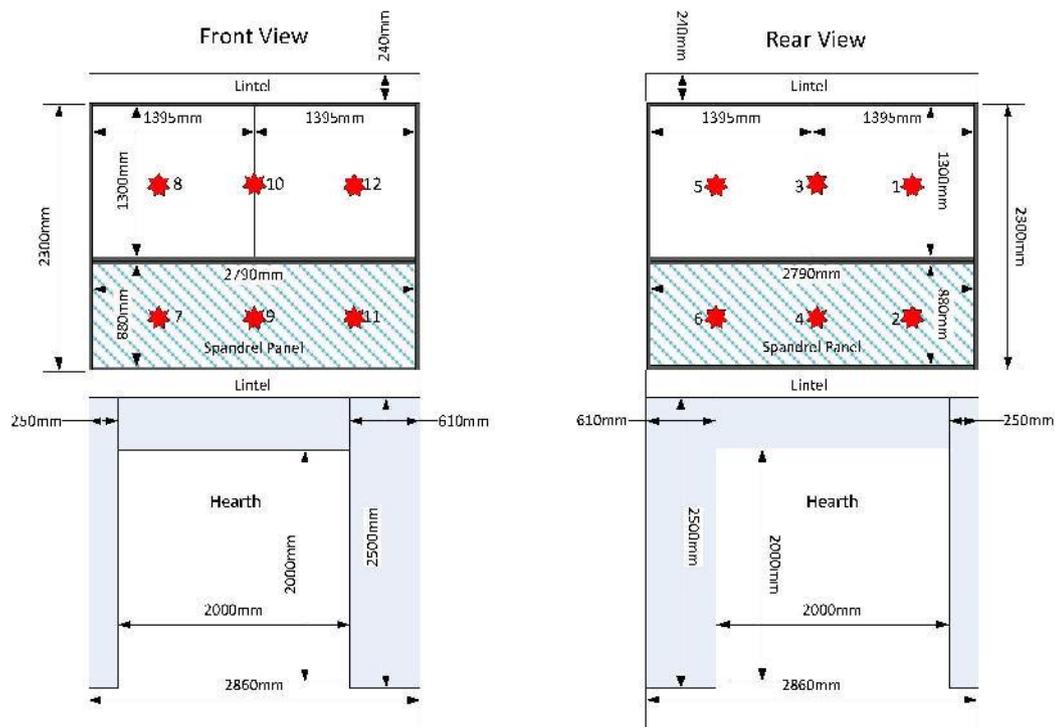
Figure 3 – Approximate locations of thermocouples in the structure

The experimental rig was instrumented with twelve 1.5 mm diameter Type K steel sheathed thermocouples. The thermocouples were arranged as shown in Figure 3. Thermocouples measuring temperatures at the glazing level were placed equidistantly. The thermocouples measuring temperatures at the spandrel panel were placed in similar locations, horizontally, to the thermocouples at the glazing level.

Thermocouples at the front of the rig were intended to record the gas/flame temperatures that the panels and glazing were exposed to, rather than solid surface temperatures. The thermocouples at the rear of the rig were approximately 300 mm from the spandrel and glazing and 1550 mm from the base of the frame; this was to record temperatures likely to be achieved within a room, hence they were not fitted to the rear side of the panels.
