The performance in fire of structural insulated panels

BD2710

BRE

December 2010
Department for Communities and Local Government

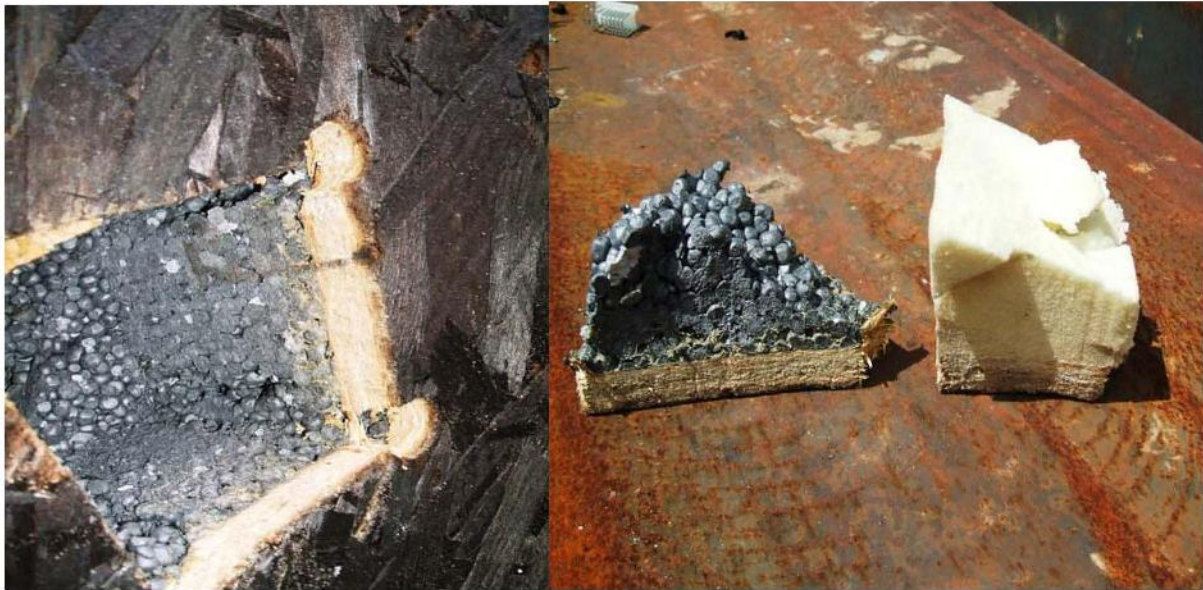
The damaged plasterboard lining was removed to reveal evidence of charring to the batten used to fix the plasterboard and limited damage to the surface of the oriented strand board. Charring was more pronounced local to the plasterboard fixings.

Following the test, a core sample was taken through the area of oriented strand board exhibiting the most damage. Figure 23a shows the area around the cut out and Figure 23b shows the sample compared to a similar section taken from a damaged polyurethane core. It can be seen that there is no damage to the insulation nor is there any evidence of delamination between the oriented strand board and the core material. This is consistent with the temperature readings.

Figure 23a Expanded polystyrene core following test

Figure 23b Comparison between expanded polystyrene and polyurethane

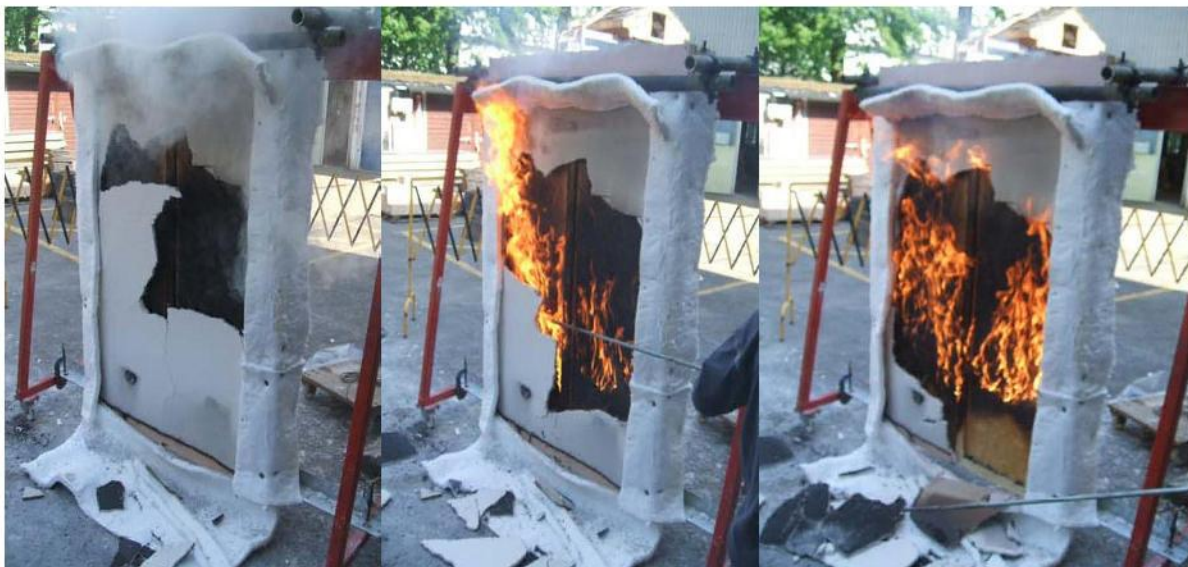
For both the polyurethane and expanded polystyrene samples, removal of the plasterboard immediately after the test resulted in ignition of the oriented strand board, see Figure 24.

Figure 24 Sequence of photographs showing ignition of oriented strand board on removal of plasterboard lining

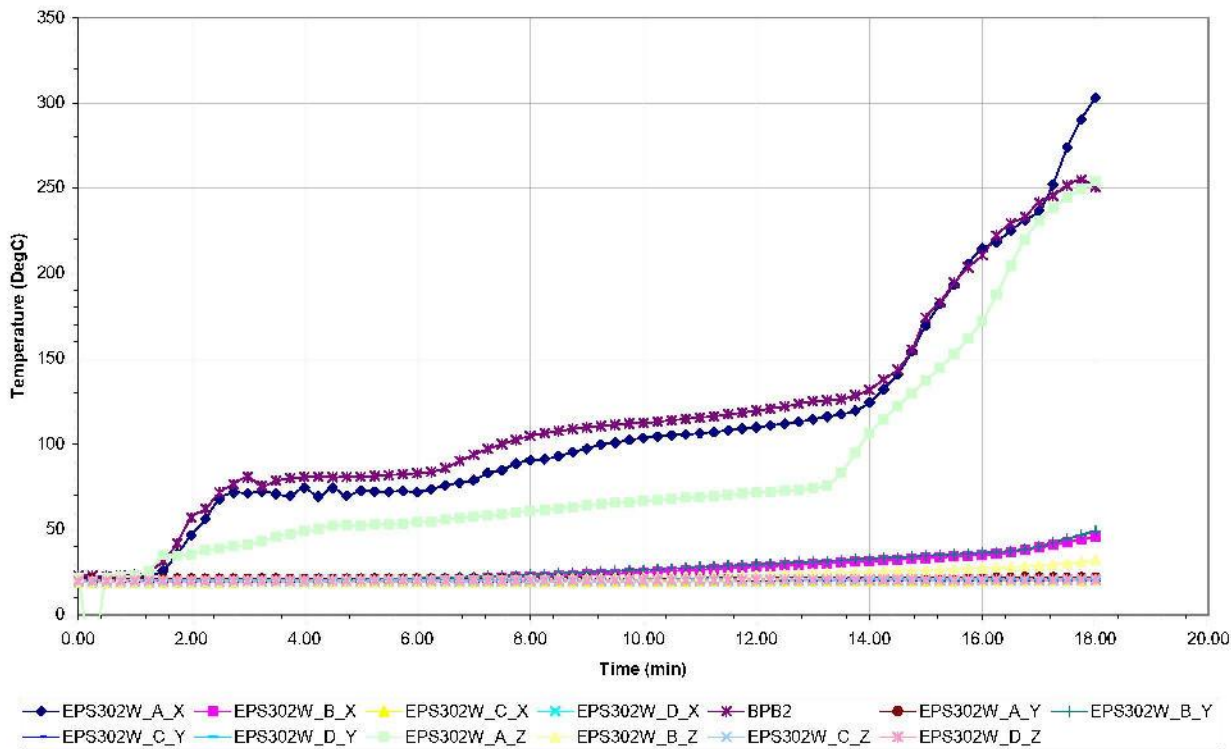
Figure 38 Temperature profile through expanded polystyrene panel protected with 12.5mm type A plasterboard

Where a single layer of 12.5mm Type A plasterboard was fixed to expanded polystyrene panels via softwood battens, the test had to be terminated approximately 20 minutes from ignition due to combustion of the exposed oriented strand board skin. A typical temperature profile is shown in Figure 38.

The results bring into question the use of such a lining for dwellings.

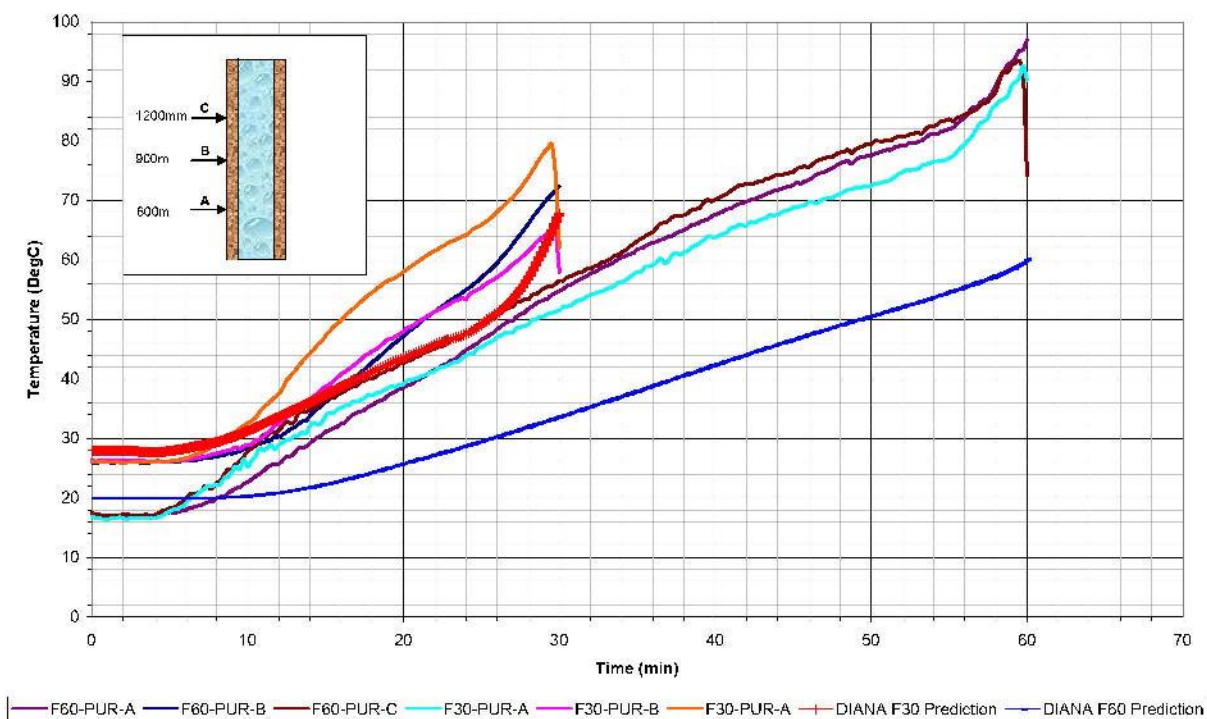
Figure 51 Comparison between modelled and observed back of oriented strand board temperatures

Some discrepancies between the predicted and measured back of oriented strand board temperatures exist, particularly in the 60 minute case, where the measured and predicted differ by some 30°C. This is not particularly significant as the temperatures observed are very low. These errors could arise due to a number of factors. The thermo-physical model adopted for oriented strand board could be inaccurate. If this is the case, then either the mean conductivity is higher than that of solid timber or the temperature dependent specific heat is more than 30 per cent lower than that of MDF, as specified by Thoemen¹⁹. Alternatively, the proportion of radiative to convective fluxes calculated in the battened void is incorrect. If this is the case, then it is likely that the model is under-predicting the magnitude of the radiative portion of heat transfer in the battened void. This issue could be further investigated by performing a number of tests on panels with the dry-lining fixed directly to the oriented strand board skin. This would eliminate the need to model the battened void, turning the problem into a simple case of one dimensional conduction. This would indicate if the oriented strand board thermo-physical model implemented is accurate or if the calculated re-radiated and re-convected fluxes in the void are inaccurate.

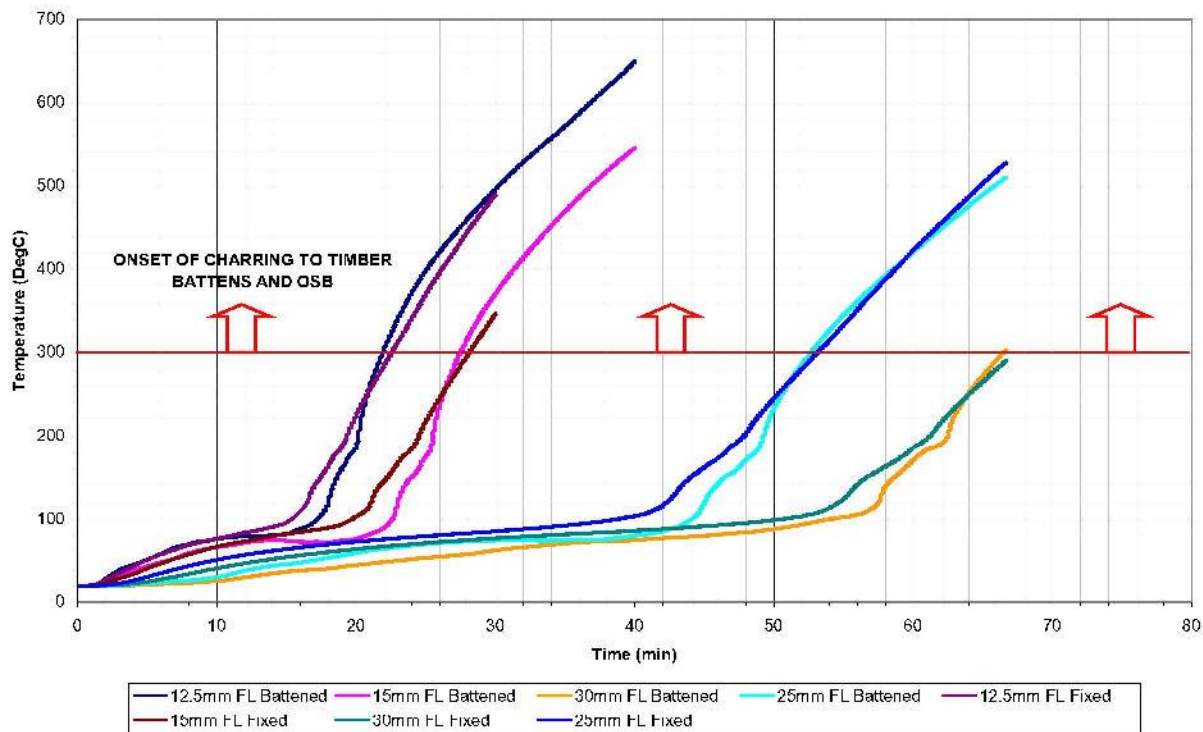
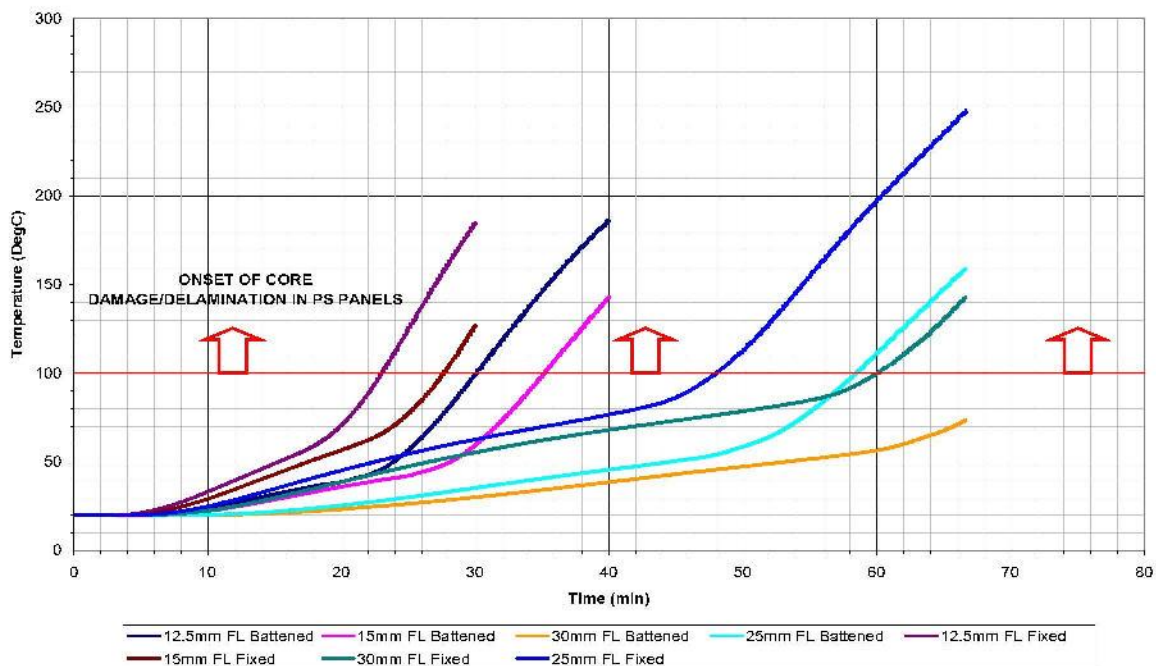
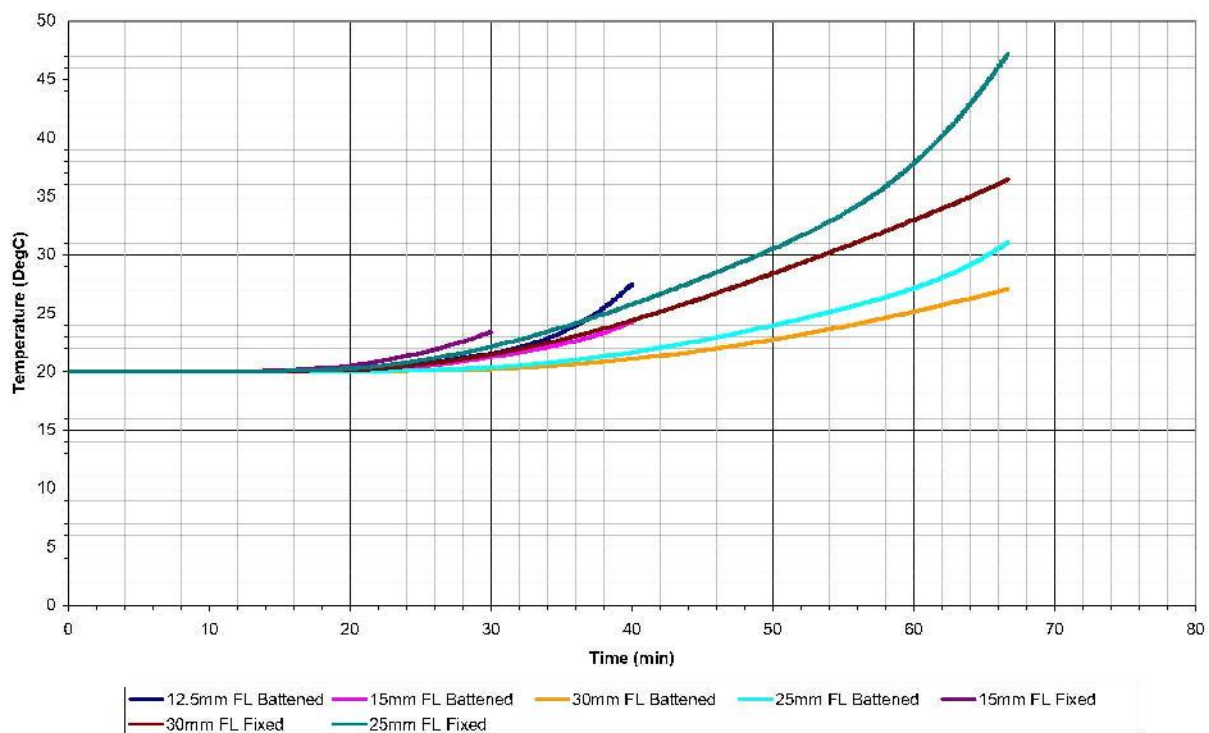
The results presented in Figures 53 to 55 are predictable. Downgrading the specification of the internal dry-lining increases panel temperatures, which in some instances could have serious consequences for the load bearing capacity of the panel. Although polyurethane cores were studied numerically, the temperature difference between polyurethane and PS cored panels has been shown experimentally to be nominal for core temperatures below the glass temperature of PS (approximately 100°C). Therefore, it could be reasonably assumed that the temperature increases with time, up until the glass temperature of PS is almost identical for the two most common core materials. As a result the study has shown that before the design fire resistance period of the panel is reached, some breakdown of a polystyrene core would occur in almost all instances. This could cause de-lamination of the bond between the oriented strand board veneer and core material and result in a loss of composite action. Under pure compression, as is the case for most walls at the fire limit state, this is likely to result in localised buckling of the veneer most severely exposed to the fire.

Perhaps even more critical to the above, the study has shown that fixing directly to the oriented strand board veneer results in significantly higher temperatures in the panel when compared to a battened lining (assuming no workmanship defects in the latter case). This is due to the additional air medium through which the heat must pass where some energy is lost due to convection as the air slowly begins to increase in temperature. This difference is particularly pronounced after 60 minutes of exposure where, for the same passive fire protection (principally plasterboard), the difference between a battened and fixed lining can be as much as 85°C.

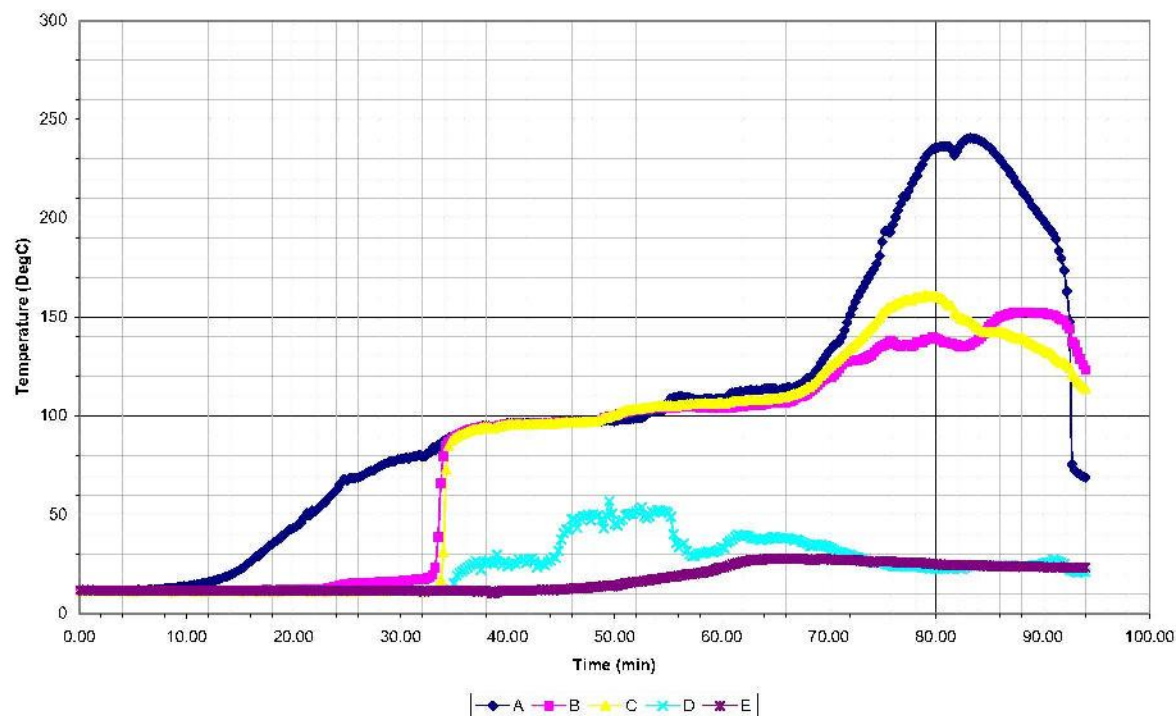
Figure 60 Temperature readings through party wall at gridline 2 – Test F1

Figures 60 and 61 show a gradual increase in the temperature behind the plasterboard as the moisture is driven off. The rapid temperature rise of the oriented strand board and the core after 30 minutes is likely to be due to migration of steam through the section via the holes used to fix the thermocouple positions. This rapid increase in temperature reaches the boiling point of water where the temperature is maintained at around 100°C for the duration of the moisture plateau. Once the plasterboard has completely dried out, the temperature of the inner layer of the oriented strand board and the temperature within the panel where the expanded polystyrene has melted can increase. The temperature of the party wall remained below the notional ignition temperature of timber (250 to 300°C) for the duration of the test.

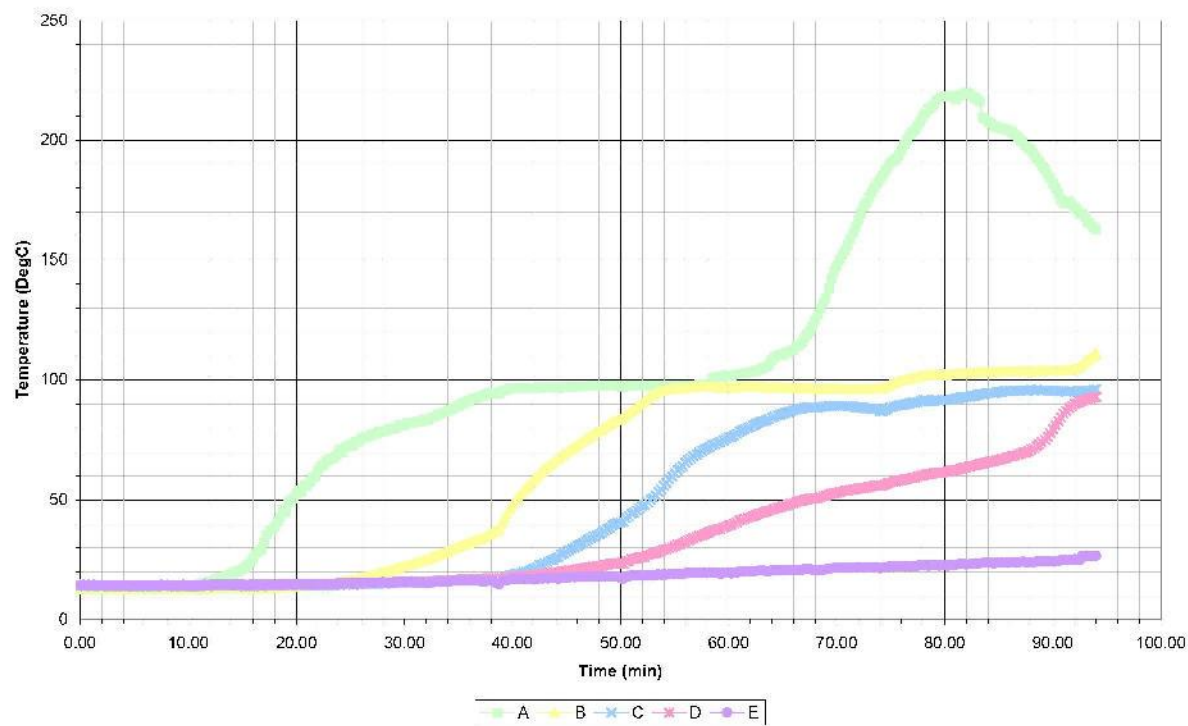
Figure 63 Temperature readings through rear wall on gridline D – Test F1

Figures 63 and 64 show a similar pattern to that for the party wall with a long moisture plateau and temperatures maintained below 300°C for the duration of the test. What is particularly noteworthy is that the temperatures within the structural insulated panel show no sign of reducing even at the end of the recording period when the temperatures behind the plasterboard are rapidly decreasing.

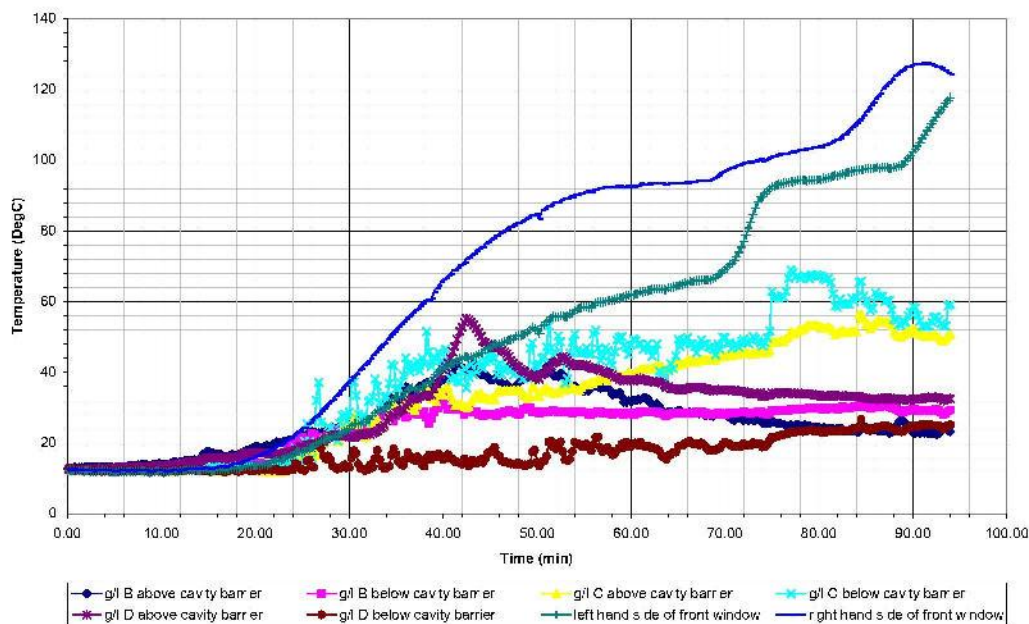
Figure 66 Temperatures in cavity on front wall (GL1) and in insulated core adjacent to window opening

Figures 66 and 67 show that there was no appreciable temperature rise in the cavity between the structural insulated panel panels and the masonry for the duration of the test. In many cases the temperature above the cavity barrier is higher than that below. This can be accounted for by the ceramic fibre seal at the top of the wall. What is particularly noticeable in the figures is the temperature rise in the insulated core adjacent to the window opening. The temperatures continue to increase at the end of the test indicating a break through either from the window itself or from a breakdown of the internal linings in the latter stages of the test.

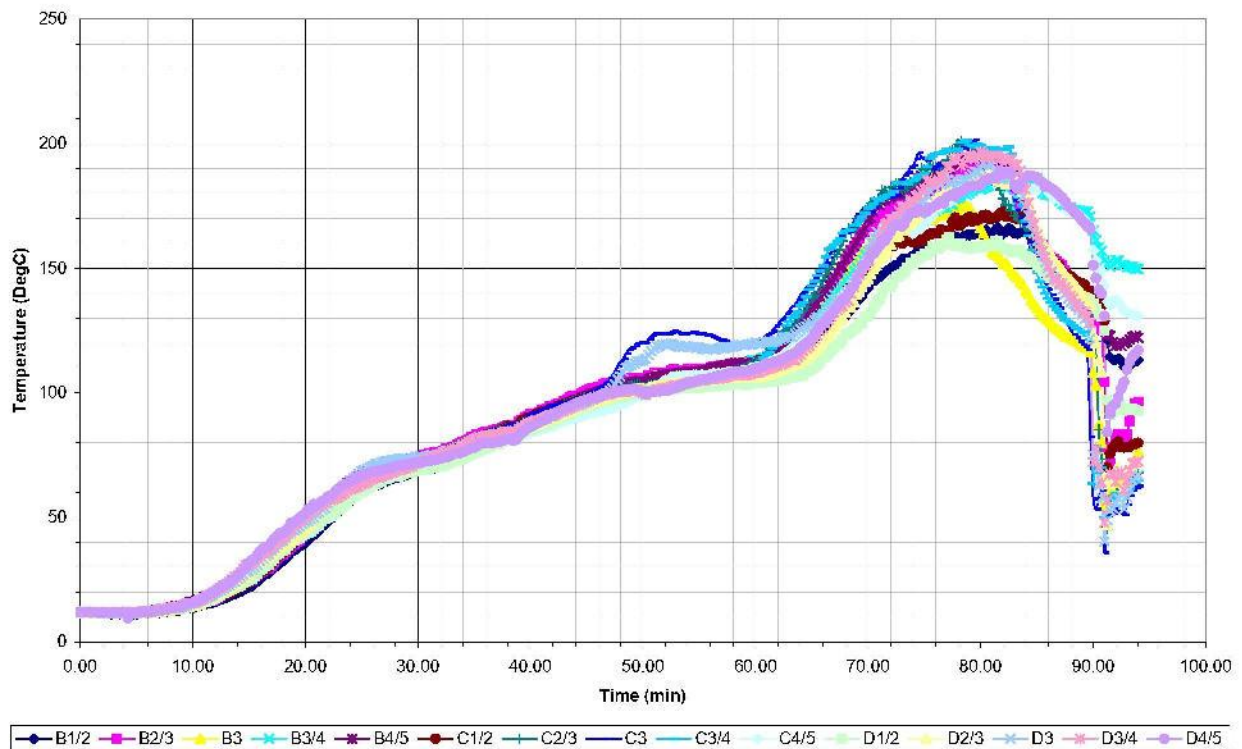
Figure 68 Temperatures in the first floor void – Test F1

Figure 68 shows that the temperatures in the floor void did not exceed 200°C for the duration of the test and all areas had cooled down appreciably by the time the fire was suppressed.

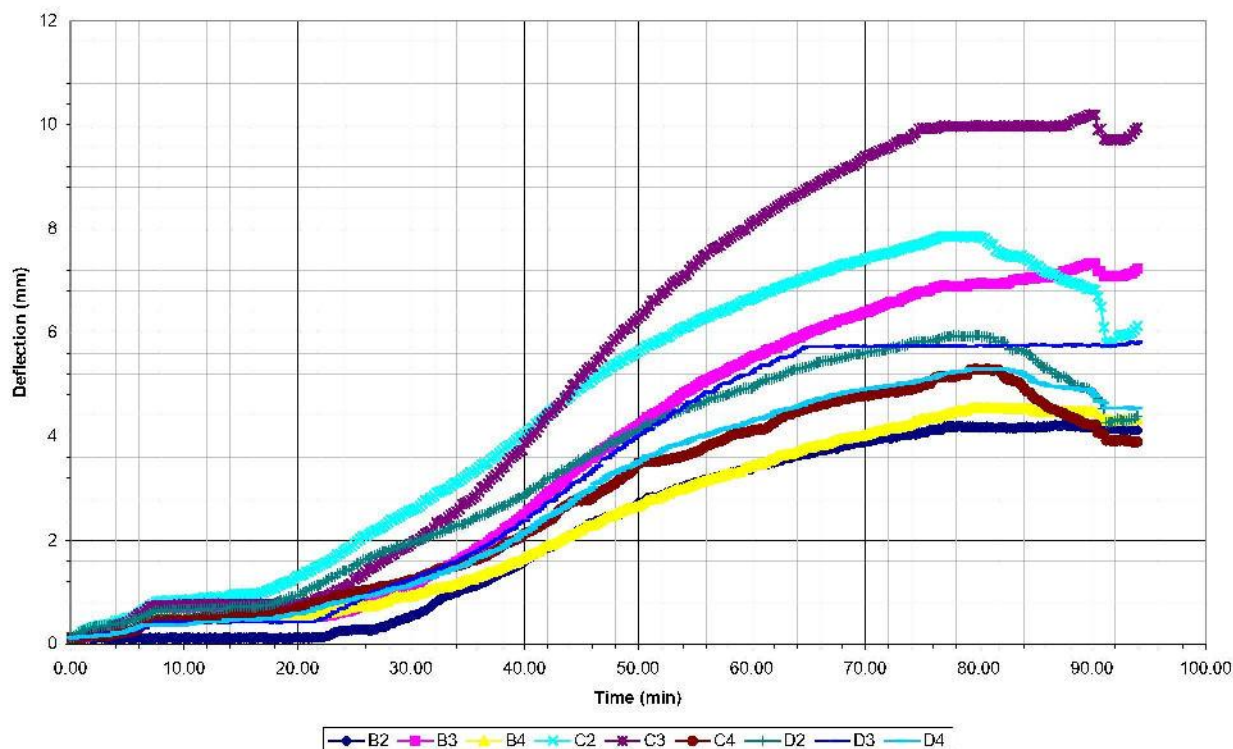
Figure 69 Displacement of first floor relative to second floor – Test F1

Figure 69 shows a maximum deflection of just over 10mm in the centre of the floor. Although the deflections have peaked and started to recover the graph shows some evidence that the deflections had started to increase again after the test was completed and the fire extinguished.

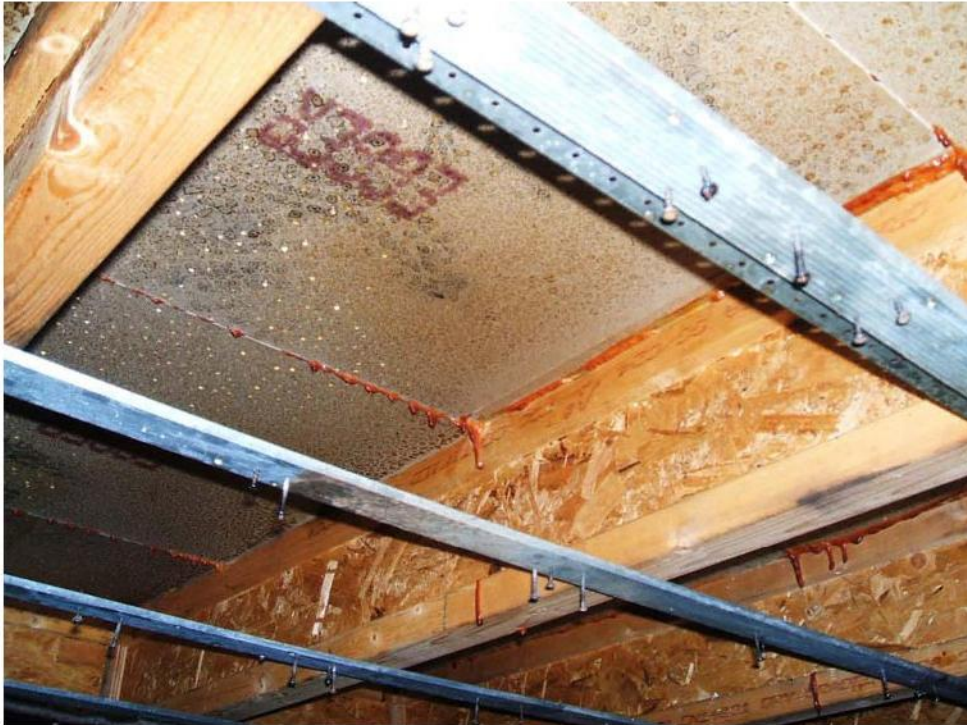
Figure 70 Engineered floor joists at end of Test F1

There was very little damage either to the engineered floor joists or the party wall, see Figures 70 and 71.

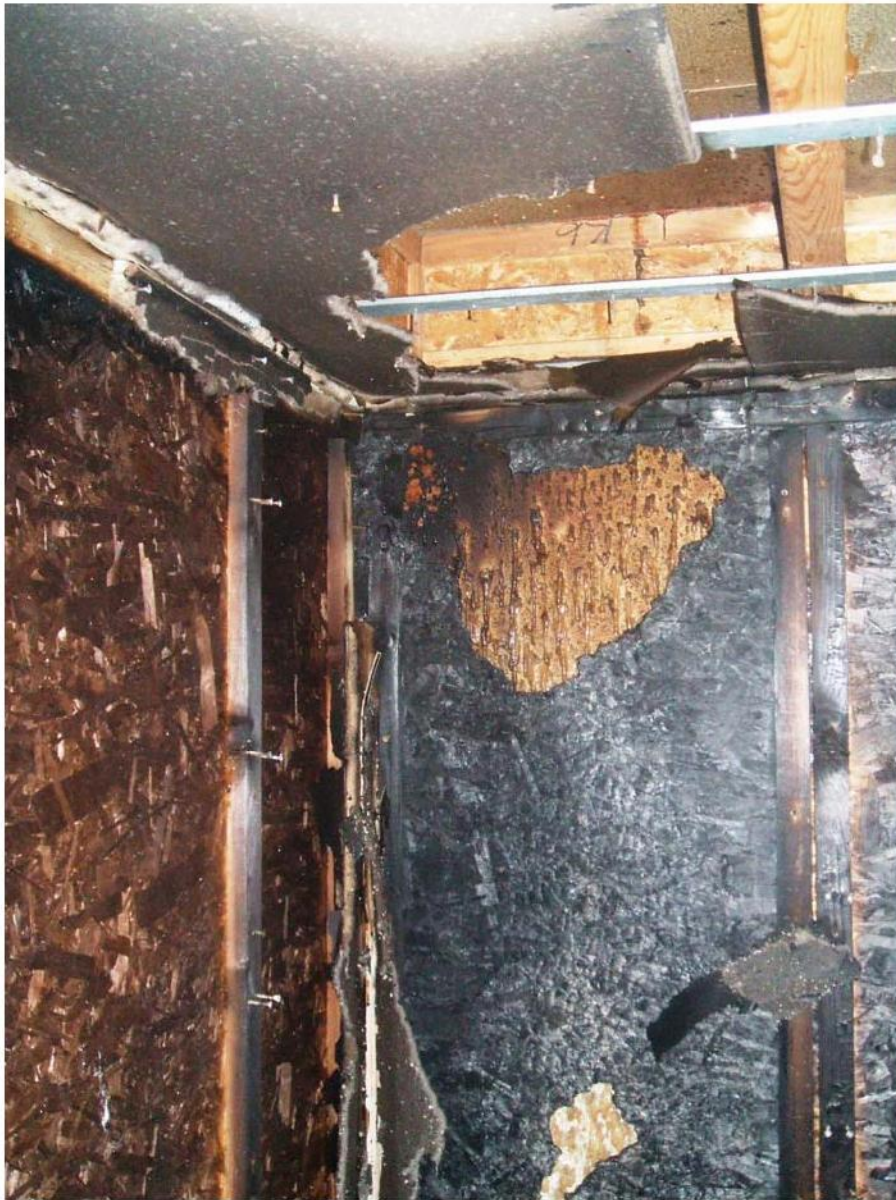
Figure 72 Damage to wall panel between side and rear wall – Test F1

Although the inner layer of oriented strand board appeared to be intact in most areas, there was some significant damage to the panels comprising the front, side and rear walls. In many areas, the core material had melted away and the inner layer of oriented

strand board had a significant amount of charring. This was particularly noticeable in the corner between the rear wall (grid line 5) and the side wall (grid line A). Once the fire and rescue service had left the facility, smoke was noticed emanating from the cavity space in this area. On removal of all the remaining plasterboard, it could be seen that the inner layer of the oriented strand board was severely damaged. As the damaged layer was removed, it became apparent that there was no insulation in this area, see Figure 72.

Once the extent of core damage was ascertained, other areas were inspected by drilling holes through the oriented strand board either from the inside or outside of the compartment. The expanded polystyrene insulation had melted from the panels in the rear wall between the door and the damaged corner shown above even though the inner layer of oriented strand board did not appear to be badly damaged, see Figure 72.

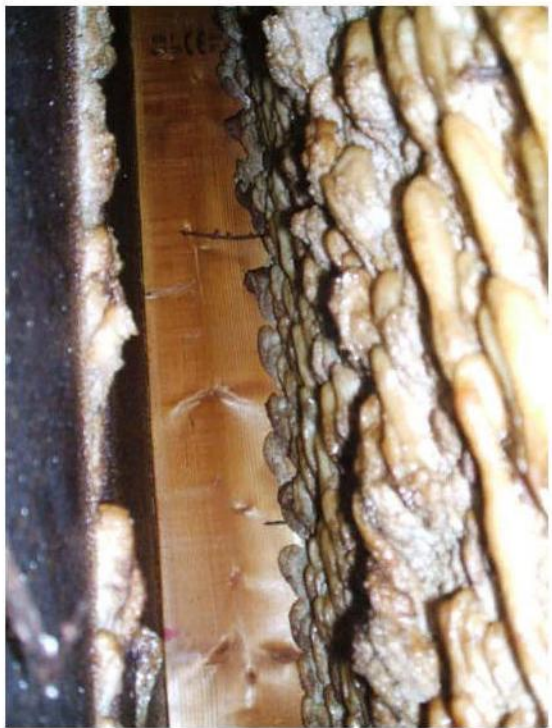
Figure 73 View through damaged structural insulated panel to window – Test F1

The insulation had melted within this area to the extent that there was no insulation between the corner studs and the timber boxing out the window. The extent of the damage can clearly be seen in Figure 73.

Figure 73 is a view looking into the structural insulated panel towards the window frame. Figure 74 is a view looking down the same panel towards the sole plate and shows how far the insulation has melted away.

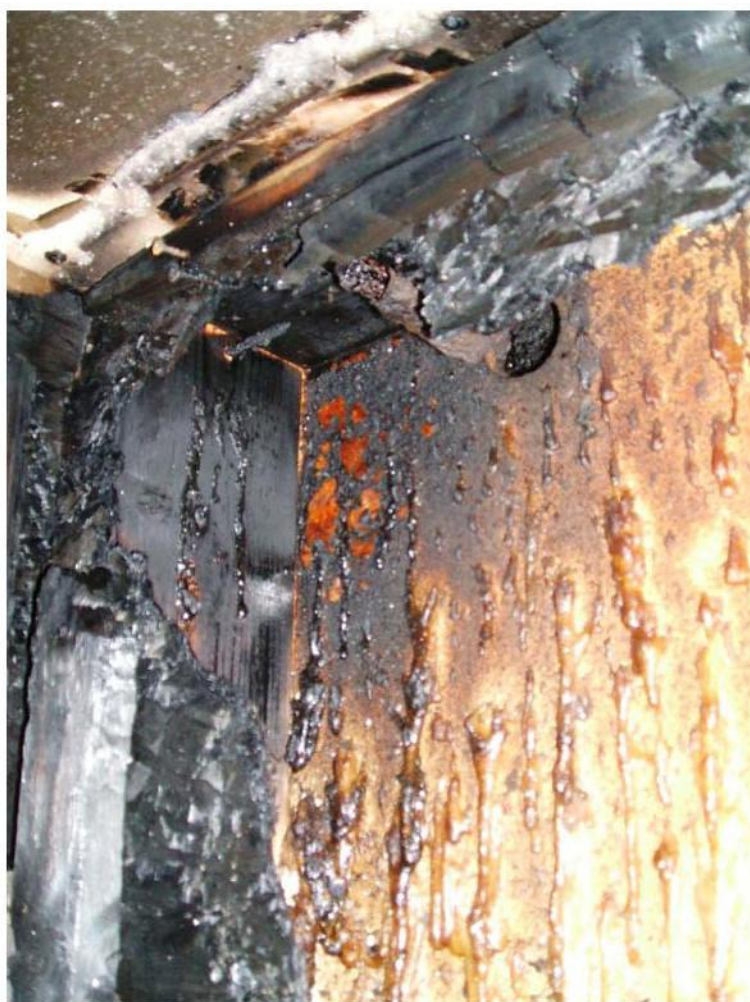
Figure 75 Location of post-test fire spread in cavity – Test F1

The fire in the cavity had started in the panel between the side window and the corner with the rear wall probably caused by smouldering of the battens used to fix the plasterboard or some movement of the joints in the dry lining at the ceiling to wall junction. The appearance of smoke and eventually flaming in the cavity between the masonry and the structural insulated panel coincided with the availability of an air supply. The panels come with prefabricated holes to facilitate lifting and erection. In a situation where there is a smouldering fire this has provided the oxygen necessary for combustion to take place. In order to extinguish the fire, it was necessary to remove the cavity barrier. In a fire test scenario with an open cavity, this only requires removing the ceramic fibre seal for access. In a real fire situation, access could be considerably more difficult. The area of combustion and the lifting hole is shown in Figure 75. Figure 76 shows the damage to the cavity barrier.

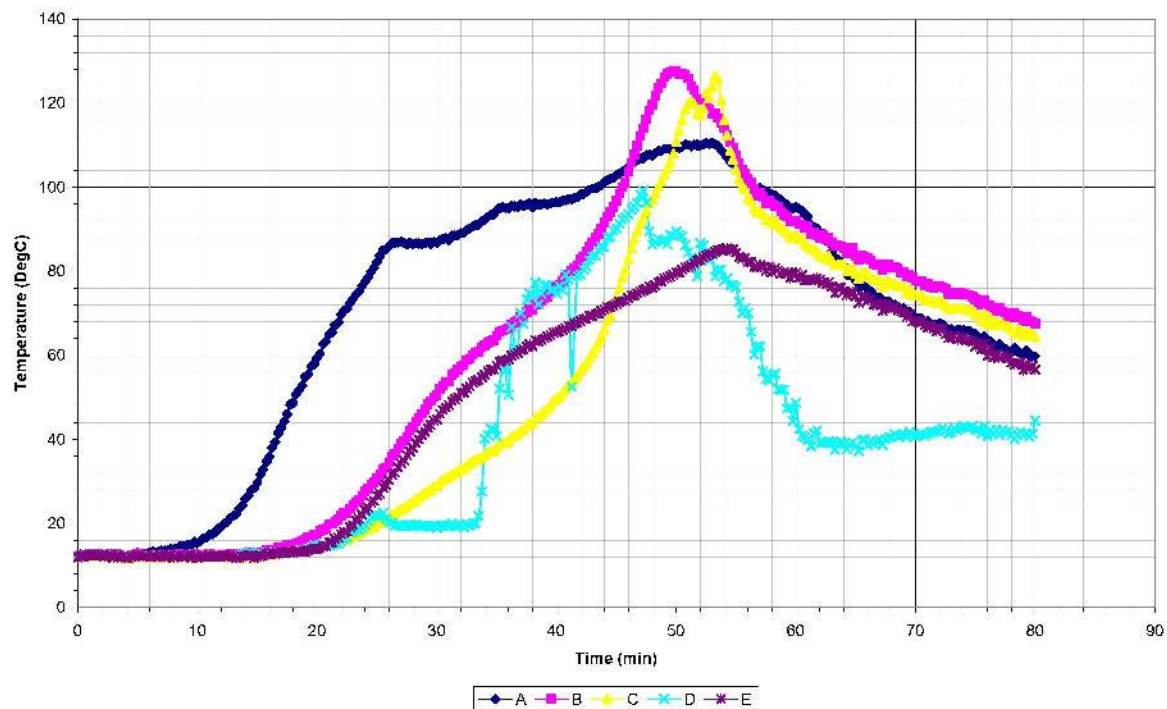
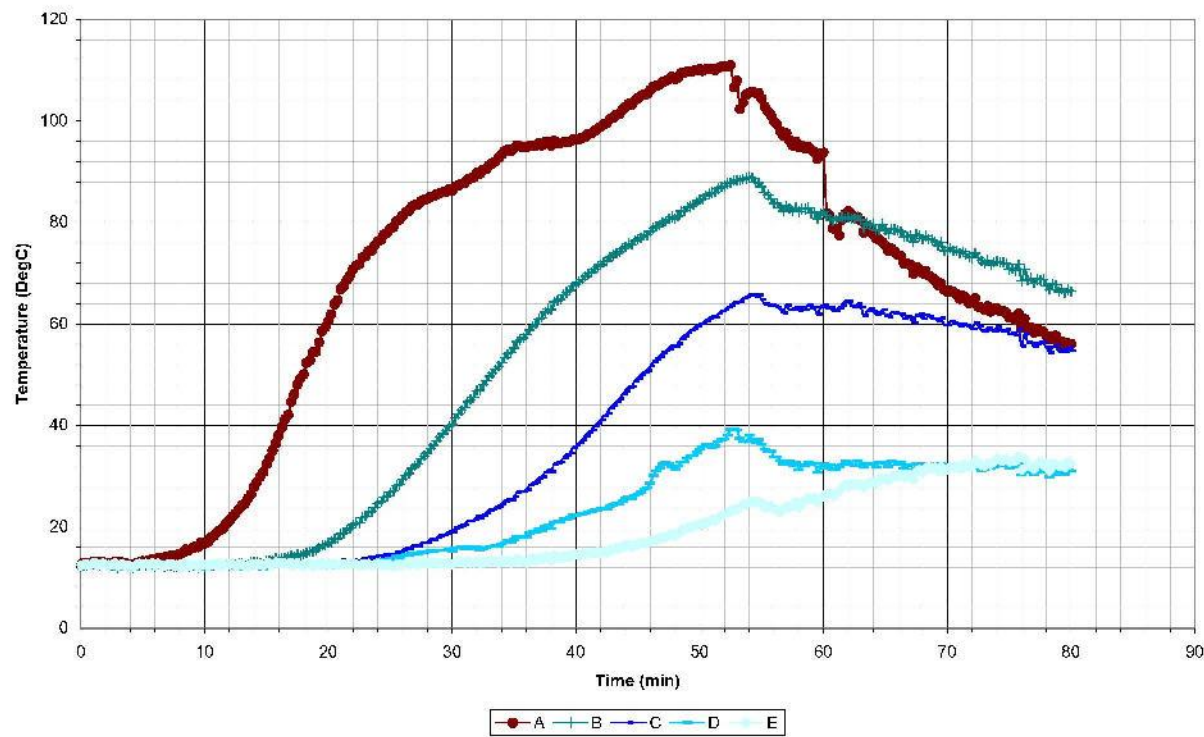
Figure 78 Temperature readings through party wall at gridline 2 – Test F2

Figure 79 Temperature readings through party wall at gridline 4 – Test F2

Figures 78 and 79 show that the temperature of the party wall remained below the ignition temperature of timber for the duration of the test. Some anomalies exist in Figure 78 which can be explained by gas and steam migration through holes drilled for thermocouple placement.

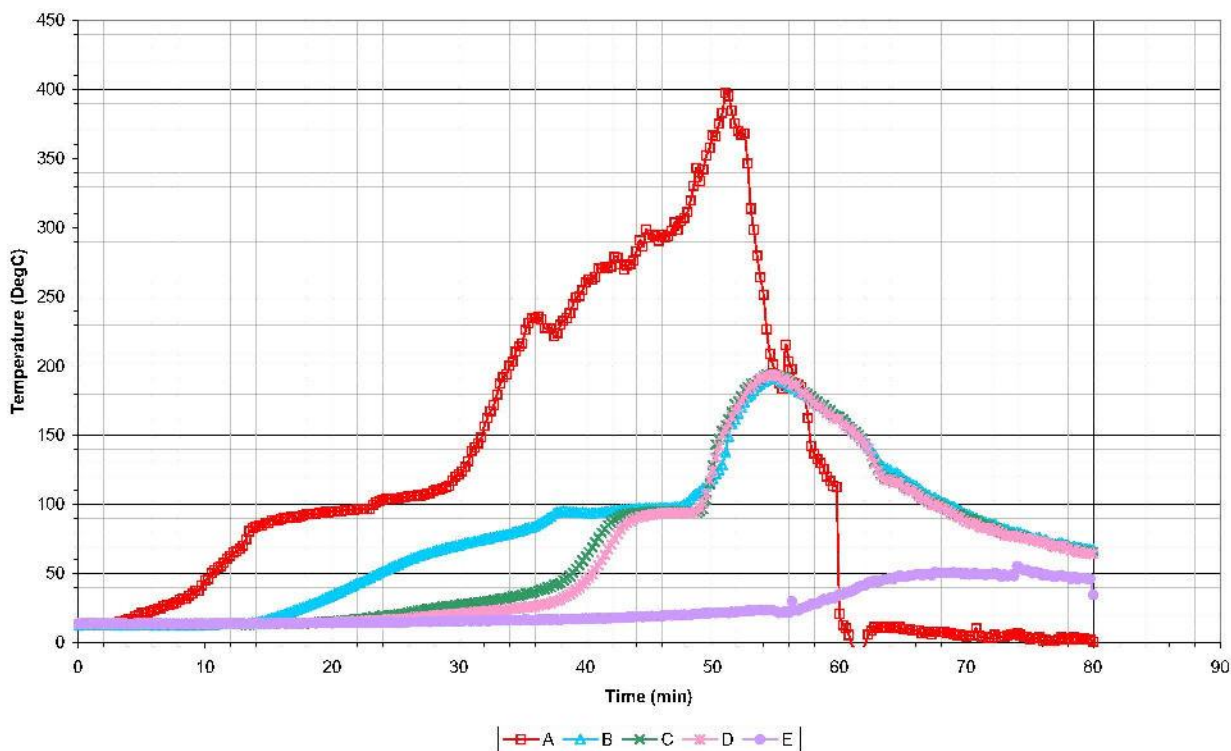
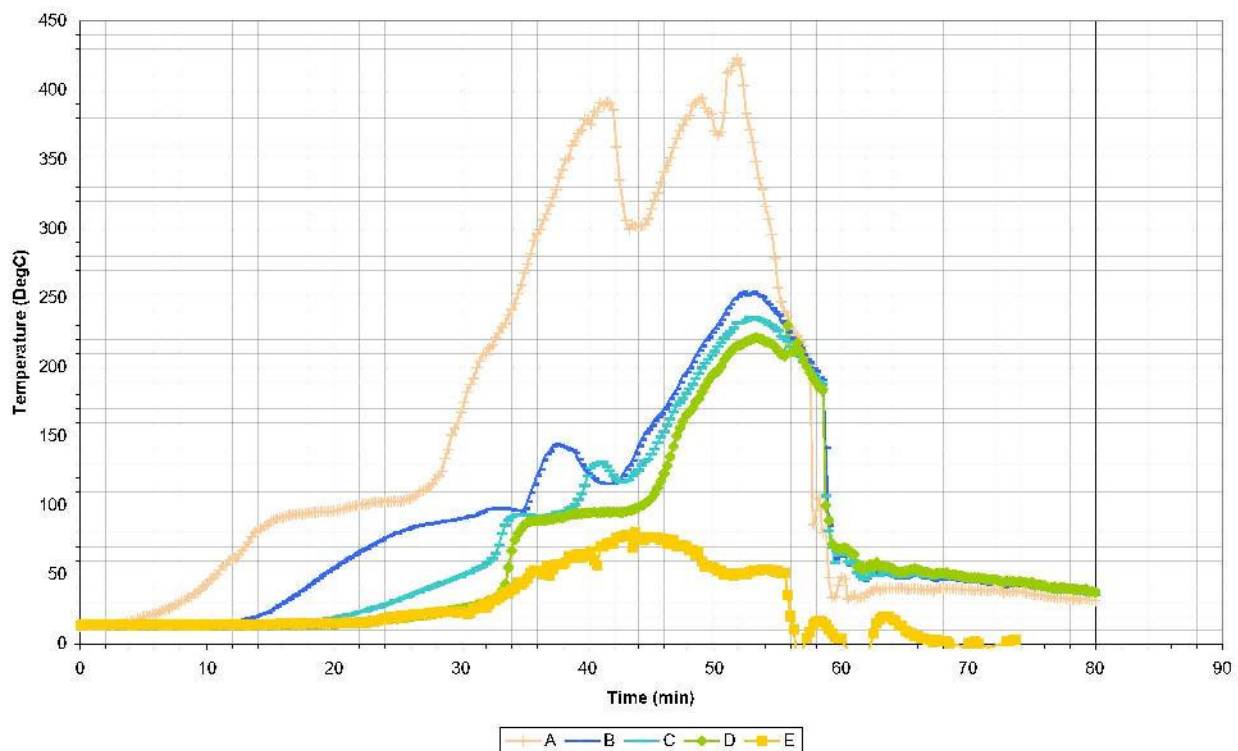
Figure 80 Temperature readings through rear wall on gridline D – Test F2

Figure 81 Temperature readings through rear wall on gridline B – Test F2

Figures 80 and 81 are consistent with a gradual breakdown of the plasterboard lining. In this case, there is evidence that the temperatures within the core continued to rise once fire-fighting operations had commenced. However, there is no evidence of an increase in temperature following fire-fighting operations.

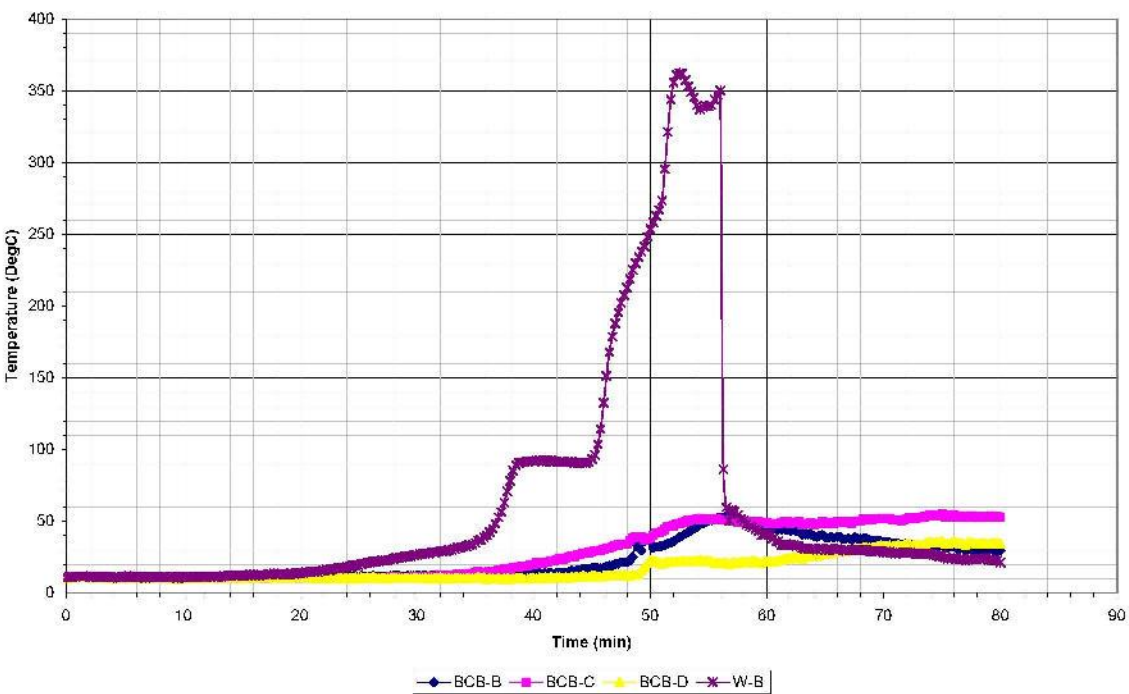
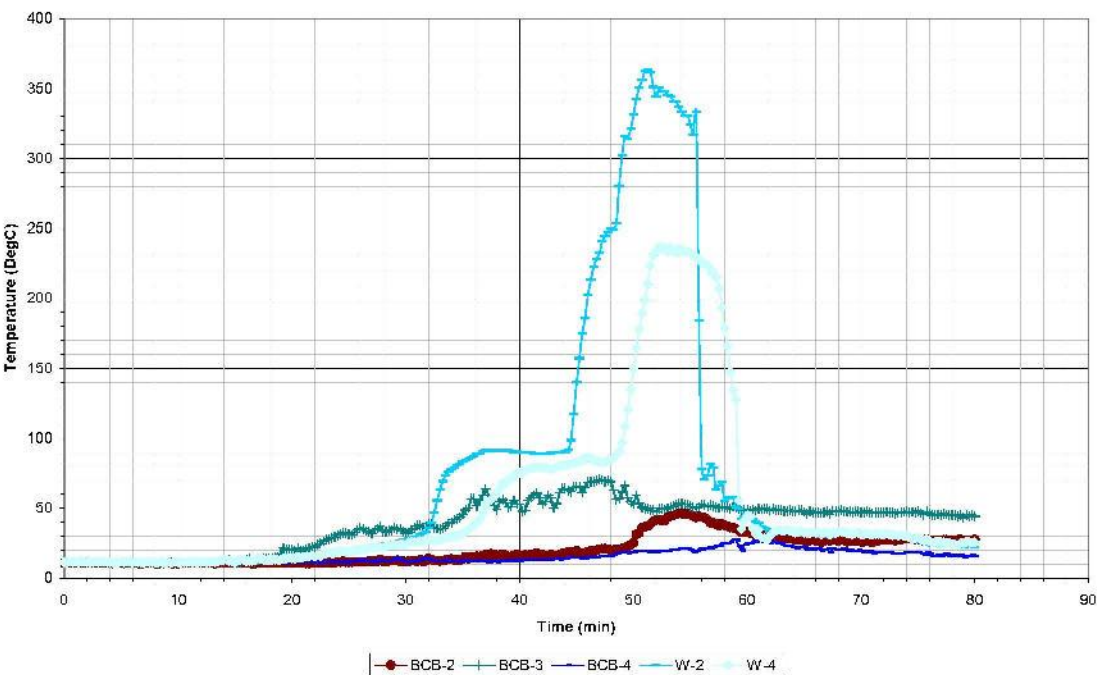
Figure 82 Temperatures in cavity on front wall (GL1) and in insulated core adjacent to window opening – Test F2

Figure 83 Temperatures in cavity on side wall (GLA) and insulated core adjacent to window opening – Test F2

Figures 82 and 83 indicate combustion in the core during the latter stages of the fire. There was no evidence either from the measured temperatures or visual observation of any breakthrough into the cavity.

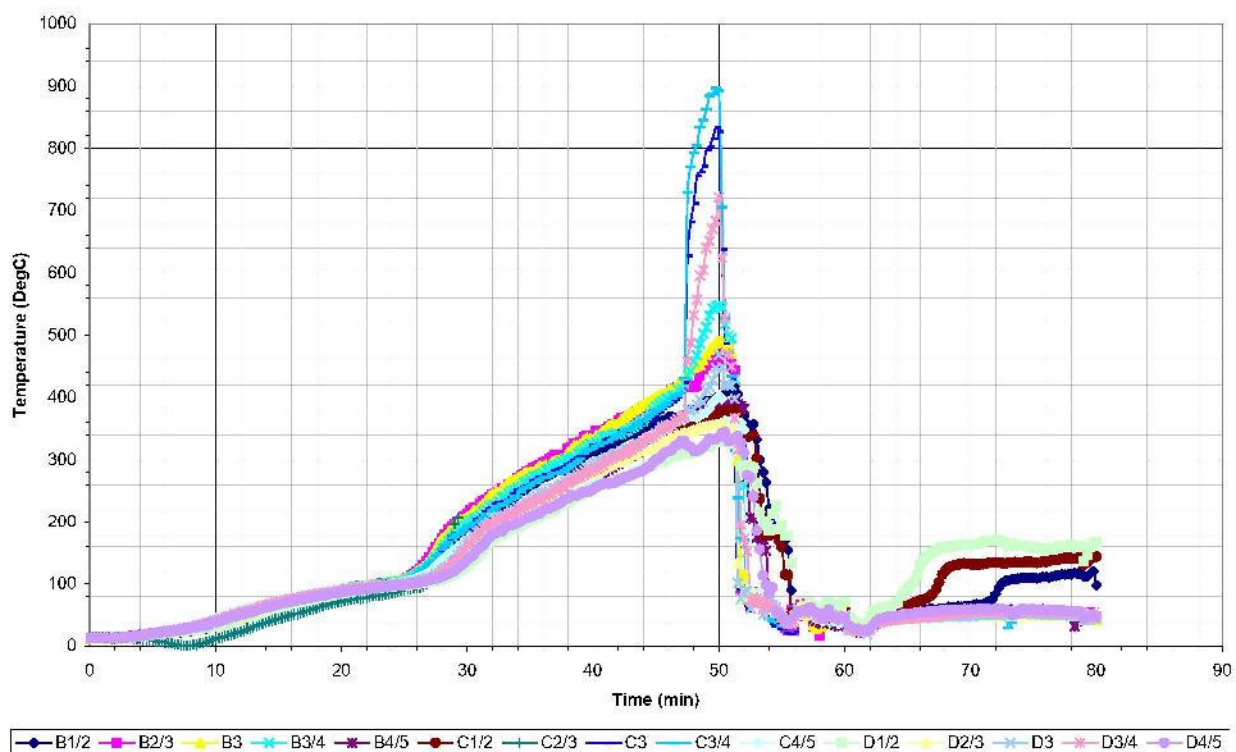
Figure 84 Temperatures in the first floor void – Test F2

The temperatures are indicative of combustion in the floor void. At this stage (in conjunction with deflection readings – see Figure 85) a decision was taken to terminate the test on the basis that the floor was in imminent danger of collapse.
