The performance in fire of structural insulated panels

BD2710

BRE

December 2010
Department for Communities and Local Government

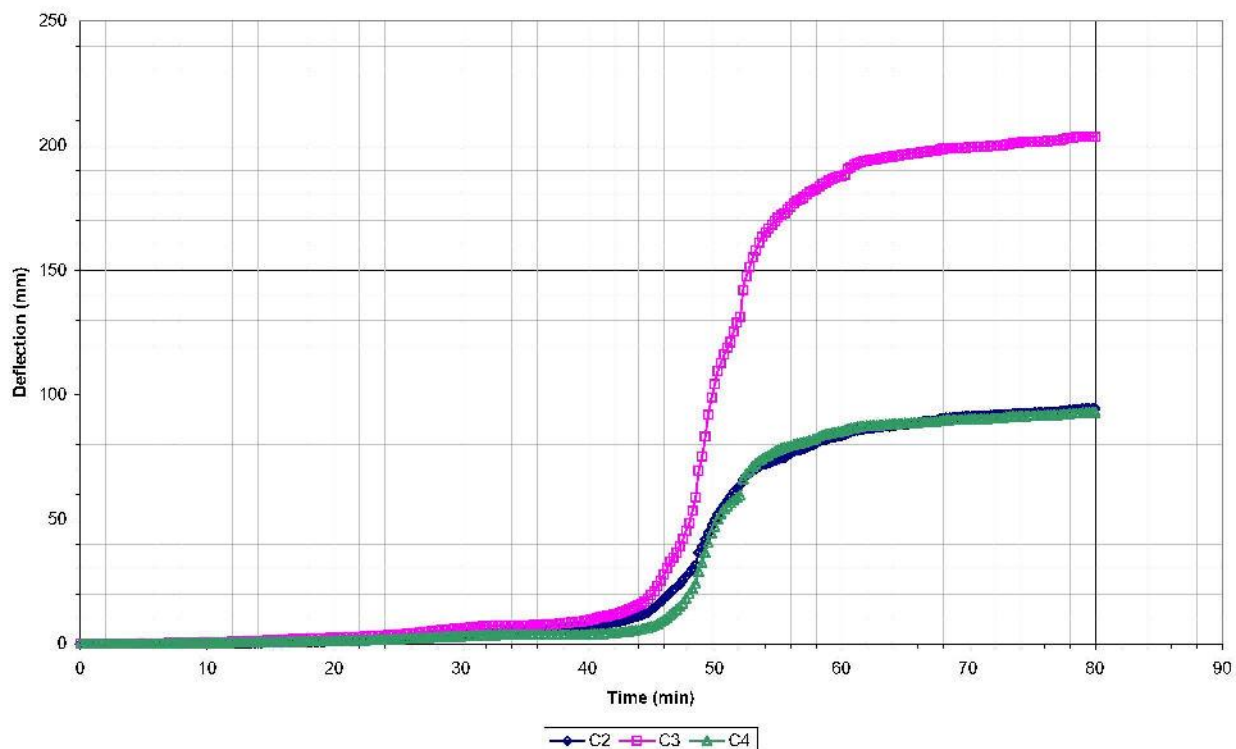
Figure 85 Displacement of first floor relative to second floor – Test F2

Figure 85 shows a rapid rate of deflection after approximately 45 minutes corresponding to the temperature rise shown in Figure 84 and the observed breakdown and fall off of the ceiling boards. The central deflection reached a value in excess of 200mm by the end of the test and showed no signs of recovery.

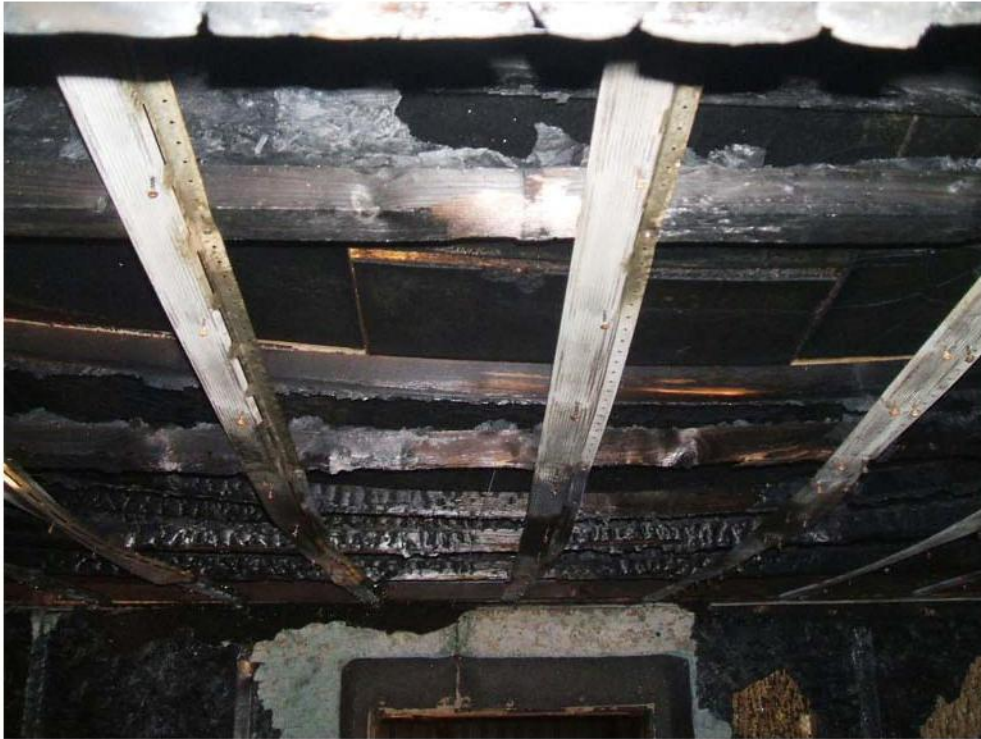
Figure 86 Engineered floor joists following Test F2

Although there was no global collapse, it is clear from the test results and subsequent observations that the mode of failure for the building is the reduction in load carrying capacity of the floor caused by combustion of the oriented strand board web members of the engineered floor joists. Figures 86 to 88 show the condition of the floor joists after the test.

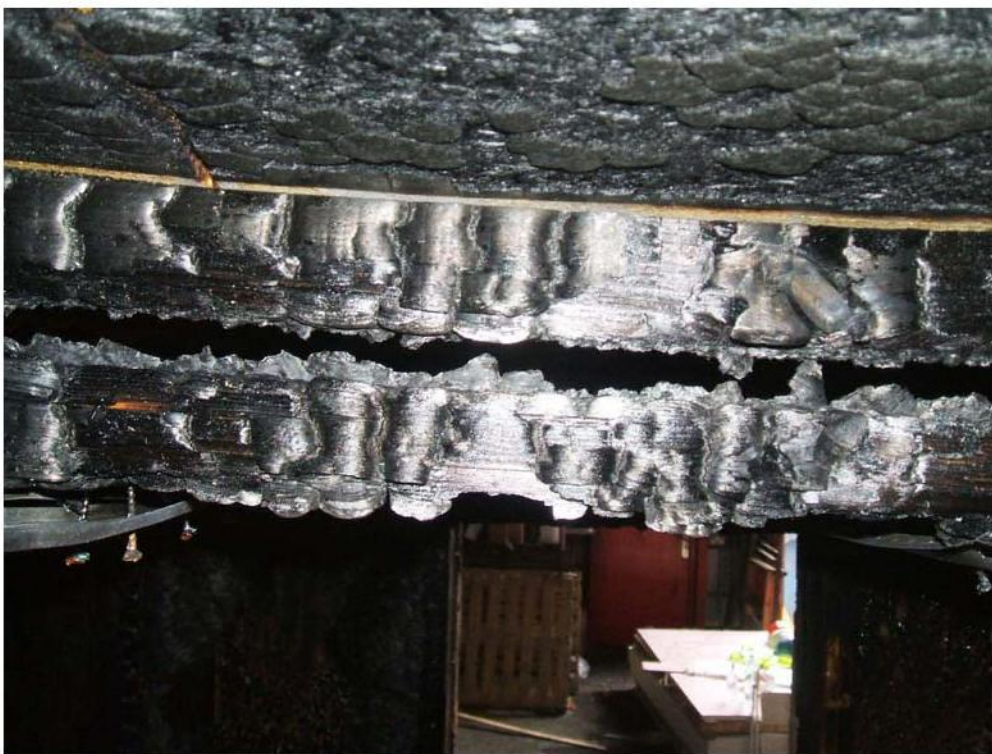
Figure 87 Close up of floor joist showing complete combustion of web following Test F2

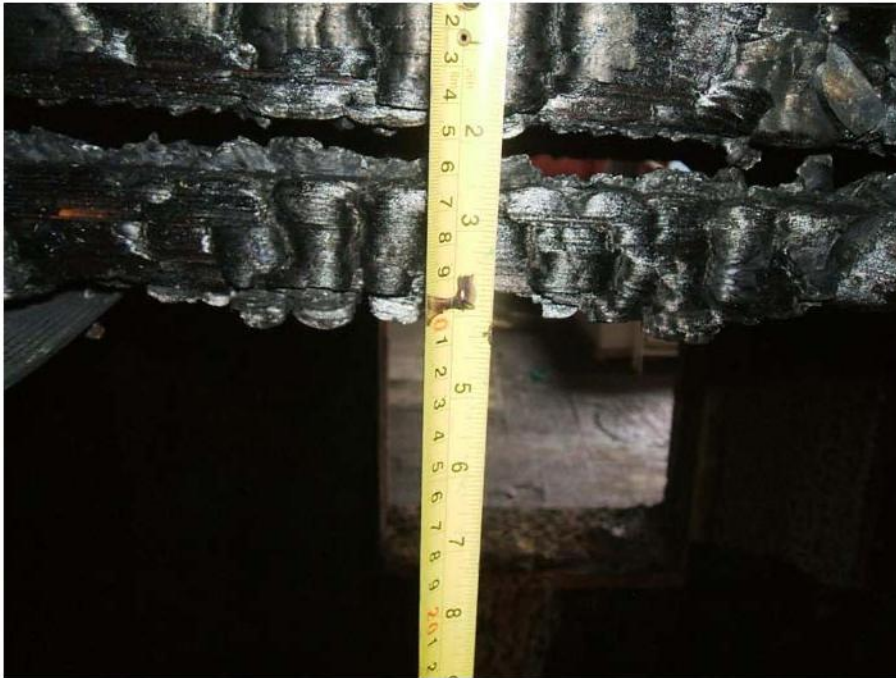
Figure 88 Residual depth of engineered floor joist (original depth = 220mm) post Test F2

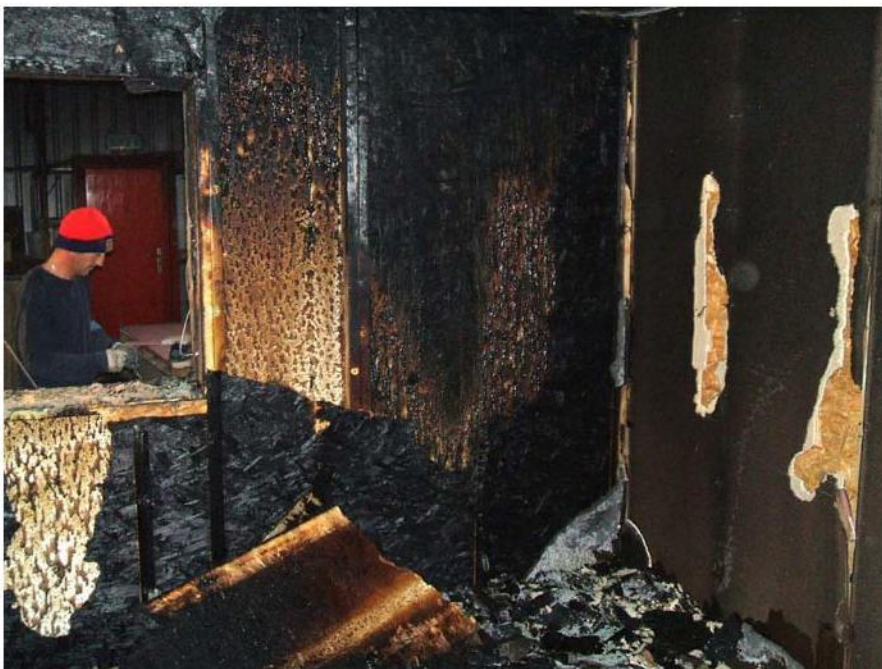
Other than the party wall, the plasterboard lining to the walls had either fallen off or disintegrated to the extent that the inner layer of oriented strand board had been involved and the insulation in the core had melted. Figure 89 provides a direct comparison between the condition of the party wall and the front wall at the end of the test.

Figure 89 Front and party wall (gridlines 1 and E) – Test F2

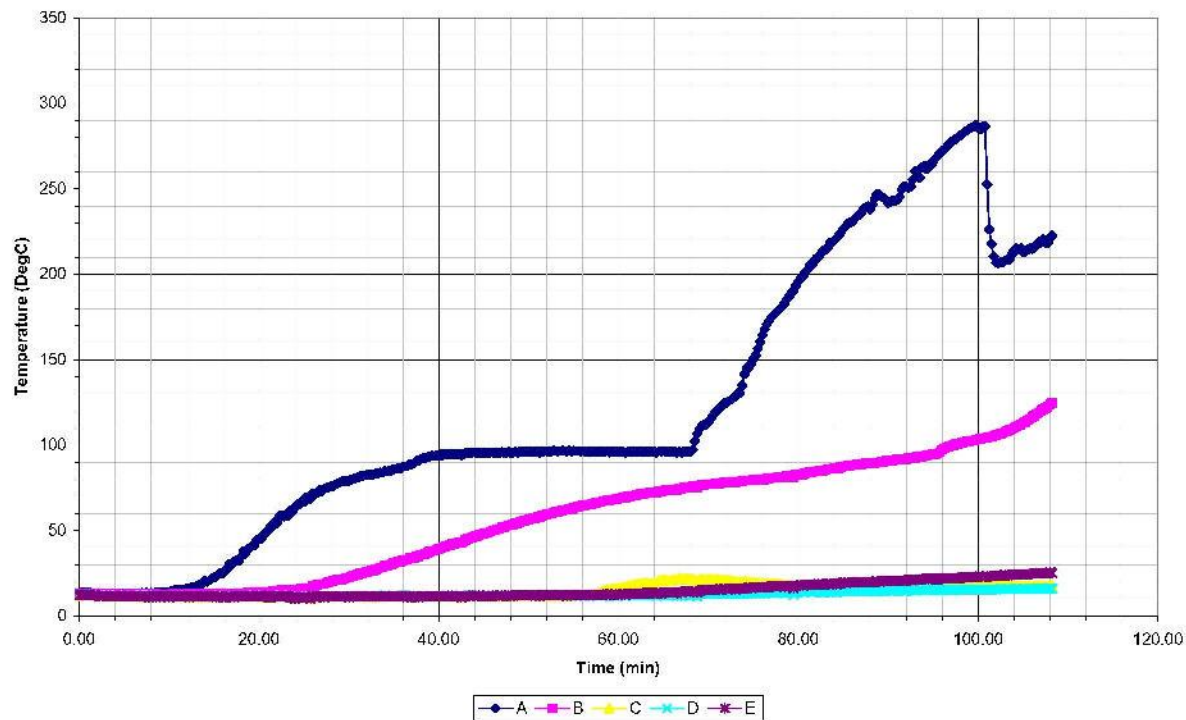
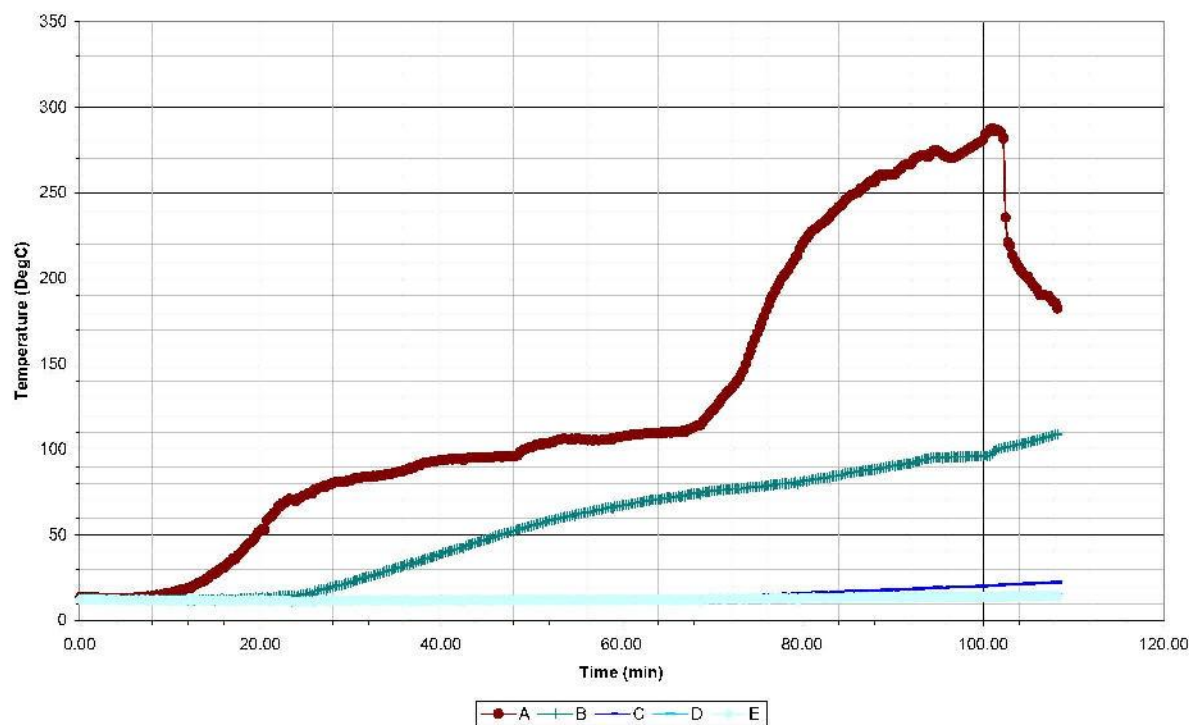
Figure 91 Temperature readings through party wall at gridline 2 – Test F3

Figure 92 Temperature readings through party wall at gridline 4 – Test F3

Figures 91 and 92 show the temperatures within the core of the structural insulated panel forming the party wall were largely unaffected by the fire for the duration of the test. However, the inner layer of oriented strand board was subject to a 200°C temperature gradient through its depth based on temperatures measured near the front and rear face, respectively.

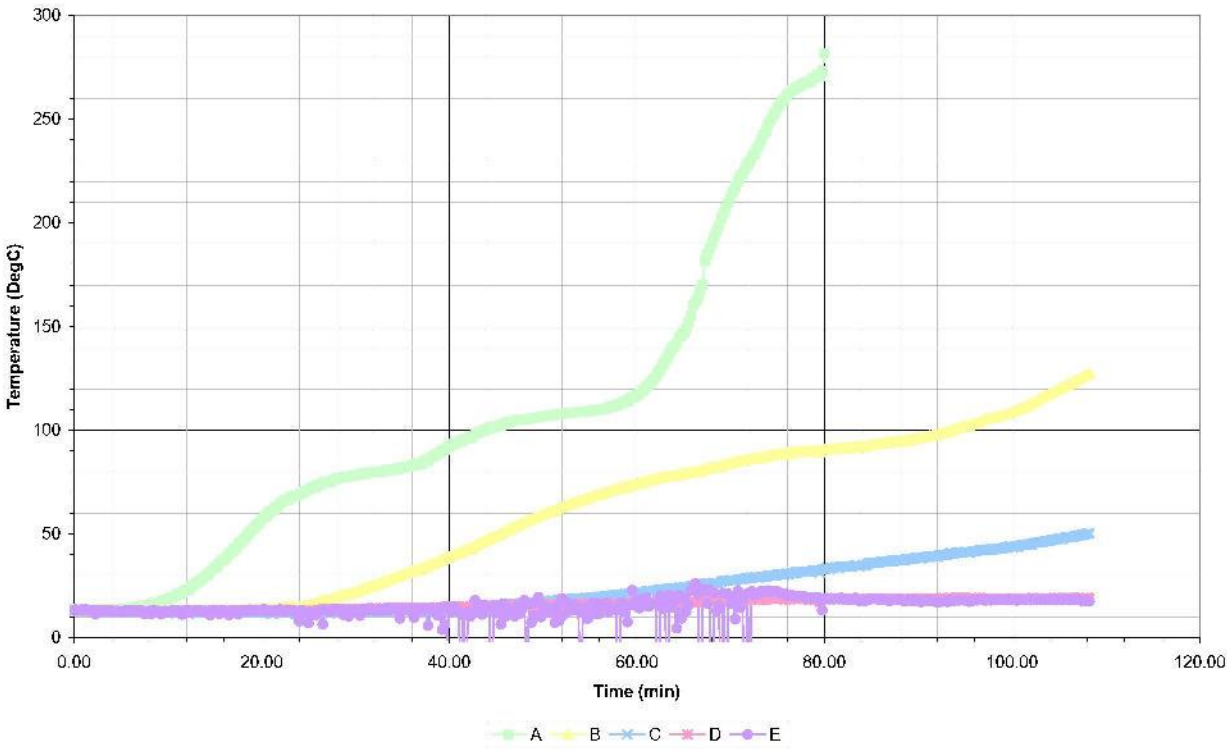
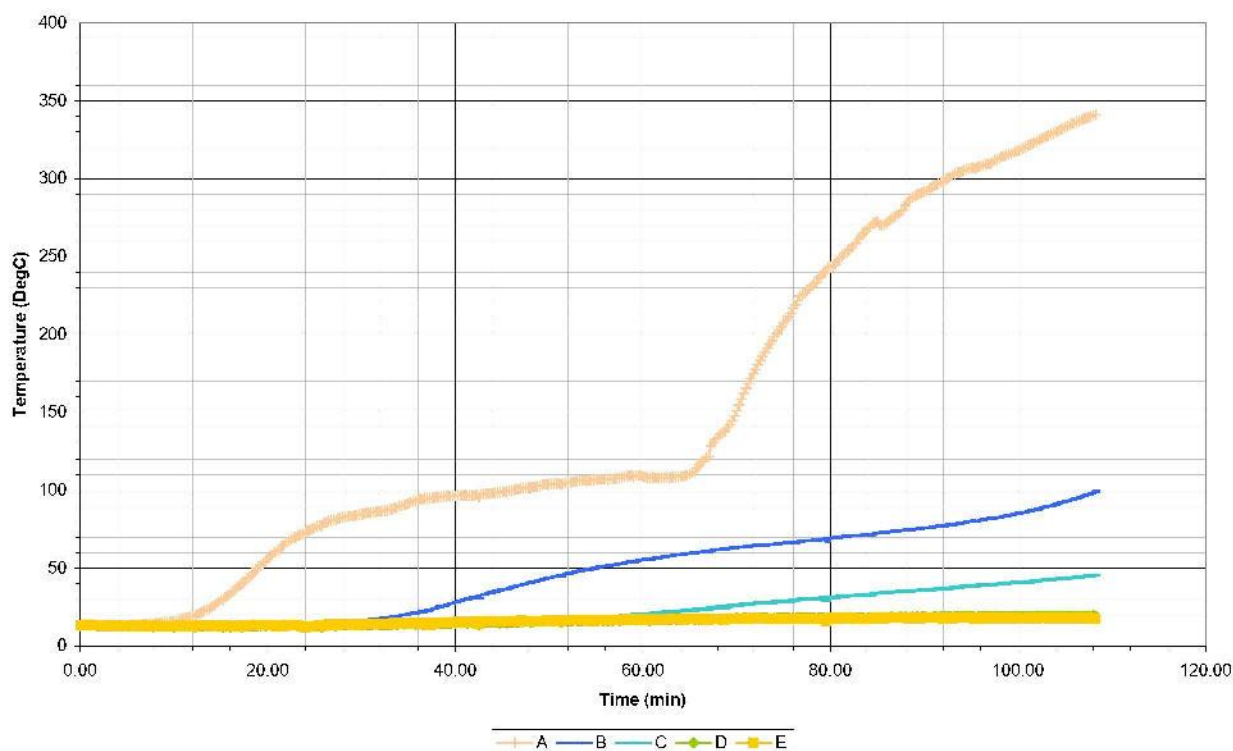
Figure 93 Temperature readings through rear wall on gridline D – Test F3

Figure 94 Temperature readings through rear wall on gridline B – Test F3

The measured temperatures again show that the fire had very little impact on the core temperatures of the structural insulated panel for the duration of the test. However, during the latter stages of the test when the atmosphere temperatures are reducing, the temperature within the core is continuing to increase despite the intervention of the fire and rescue service. Again, there is a significant temperature gradient apparent in the inner oriented strand board veneer which is also in the order of 200°C.

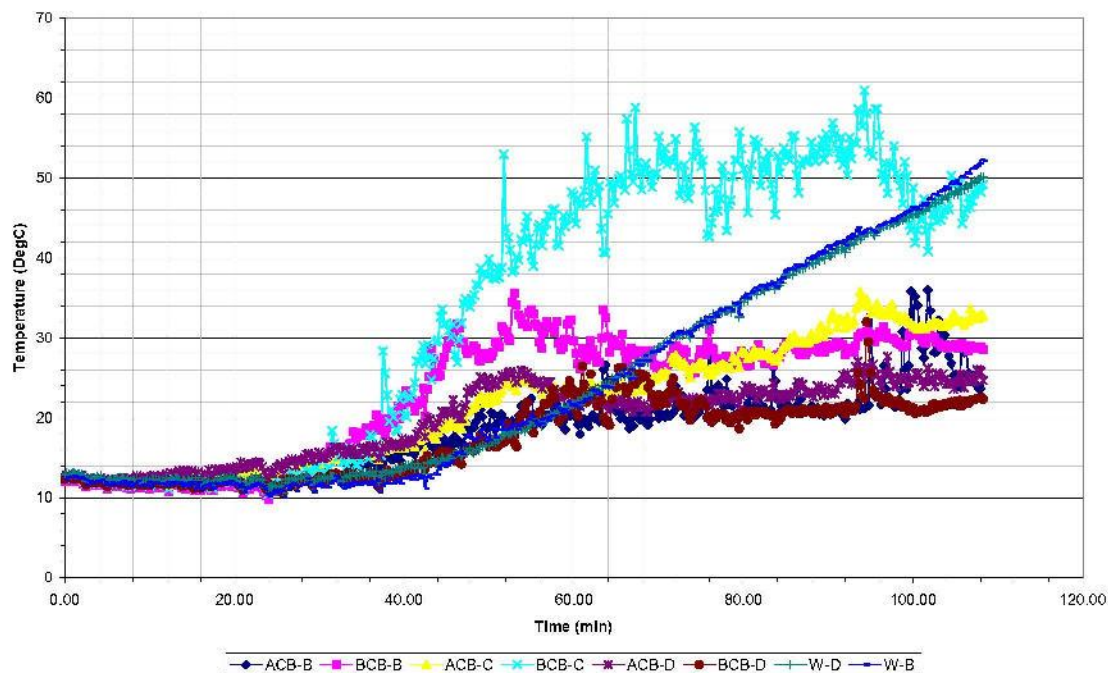
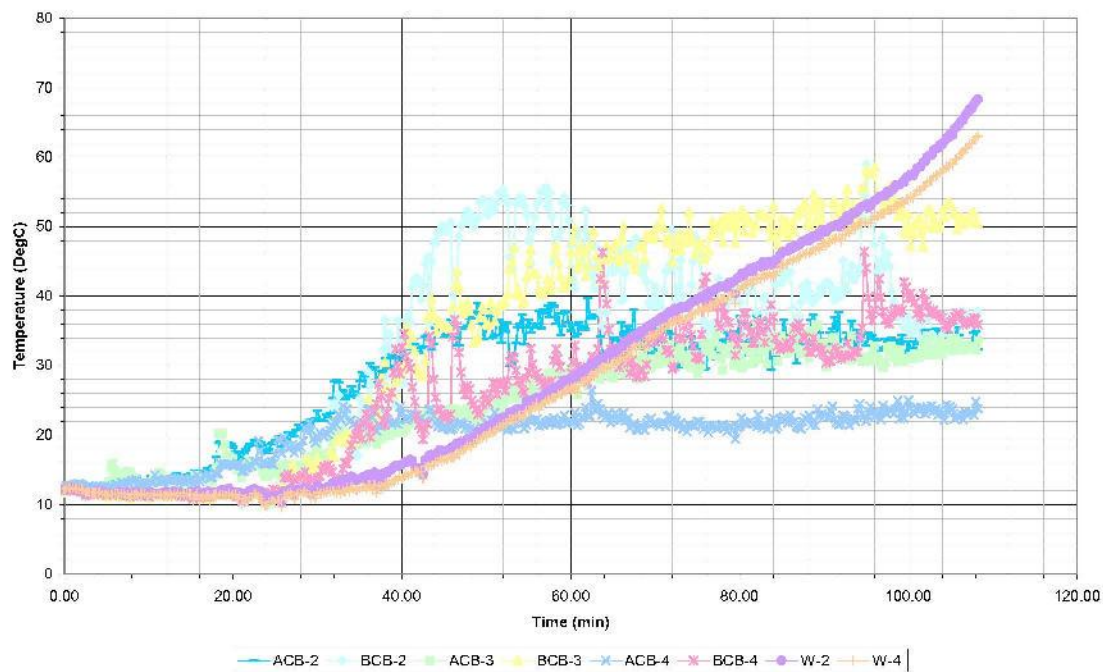
Figure 95 Temperatures in cavity on front wall (GL1) and in insulated core adjacent to window opening – Test F

Figure 96 Temperatures in cavity on side wall (GLA) and insulated core adjacent to window opening – Test F3

Although the temperatures are below 70°C for the duration of the test, the core temperatures are increasing at a time that the fire has been suppressed.

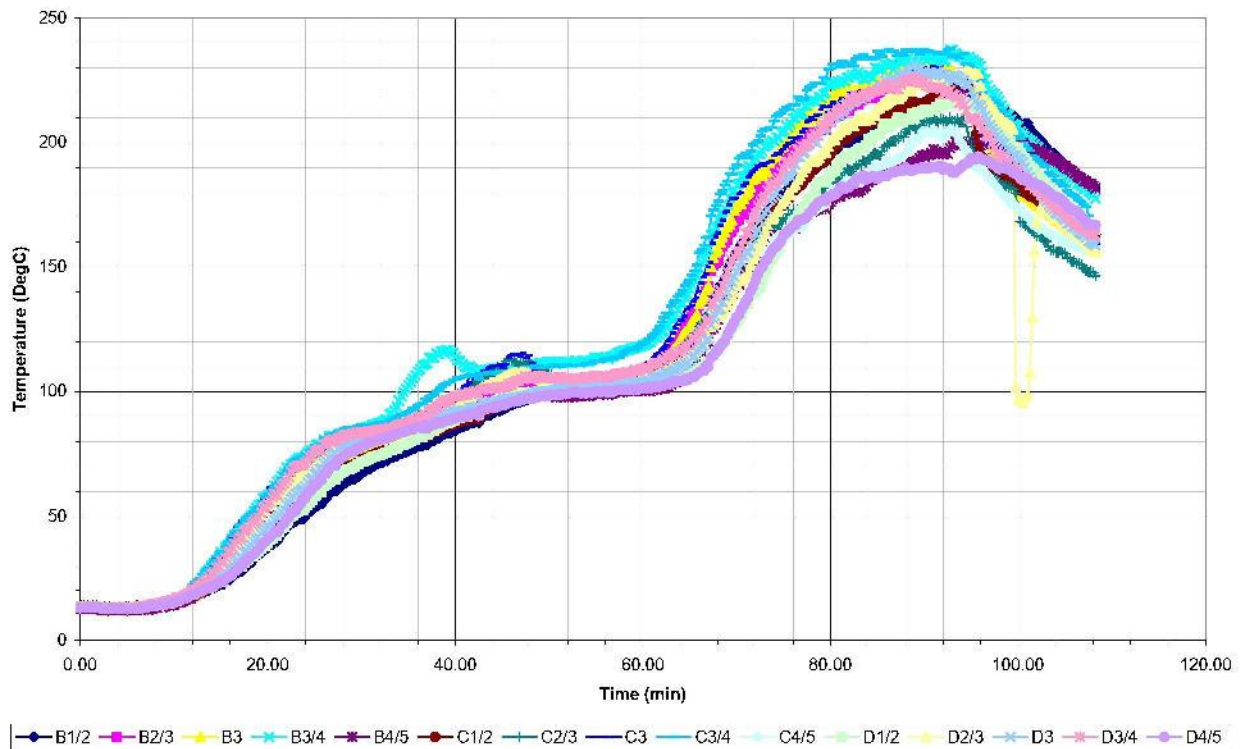
Figure 97 Temperatures in the first floor void – Test F3

Figure 97 shows that the temperature in the floor void did not exceed 250°C for the duration of the test and that all areas (in contrast with the wall panels) had cooled down appreciably by the time the fire was suppressed.

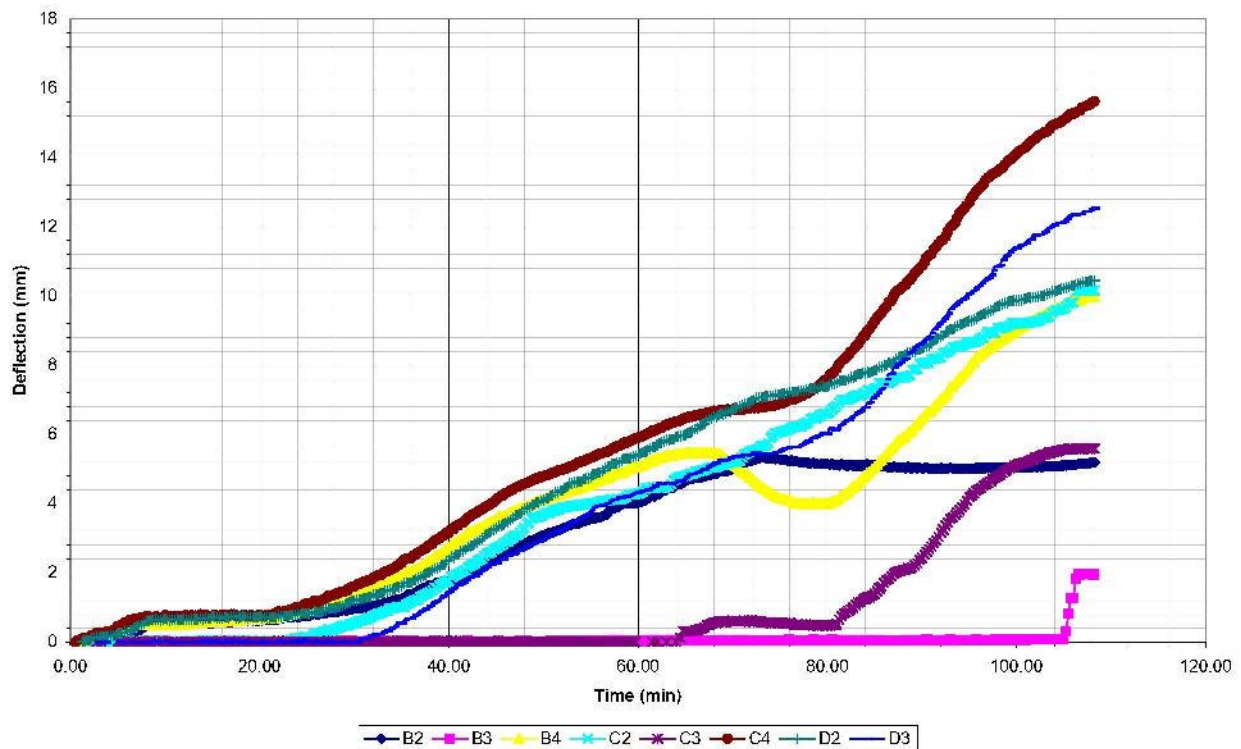
Figure 98 Displacement of first floor relative to second floor – Test F3

Figure 98 shows a maximum deflection of almost 16mm with an increasing rate of deflection towards the end of the test. The floor continued to deflect once the fire had been extinguished.

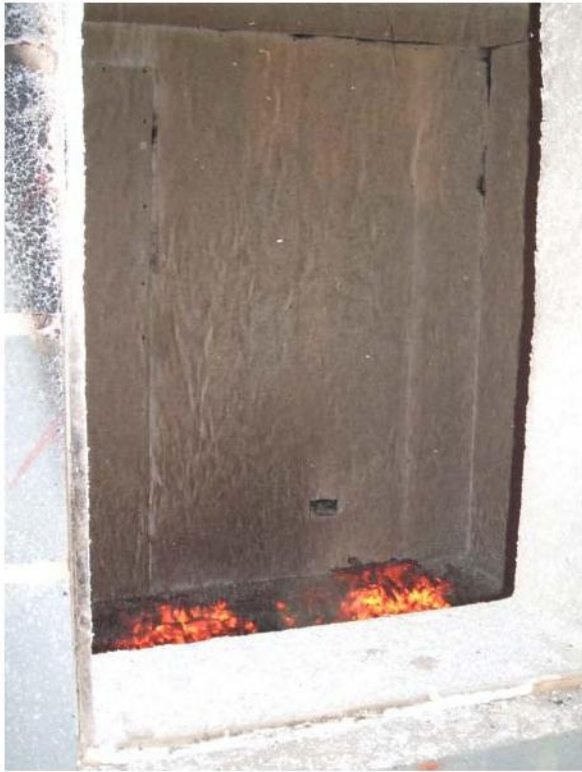
On completion of the test, initial observations suggested there was very little damage as the linings were largely still in place, see Figure 99. There was no evidence of any significant damage to the floor joists and no indication that the fire had entered the first floor void, see Figure 100. However, once the fire load had been extinguished it was clear that the temperatures within the structural insulated panel panels were increasing and eventually the walls ignited in a number of different locations with the polyurethane involved in the combustion process. The small ignition sources were dealt with but it was unclear where the next outbreak would occur. All the remaining plasterboard was stripped away and the oriented strand board inspected.

Figure 99 Condition of internal wall and ceiling linings at end of Test F3 (Note location of service penetration)

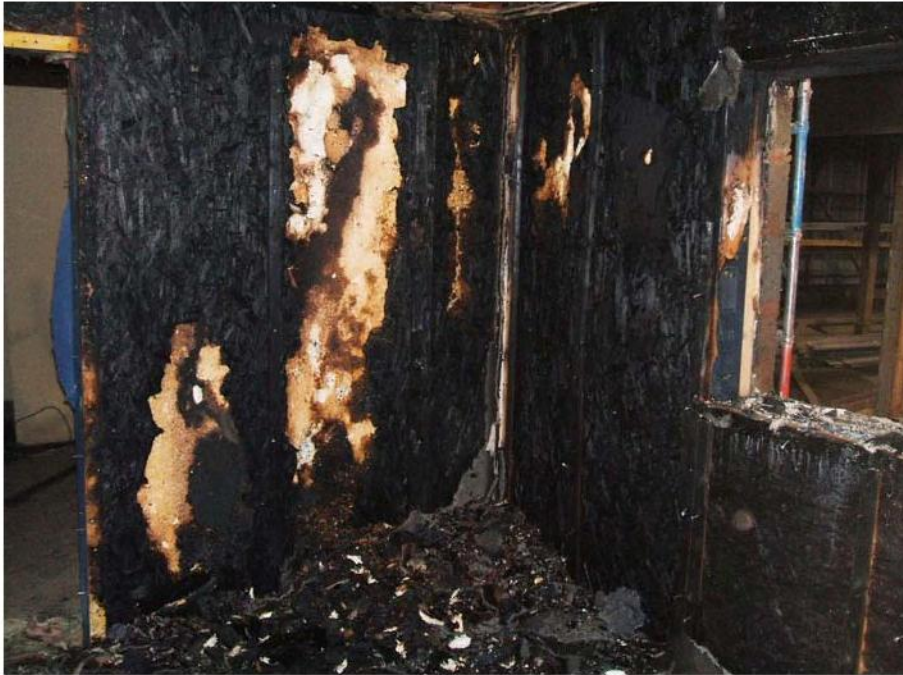
Damage to the core was extensive in certain areas, see Figure 101 and more localised in other areas, see Figures 102 and 103.

Figure 101 Damage to structural insulated panel on rear and side wall – Test F3

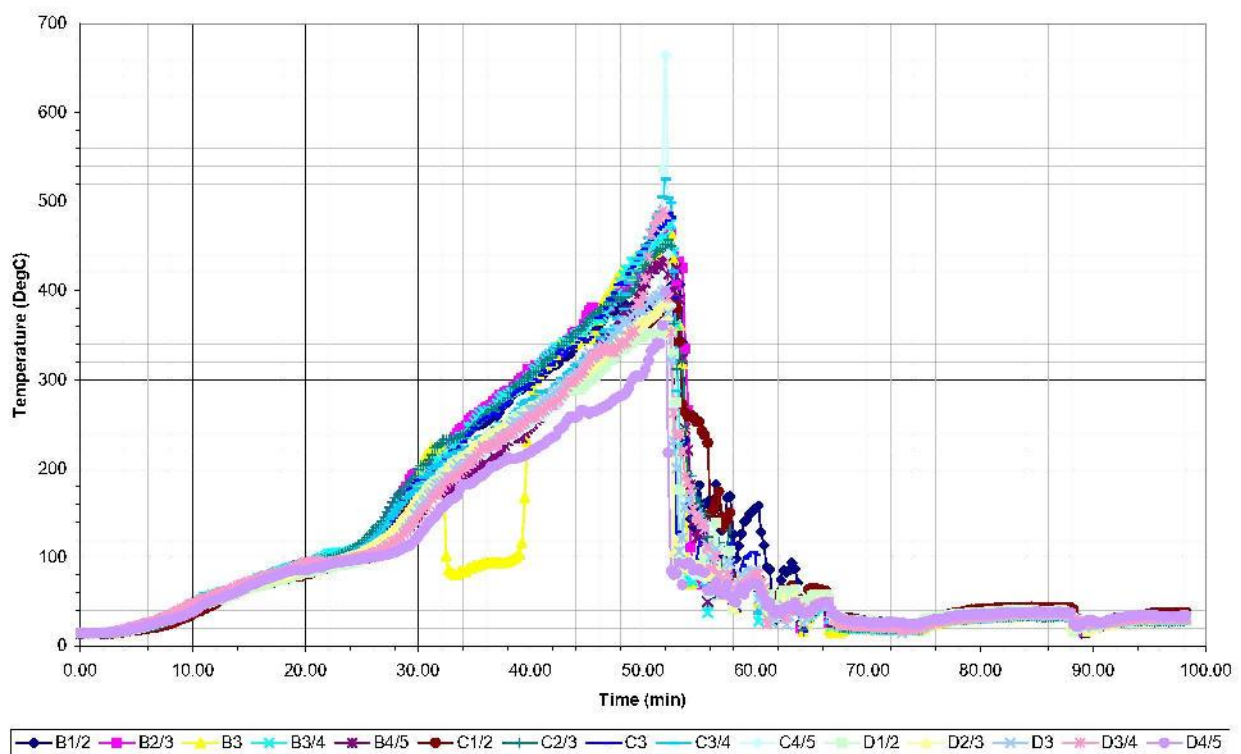
Figure 111 Temperatures in the first floor void – Test F4

Figure 111 indicates a break through of the fire into the ceiling void and burning of the joists.

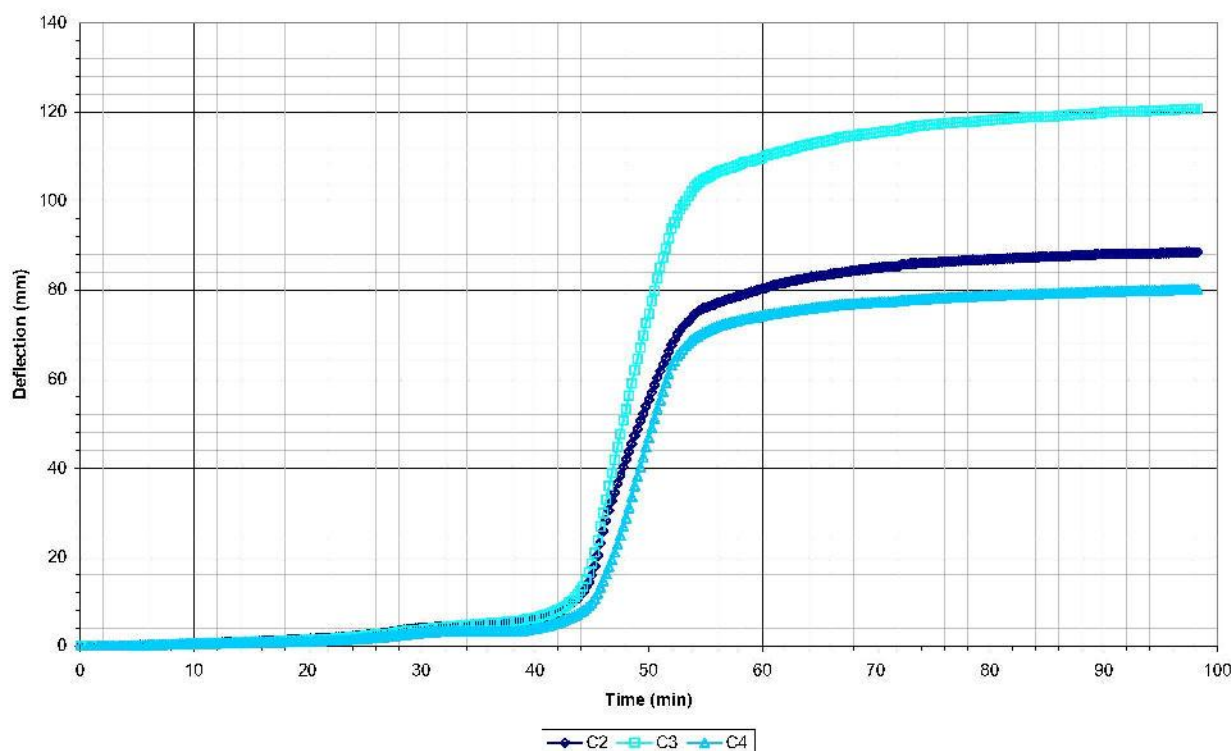
Figure 112 Mid-span deflection of the first floor relative to second floor – Test F4

Figure 112 shows a maximum deflection of approximately 120mm with a very rapid rate of deflection just prior to termination of the test, giving little warning of impending collapse.

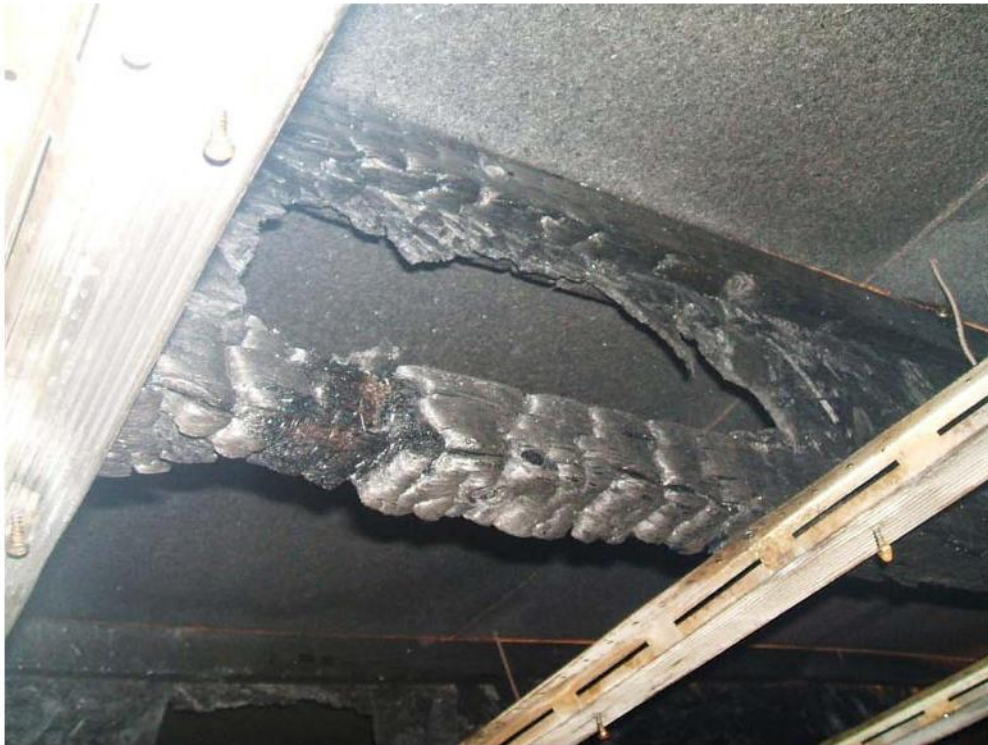
As with the expanded polystyrene 30 minute test, the most significant damage was to the floor joists following spread of fire to the floor void once the integrity of the ceiling linings had been compromised. As in the previous case, a collapse of the floor has been shown to be the mode of failure for this form of structure. The degree of damage to the floor was less than the corresponding expanded polystyrene case but this was due to a slightly earlier instruction to terminate the test. The damage to the floor joists is shown in Figures 113 and 114.

Figure 113 Damage to engineered floor joist – Test F4

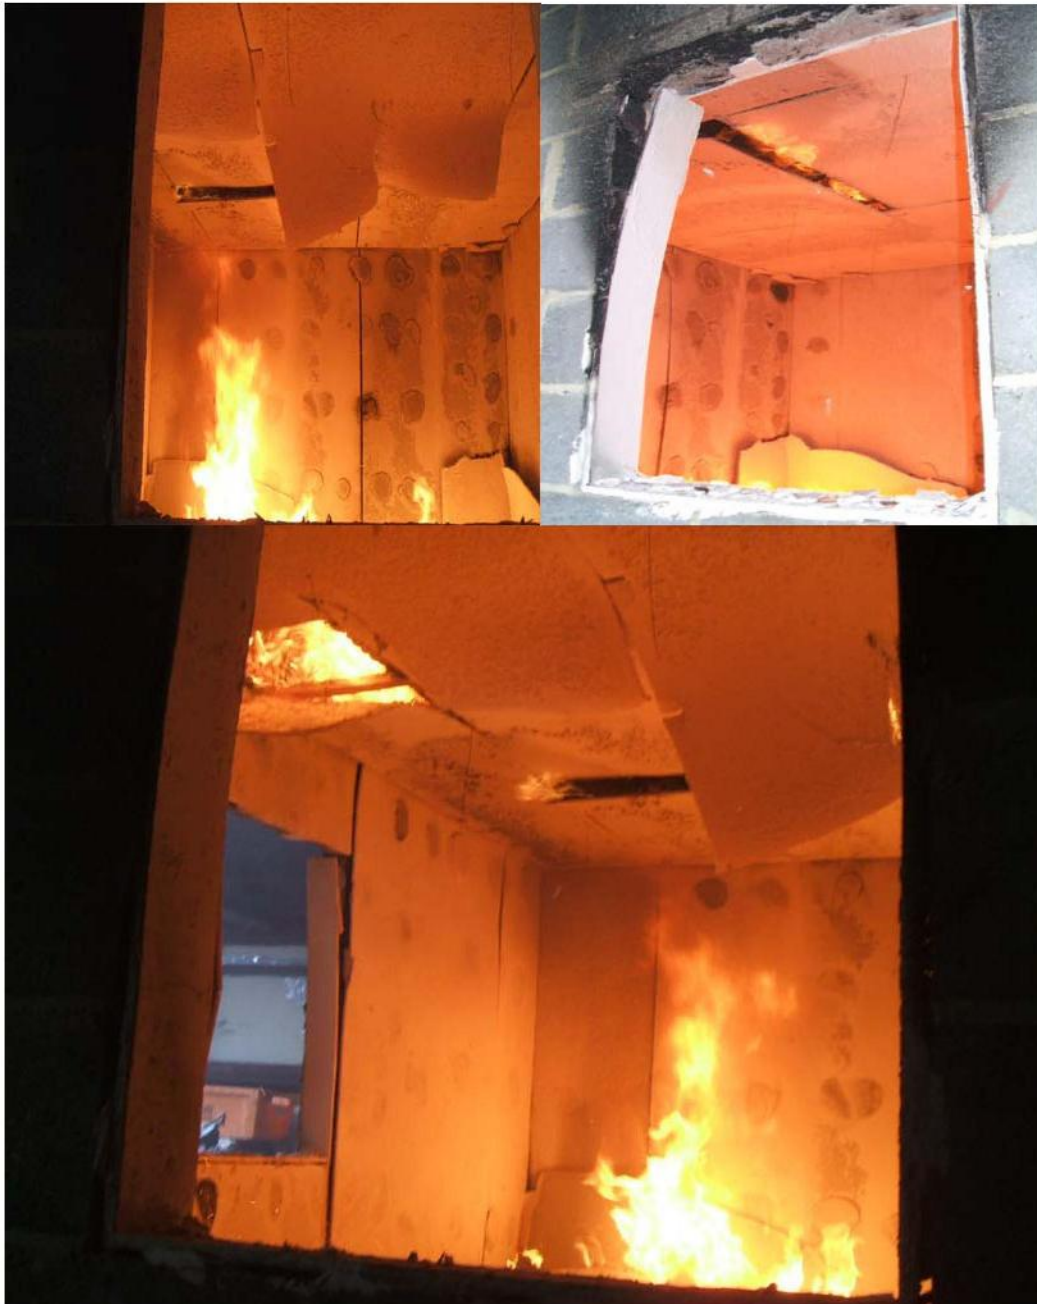
During the steady-state phase of fire development, with compartment temperatures around 1000°C, a number of the wall boards fell away from the masonry substrate. Towards the end of this phase of fire development, localised areas of the exposed layer of ceiling board fell into the compartment with gaps opening on the lower layer, allowing hot gases and sporadic flaming into the floor space between the joints. Figure 131 clearly illustrates this.

Figure 131 Damage to ceiling boards leading to localised flaming of floor joists

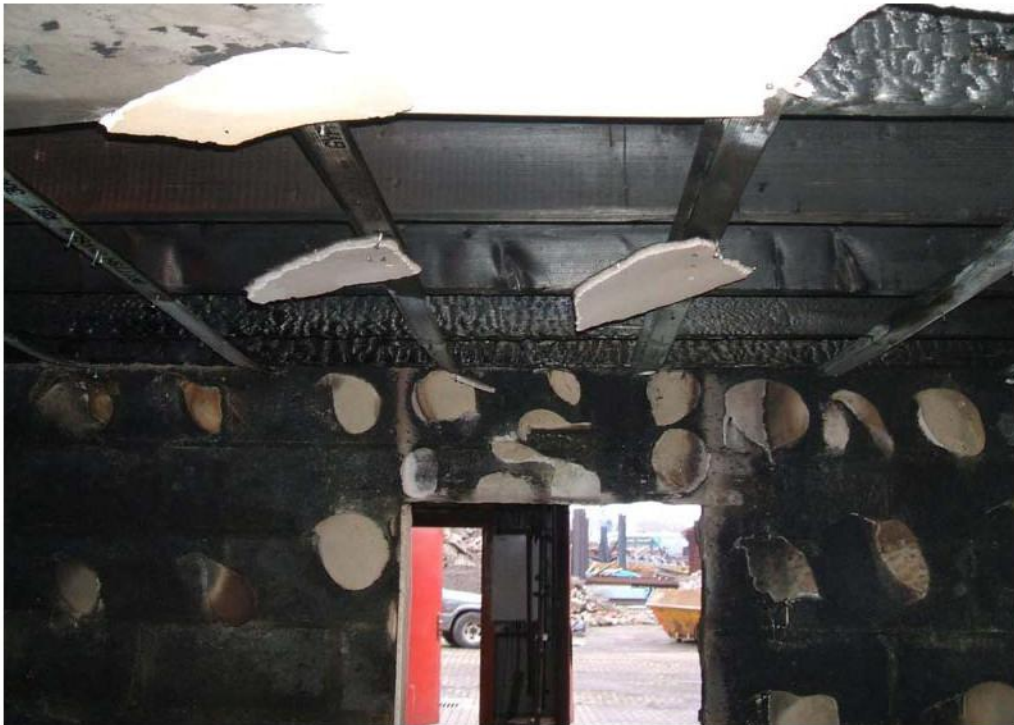
The results are confirmed by visual observation. Figure 133 shows the extensive charring towards the front of the compartment (joists 1 and 2) as well as localised charring of joist 5.

Figure 135 Charring of floor joists following test

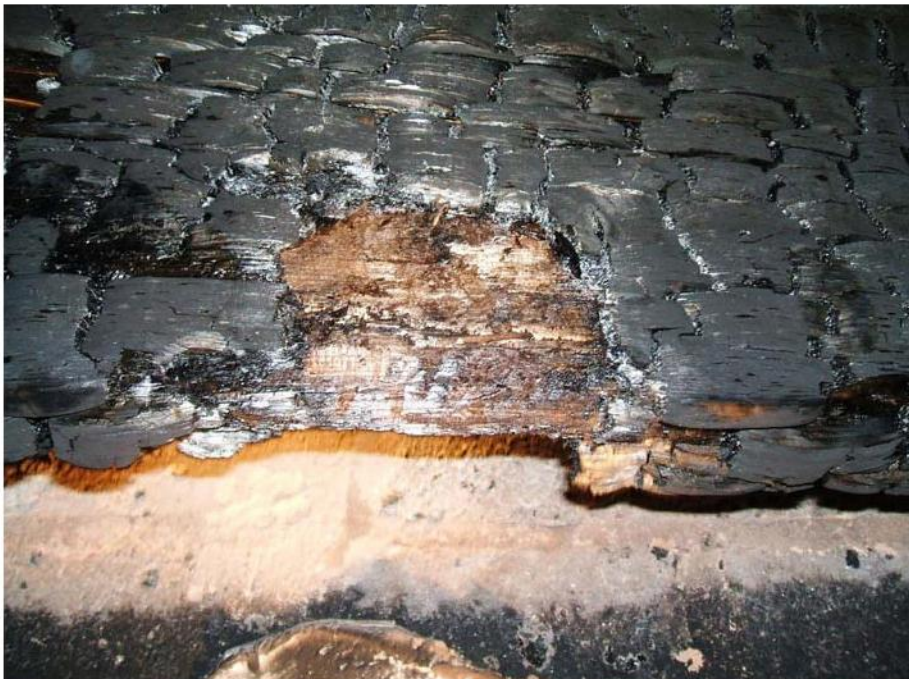
Figure 136 shows the extent of charring, where the char layer has been scraped away back to the solid timber. The maximum depth of charring was approximately 15mm, leaving a residual core of approximately 15mm of solid timber.

Figure 136 Extent of charring to floor joist on gridline 1

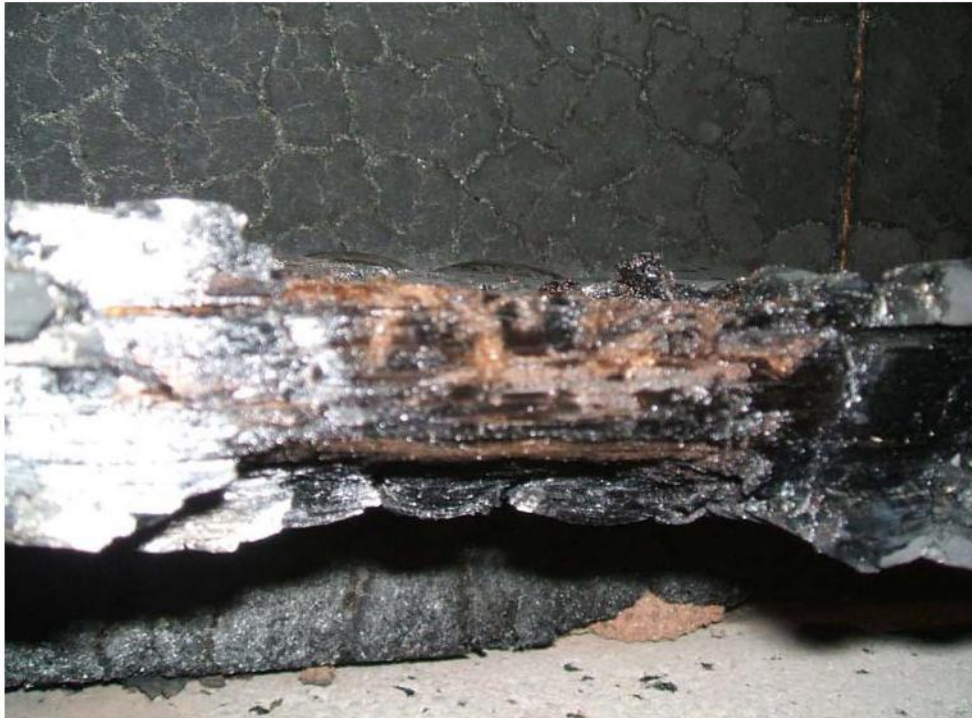
Despite the extensive flaming in the ceiling void, there was no significant breakthrough of the fire through the chipboard flooring. The flooring itself provided some resistance to the spread of flame; see the visible charring in Figure 137.

Figure 137 Underside of floor joist on gridline 1 showing charring of chipboard flooring

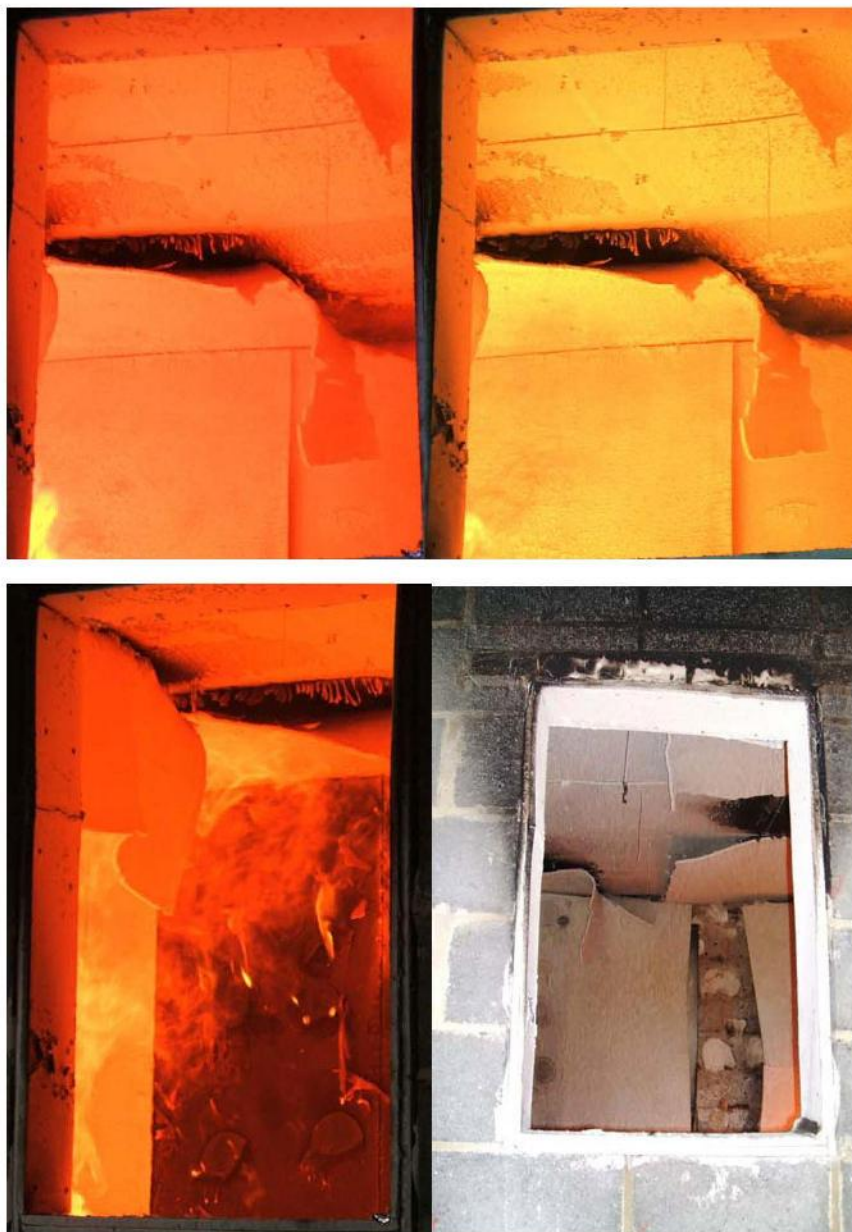
Although the overall fire development was very similar for Test 1 and Test 2, with flashover occurring in a similar time frame the plasterboard appeared to survive for longer in Test 2 with the first observed loss of the exposed layer of ceiling board occurring approximately 49 minutes from ignition. At this point, temperatures within the compartment had effectively peaked.

Although damaged, the inner layer of boards remained relatively intact and provided protection to the floor joists for a period sufficient for external flaming to have died down to the extent that flames were no longer in contact with the ceiling. This is shown in the sequence of photographs in Figure 142.

Figure 142 Performance of plasterboard

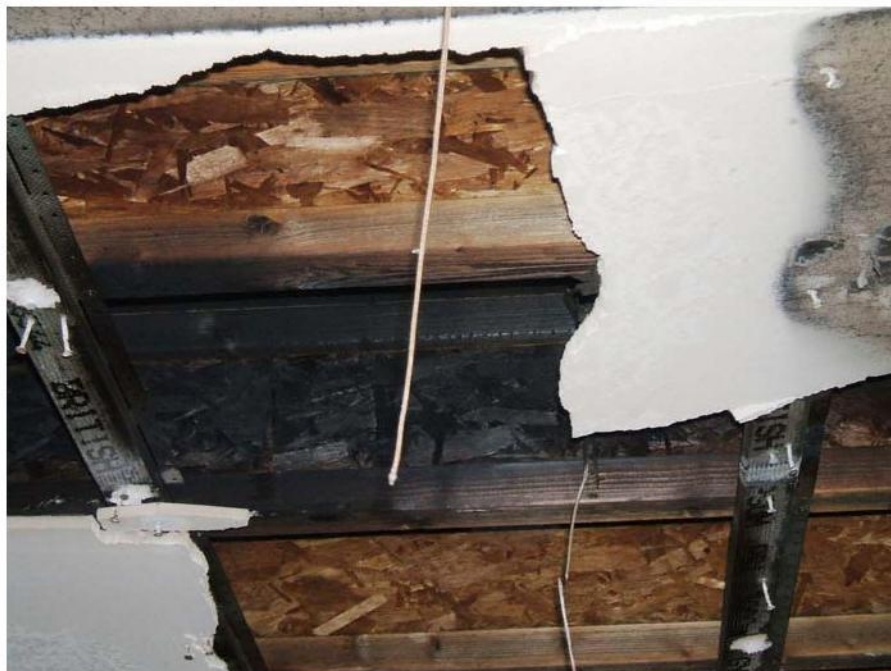
The measured peak temperatures and observations following the test show that at least one of the joists must have been very close to the self-ignition temperature. Figure 145 illustrates the charring of the bottom flange, the oriented strand board web and, particularly the top flange.

Figure 145 Charring of I joist close to the front opening
