The performance in fire of structural insulated panels

BD2710

BRE

December 2010
Department for Communities and Local Government

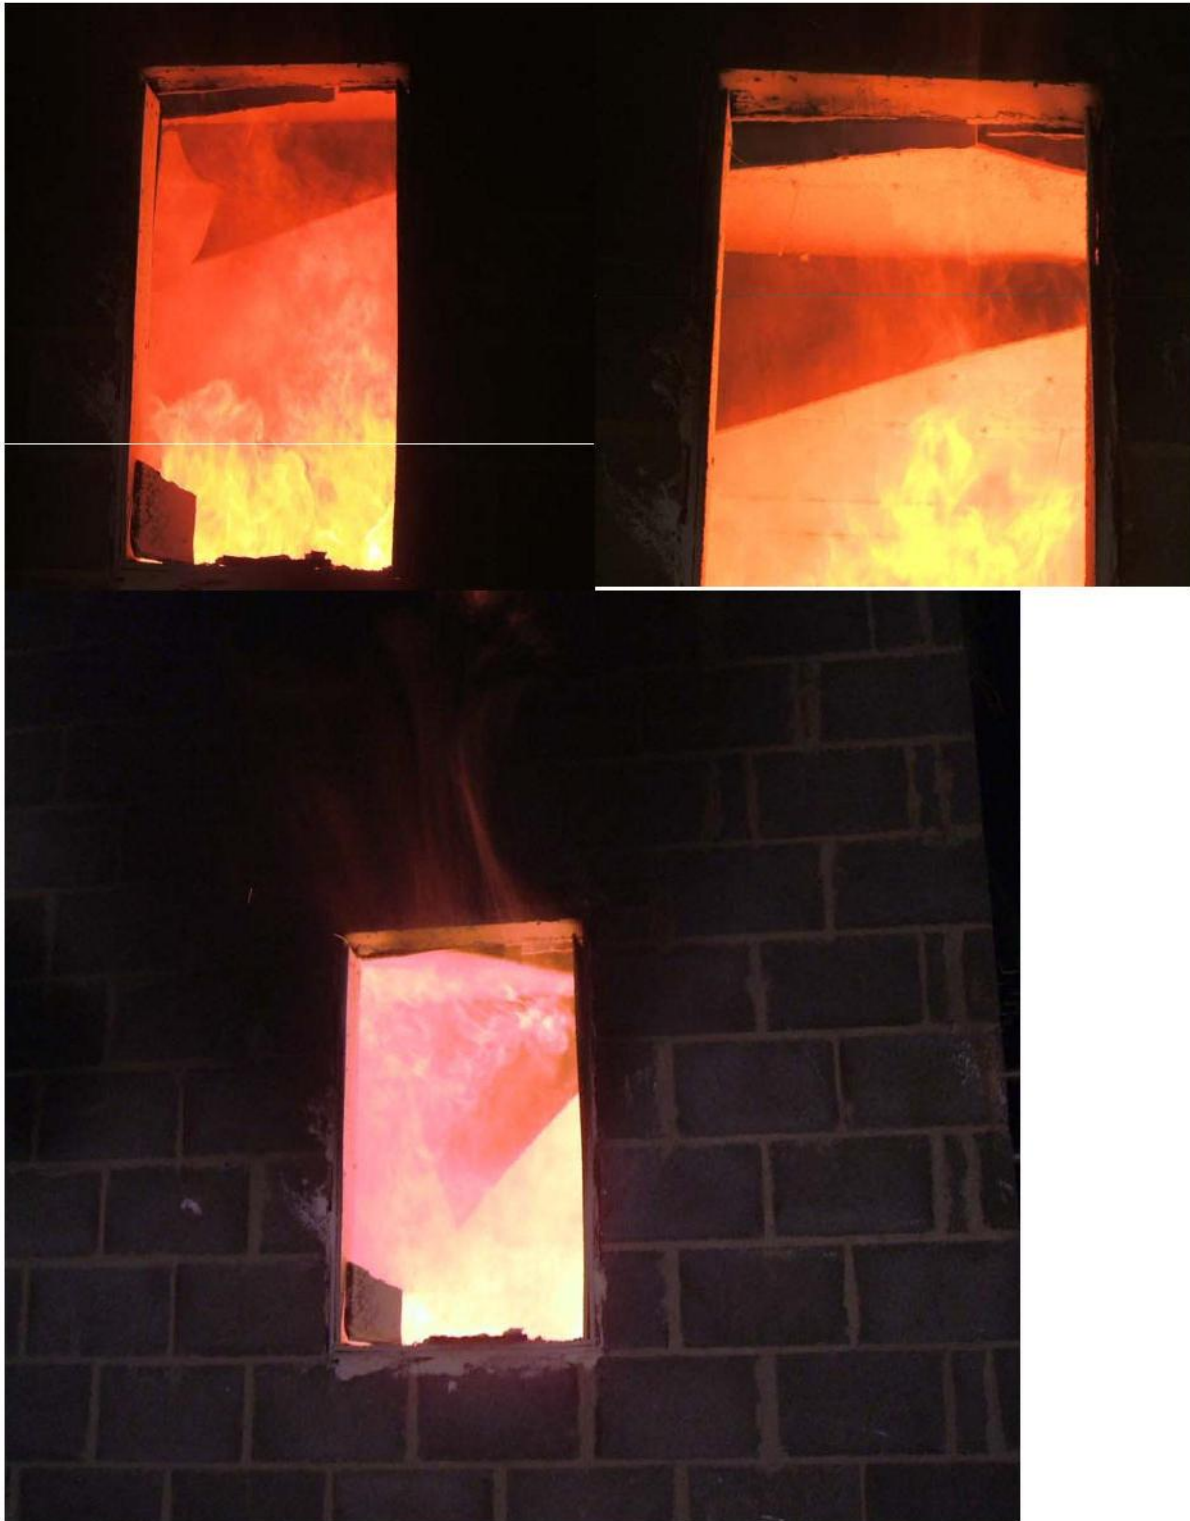
During Test 3, the boards were seen to bend downwards approximately 40 minutes from ignition. There is no clear delineation between loss of the first layer and the second layer. From the results and the observations it would appear that the boards opened up locally to allow flames to enter the ceiling void and impinge directly on the floor joists. Figure 152 shows this sequence of events.

Figure 152 Ceiling boards opening up during test leading to flaming in void

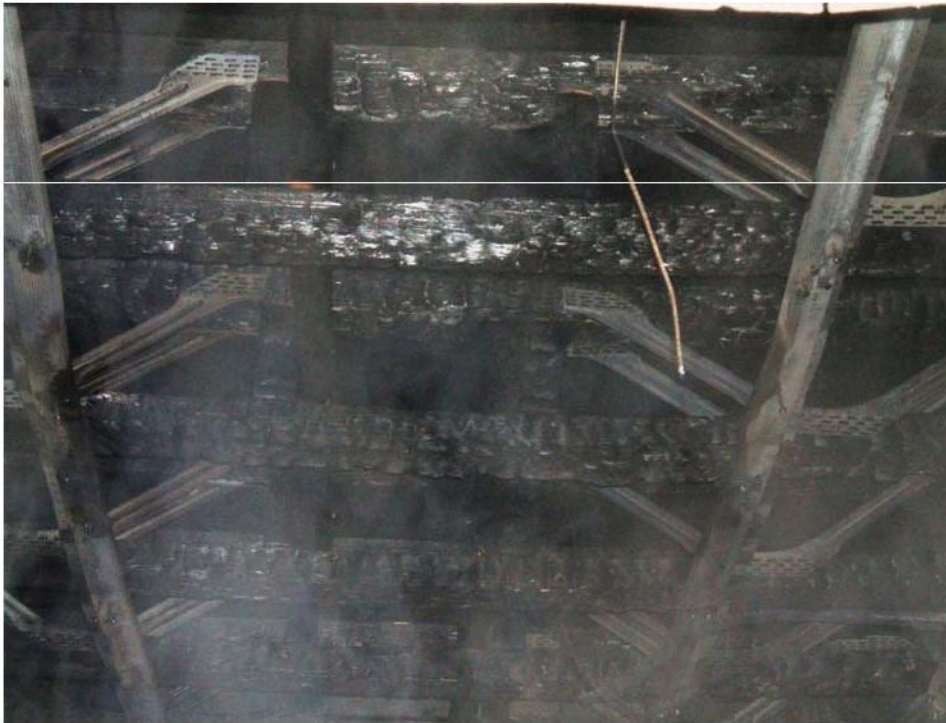
Despite a rapid rise in temperature some forty minutes from ignition no attempt was made to extinguish the fire. Both temperature and deflection readings indicated that the fire had entered the ceiling void and the joists had become involved in the fire. Observations following Test 3 confirmed that there had been significant fire spread in the ceiling void. Figure 154 shows the floor joists immediately after the fire had been extinguished. Figure 155 shows the charring of floor joists.

Figure 154 Extensive charring to floor joists

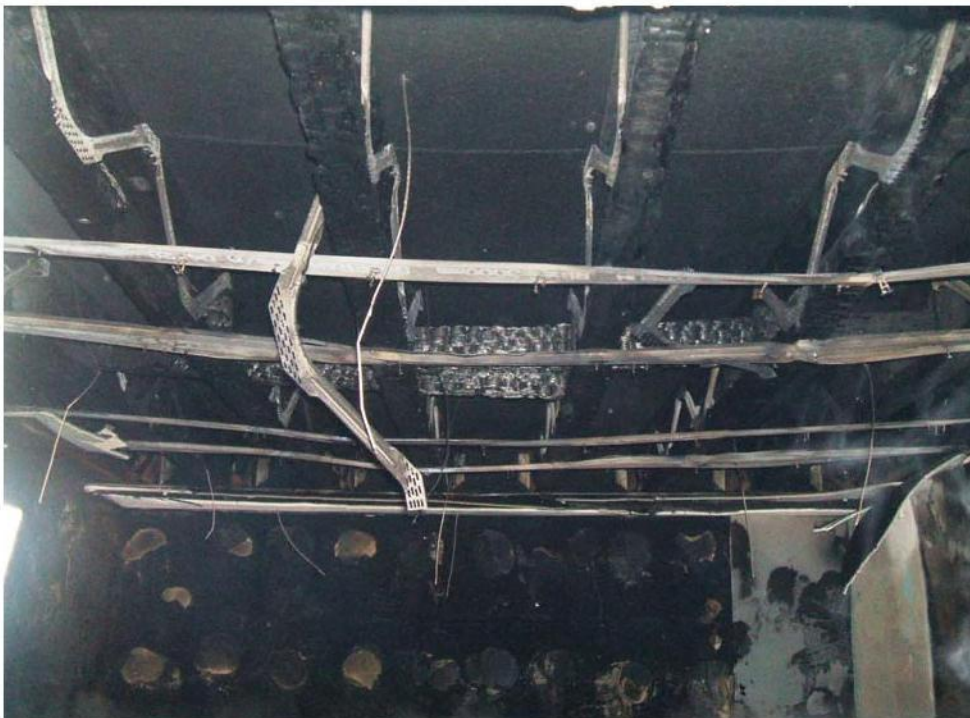
Figure 155 Charring of floor joists and strongback noggin

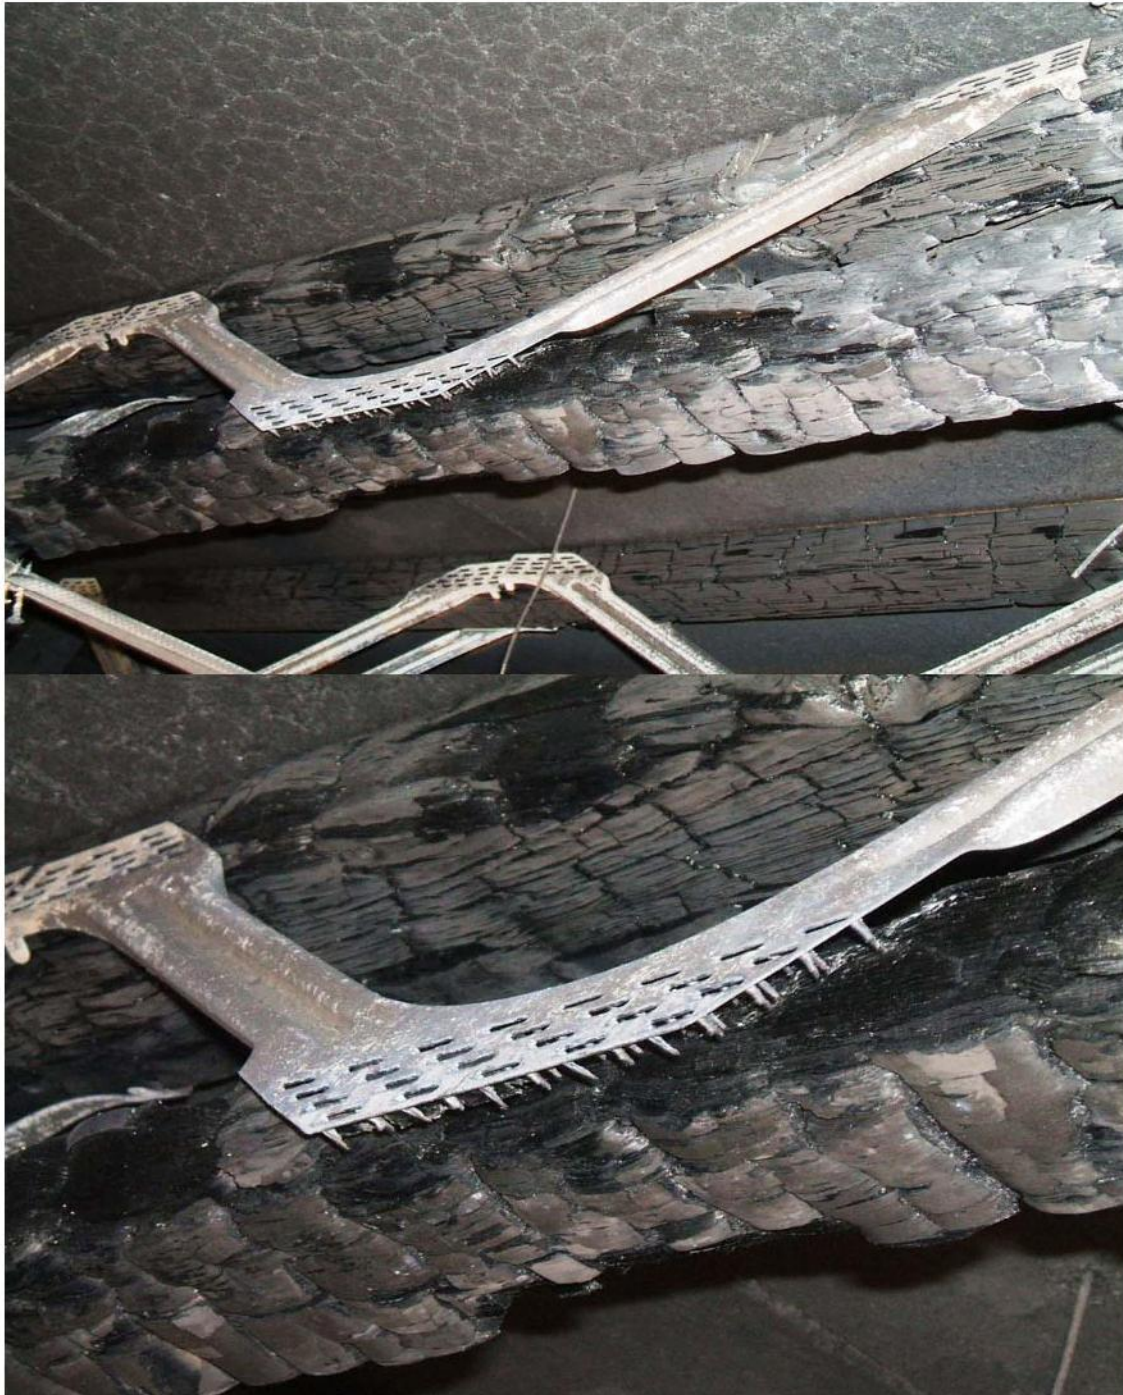
Steel web pieces used in the fabrication of timber trusses with steel webs such as those tested are produced from galvanised sheet steel, shaped to provide rigidity with teeth punched into the plate and embedded in the timber. The charring of the timber has, in a number of places, led to the teeth coming away from the bottom chord, see Figure 156.

Figure 156 Loss of connection between steel web and solid timber chord

Figure 156 also shows the extent of charring to the timber. From measurements taken on site the maximum depth of charring recorded resulted in a residual timber section of 50mm x 20mm from an initial nominal section size of 72mm x 47mm. Figure 157 illustrates this.

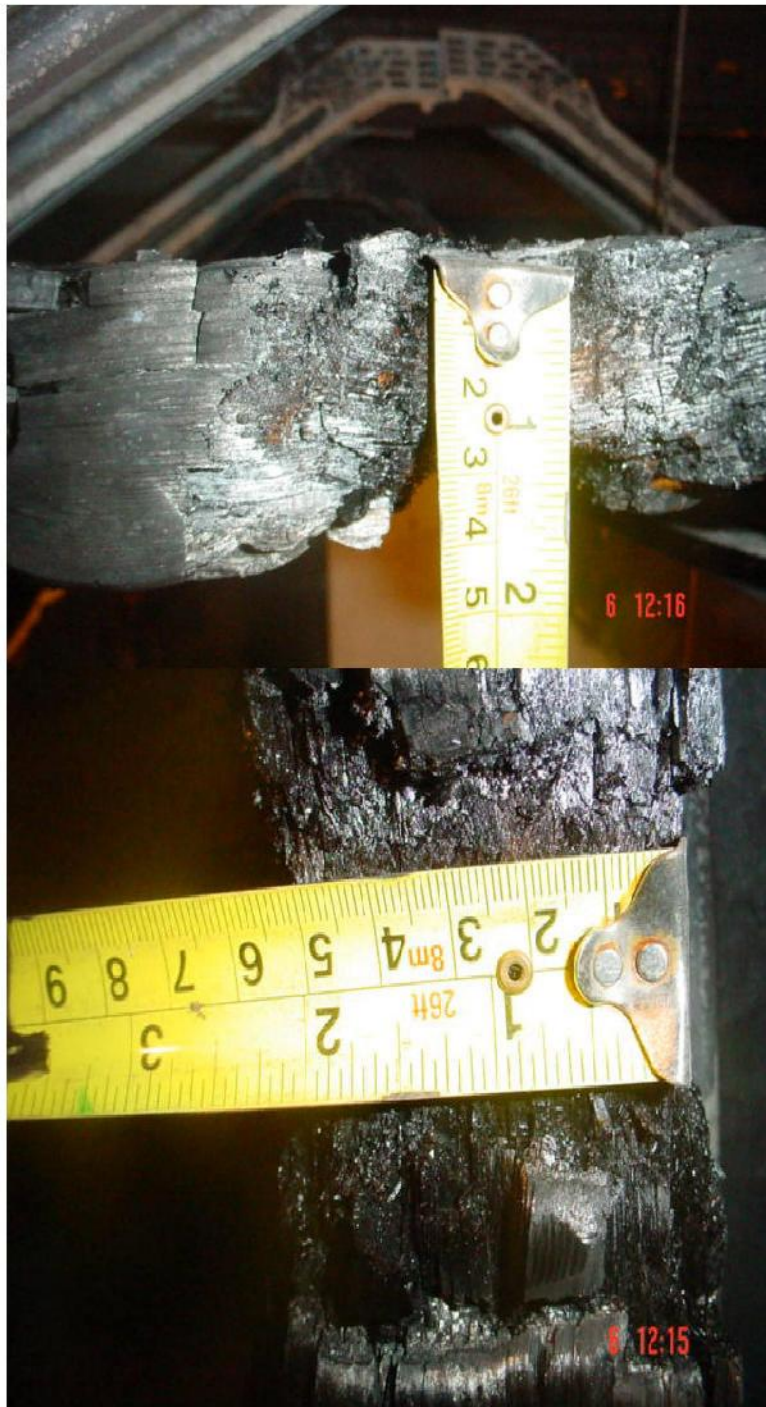
Figure 157 Residual section indicating extent of charring

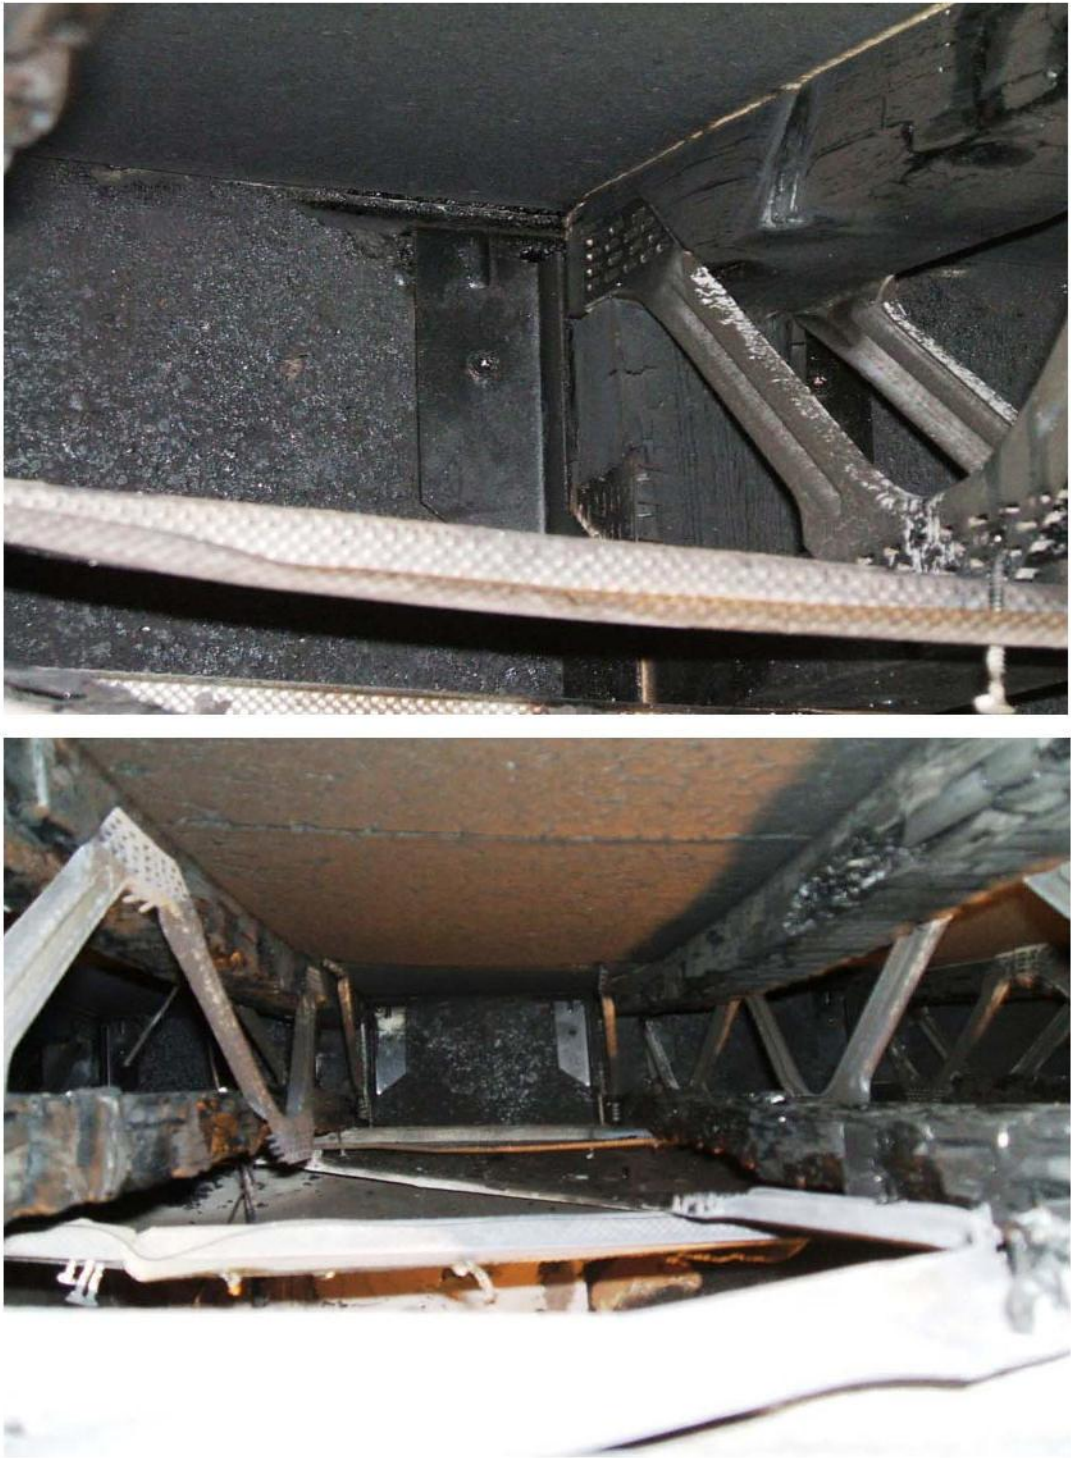
Although there was significant deformation of the floor, there was no appreciable damage to the joist hangers used to transfer the load from the joists to the load bearing blockwork wall. Figure 158 shows the joist hangers immediately following the test.

Figure 158 Joist hangers immediately after test
