**123 TAPLOW HOUSE
CHALCOTS ESTATE**

**FIRE DAMAGE REPORT FROM
ABSIEL SURVEY**

HARLEY CURTAIN WALL INCIDENT REPORT FORM 1

CONTRACT NO: C1031 Chalcots Estate
LOCATION: 123 TAPLOW HOUSE
RE: FIRE DAMAGE REPORT FROM ABSIEL SURVEY
DATE OF INSPECTION: TUESDAY 18th January, 2012

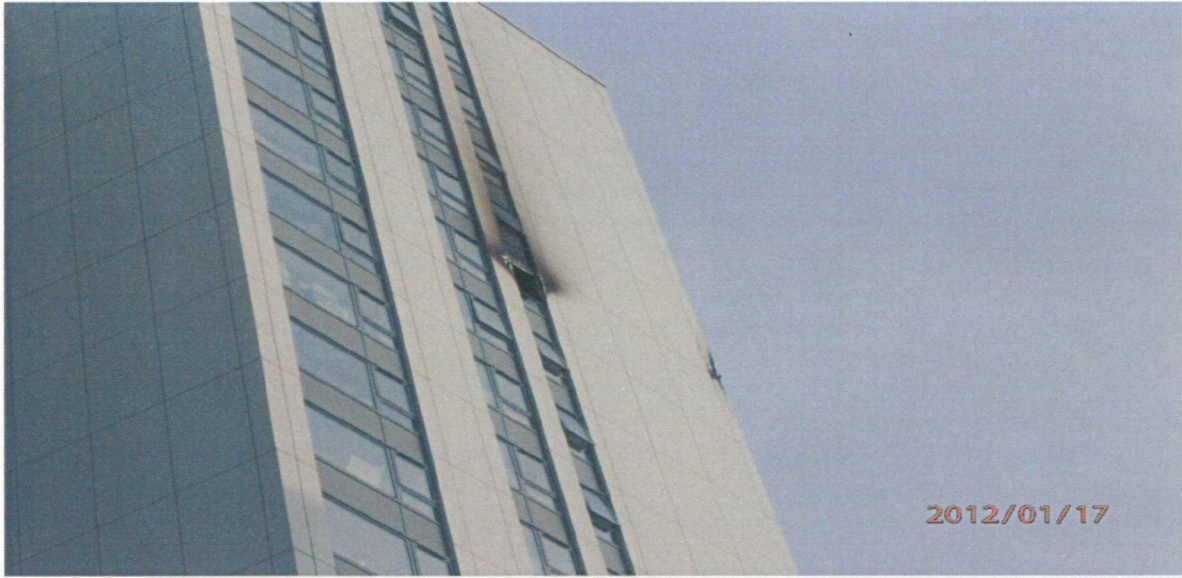
With respect to the AOV in the communal areas, we have noticed that there is visual smoke damage to the frame member following the fire. We would recommend that Colt inspect these windows to check the operation of these mechanically operated vents.
