BRE Global Client Report

BS 8414-1:2015 + A1:2017 test referred to as DCLG test 2.

Prepared for: DCLG
Date: 3rd August 2017 (Issue 1.0)
12th September 2017 (Issue 1.2)
Report Number: B137611-1037 (DCLG test 2) Issue: 1.2

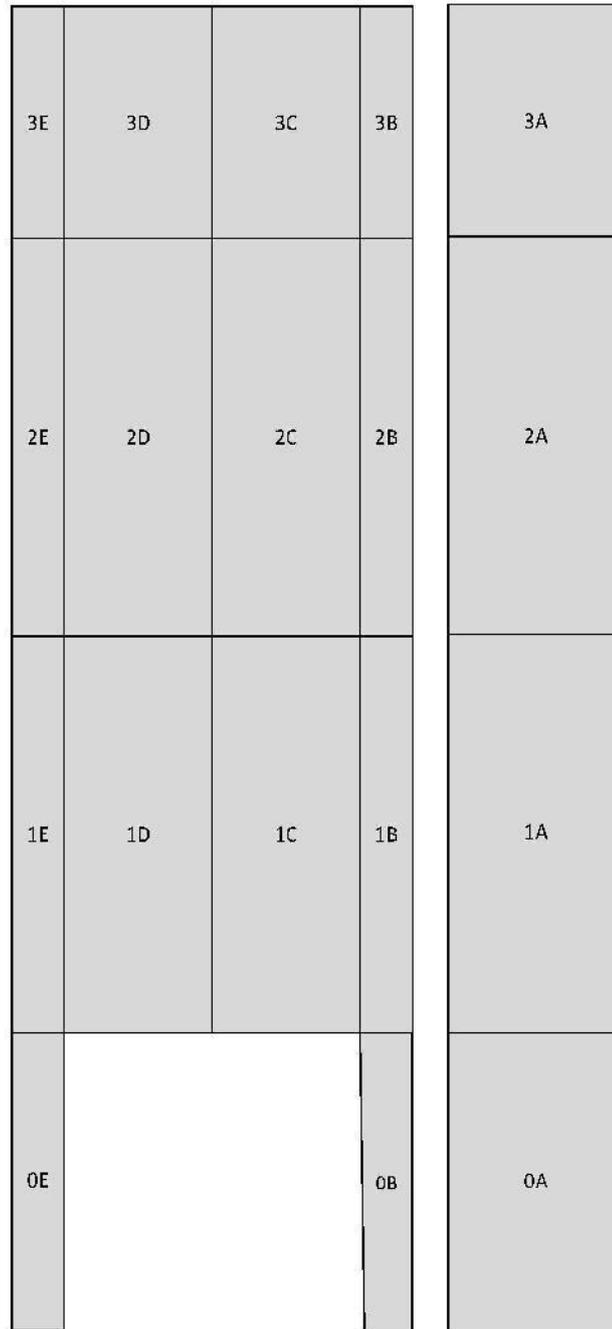
Figure 1. Layout of panels and labelling system used for reporting purposes. Not to scale.

On the main wall, approximately 20% of ACM panel 1C was consumed - see Figures 1, 21&22. This damage was sustained in a strip approximately 250mm-wide×1800mm-high positioned directly adjacent to the centre line of the combustion chamber, and extended from 500mm above the opening to the height of the second cavity barrier – see Figures 21&22. Partial consumption (inner aluminium layer of panel remained intact) affected a 200mm-high x 450mm-wide strip at the base of the fully consumed section of panel 1C.

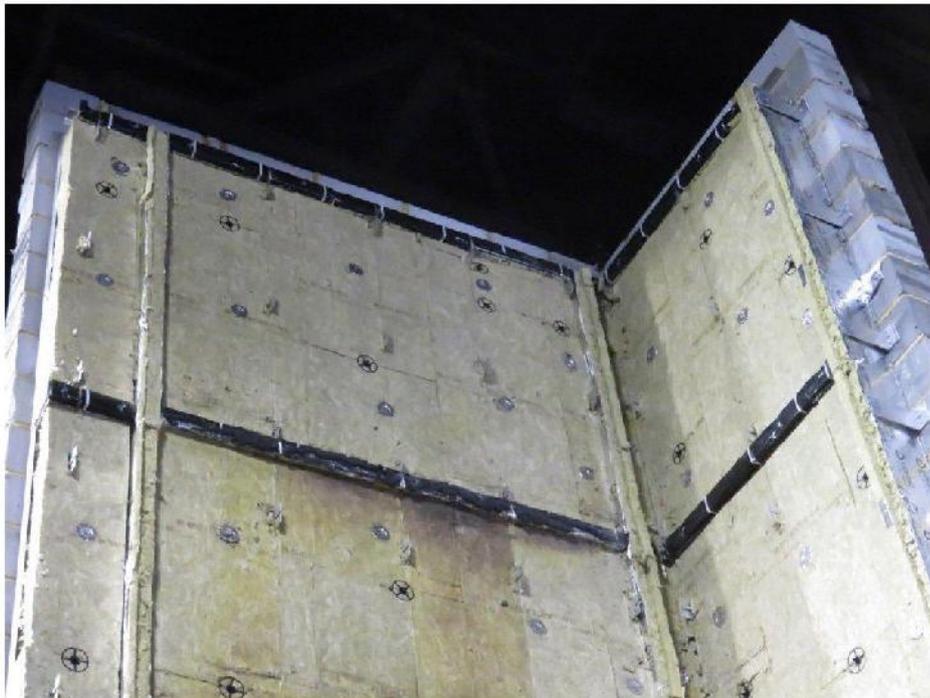
Figure 31. Cladding system beneath ACM panels between the third and fourth horizontal cavity barrier (approximately 4700-6360mm above the combustion chamber).
