GRENFELL TOWER INQUIRY: PHASE 1 REPORT OVERVIEW

REPORT of the PUBLIC INQUIRY into the
FIRE at GRENFELL TOWER
on 14 JUNE 2017

Chairman: The Rt Hon Sir Martin Moore-Bick
October 2019

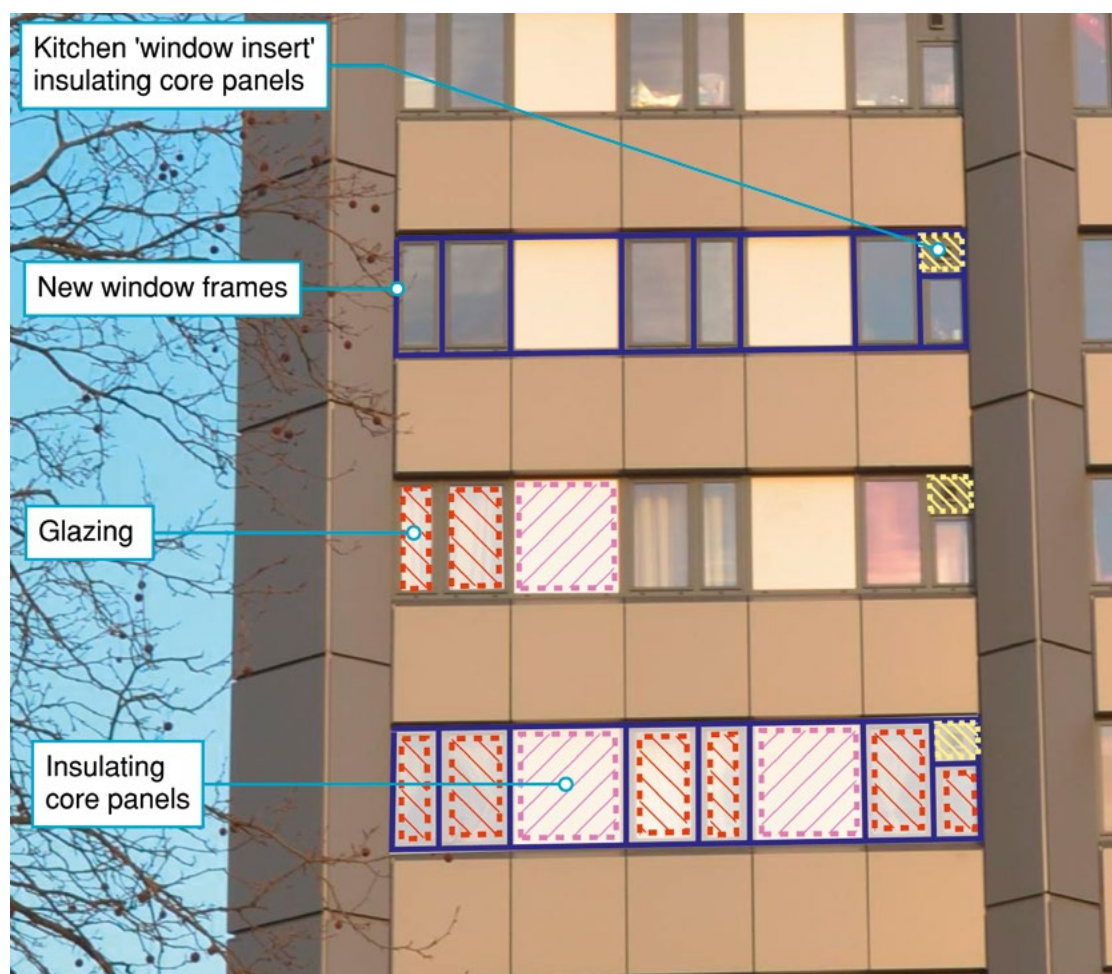
Figure 6.1

6.9 This is a close-up picture of the tower at the higher floors after the external cladding works had been completed:²

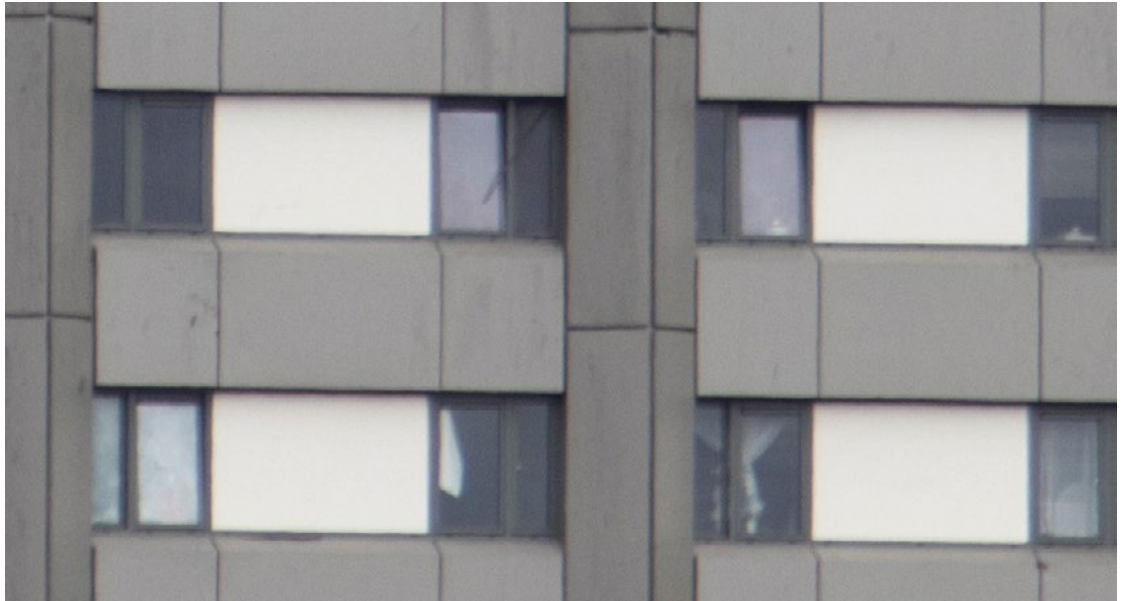
Figure 6.2

- 6.15 On the columns, the cassette panels were longer in shape, each one extending from halfway up the spandrel panel below the window, to halfway up the spandrel panel above the window, as can be seen from the image above. This meant that there was a continuous panel at the junction between the windows and the column.¹⁵ The column panels were also fixed to the face of the concrete columns using steel angle pieces and cladding rails.¹⁶ The columns were clad with one panel per face, i.e. two panels for the internal columns and three panels on the corner columns. There were gaps of between 15mm and 30mm

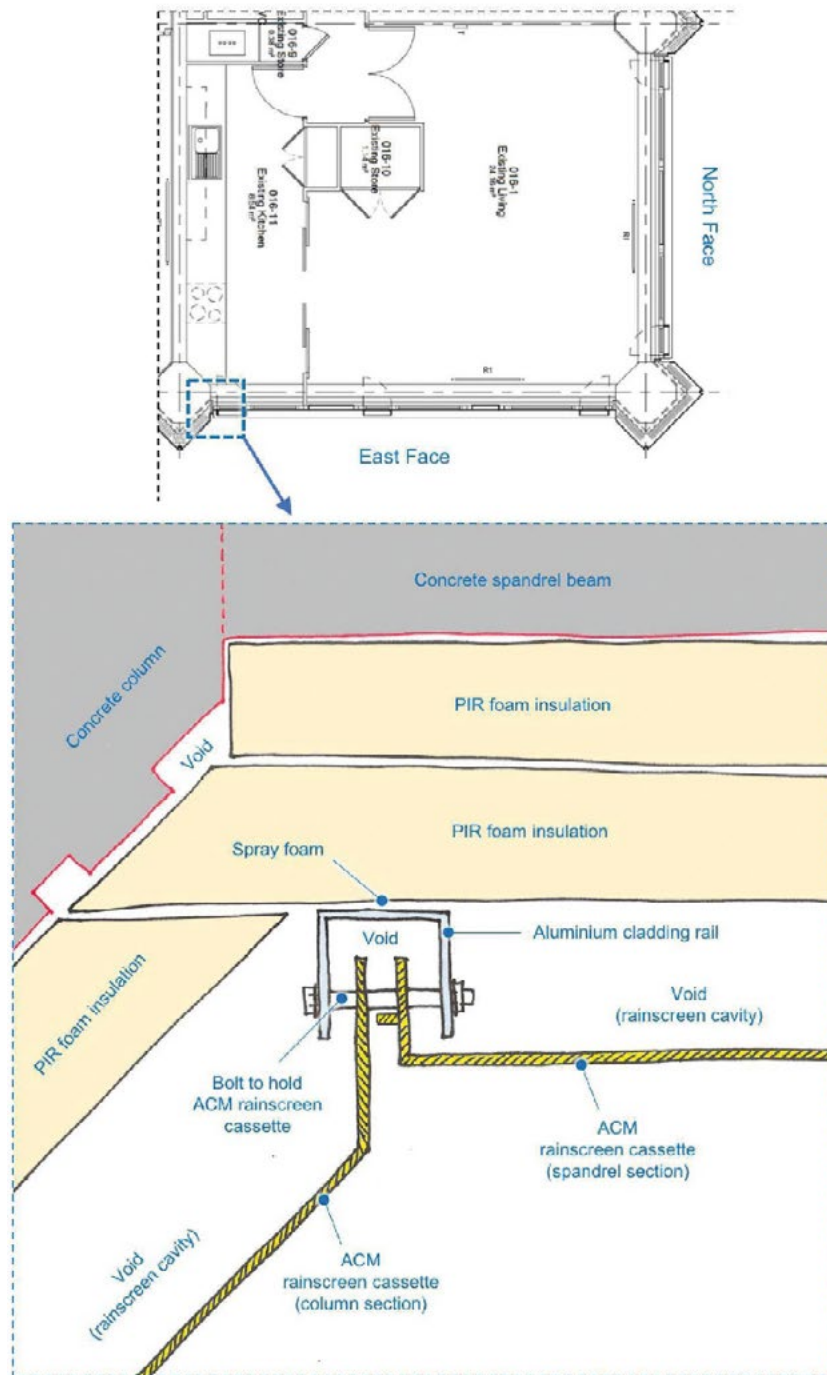
Figure 6.3

a horizontal section detail taken from Professor Bisby's report, which shows the refurbished system at the junction between the concrete spandrel beam and the concrete column:²⁶

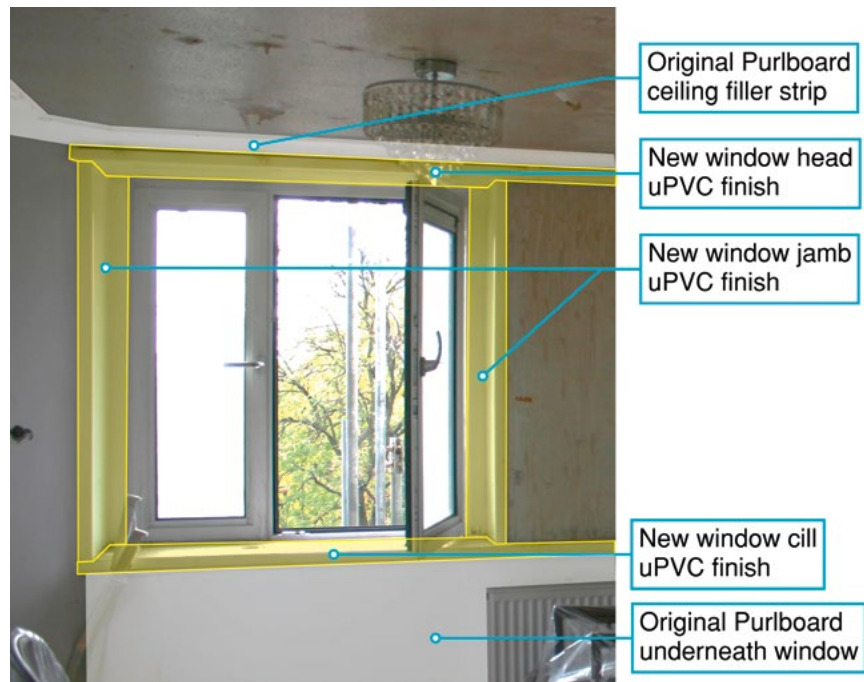
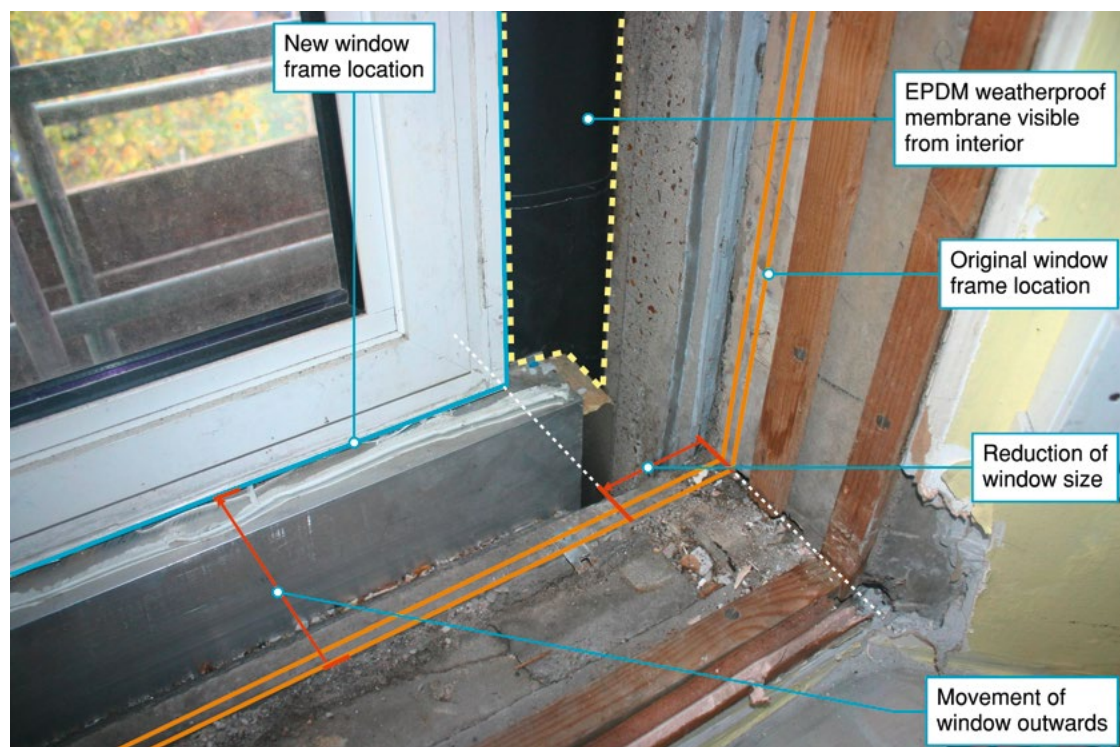
at about 90°C.⁵⁵ It has an ignition temperature of between 318°C and 374°C.⁵⁶ It chars when exposed to heat and generally displays limited surface spread of flame due to its high chlorine content.⁵⁷ The uPVC window surrounds were glued partly to the pre-existing timber window sills, window heads and window jambs, and partly to 25mm insulation boards which were used to close off the opening into the cavity in the cladding caused by the repositioning of the windows. No mechanical fixings appear to have been used.⁵⁸ The new window arrangement is illustrated in the following photographs:⁵⁹

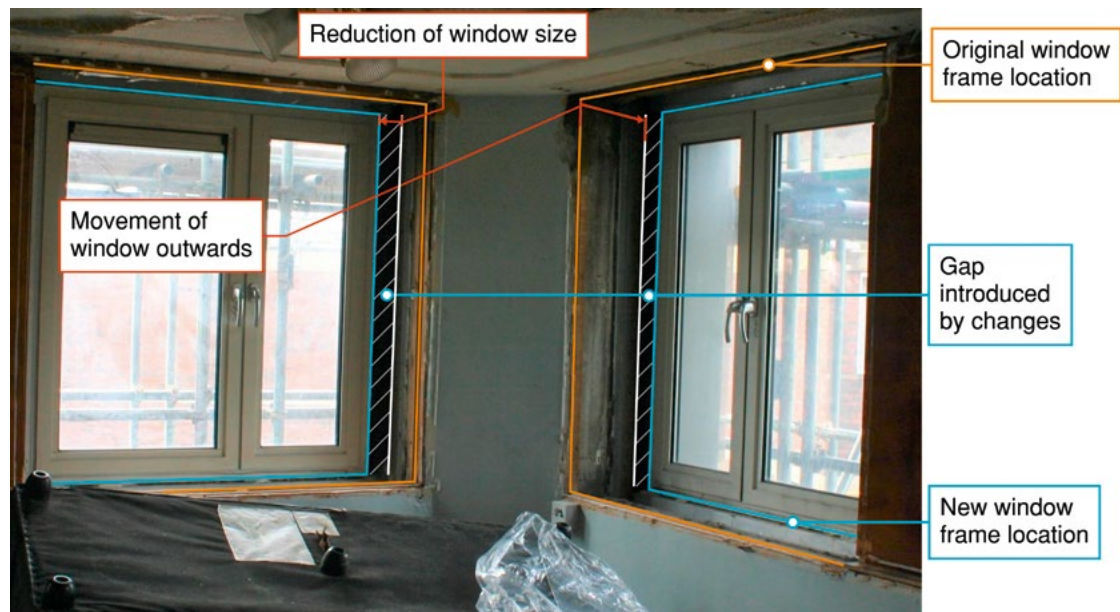
Figure 6.9

6.33 The following figures show the position of the original window frames together with other features of the new window arrangement, including the windows themselves, the EPDM membrane and the gaps created by the reconfiguration of the windows:⁷³

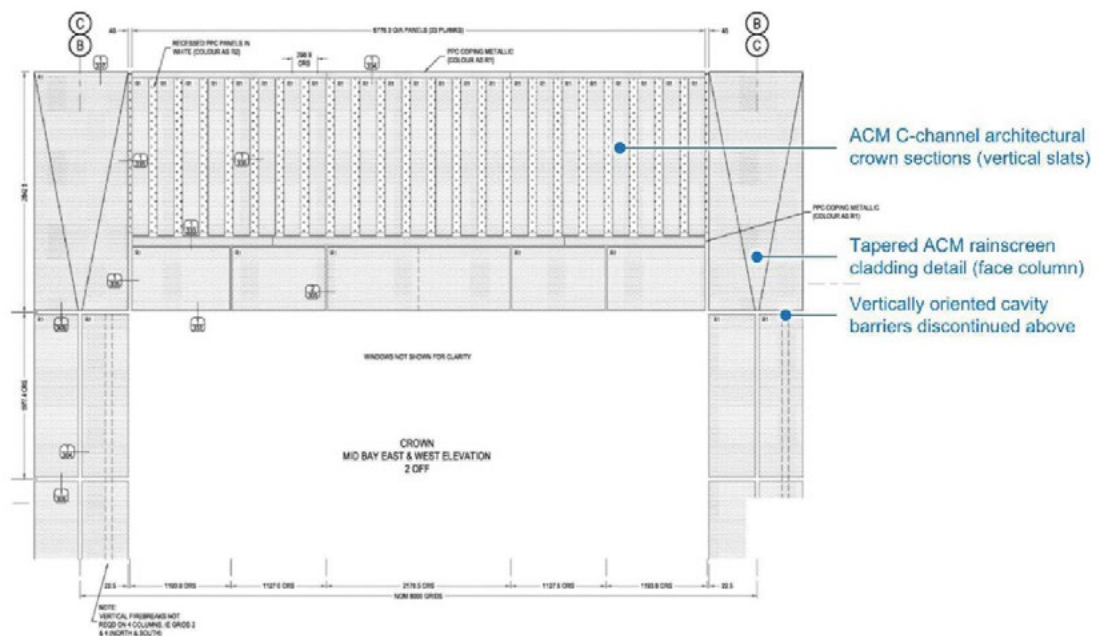
Figure 6.11

6.36 Below is a design drawing of the architectural crown at roof level and showing the new “C”-shaped ACM fins and the new detailing at the top of the columns.⁷⁶
