Fire Performance Testing of an External Cladding System
BS 8414-1:2015 + A1:2017

Test Report

Prepared for : Kingspan Insulation Ltd.
Project : System Development
Report No. : DLR1453 Rev.0
Sample : Kooltherm K15 –Alpolic/fr - BML100

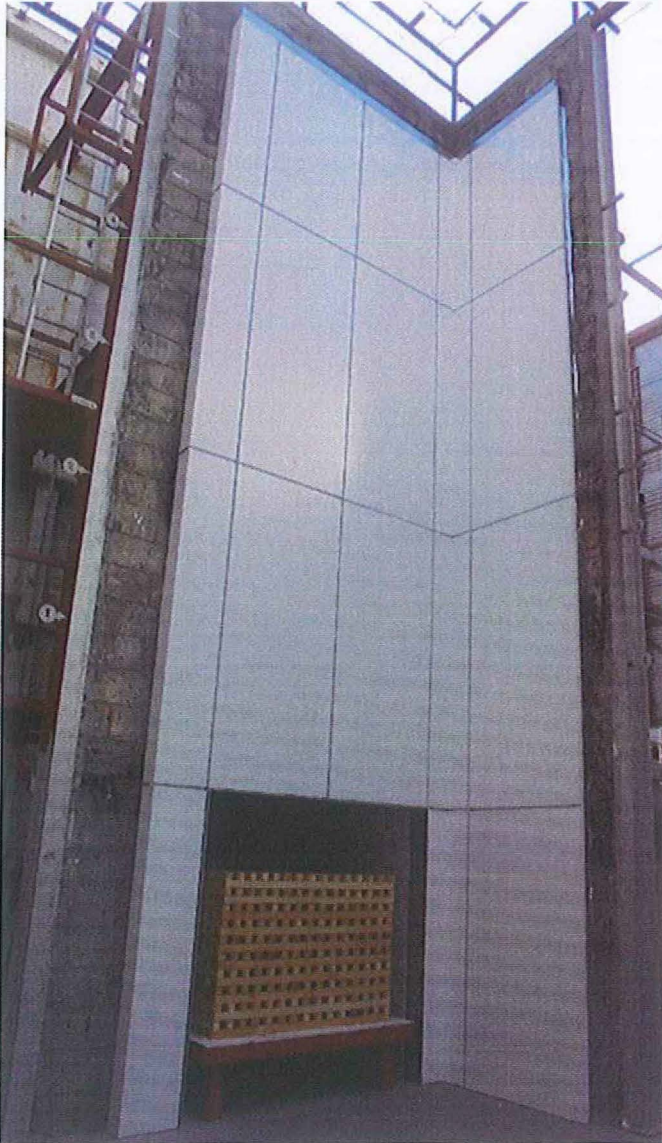
Figure 1 Photo DLP C2753C/7259 External View of the Test Sample

Photo DLP C2753C/7259 shows an external view of the sample.
