BRE Global Client Report

BS 8414-1:2015 + A1:2017 Test referred to as DCLG test 7.

Prepared for: DCLG
Date: 18th August 2017 (Issue 1.0)
12th September 2017 (Issue 2.1)
Report Number: B137611-1037 (DCLG test 7) Issue: 2.1

This report is one of a series, commissioned by the Department for Communities and Local Government (DCLG) intended to establish how different types of Aluminium Composite Material (ACM) panels in combination with different types of insulation behave in a fire.

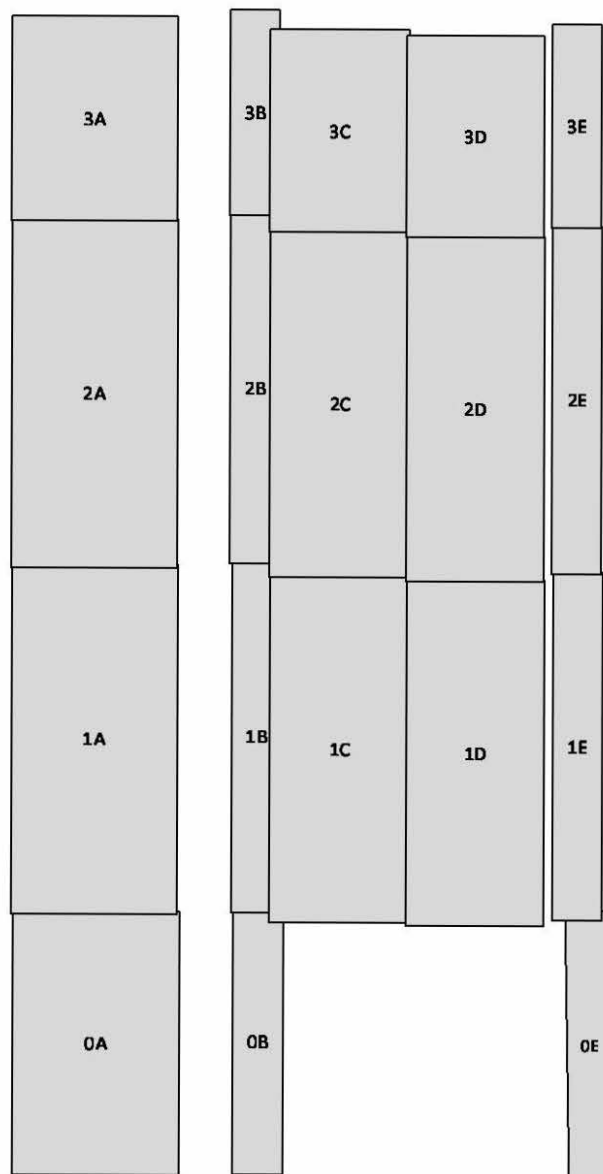
Figure 1. Layout of panels and labelling system used for reporting purposes. Not to scale.

On the main wall, the damage to the ACM panels was (See *Figures 22 to 28* and with reference to *Figure 1*):

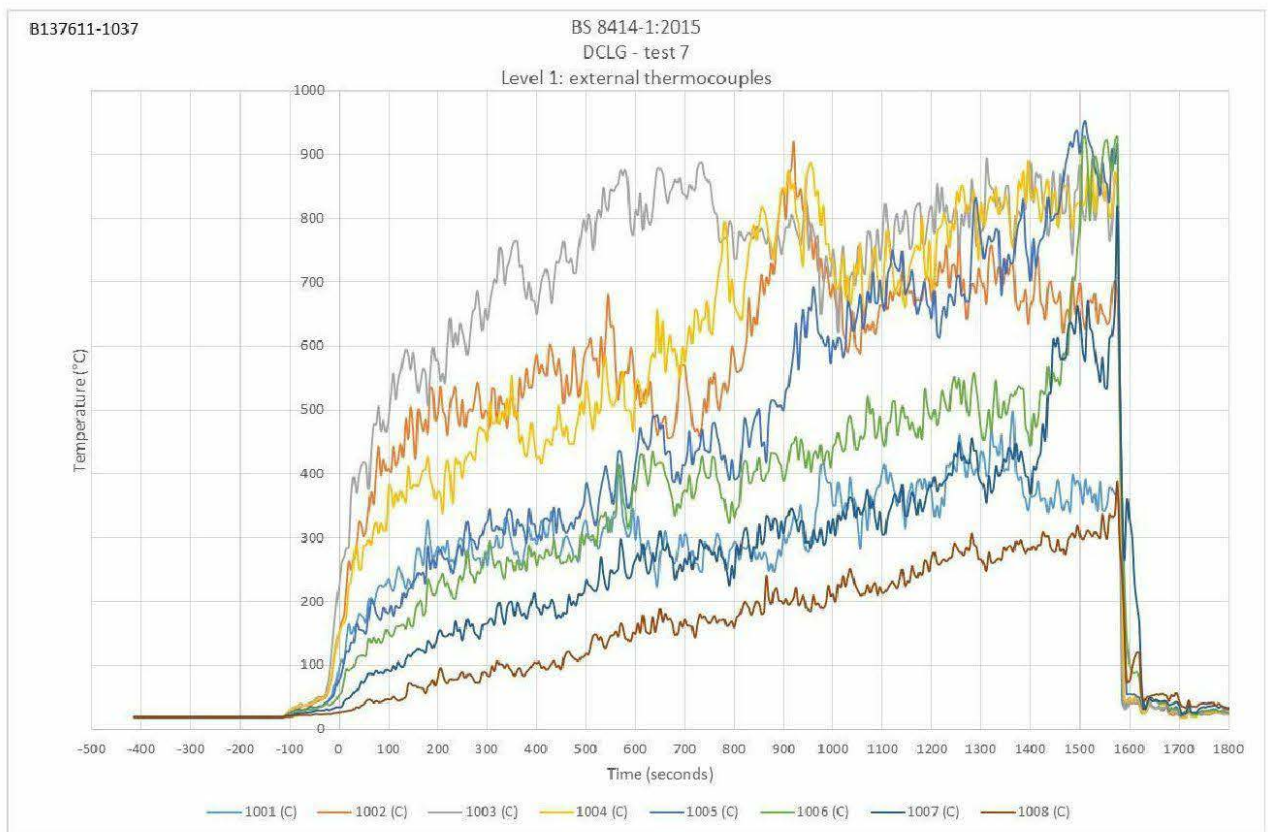
Figure 18. Level 1 external thermocouples.

Figures 18-21 provide the temperature profiles recorded. Figure 12 shows the system before the test.
