BRE Global Test Report

BS 8414-1:2015 + A1:2017 test on a ventilated façade system with Kingspan Kooltherm K15 insulation and Alpolic/fr panels.

Date: 11th January 2018

Report Number: P109939-1000 **Issue:** 1

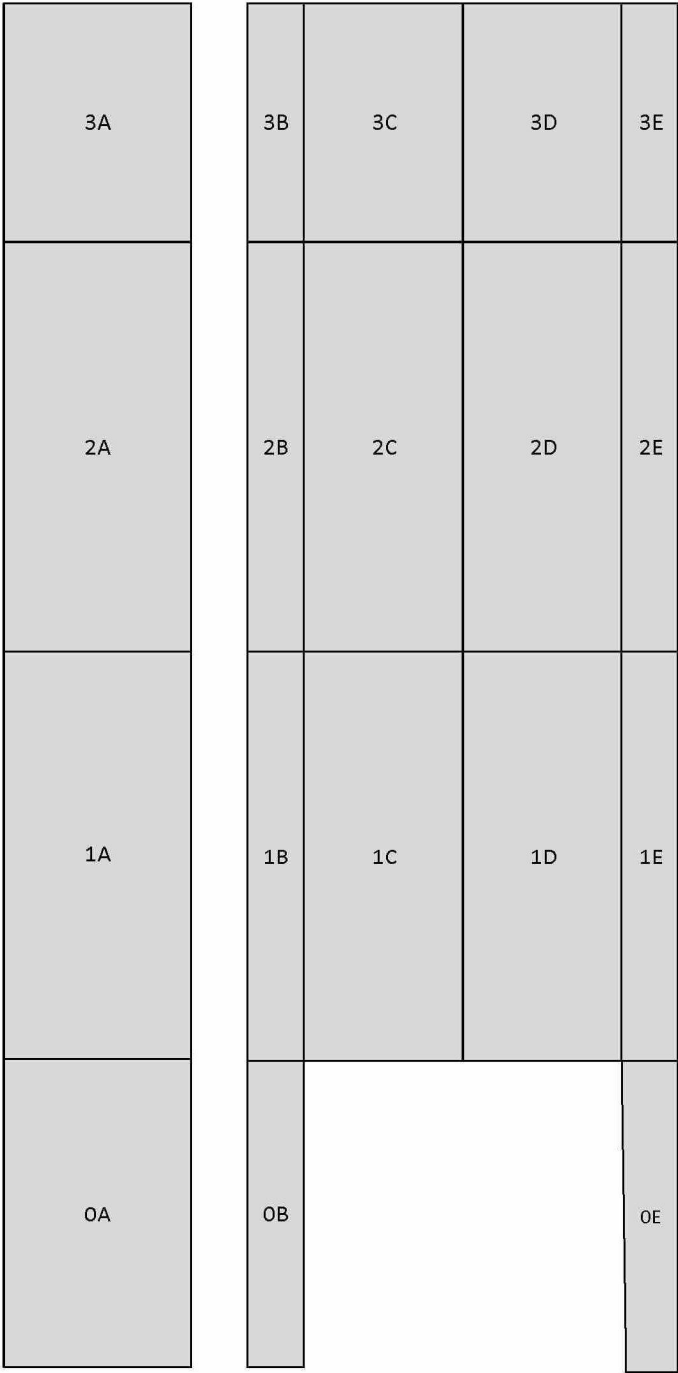
Figure 2. Layout of panels and numbering system used for reporting. Not to scale.

Panel 2D. Approximately 50% consumed. Section remaining in the form of an inverted triangle 600mm width at top x 100mm at base (full panel height). Panel loosely attached at outside vertical edge and distorted away from the wall.

2C & 2D Extensive damage and charring to insulation. Masonry substrate visible in places.
