The Lakanal Fire

LFEPa Briefing

28th August 2013

David Crowder

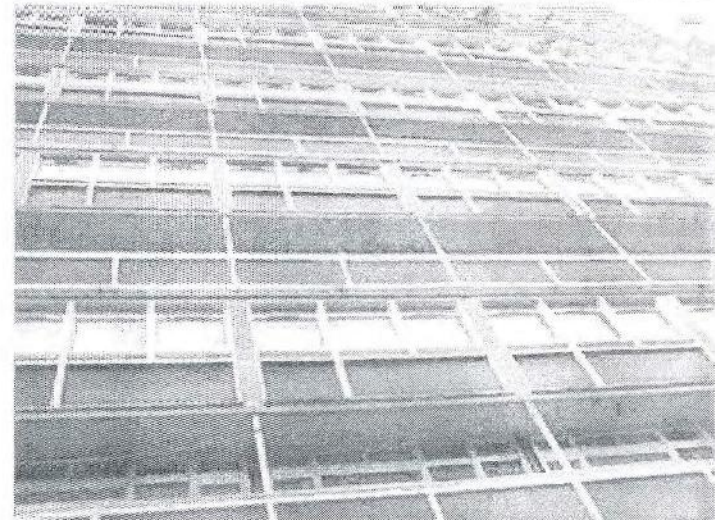
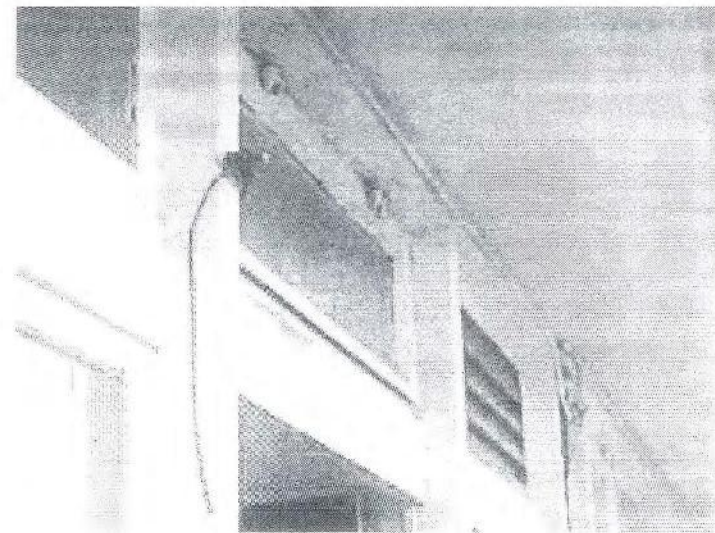
1970s refurbishment work

- Windows replaced
- Records indicate:
 - timber frame window sets
 - Asbestoslux infill panels
- External surface of panels specified as 'non-combustible'

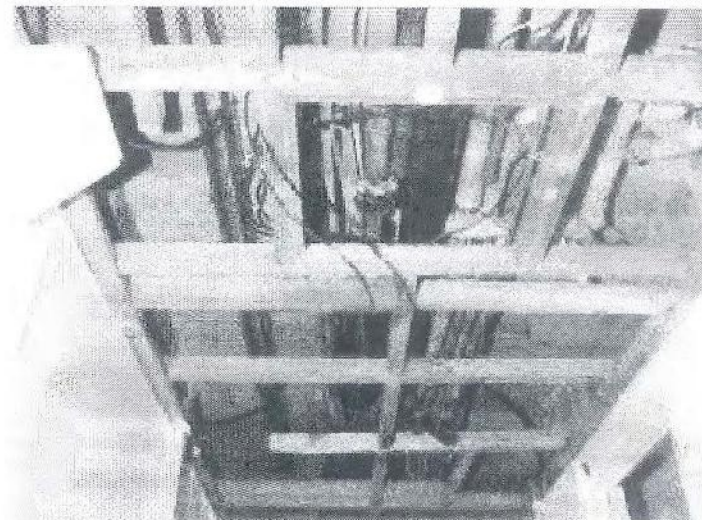
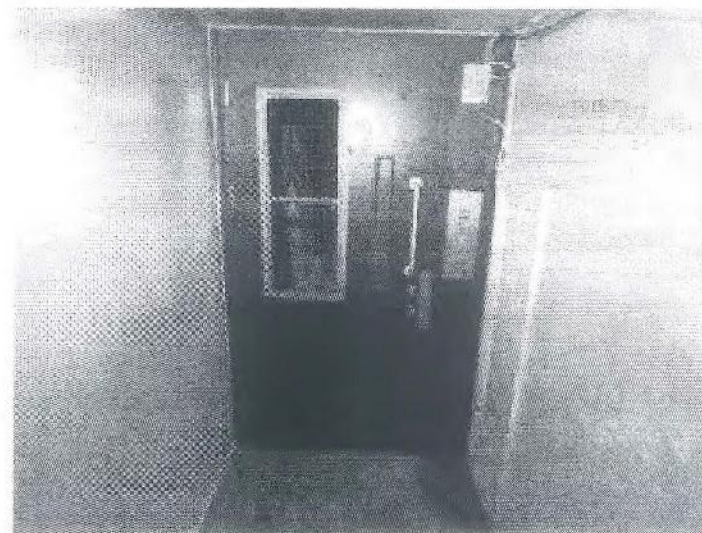
1980s refurbishment work

- Installation of security doors
 - Impact on cross ventilation recognised
 - Requirement for minimum 0.5m^2 open grille area (+ 1m^2 manually opened) in approval
- Replacement of central heating system
- Introduction of suspended ceiling in common corridors
- Subsequent upgrading of suspended ceiling with 'Panoflam' ceiling panels

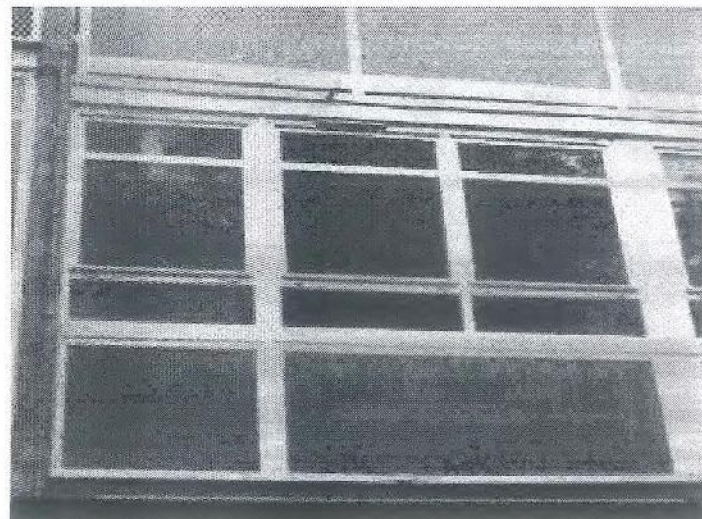
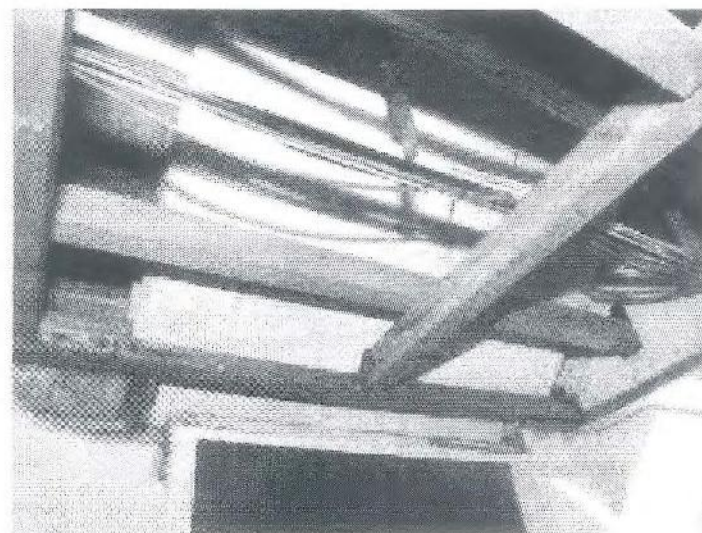
2006-2007 refurbishment work

- Planned Preventative Maintenance
- Decent Homes
- Various repairs, renewals and redecoration works
- Renewal of windows
 - Removal of asbestos
 - Installation of new window sets
- Renewal of balcony doors
- Upgrade landlords electrics and rewiring in flats where required
- Installation of kitchen extractor fans

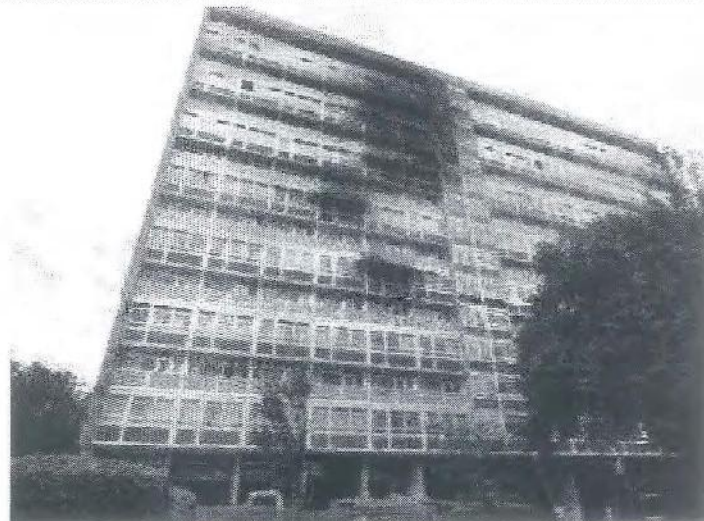
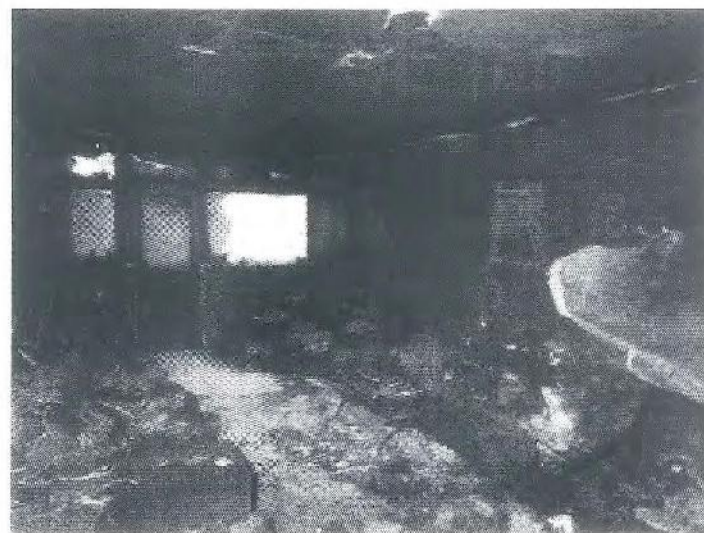
Conclusions

- Building considered 'state of the art' when built
- Featured in Architects' Journal
- Large number of issues crept in over a number of years
- Overall worsening of conditions through years of neglect
- No one single factor sufficient to have caused death in isolation
