# Site Visit Report

## External Doors

Site visit report Nº2343

<b>LHC Nº</b>	<b>Project title</b>	<b>Participating Body</b>	<b>Technical Officer</b>
35052	C5 External Doors Programme	Royal Borough of Kensington and Chelsea	AF

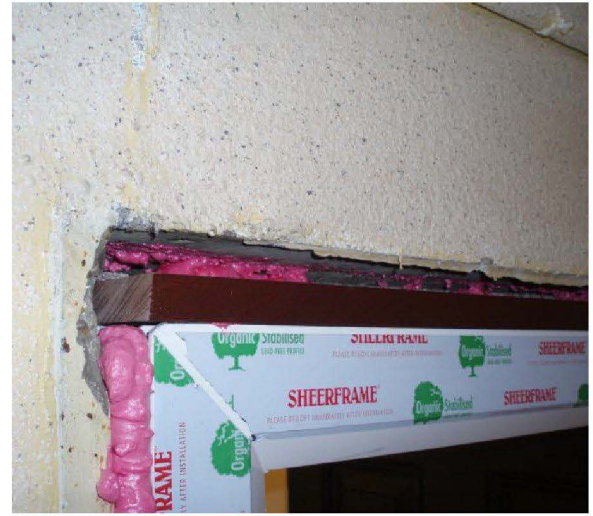
These two images illustrate packers being used next to fixings, fire foam has been applied around the frame. In this particular case fitters were asked to top it up.
