Witness Statement

8 The Metropolitan Police Service (MPS) requested an investigation into the gas installations within Grenfell Tower following a serious fire, the fire took place on the 14th June 2017.

Grenfell Tower over the years has undergone major renovations, which included the decommissioning of one of the original gas service risers and a new gas service riser being installed in 2017.

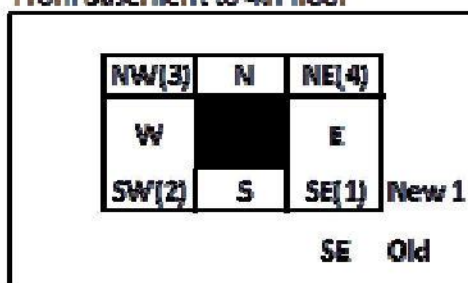
From Basement to 4th floor

There is a total of five risers from the basement that supply the building

- SE - original riser (decommissioned)
- SE (1) - new riser, replaces decommissioned riser
- SE - original riser capped off on the ground floor, SE (1) replaces this supply through building.
