OPERATION NORTHLEIGH
Site Investigation Report

Site Investigation Report

PROJECT NO. 70042523

DATE: AUGUST 2018

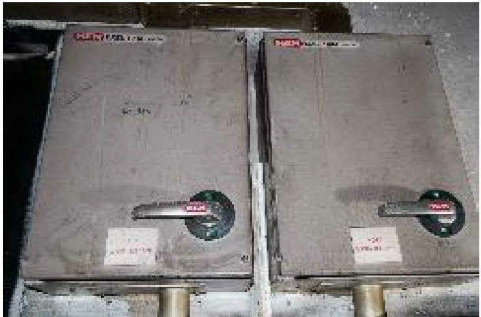
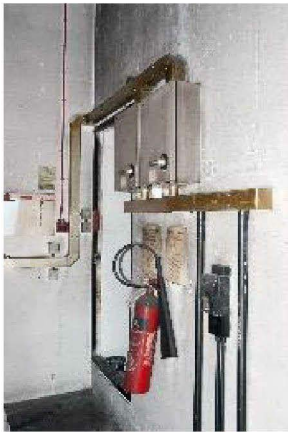
- The lift main isolators were located adjacent to the machine room access door.

- The trunking lids were removed (during this visit) from underneath the mains isolators in order to check the condition of the mains cables.
