Metropolitan Police Service London, UK

HVAC Logic and Functionality Testing

Reconstruction and testing of Grenfell Tower smoke extraction system

Report No. 2020-0400 Rev. 1

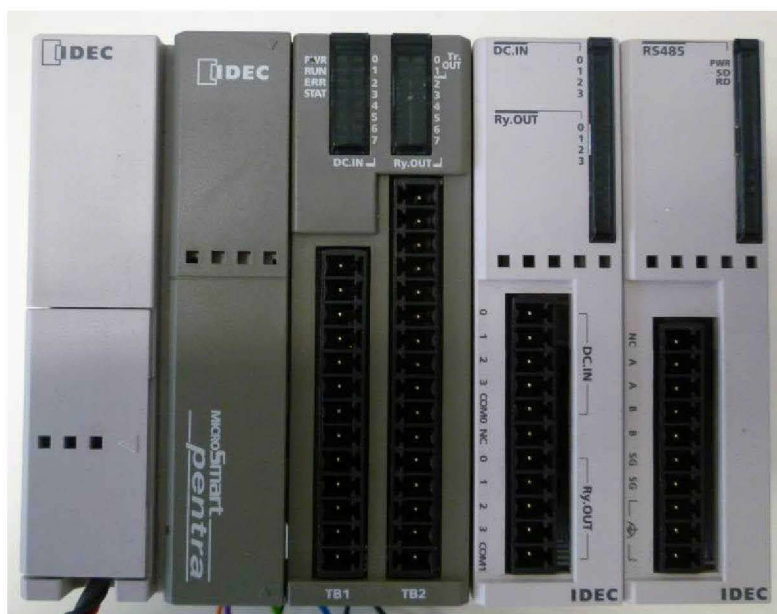
Figure 4.2: Top view of the PLC

The Master Panel unit was located on the ground floor Hub Room of the tower. This unit contained the Programmable Logic Controller (PLC), one Modbus board, twelve 24 V d.c. relays, terminal blocks, and the fire service auto-dialler. The Master Panel was delivered to RINA with the PLC removed. The opened Master Panel is shown in Figure 4.1. The empty space in the middle left of the panel was where the PLC was located. The PLC was delivered to RINA as a separate exhibit. The PLC was an IDEC unit consisting of four modules combined together, shown in Figure 4.2 and Figure 4.3. There was corrosive damage to several of the 24V d.c. relays which were located at the bottom of the Master Panel, and that damage was presumed to be as a result of water damage that occurred during the fire. There was no evidence of external damage to the PLC.

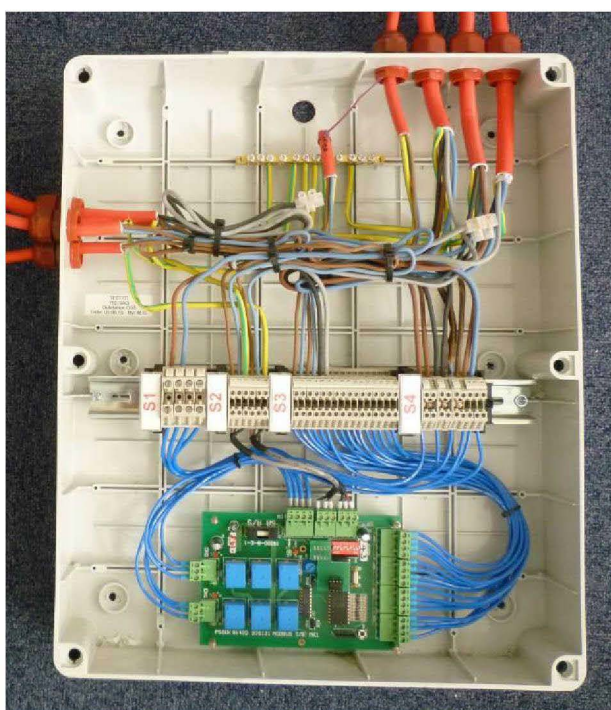
The outstations on each floor consisted of a series of terminal blocks, and one Modbus I/O board; expect in the case of O/S 1, which contained three stacked Modbus I/O boards, one for the floor 3 lift lobby, and one each for the for the second fire zones on the ground and second floor. All of the outstations in the tower were delivered to RINA. These arrived with a varying degree of damage from the fire, with the lower floors less affected. A typical undamaged outstation (O/S 5) is shown in Figure 6.1, while a

Figure 6.1: O/S 5, a typical example of an undamaged outstation

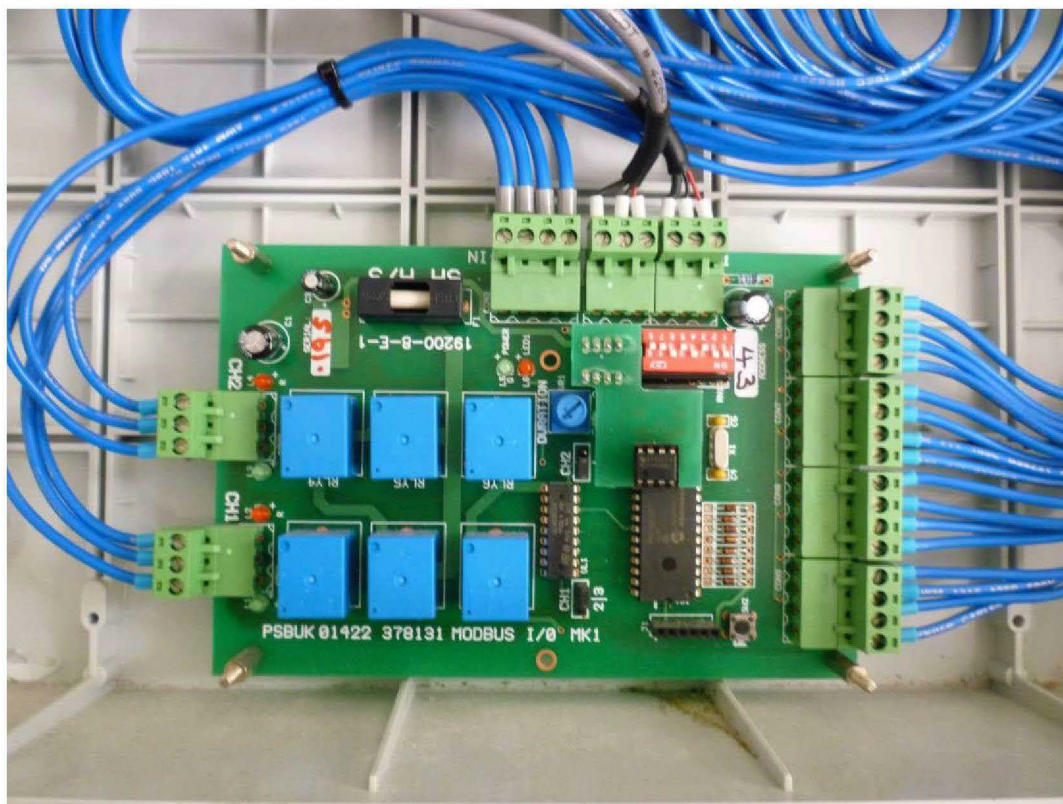
Figure 6.3: Modbus I/O Board from O/S 5

Some text was marked on the Modbus I/O boards indicating: inputs and outputs, communication details, and model number and revision of the board. The communication details were: 19200 baud rate, 8 data bits, even parity, and 1 stop bit. Three board revisions were found across the outstations in the tower, these were:

- PSBUK 01422 378131 MODBUS I/O MK1
- PSBUK 01422 378131 MODBUS I/O MK1 v8 ("v8" handwritten)
- PSBUK 01274 694999 MODBUS I/O MK2

The rotary switch (potentiometer) was found to control the on/off time after power cycling the board. This could vary the timer between 2.7 seconds and 2 minutes 59 seconds. This corresponds with what was written on the board, "3 Sec" "3 Min".

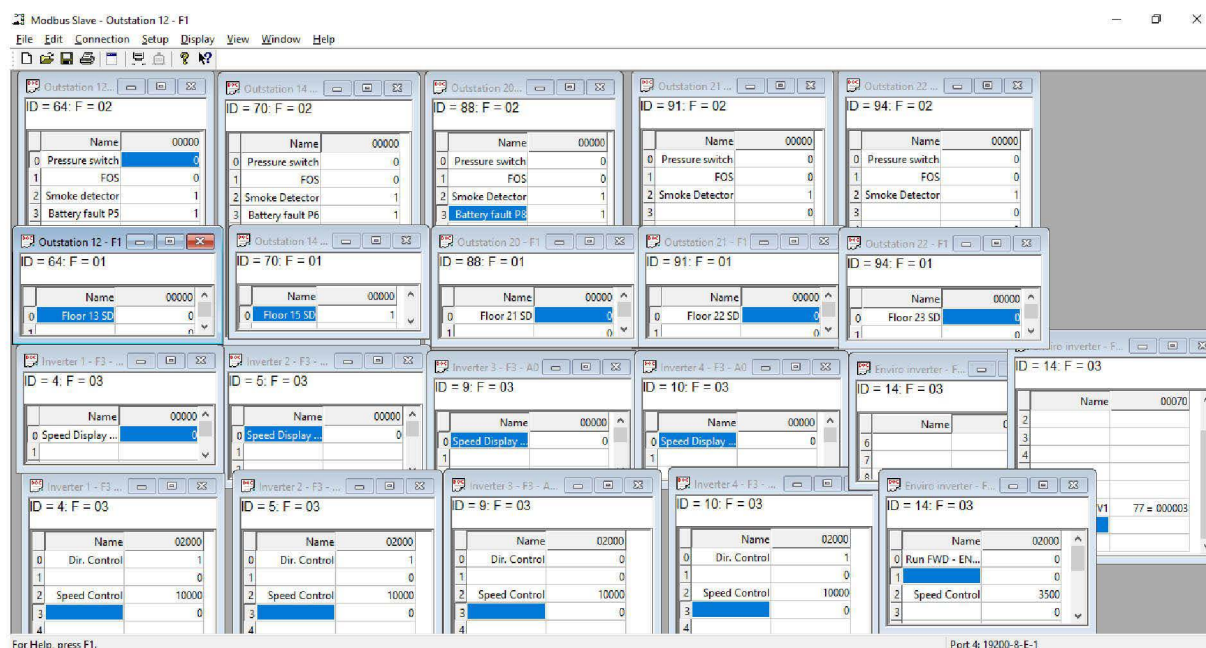
Figure 7.2: Screenshot of the Modbus simulation software

Outstation	Modbus number	Notes
12	64	Board did not respond.
13	67	Board did not power up and was repaired.
14	70	Board did not respond.
20	88	Board did not respond.
21	91	Board did not respond.
22	94	Board did not respond to 94, but did respond to 64. DIP switches correctly position for 94.

The non-operation boards and the inverters were simulated using computer software, “Modbus Slave” by Witte Software. A screenshot of this software is shown in Figure 7.2. This was done to prevent the system from reporting communication errors, and to allow the system function as closely as possible to its condition before the start of the 2017 fire. After simulating these non-operation boards, and the inverters, and connecting the remaining equipment, the HMI was only left with a message reporting that a service was due: “Service Required”. If the environmental control input was simulated from the BMS, the HMI panel also scrolled the text: “Environmental Sequence Running”. With the environmental sequence running, the system would open and close a selection of dampers every 15 minutes. The control of this sequence is shown in Table 7.2. The dampers in fire zones 25 and 26, on the ground floor community lobby and second floor boxing studio were not programmed into this sequence and did not activate during the simulation.

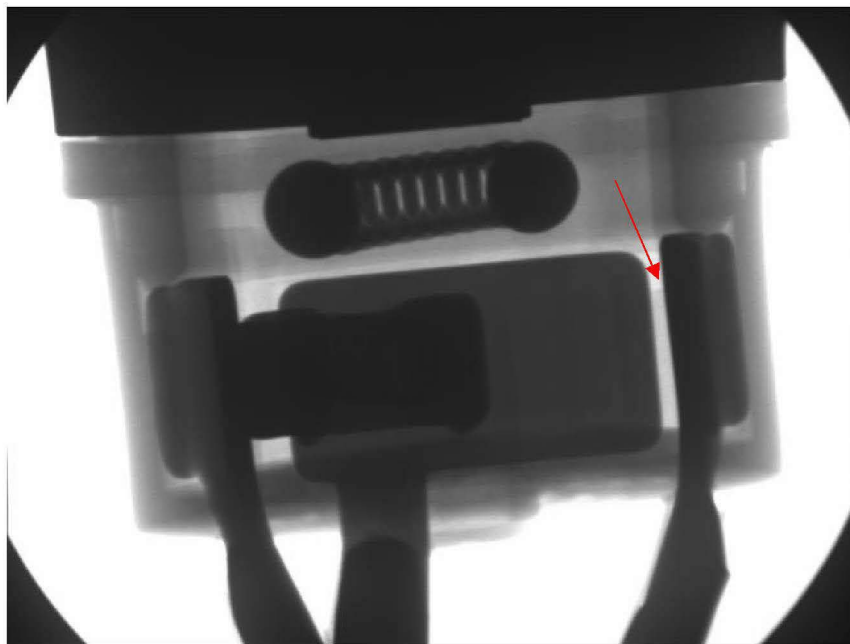
The FOS on the HMI panel was recorded in-situ after the fire with the key present in the device, and turned to the ON position, with the touch screen of the device showing it having switched to the override mode, and dampers open on the 18th floor [2]. Information from MPS was also received that none of the FOS in the lift lobbies were activated by the firefighters. Despite this, the records from the PLC show that it had received input from the FOS on several floors. Examination of a FOS from the second-floor lift lobby showed simple construction, with a key operated switch (Figure 8.1). A sticker on the back of the unit identified as a "KAC Alarm Co. Ltd K21SYS-11". A datasheet found online from the manufacturer lists electrical and environmental specifications [6]. The electrical properties were suitable for its application. The environmental properties specified an operating temperature of " -20°C to 55°C ", and an ingress protection of "IP24". An x-ray image of the FOS from floor 2 is shown in Figure 8.2 and the red arrow in this x-ray image indicates the spacing between the contacts.

Figure 8.2: X-ray of the FOS from floor 2 set to the auto (off) position
