Report of Roger Howkins

Concerning the lifts at

Grenfell Tower

For the Grenfell Tower Inquiry

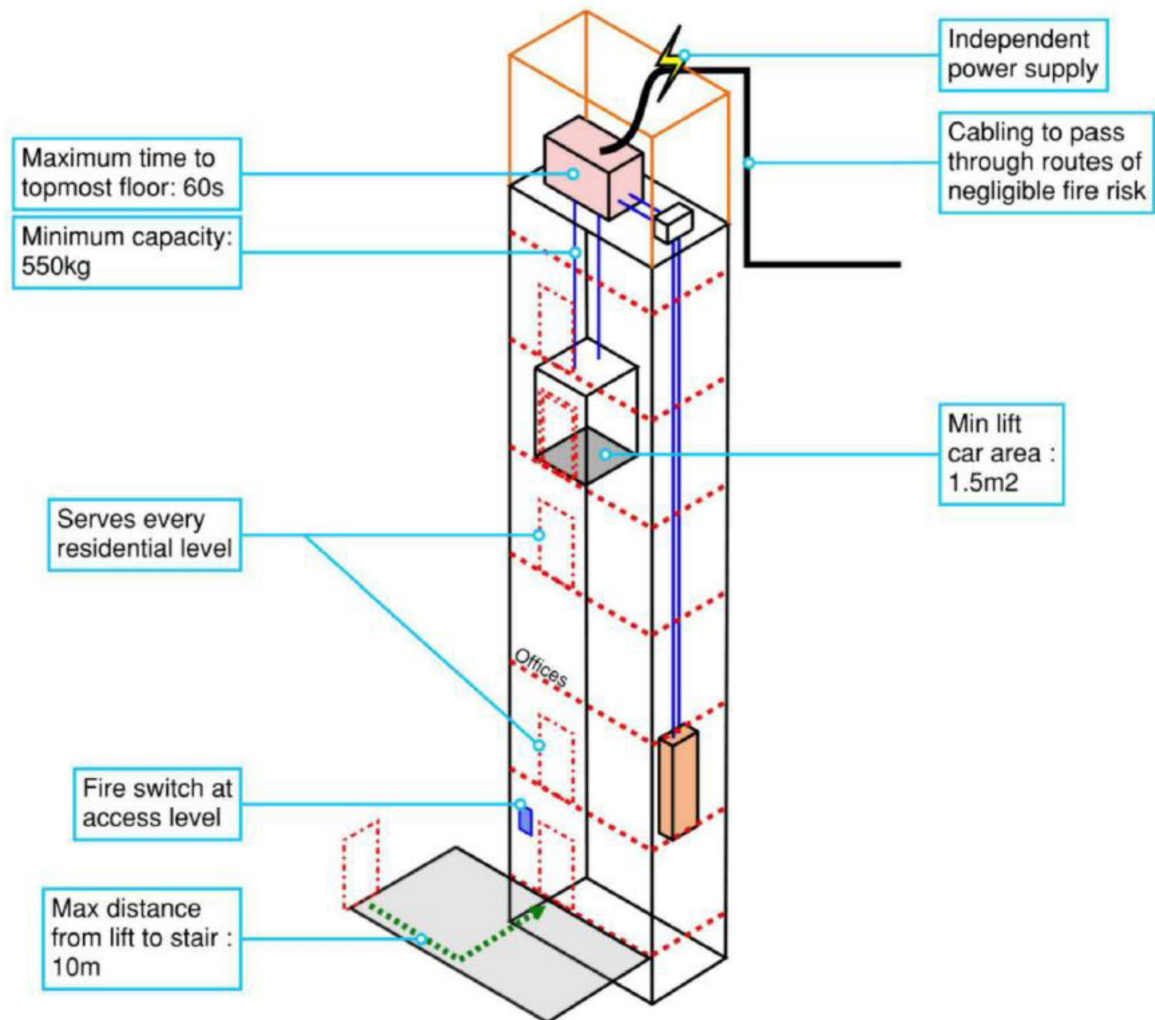
Figure L.2: 'Fire lift' requirements as per CP3 1971

34. Dr Barbara Lane's Phase 1 report¹ contains a helpful diagram summarising the requirements of CP3 1971 which I reproduce below:

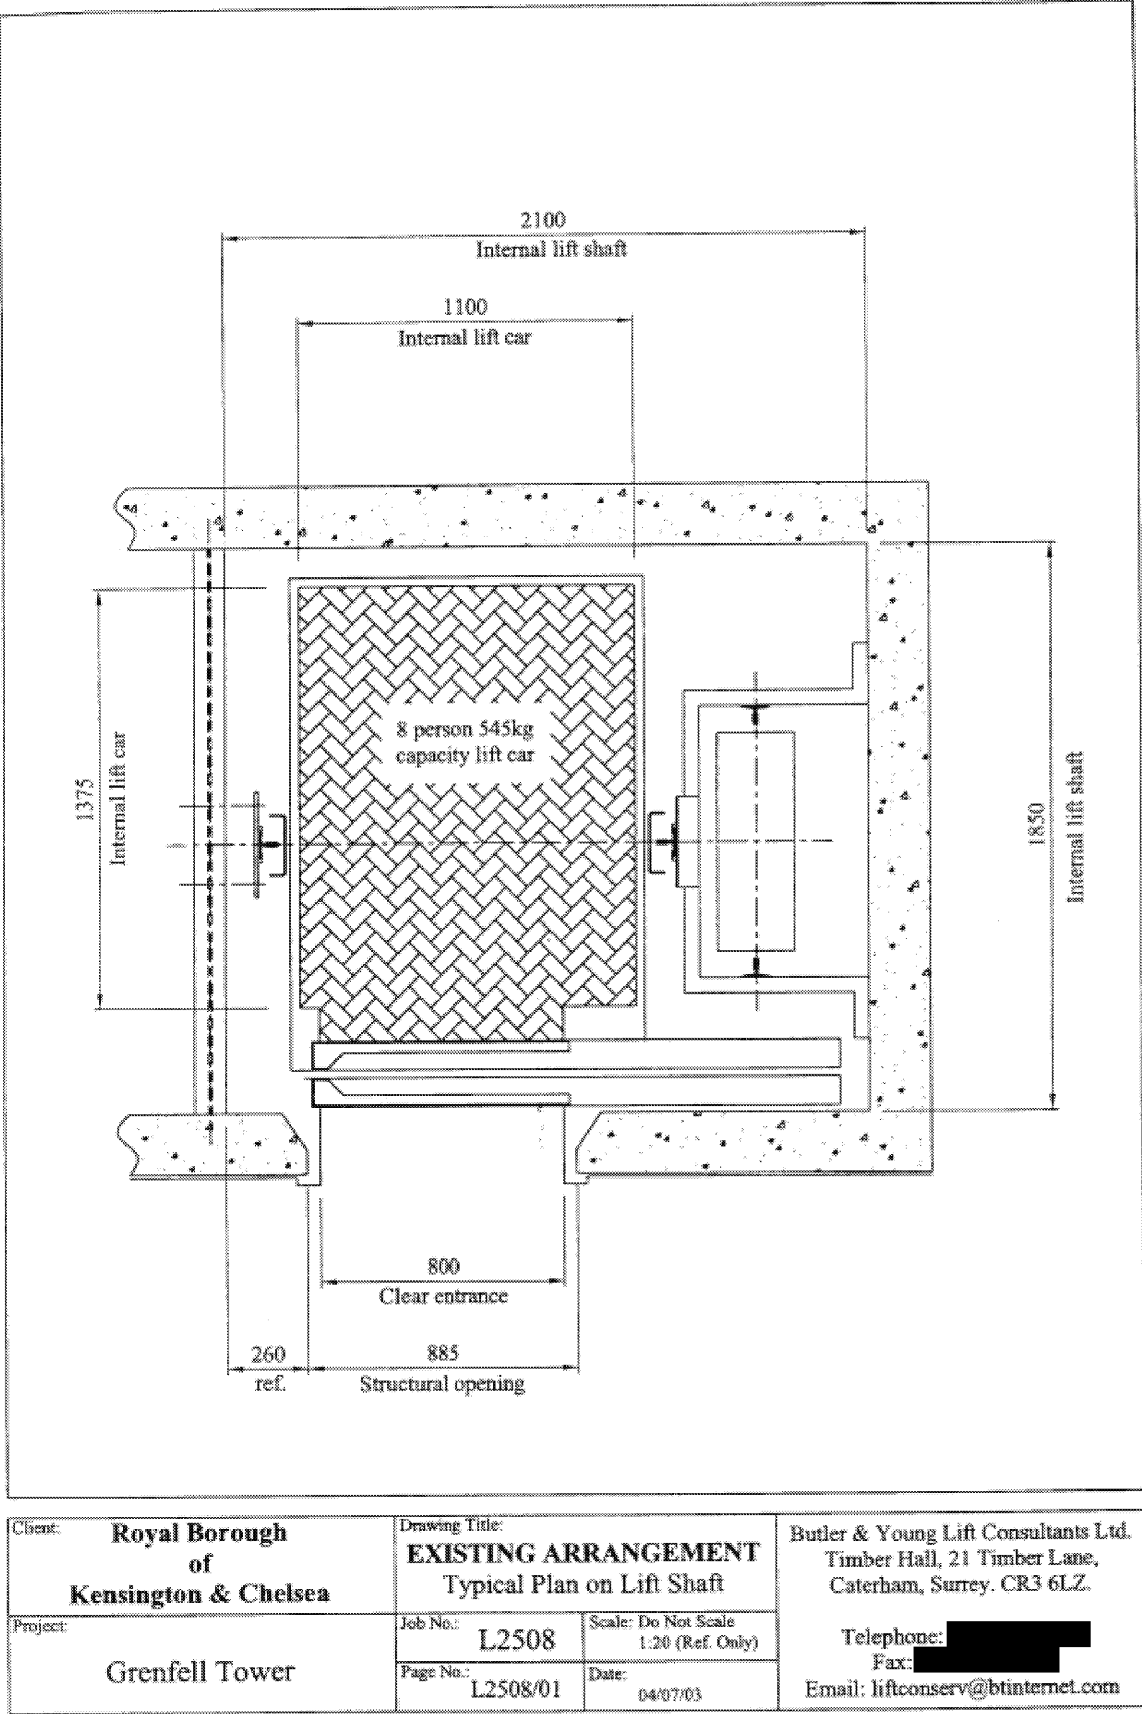
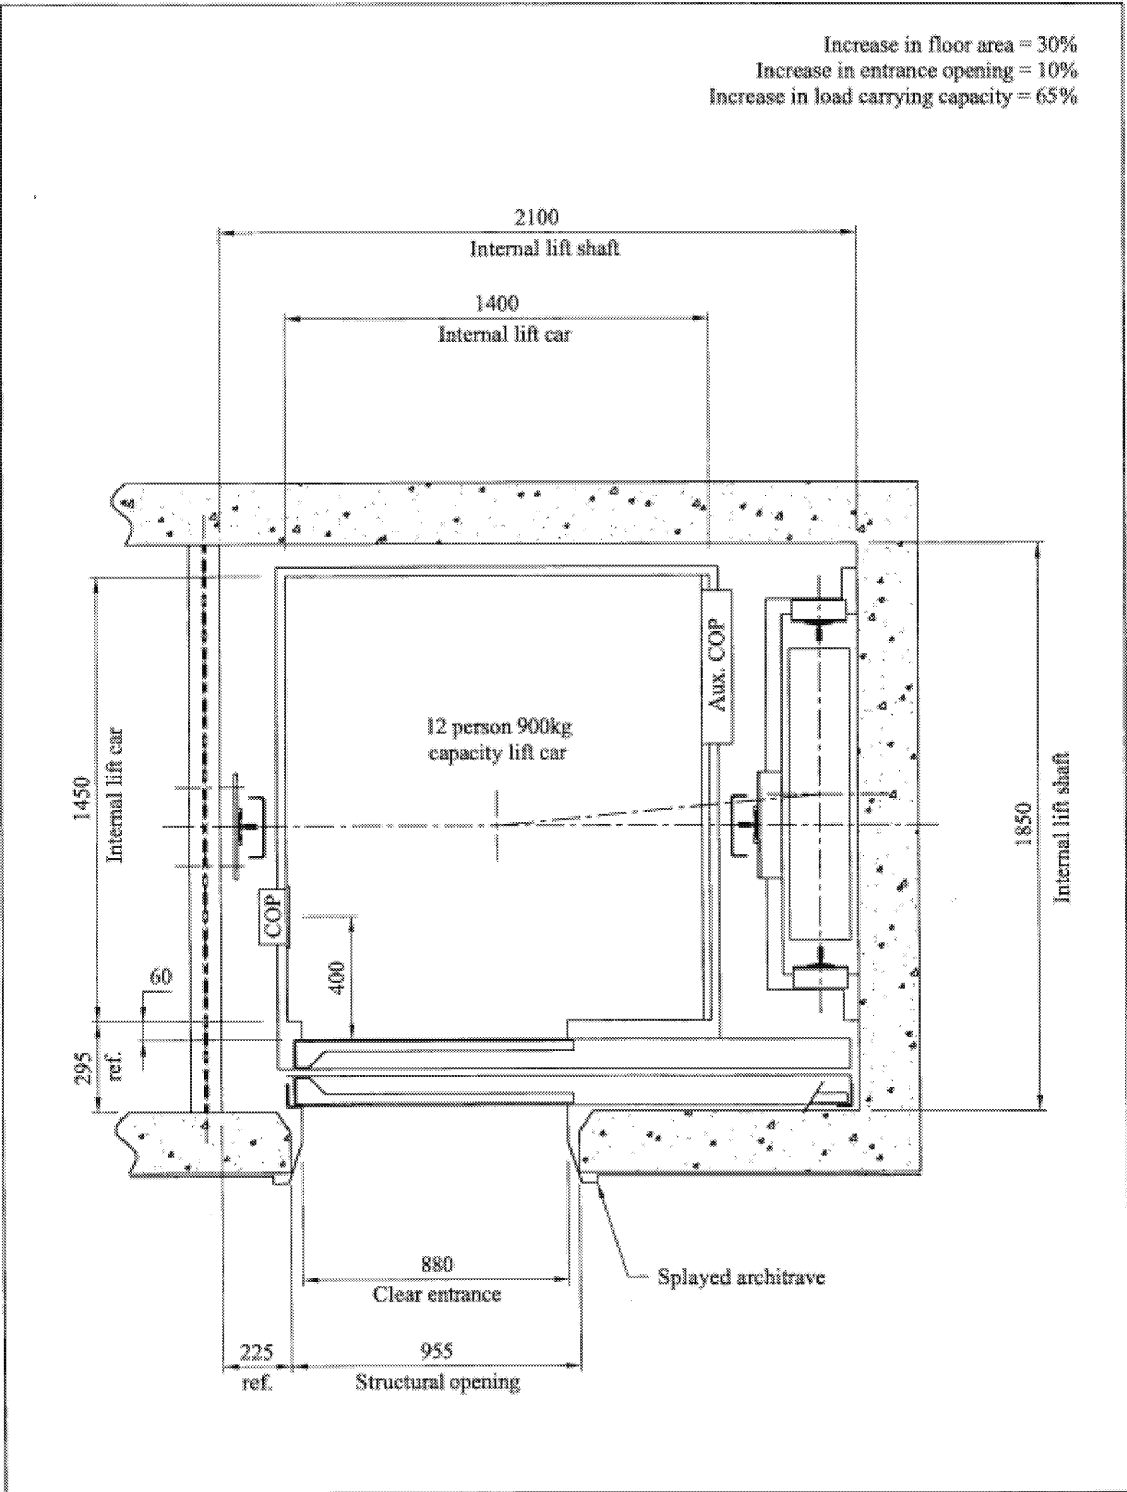
234. The Project 1 drawings titled ‘Existing Arrangement’ and ‘Proposal Arrangement’ {APX00005557} are inserted below. The drawings are dated 4 July 2003 and they are not to scale. It is likely that they were produced alongside the specification but it is very unlikely that they were the final drawings. Therefore, they can only provide a guide to the Project 1 works.

235. These drawings show that the existing lift was 8 person, 545kg capacity and the new lift was 12 person, 900kg capacity.
236. In the pre-refurbishment drawings, two car guide rails can be seen on either side of the lift car. In the post-refurbishment drawings, two car guide rails can also be seen on either side of the lift car. The car guide rails on the counterweight side must have been relocated together with new guide fixings, because the car size was increased and also the counterweight size was increased. As for the car guide rails on the other side, they are fixed to the structural wall of the lift well. It is not clear from the drawings or other documentation if those car guide rails were left in the same position or whether they were relocated.
237. The minutes of a Contract Progress meeting dated 22 June 2005 {APX00005531} say that guides were relocated:
