Report of Roger Howkins

Concerning the lifts at

Grenfell Tower

For the Grenfell Tower Inquiry

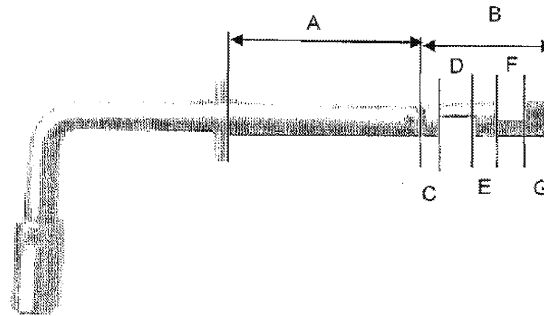
- 591.3. ER/1 – Express Drop Release Lift Key.
 - 591.4. LJH/67 – the lift key sent by Ricky Nuttall.
592. Andre Horne's testing found a significant difference in dimension between LJH/67 and the other three keys – DER/22, SJG/01, and ER/1. This difference rendered LJH/67 unuseable in fire control panel BJG/74 and the exemplar fire control panel ER/2. It should be noted that all of the keys were of different dimensions. The table setting out the measurements in his report is reproduced below:

A	B	C	D	E	F	G
DER/22	57.5	35.26	4.5	10.24	5.24	9.94	5.90
SJG/01	55.79	35.55	4.54	10.13	4.63	10.00	6.76
ER/1	58.72	35.29	4.00	10.29	5.04	10.12	6.0
LJH/67	55.15	36.41	7.69	10.06	4.28	10.08	4.53

593. Furthermore, Andre Horne concluded that DER/22 was slightly ill-fitting and that it could have been responsible for the damage to the side wards found on BJG/74. He found: *"If a fire control panel with the same dimensions as Item BJG/74 is encountered and a drop key such as the one in Item DER/22 is used, it may cause the same problems encountered during the response to the fire in Grenfell Tower."* He also found that DER/22 would not have worked normally even if BJG/74 had not had bent side wards.
594. SJG/01 worked normally in both fire control switches.
