## Appendices to the Report of Roger Howkins

### Vertical Transportation Engineer | Lifts | Arup

### Grenfell Tower Inquiry | September 2020

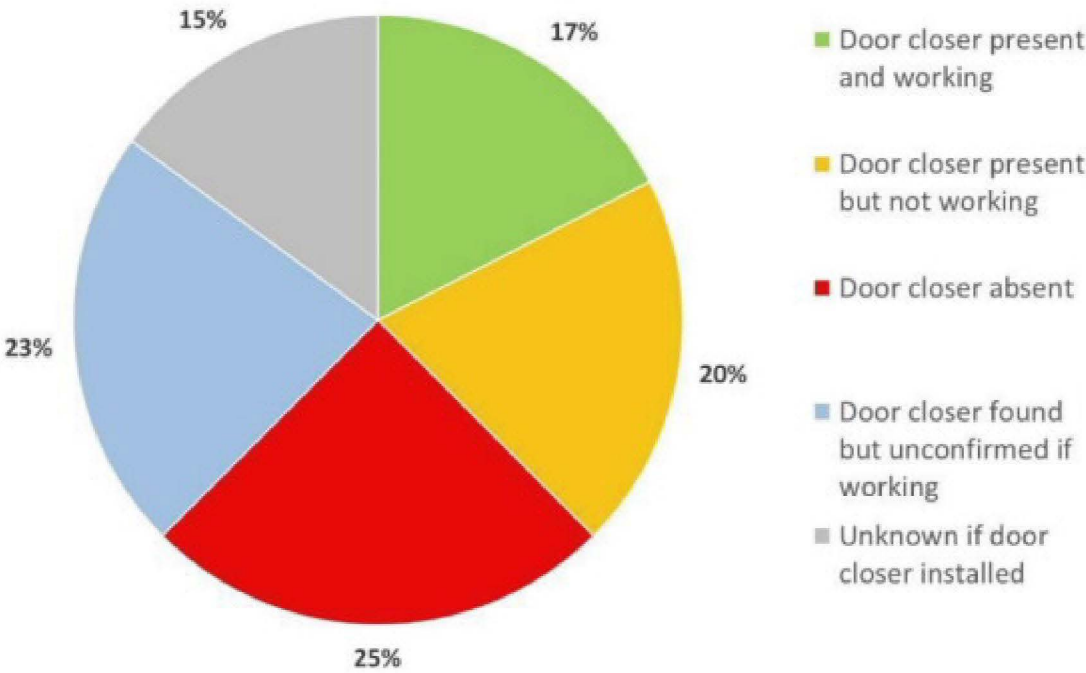
18 Table 1 provides current data relating to flat front doors (further work is ongoing to attempt to reduce the number of unknowns currently in this table). As shown by Figure 1, 45 percent of flat front doors from Floor 4 to Floor 23 did not have a working door closer installed ("Door closer present but not working" plus "Door closer absent"), 38 percent were unknown ("Door closer found but unconfirmed if working" plus "unknown if door closer installed") with 17 percent of flat front doors with working door closers.

Figure 1 – Chart showing percentage of working versus non-working door closers from Floor 4 to Floor 23 (120 flats)

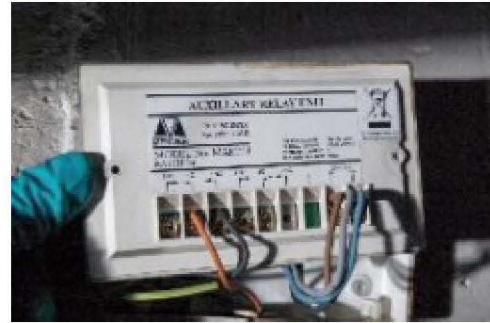
- ⌋ Within the machine room an electrical unit to provide the electrical connectivity interface for the lifts to the building alarm system.
- ⌋ The purpose of this unit was to recall the lifts to a designated floor when a fire was detected.
- ⌋ We removed the protective cover to confirm wiring was intact.

- ⌋ We confirmed fire alarm interface was connected to one of the controllers. We also confirmed that an interconnecting wire was connected to the second controller in order to provide a suitable signal.
- ⌋ We confirmed there was a connection for the fireman's switch on the controller wiring diagrams.
- ⌋ We confirmed there was a connection for the fireman's switch to both controllers (yellow & grey wiring).
- ⌋ We were unable to confirm a connection of a second fireman's switch.

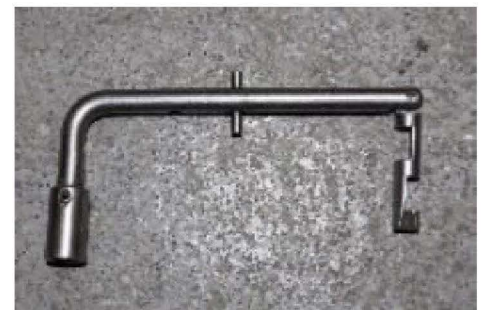
- ⌚ A drop type key is used to both operate the fireman's switch and to open the landing doors of the lift in an emergency.
- ⌚ The notches on the release key align with similar notches inside the box in order to operate the switch. This is to prevent access by unauthorised persons.

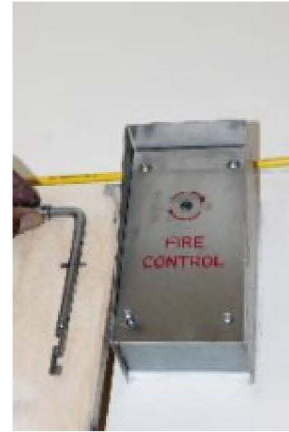
- It was not possible to operate the fireman's switch using the release key.

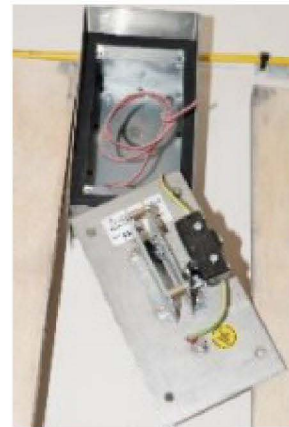
- We removed the faceplate to discover that there were no wires connected to the fireman's switch.

- The conduit from the shaft to the rear of the box contained one red wire. This was possibly a draw wire for future connection.
- With the faceplate removed we checked the operation with the release key. It was very difficult to align the key to the slots in the brackets to operate the micro switch.
- The micro switch was not bi-stable i.e. it was spring loaded and returned to its normal operating position.

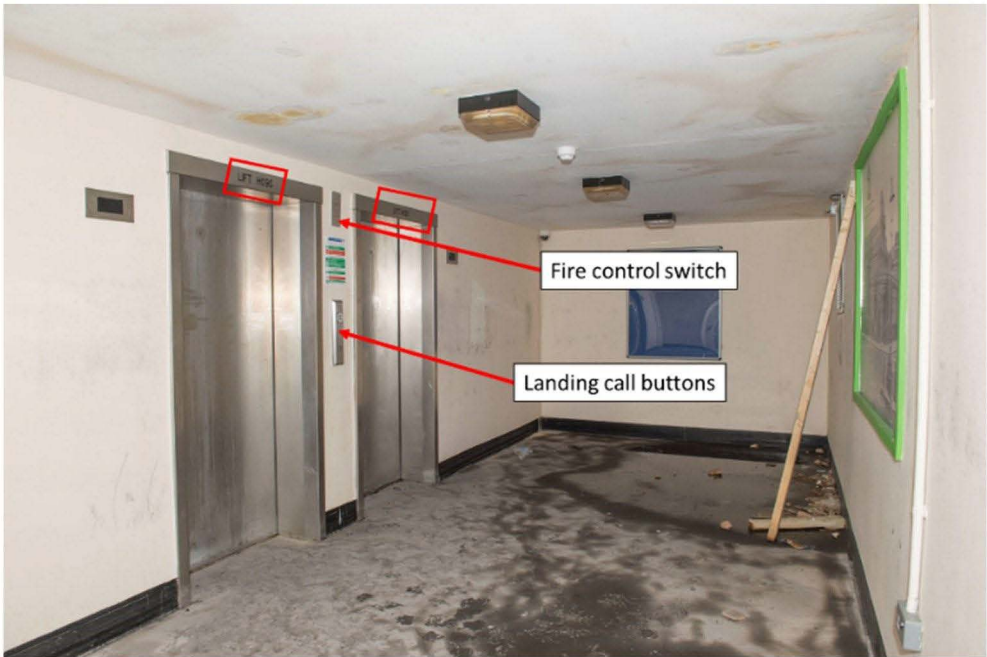
- 45.1 There was a single set of landing call buttons (up or down) in the lobby on each floor and each lift had a display unit mounted to the wall just above head height (Figure 8). It was assumed this display unit showed the location of the lift and/or an indication of direction of travel. This could not be confirmed by physical examination. The landing call buttons also had a sign indicating the floor number; however, this numbering was misleading. For example, on the 10<sup>th</sup> floor of the Tower this sign stated that it was the 7<sup>th</sup> floor which was the old numbering of the floors, see Figure 9.

Figure 8 – Ground floor lift lobby showing lift identification, the fire control switch and landing call buttons. (Ground\_2526639\_SCM\_0020\_card\_2.jpg annotated by BRE)

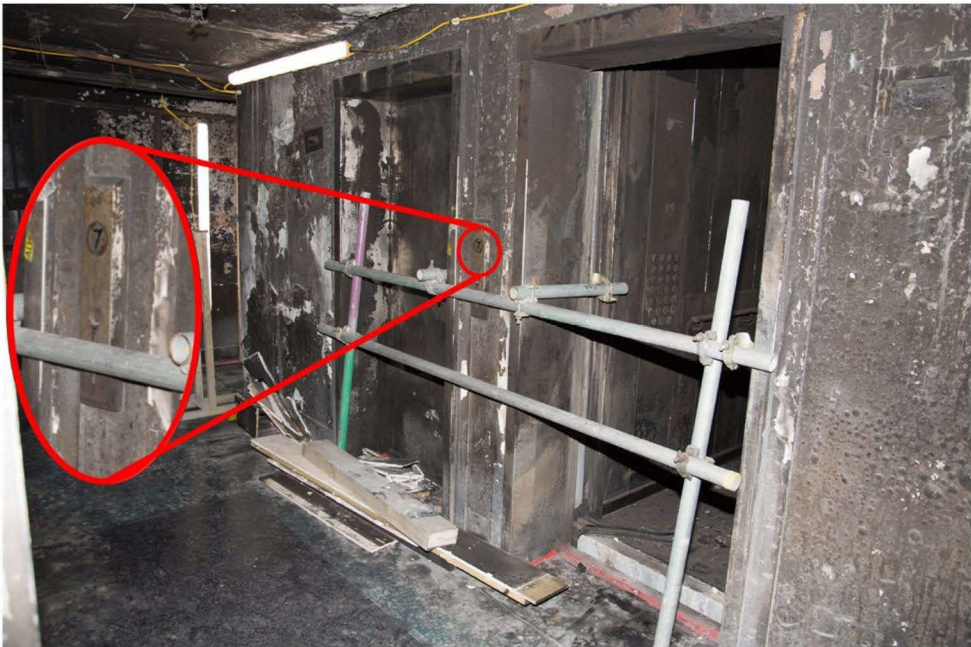
Figure 9 – Lift lobby on 10<sup>th</sup> floor with floor sign indicating 7<sup>th</sup> floor (inset is zoom and crop of image). (2661147\_C1\_dsc\_0017.jpg cropped and annotated by BRE)

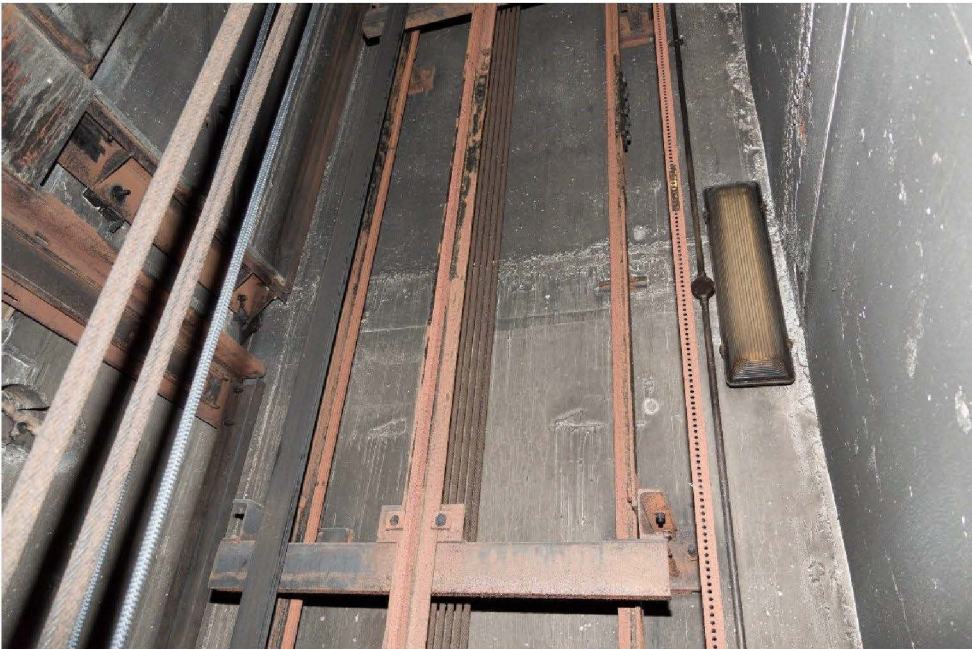
- 45.6 The lift well itself is formed of reinforced concrete walls and contained the lift cars and associated moving equipment. As mentioned above the well is divided approximately in half by a metal grille separating the two halves of the lift well. On the north wall of the lift well in the back corner, lighting was installed, see Figure 10. These plastic light fittings were discoloured

but did not show any signs of heat distortion. However, the lift landing doors on the lift well sides were blackened and some had clearly suffered heat damage particularly from the 7<sup>th</sup> to the 23<sup>rd</sup> floors. Based on this evidence, the primary route for smoke spread into the lift well was, in BRE’s opinion, via the lift landing doors.

Figure 10 – Lighting unit on north wall of lift well (2661146\_Card2\_\_DSC\_0076.jpg)

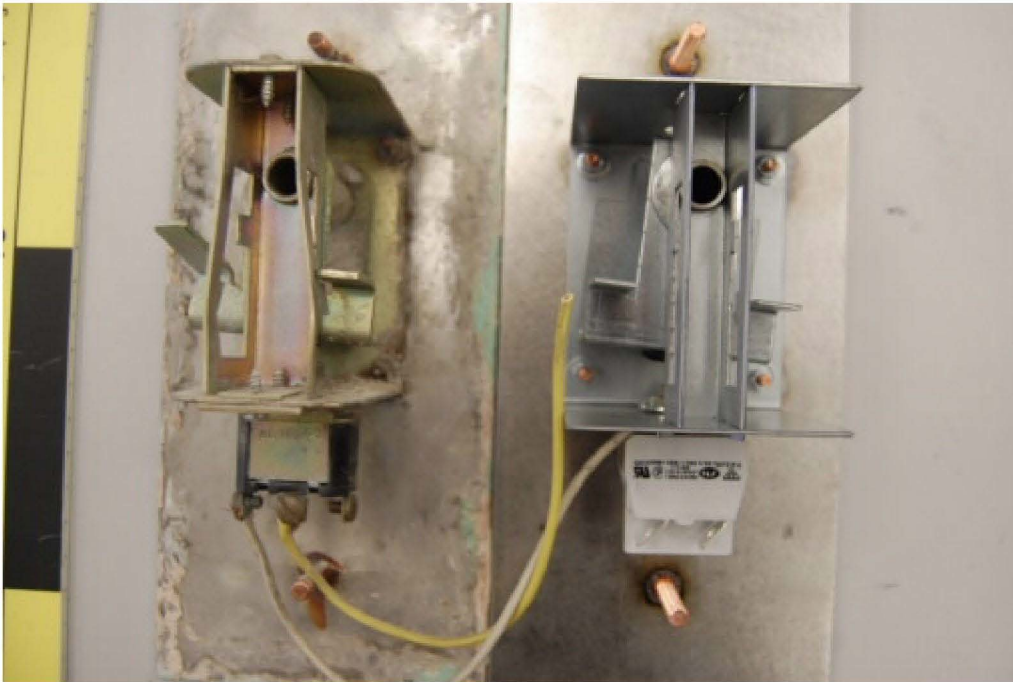
**Photo 13** Deformation of 'side wards' to fire switch BJJ/74 (left) compared with ER/2 (right)

Observation: there is 'green' wall paint visible on the side and on the bottom of the fire control switch. It is not known the age of the paint.

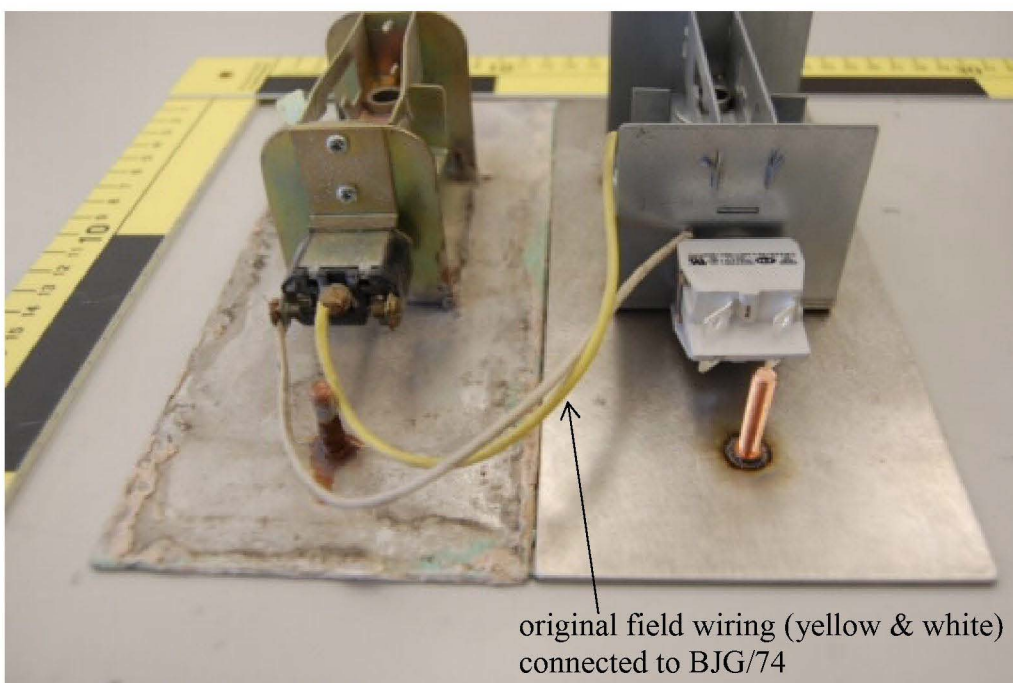
**Photo 14** BJJ/74 (left) and ER/2 (right) – View from bottom showing electric micro switch

Note: the 'yellow' and 'white' field wiring was connected onto BJJ/74.

- \* The MPS visual examination of BJK/74 indicate a build up of builders’ material on the switch casing and also the micro switch (**Photo 14**) was jammed. It appeared to be a wall plaster used during the works.
- \* During the examination the micro switch became free and the microswitch operated. It is not known what caused the micro switch to jam, but there were plaster grains on the work bench.
- \* It is considered that the build up of builders’ material on the top of the switch was from the original works and not caused by the extraction of the switch. This is also my opinion.
- \* The micro switches installed on BJK/74 and ER/2 operated correctly when the jam was cleared. This was proved by using a digital multimeter provided by BRE.

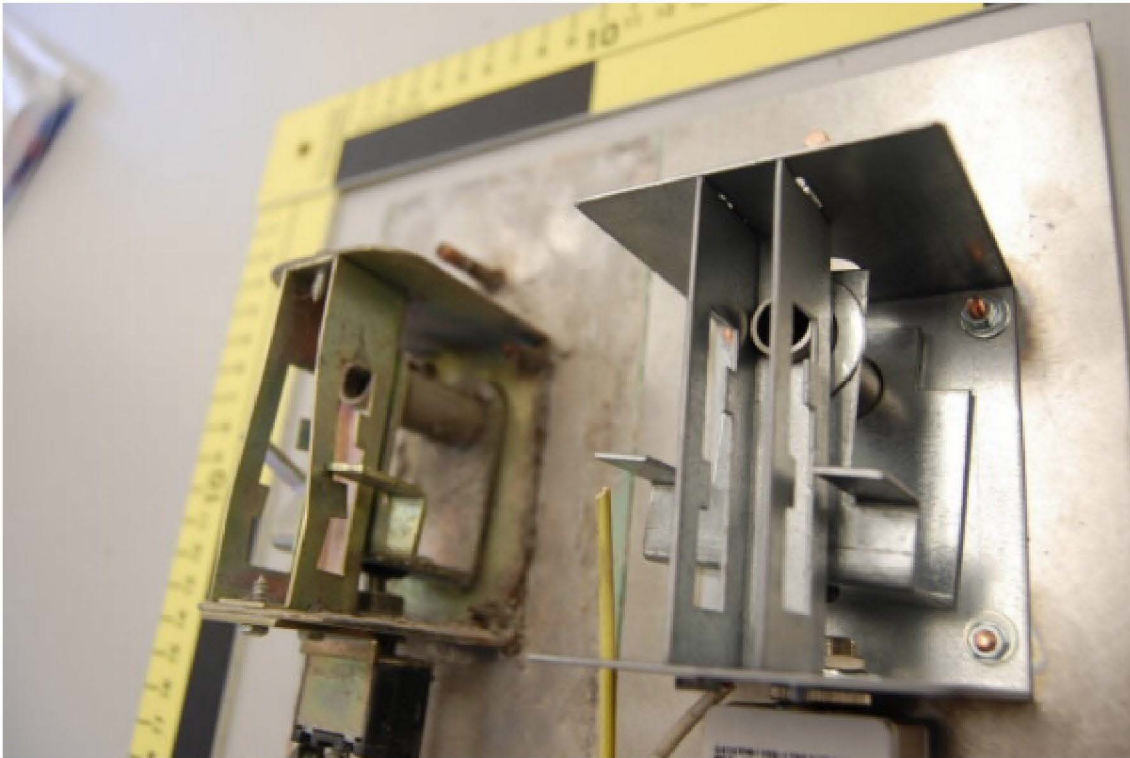
**Photo 15** BJB/74 (left) and ER/2 (right) – Side view detailing deformer ‘side wards’

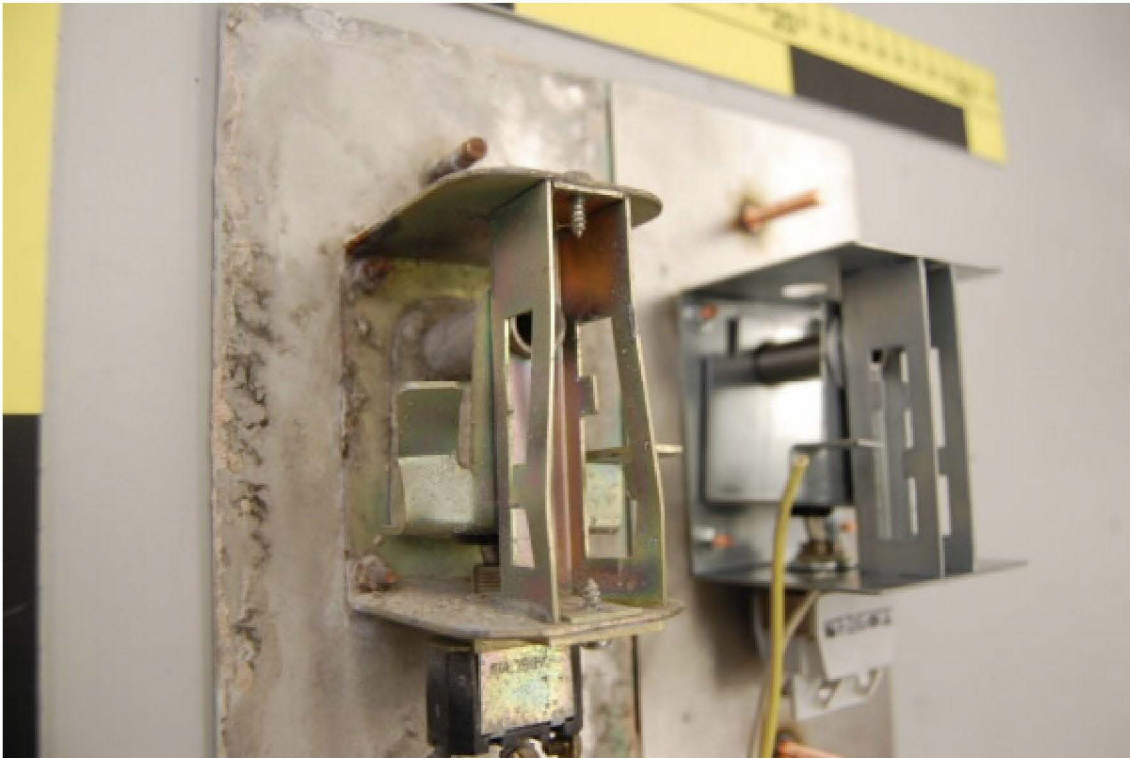
**Photo 17** Comparison of ‘side wards’ BJK/74 (left) and ER/2 (right)

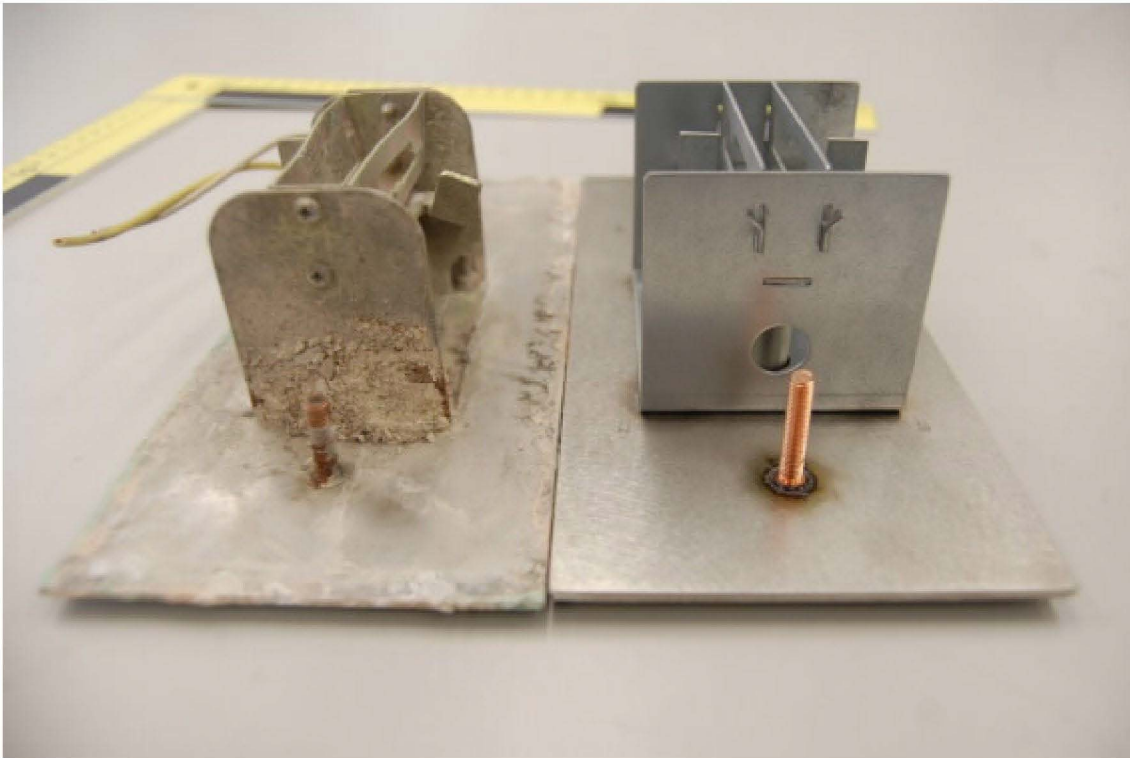
**Photo 18** Builders' material on top of fire control switch BJJ/74 (left) and new fire control switch ER/2 (right)

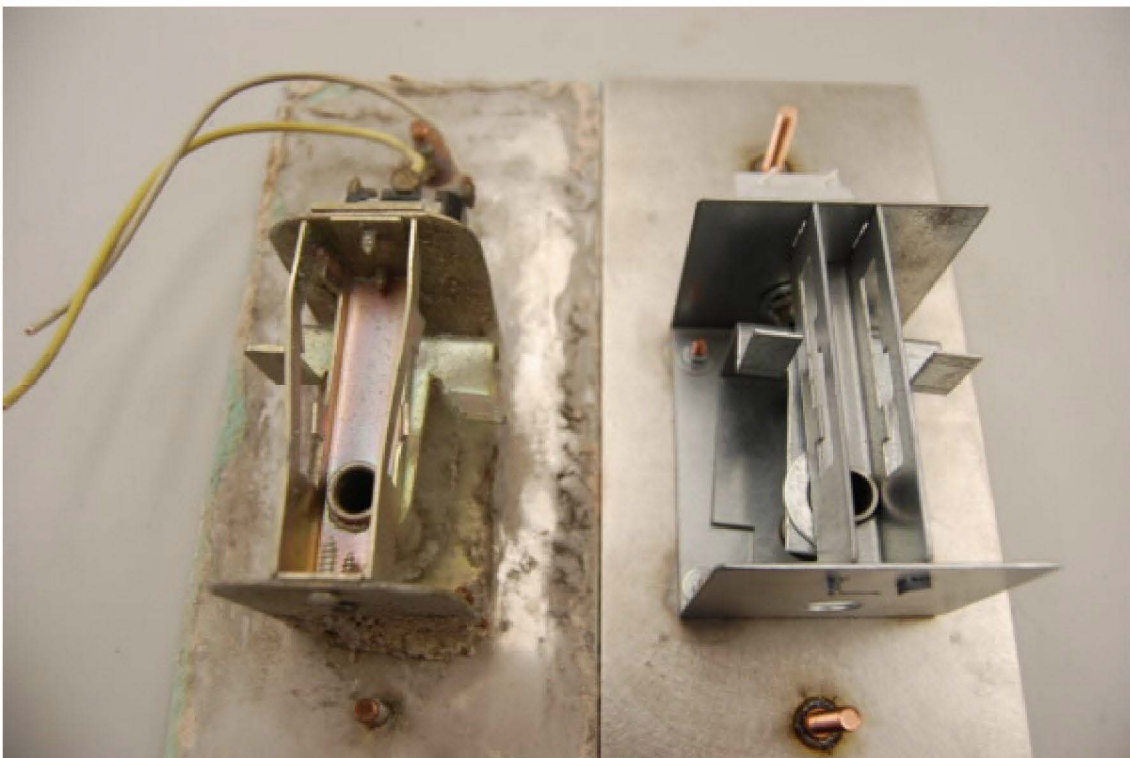
**Photo 19** Comparison of BJJ/74 (left) and ER/2 (right) - Detailing builders' material build up on BJJ/74

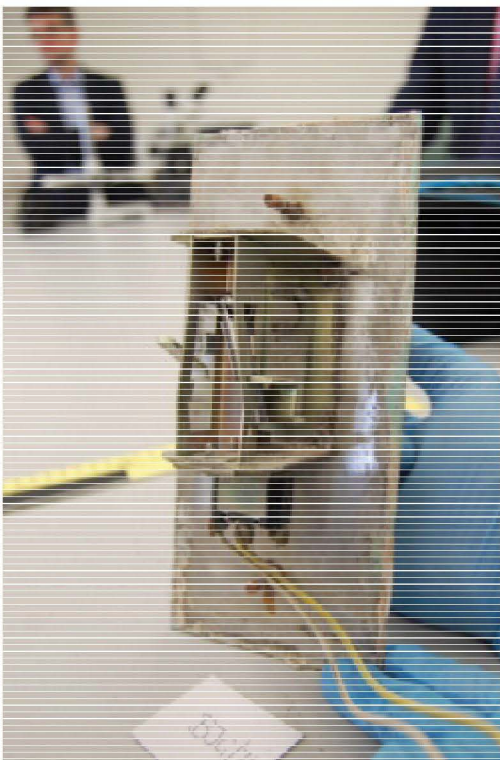
It was noted that the 'express' drop key ER/1 and the drop key used by Jeff Turner (JT) have slightly differing dimensions and one would operate the fire control switch and the other 'express' drop key would not operate the fire control switch. In my opinion, this indicates a lack of constancy in manufacturing tolerances of the switch or drop key.

**Photo 24** 'Express' drop key inserted into BJG/74 barrel

It was recommended by the MPS that the Fire Service 'express' drop key used on the night of the fire is to be obtained for comparison purposes with the 'express' drop key used during this witnessing inspection.

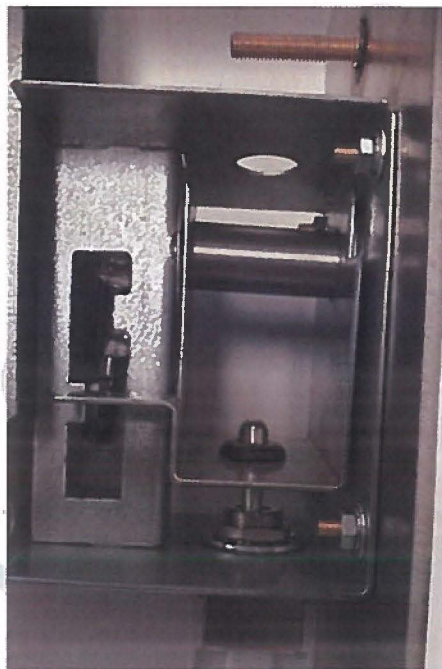
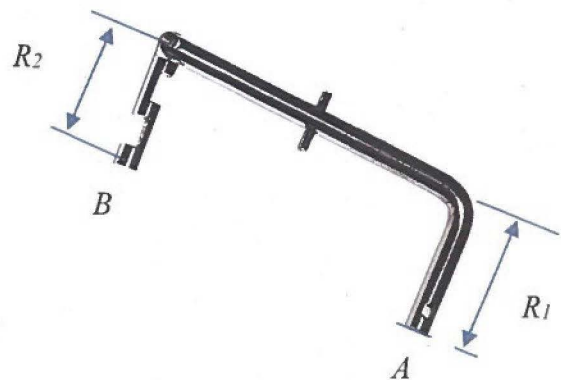
Figure 3. Control switch: (a) case and (b) 'drop key'.

The control switch case ('back box') structure has two steel frame plates ('cheeks' on either side of the entered key). The plates have a "labyrinth" (see Figure 3) designed to ensure that only the proper key could be turned, i.e. any improper/ vandal generated tool would hit the 'cheeks' and fail to turn.

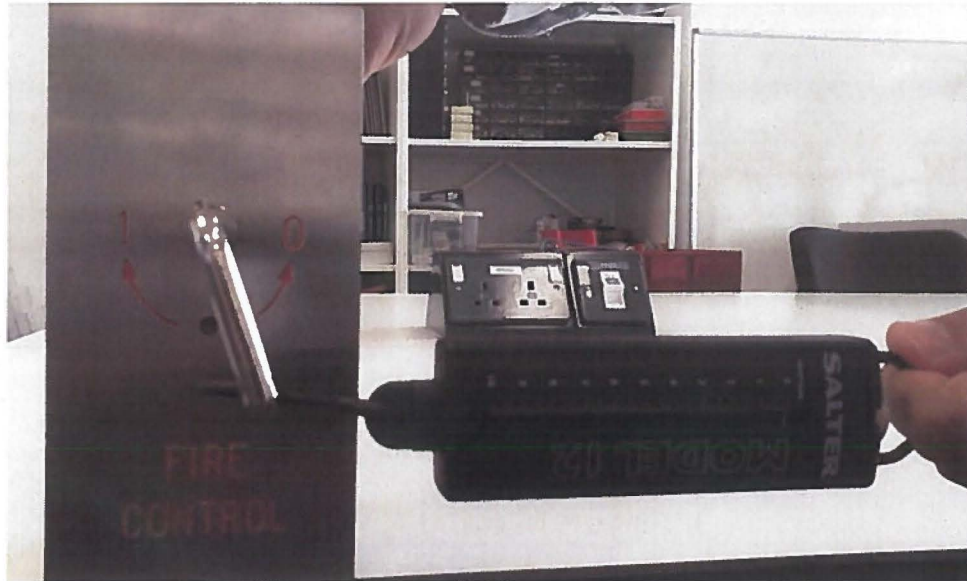
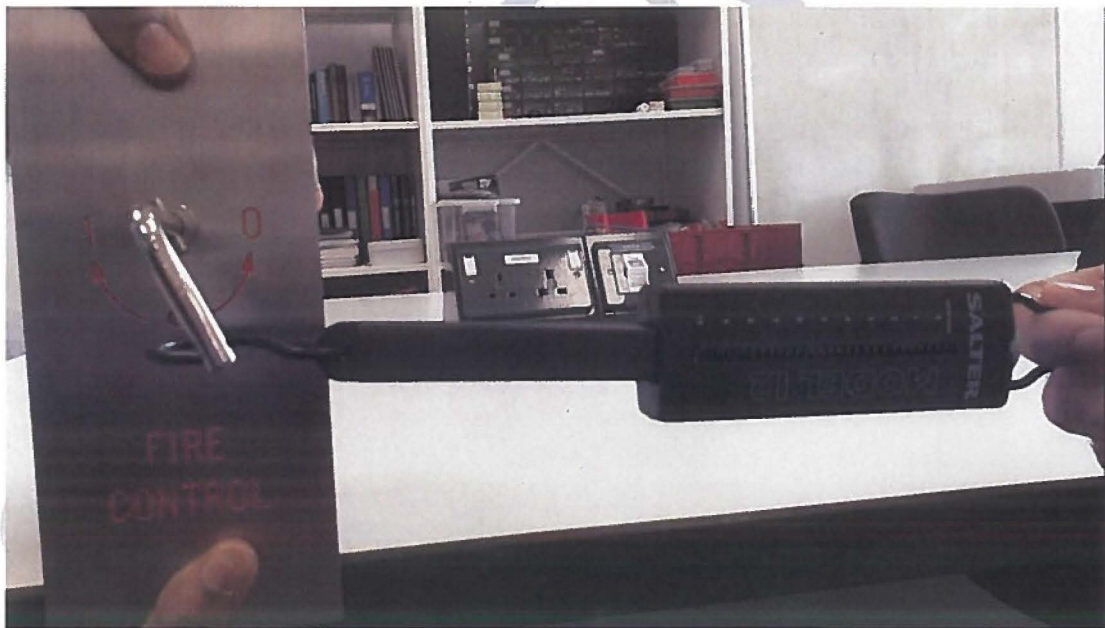
**Figure 4. Experimental setup used to determine the force required to operate the switch**  
Salter Brecknell (Model 12) Spring Balance was used to determine the force required to operate the switch. Figure 4 (a) (b) illustrates the measurement setup.

The force used to operate the switch was measured to be 10.5 N.

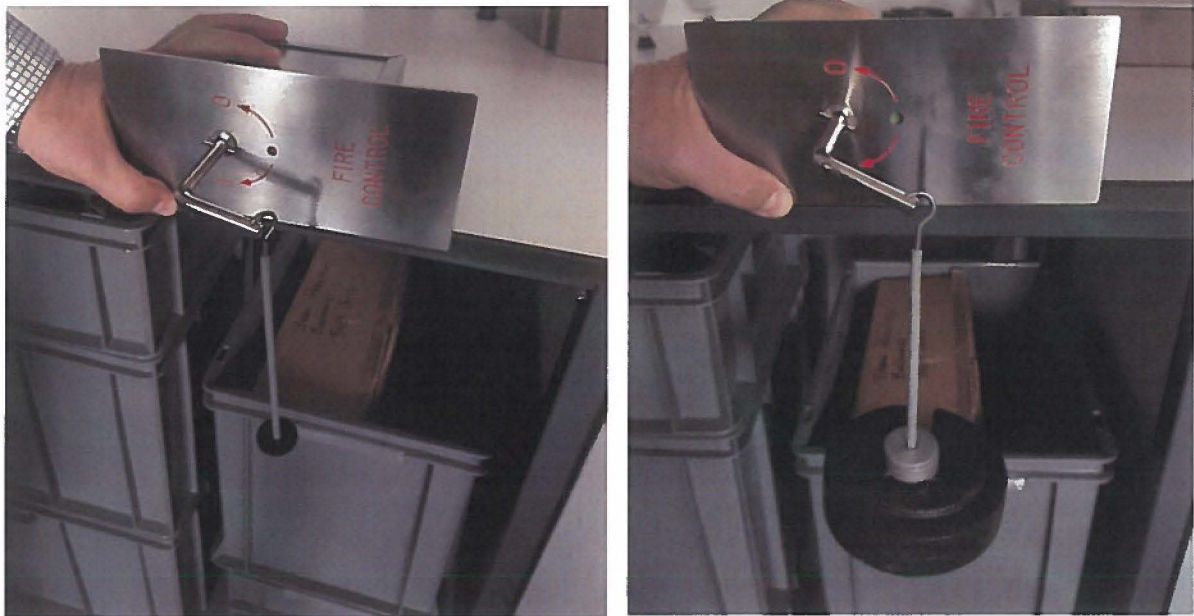
**Figure 5. Experiment with dead weights.**

In addition, the measurement was repeated by a 'dead weight' experiment (see Figure 5).

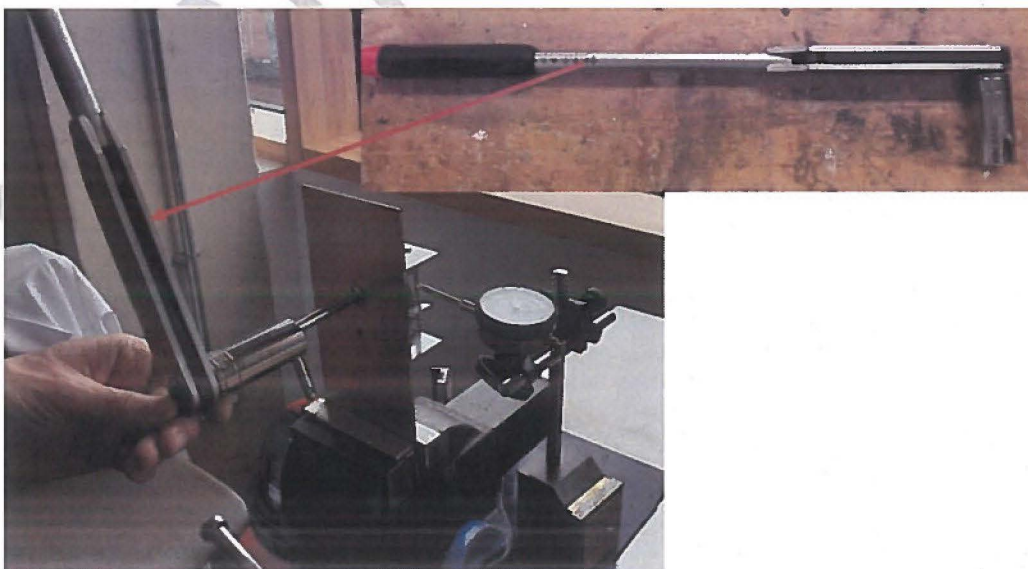
**Figure 6. Torque wrench test setup.**

The second test involved the setup illustrated in Figure 6. In this setup the switch was clamped in a workshop vice with the drop key operated by a torque wrench (Kennedy 3/8" SQ Torque Wrench [3]). With the drop key bottom end point engaged with the plate the torque was recorded and the bending displacements measured (see Figure 6,7). The torque values were then transposed to calculate the forces involved.

The torques measured were 12 Nm and 14 Nm, corresponding to the force values of 266.7 N and 311.1 N, respectively. The maximum displacements of the plate recorded were 1.76 mm and 2.08 mm respectively (see Table 1). Video evidence is available to confirm and illustrate the test procedures applied.

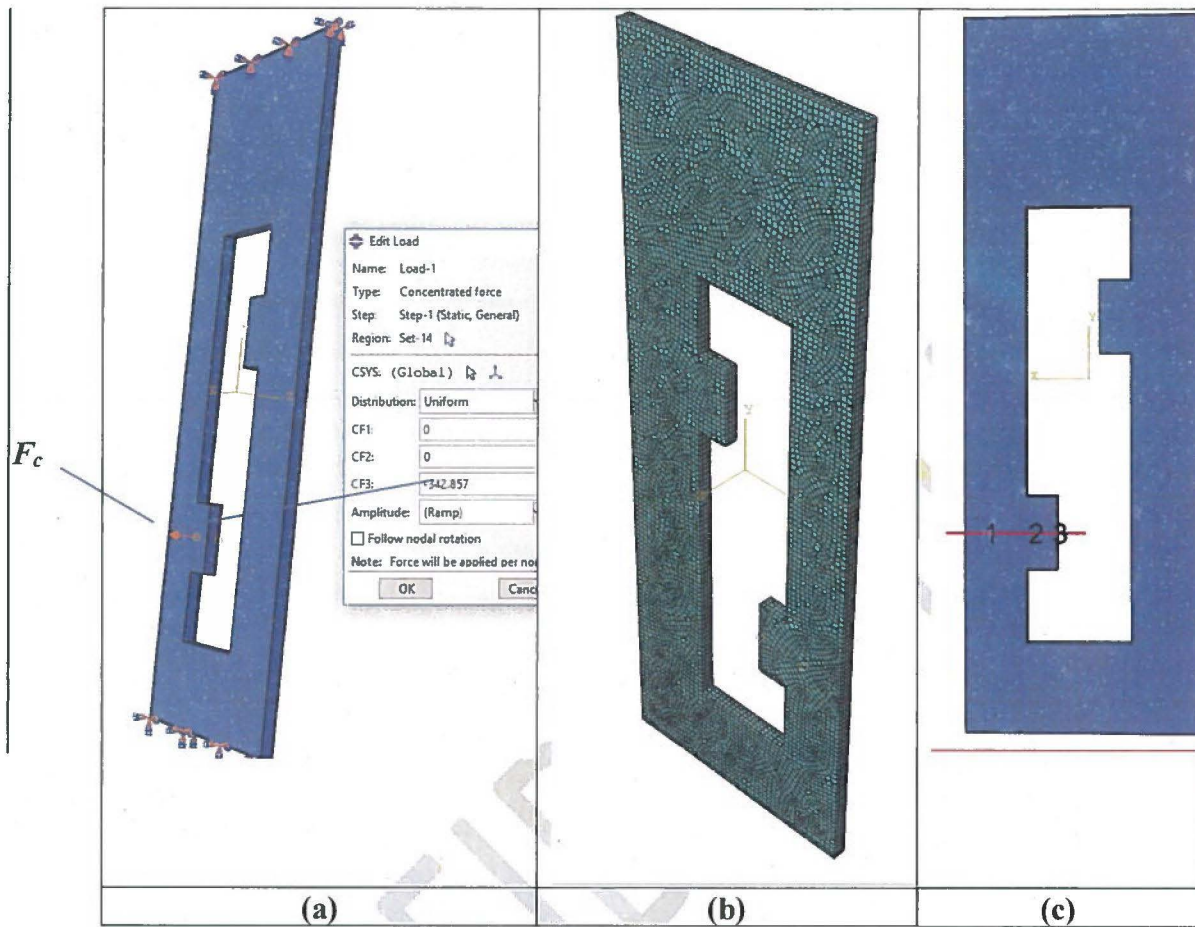
A simplified CAD model and Finite Element Analysis (FEA) were developed to calculate the bending displacements of the the steel frame element under the loads measured. The results are summarised in Table 2 and the model is illustrated in Figure 8.

The results demonstrate that the bending deflections calculated from the FEM model are close to the measured values.

Figure 8. FEM model: (a) boundary and load conditions; (b) FEM mesh applied; (c) load locations.

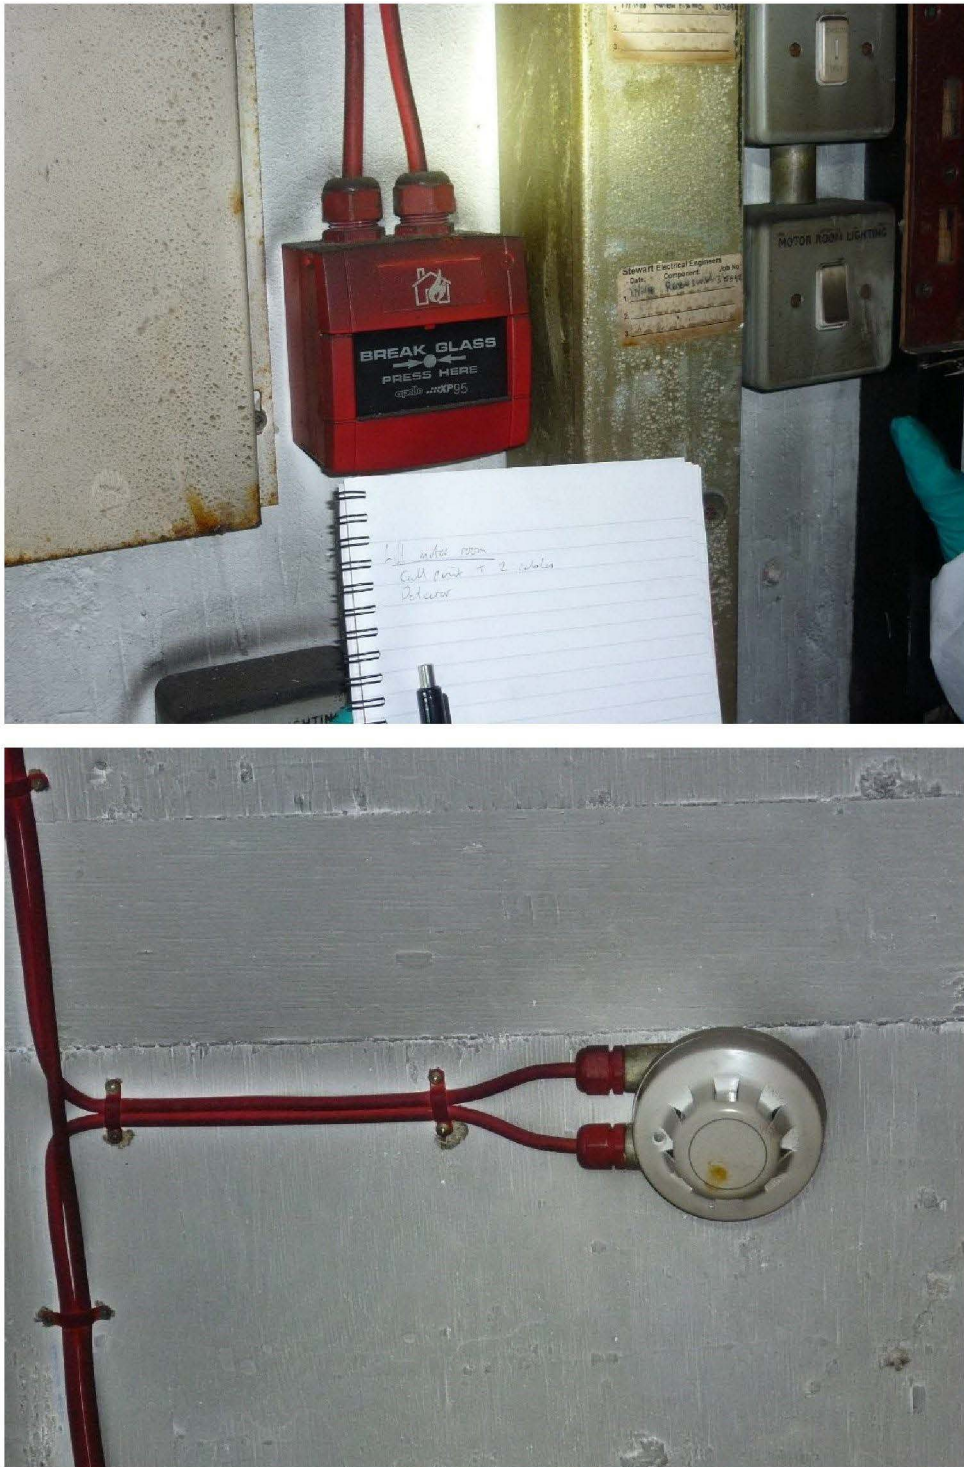
The lift motor room had a fire detector attached to the ceiling, a manual call point close to the entrance door and a sounder/beacon on the wall close to the location of an ‘Auxillary Relay Unit’ mounting back box (see Figure 16 and Figure 17). The Auxillary Relay Unit had been removed as a Police Exhibit but its

Figure 17: Manual call point and smoke detector in lift motor room

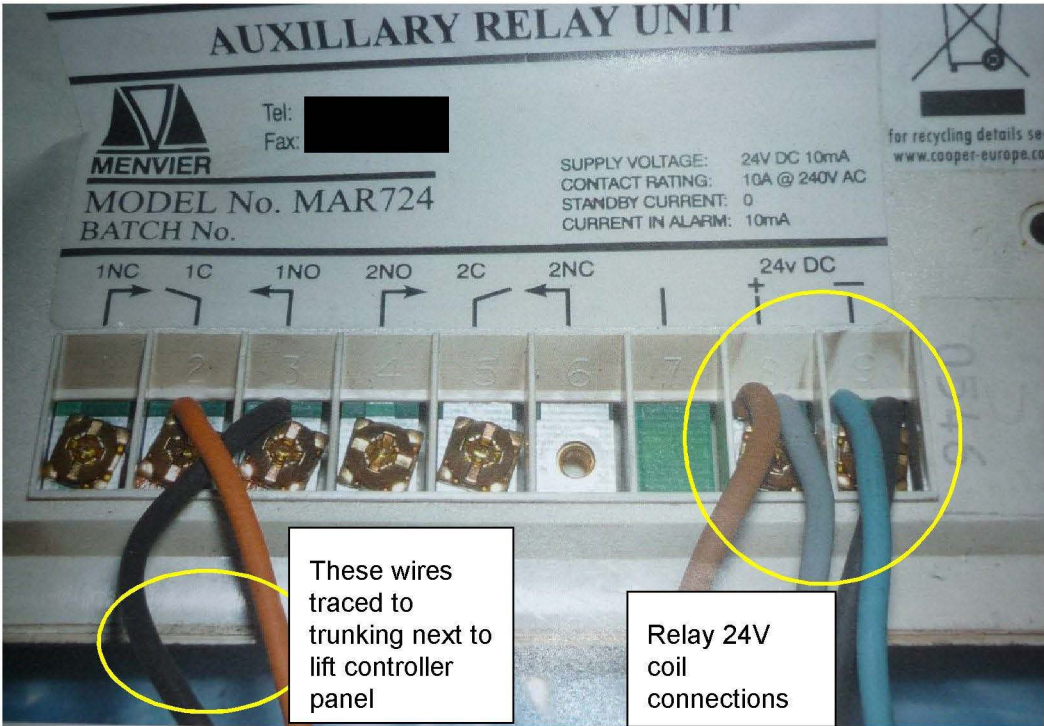
Figure 18: Auxillary Relay Unit

Figure 18 shows a black wire and a brown wire connected to the 1NO and 1C relay contacts. These wires were traced visually and by an electrical continuity tester from the auxiliary relay mounting back box (auxiliary unit removed) to the black and brown wires in the metal trunking cut close to where the trunking would have met the lift controller panel (See Figure 19).

Figure 18 shows 2 pairs of wires (24V DC+ brown and grey / 24V DC - black and blue) connected to the 24V coil of the Auxillary Relay Unit. These wires were part of a 4 core cable which was traced from the Auxillary Relay Unit mounting back box to the sounder/beacon located on the same section of wall. The connections at the base to the sounder/beacon are shown in Figure 20. The brown and blue wires from the Auxillary Relay Unit mounting back box are seen to pass into and out of the sounder / beacon. The brown and blue wires coming out of the sounder / beacon are part of a second 4 core cable that passes through the wall from the lift motor room to the next-door plant room (containing large water tanks). The black and grey wires bypass the sounder / beacon and are joined to the second cable that carries the brown and blue wires from the sounder / beacon. Electrical continuity testing confirmed that the sounder / beacon was connected to the to the Auxillary Relay Unit coil (brown and blue wires). Therefore, energisation of the Auxillary Relay Unit would also cause the sounder / beacon to operate.

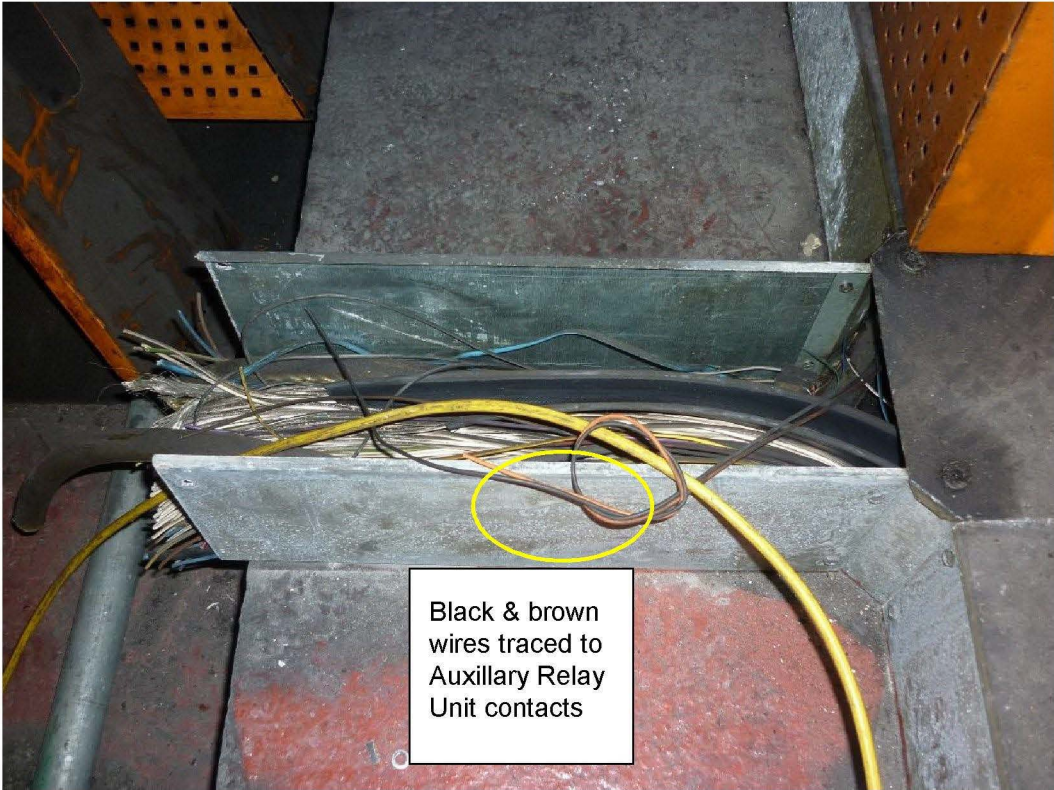
Figure 19: Metal trunking containing cables and wires to lift controller

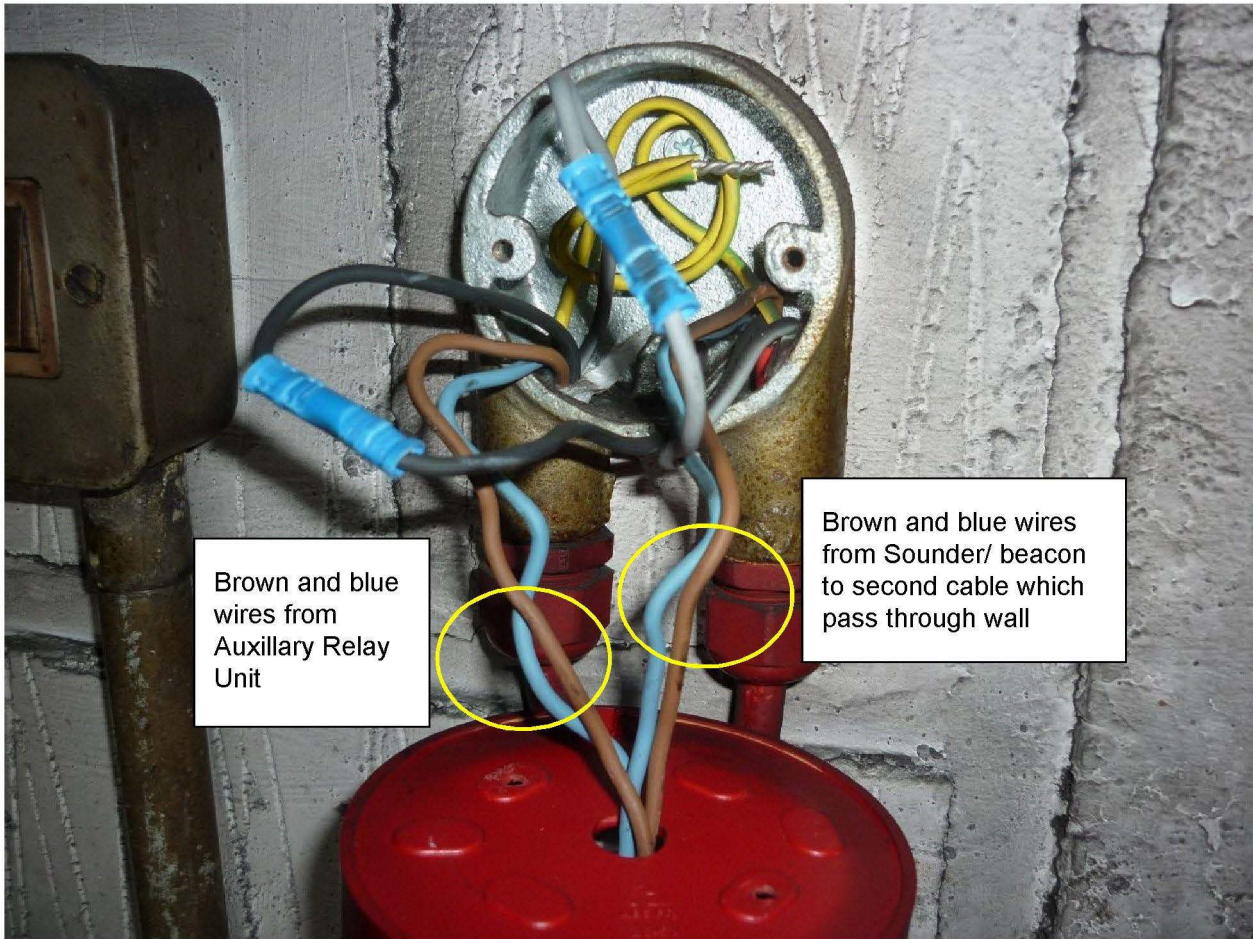
Figure 20: Cable connections at base of sounder / beacon in lift motor room

Note: Left hand side, 4-core cable from Auxillary Relay Unit. Right hand side, 4-core cable passes through wall to next-door plant room

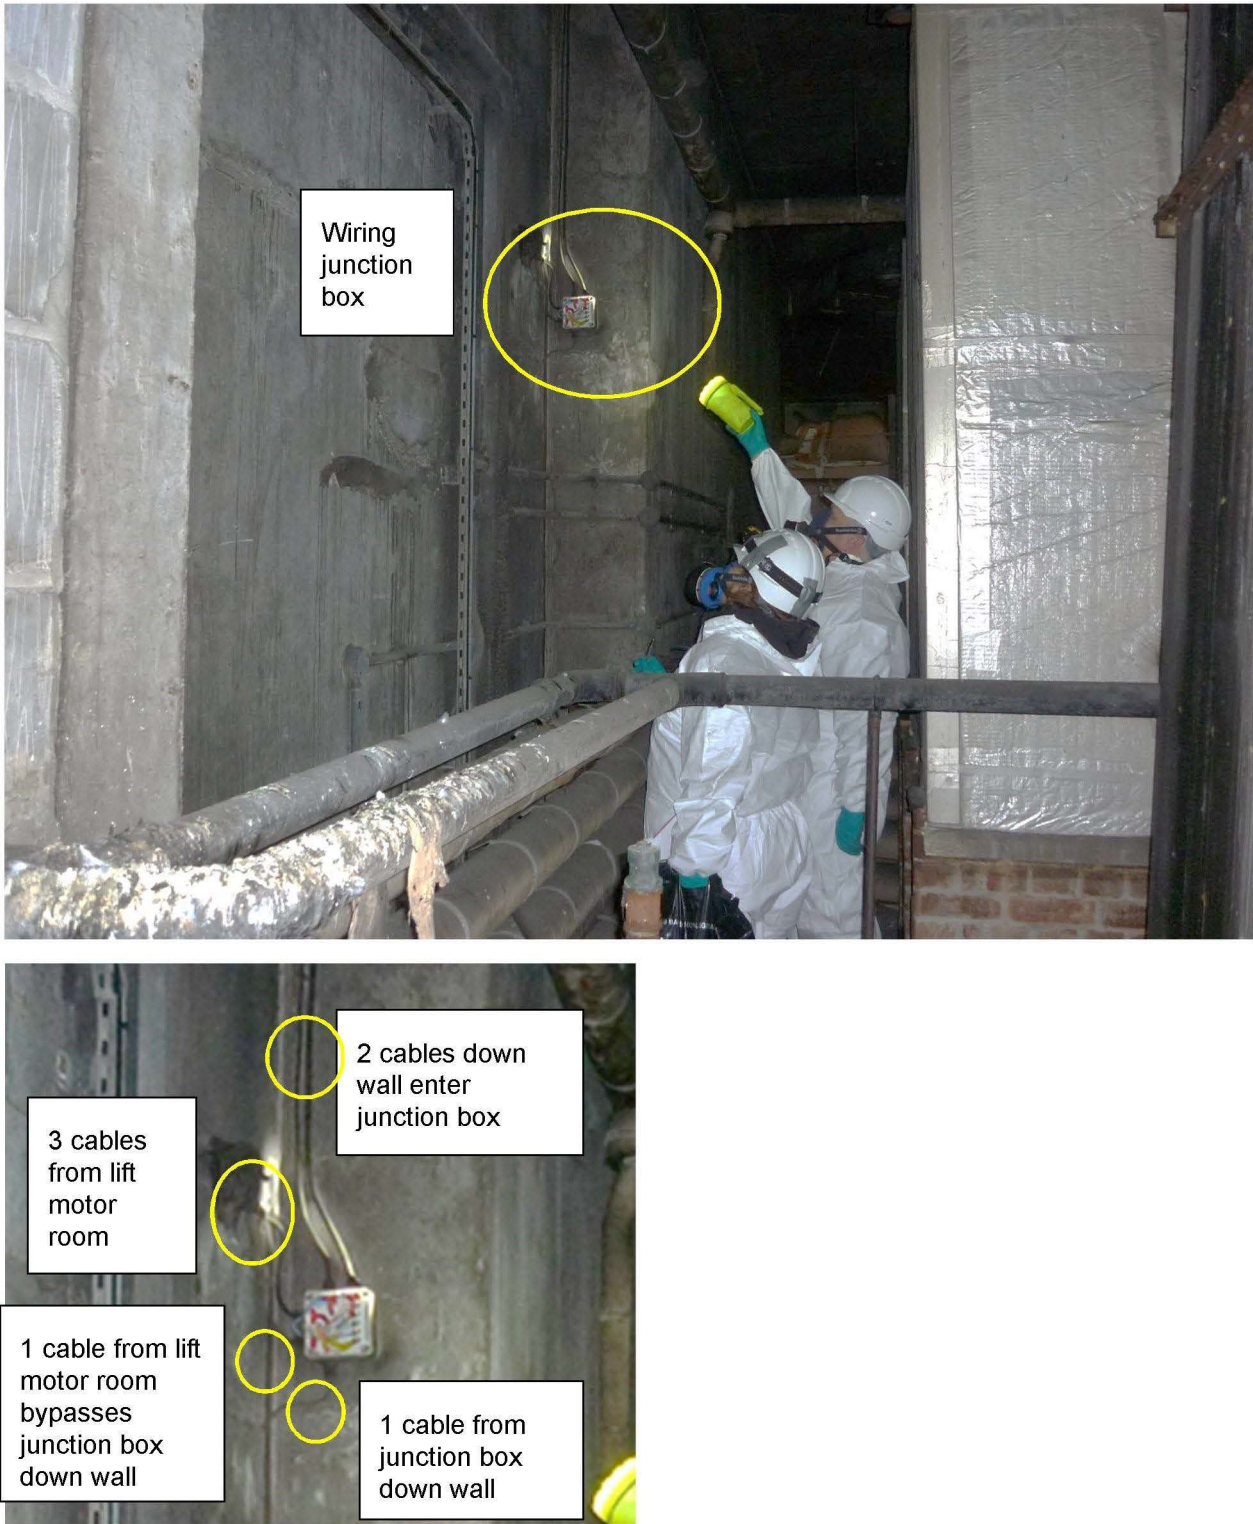
The 3 cables from the lift motor room sounder / beacon, detector and manual call point passed through the wall to the next-door plant room containing large water tanks (see Figure 21). Tracing these cables to the adjoining plant room showed one cable descended down the wall and 2 of 2-core cables entered a wiring junction box mounted on the wall. A 2-core cable exited the bottom of the wiring junction box and ran down the wall alongside a second cable that ran directly from the lift motor room. Electrical continuity testing confirmed that the cable running directly from the lift motor room was the 4-core cable that was connected to the Auxillary Relay Unit and the sounder / beacon in the lift motor room.

The two cables (one 2-core cable from the junction box, one 4-core cable from Auxillary Relay Unit via sounder/beacon) (See Figure 21 and Figure 22) were traced visually and appeared to pass through the floor to the 23<sup>rd</sup> floor below. The cables were traced visually from the 23<sup>rd</sup> floor down each floor until the ground floor riser (see Figure 23). These cables were traced physically from the ground floor riser to the plant room by physically pulling them upwards and removing in sections on a floor by floor basis.

Figure 21: Wiring junction box on wall in water tank room next to lift motor room, showing 3 cables from lift motor room
