## Appendices to the Report of Roger Howkins

### Vertical Transportation Engineer | Lifts | Arup

### Grenfell Tower Inquiry | September 2020

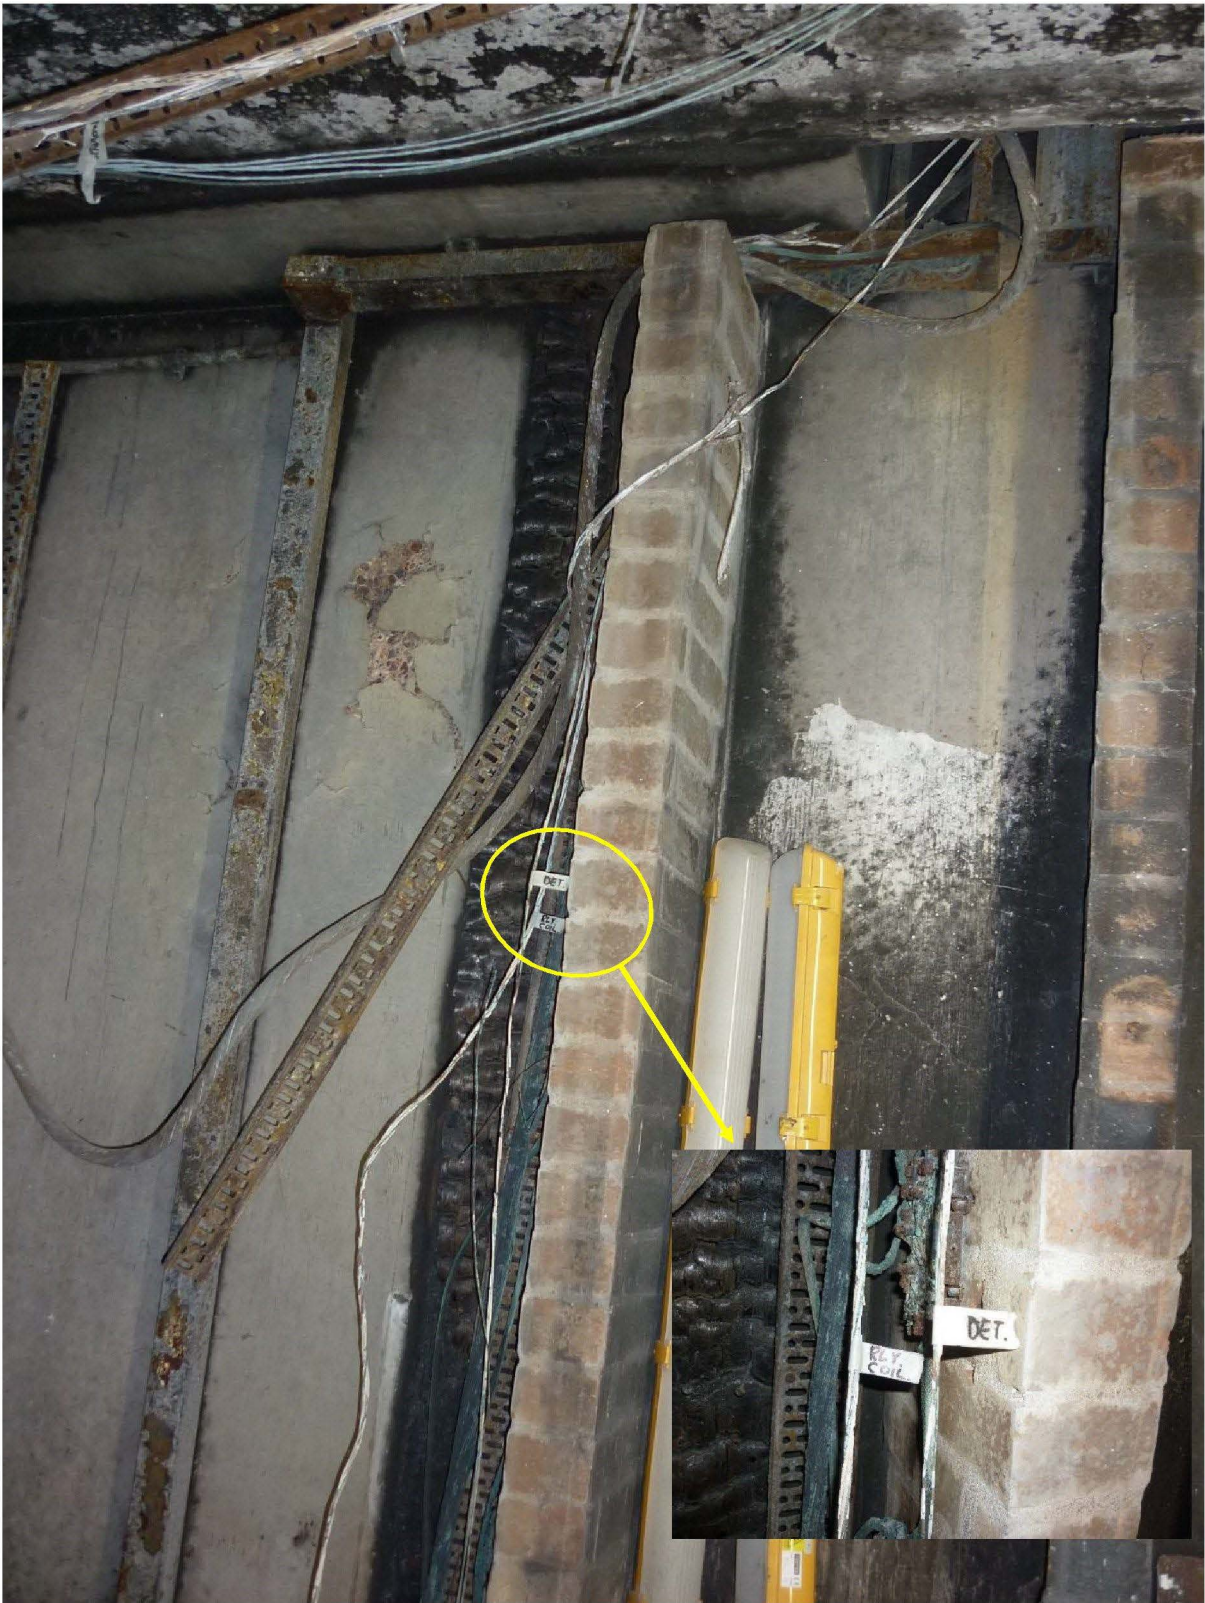
**Figure 23: Cables from Lift Motor Room descended the building floor, labelled Relay Coil and Detector**

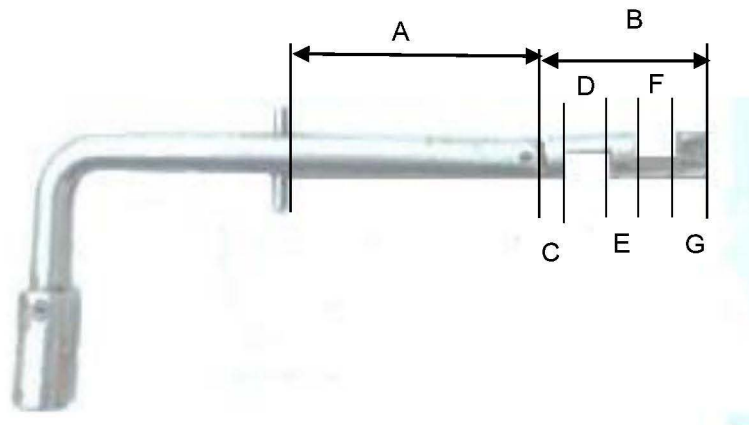
The drop key was found to be similar in all dimensions to the drop keys, Items ER/1 and SJG/01. There was however a significant difference in dimension C between the other drop keys and the drop key, Item LJH/67. The drop key dimensions are provided in the table below.

The difference in dimension C is the dimension that results in drop key, Item LJH/67, being un-useable in fire control panels such as Items BJG/74 and ER/2.

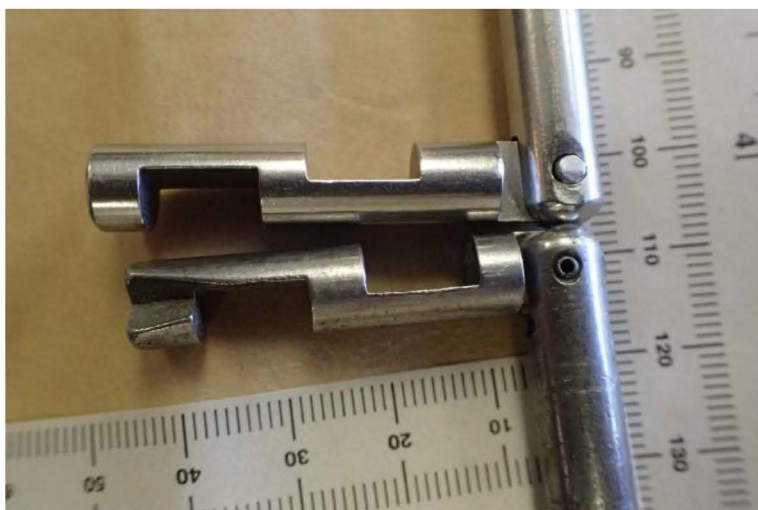
Key LJH/67 at the top and  
Key ER/1 at the bottom

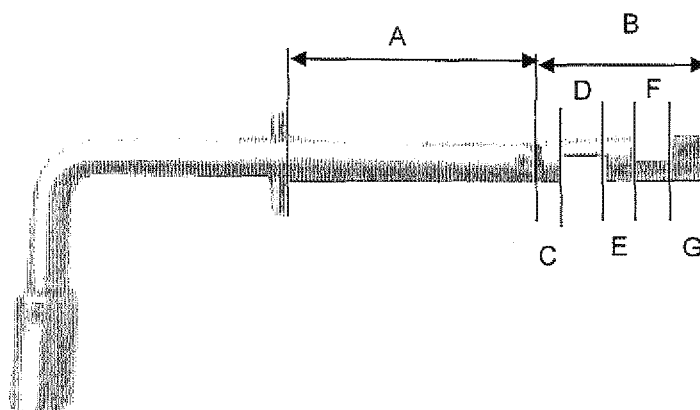
The drop key was found to be similar in all dimensions (but not the same) to the drop keys, Items ER/1 and SJG/01. There was however a significant difference in dimension C between the other drop keys and the drop key, Item LJH/67. The drop key dimensions are provided in the table below.

The difference in dimension C is the dimension that results in drop key, Item LJH/67, being un-useable in fire control panels such as Items BJG/74 and ER/2.

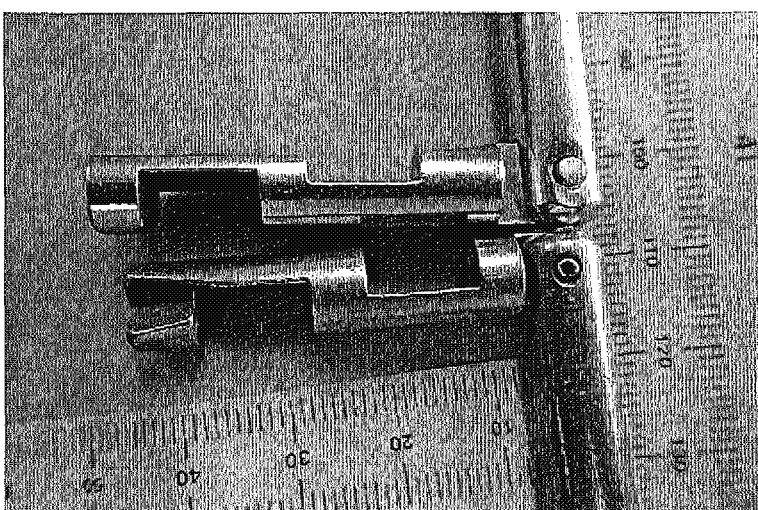
Key LJH/67 at the top and  
Key ER/1 at the bottom

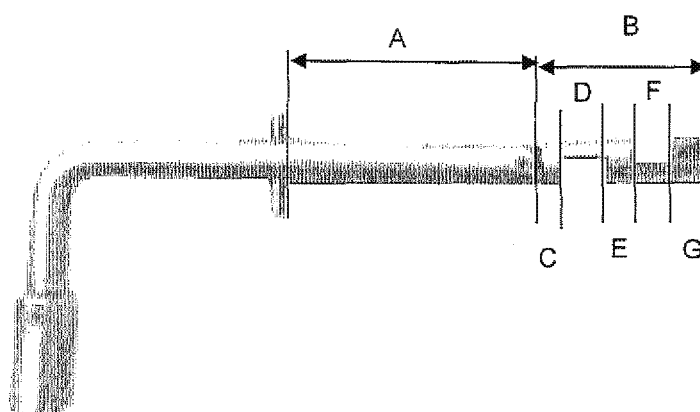
The drop key was found to be similar in all dimensions (but not the same) to the drop keys, Items ER/1 and SJG/01. There was however a significant difference in dimension C between the other drop keys and the drop key, Item LJH/67. The drop key dimensions are provided in the table below.

The difference in dimension C is the dimension that results in drop key, Item LJH/67, being un-useable in fire control panels such as Items BJG/74 and ER/2.

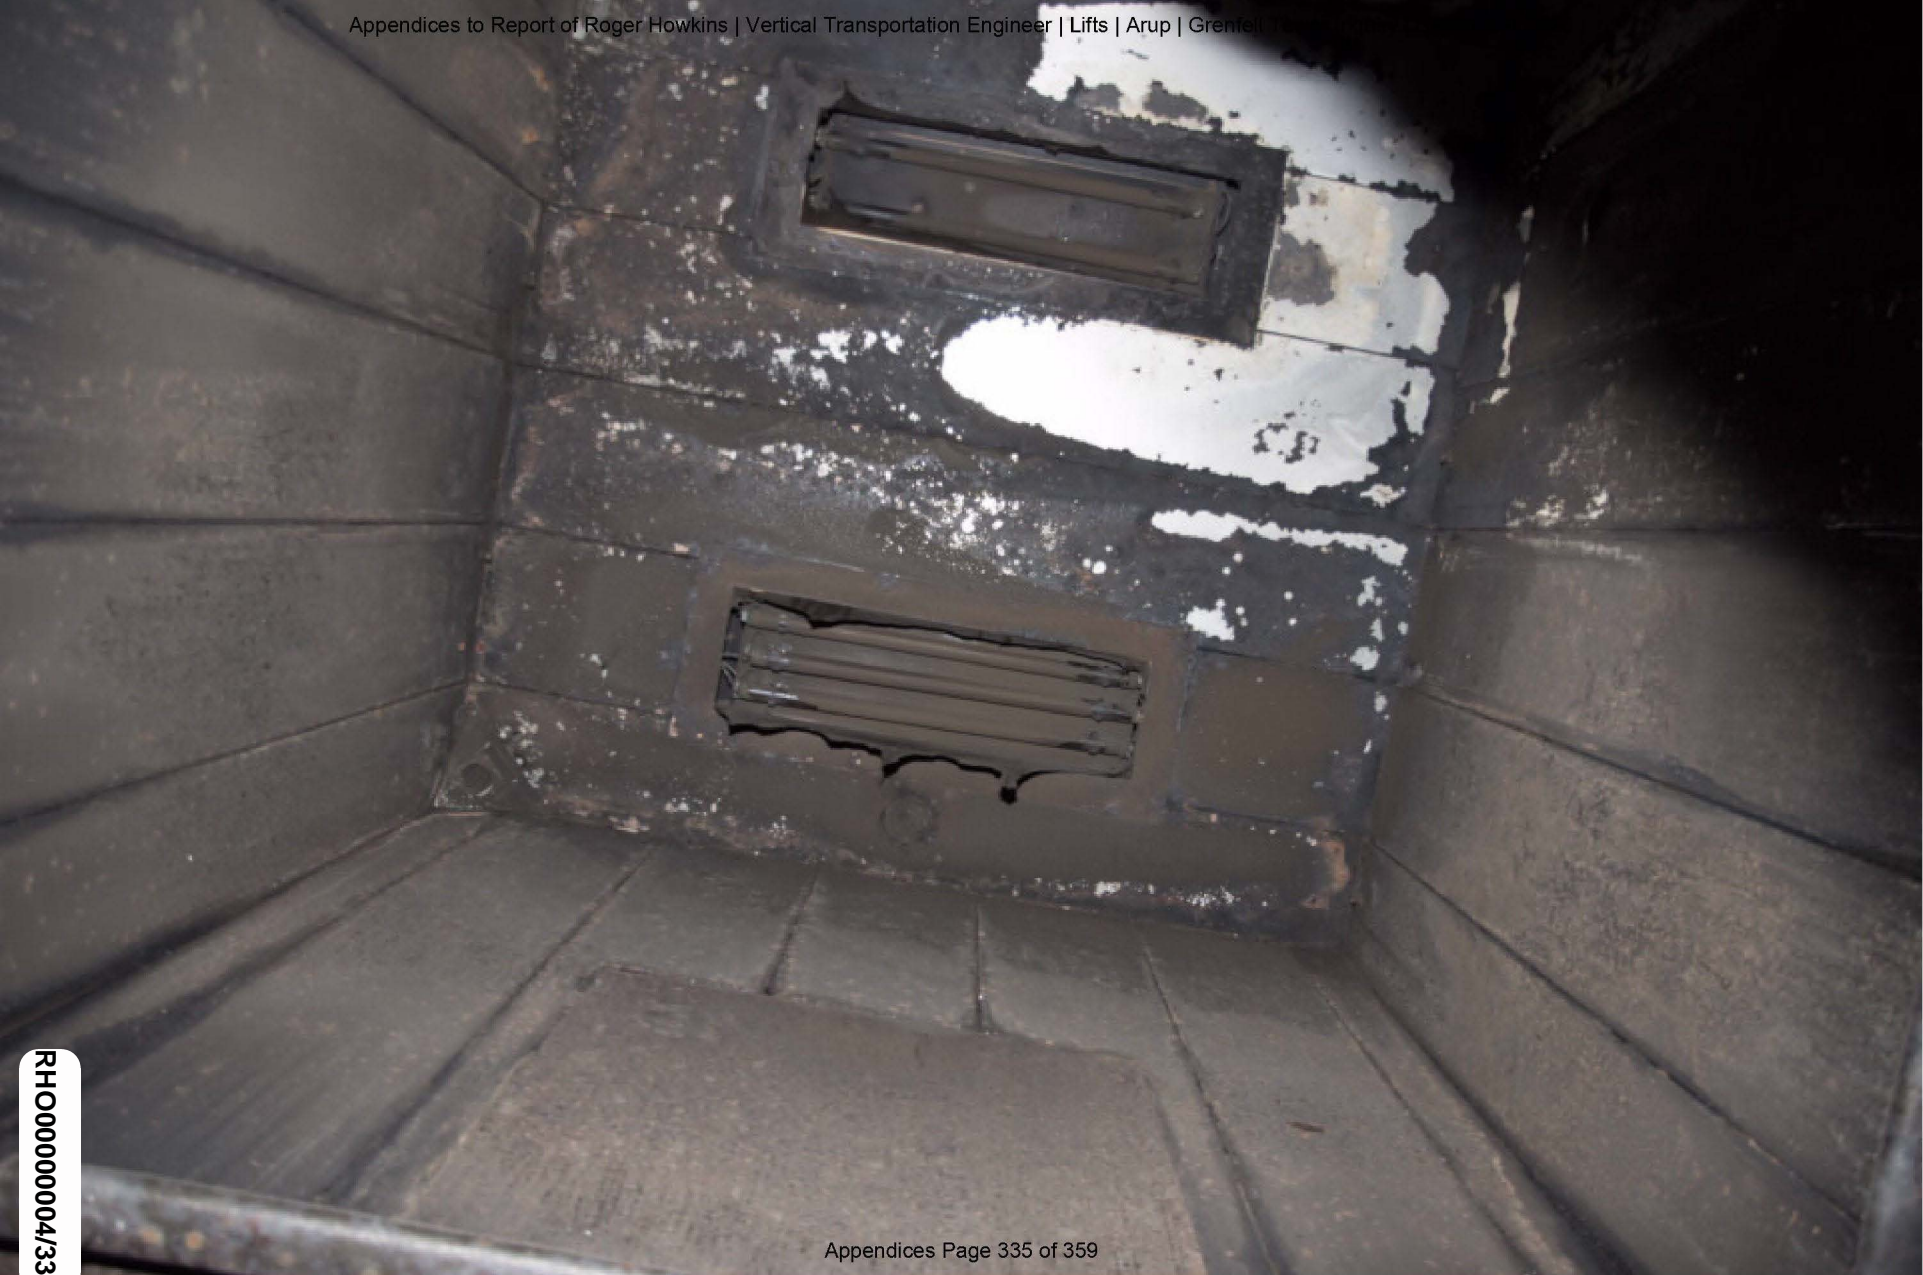
### **MET00065300 – Lift car ceiling from inside car**

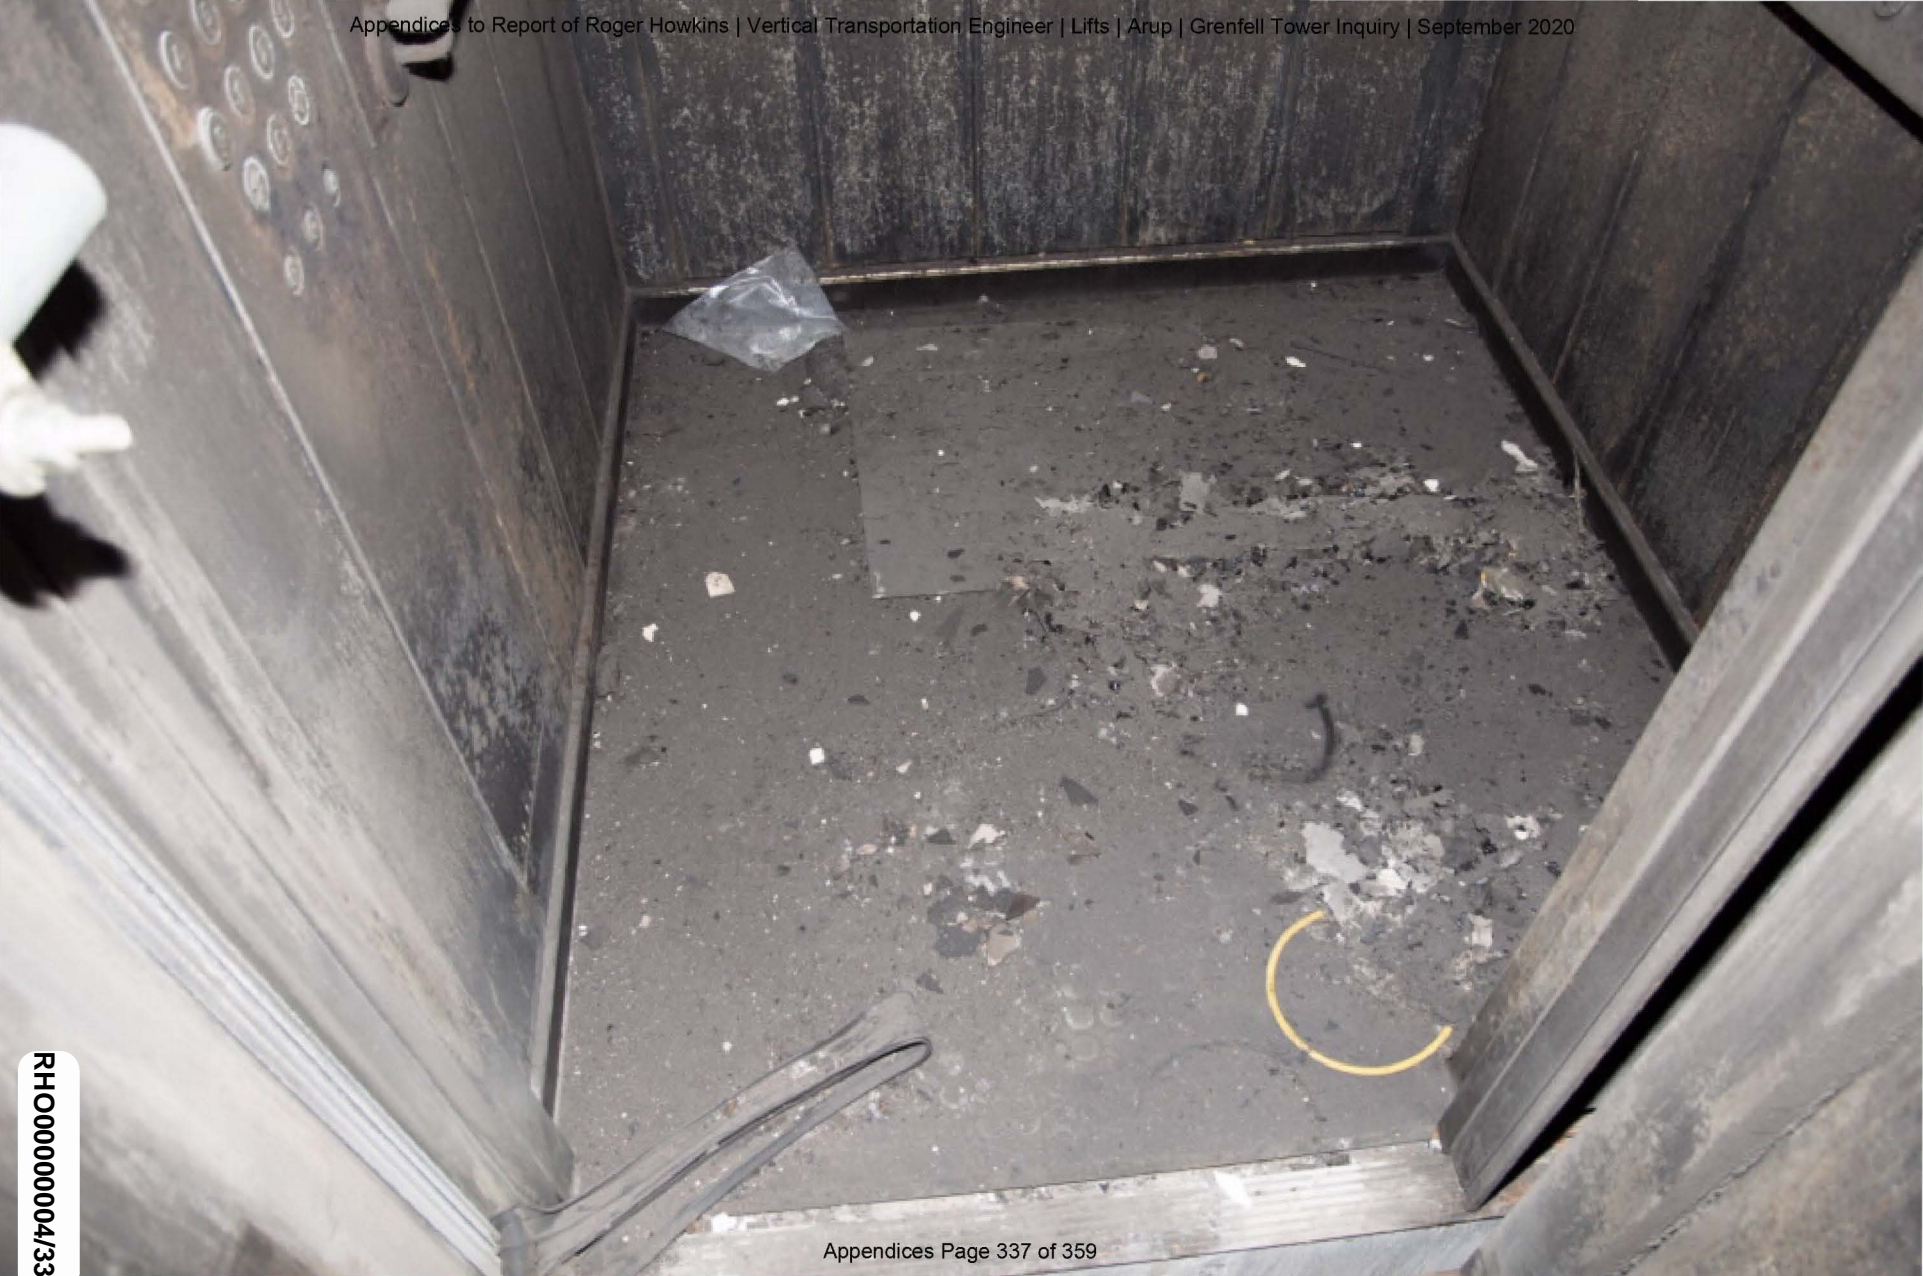
**MET00065397 – Lift car interior showing car  
operating panel on left hand wall**

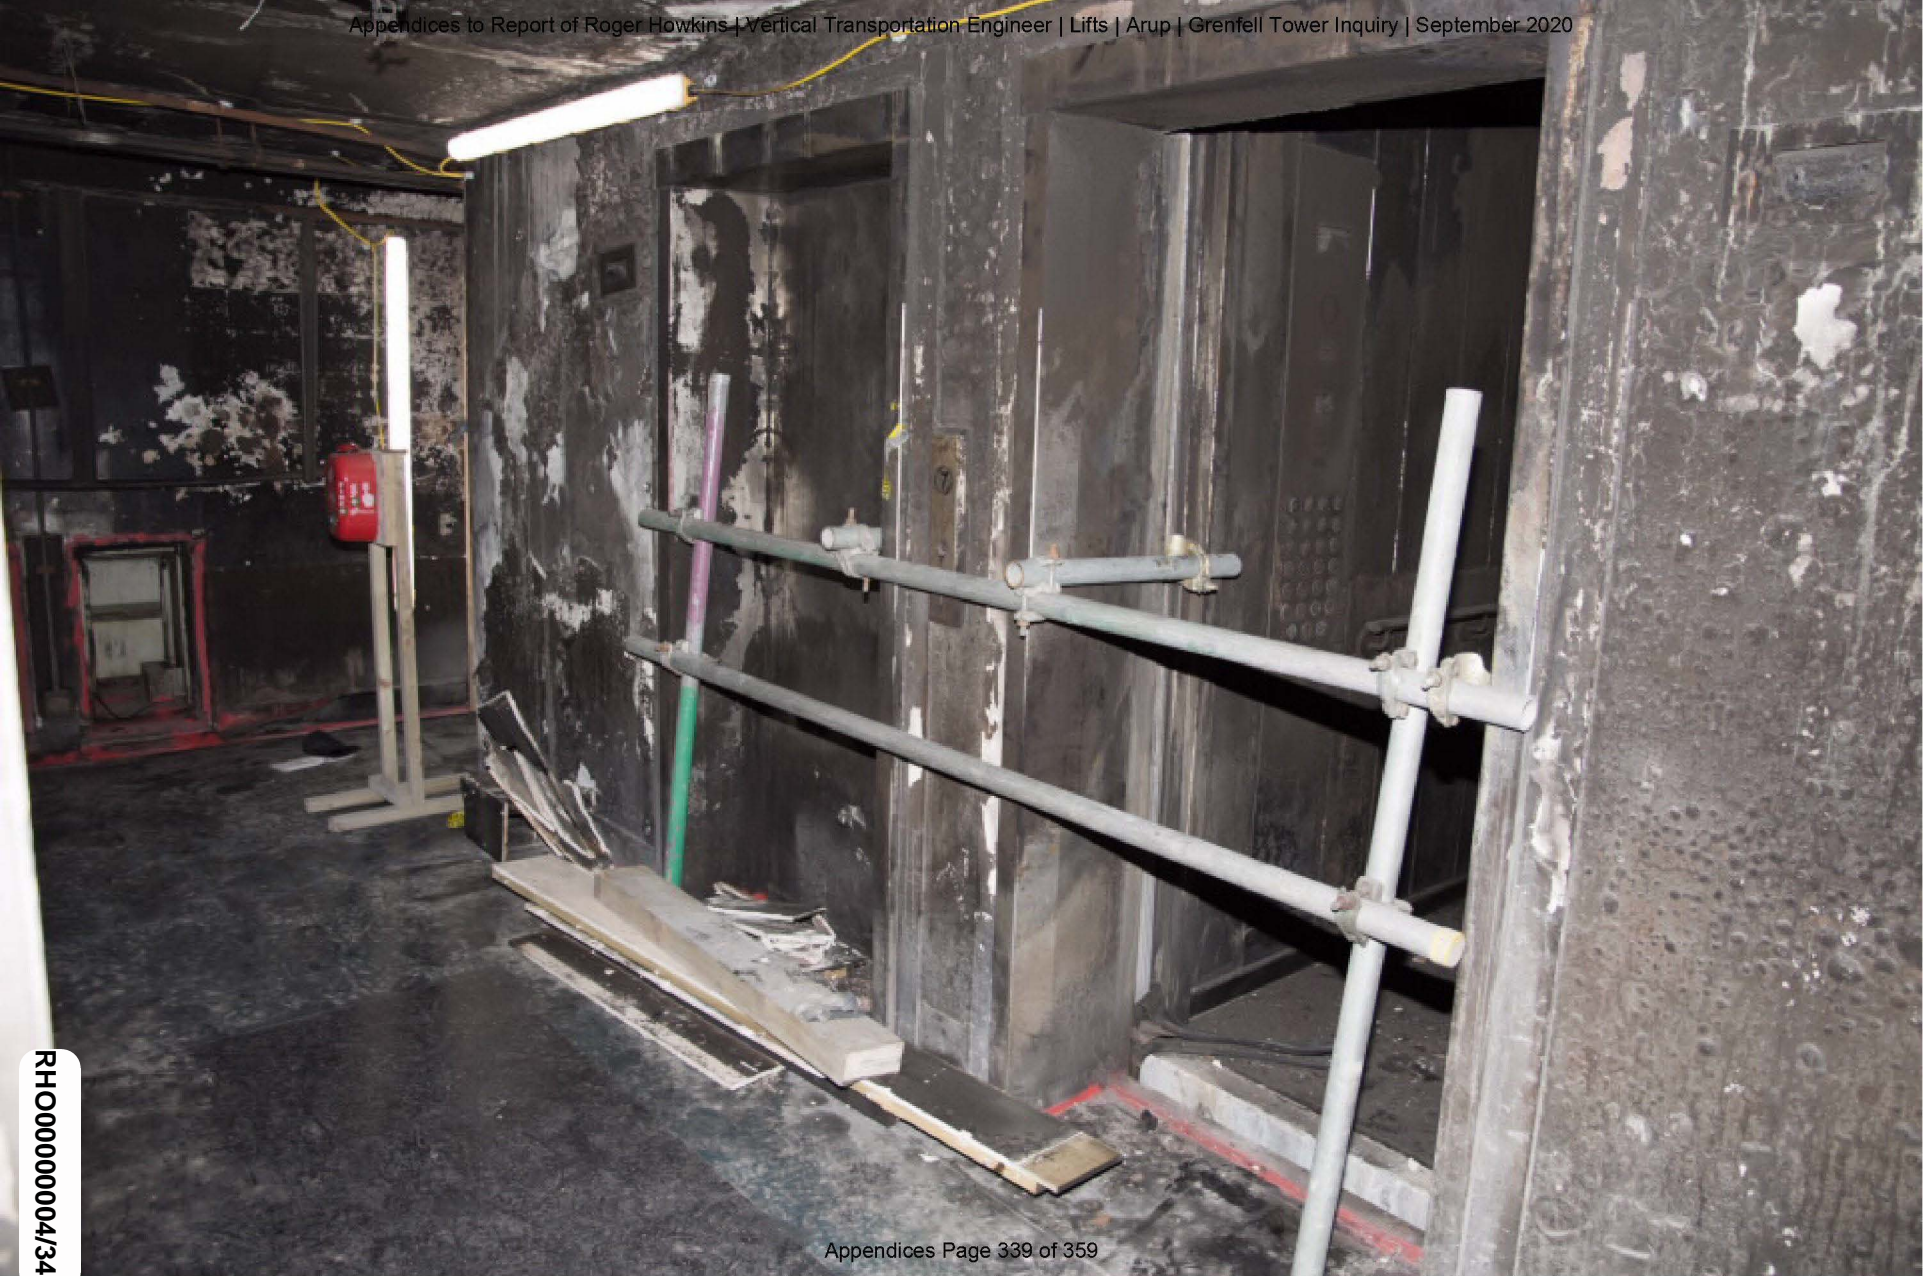
### **MET00065423 – Floor entrance**

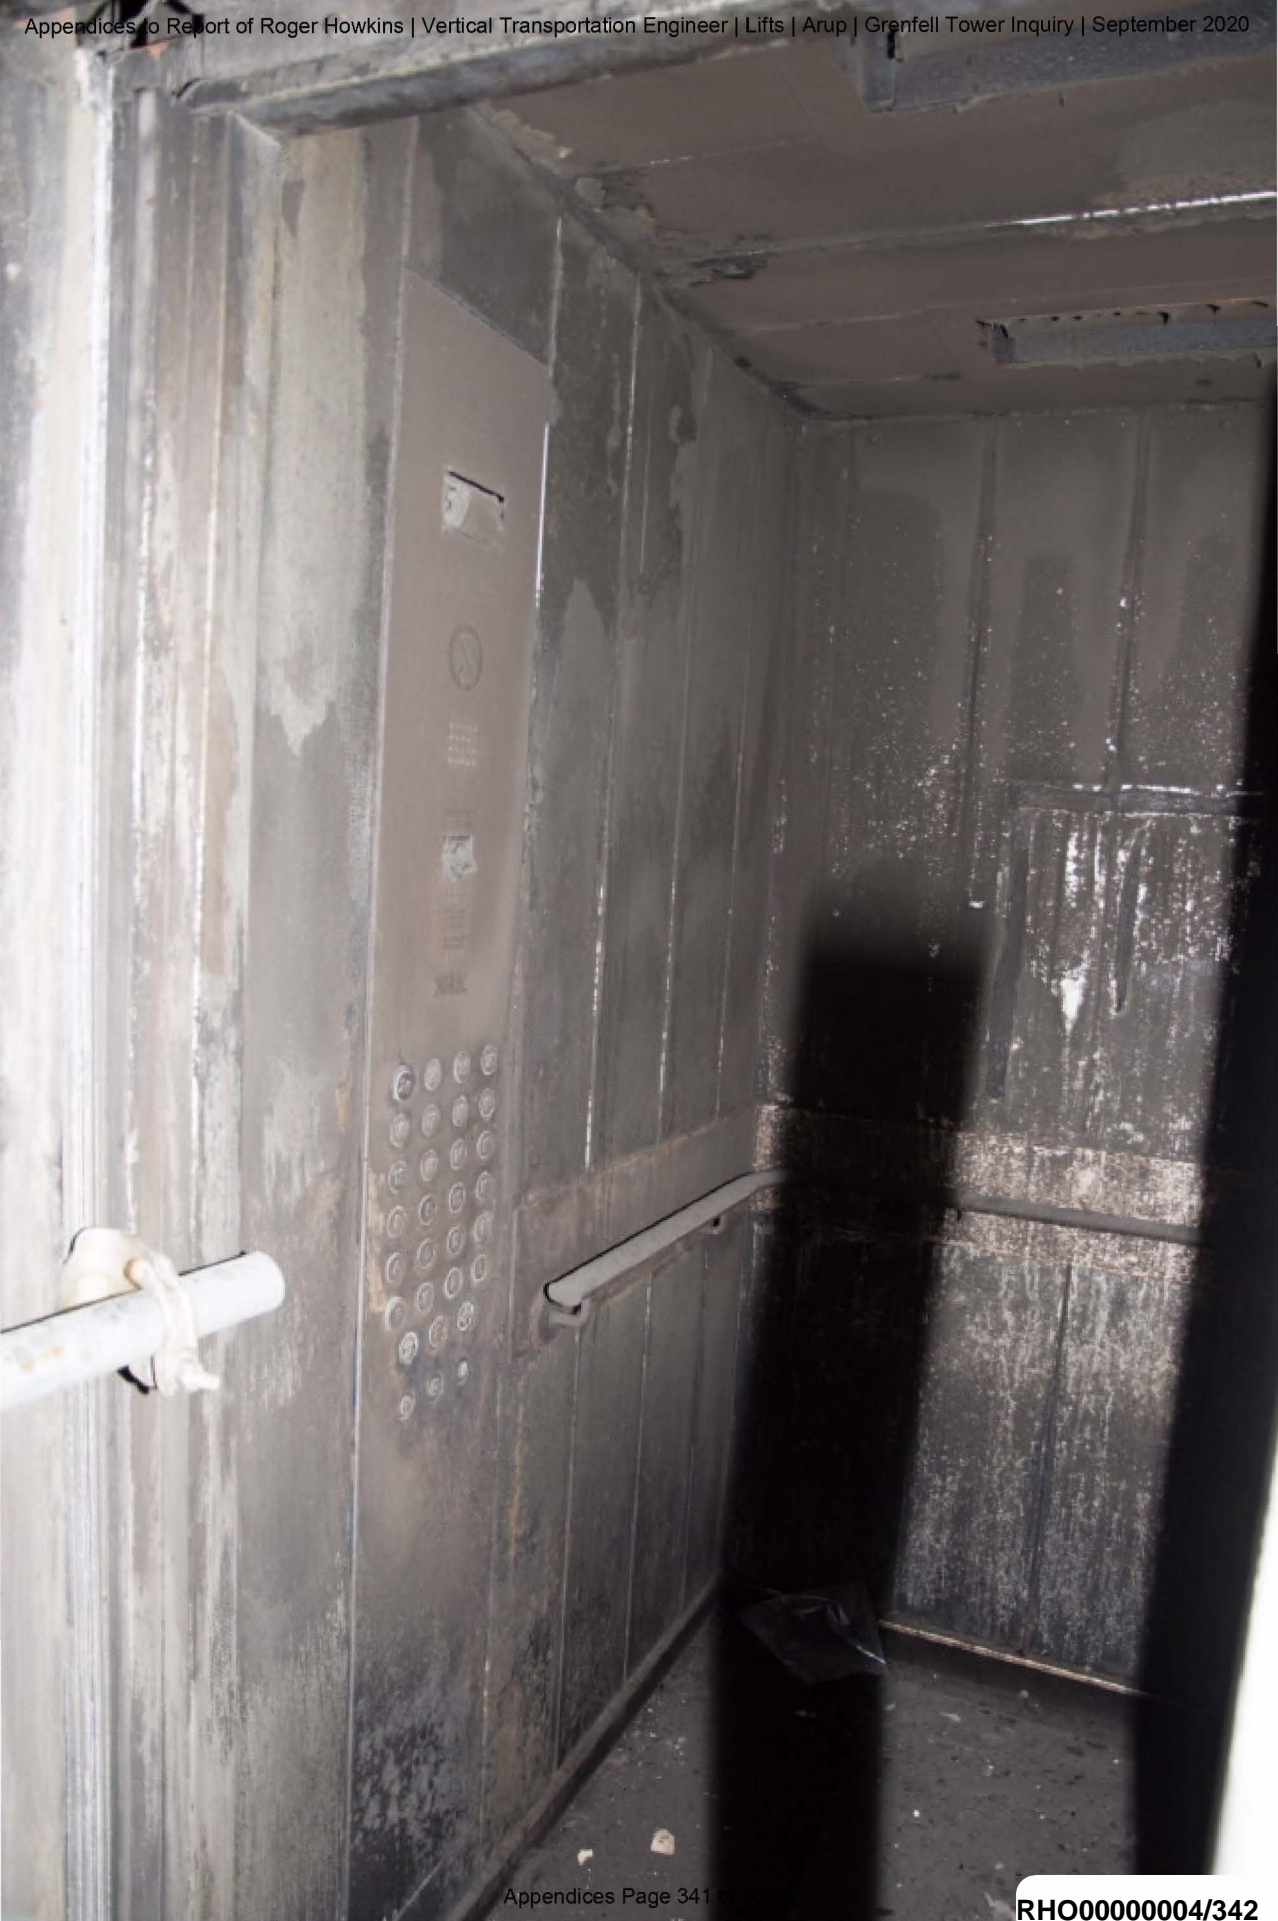
### **MET00065481 – Lift car interior showing car operating panel on left hand wall**

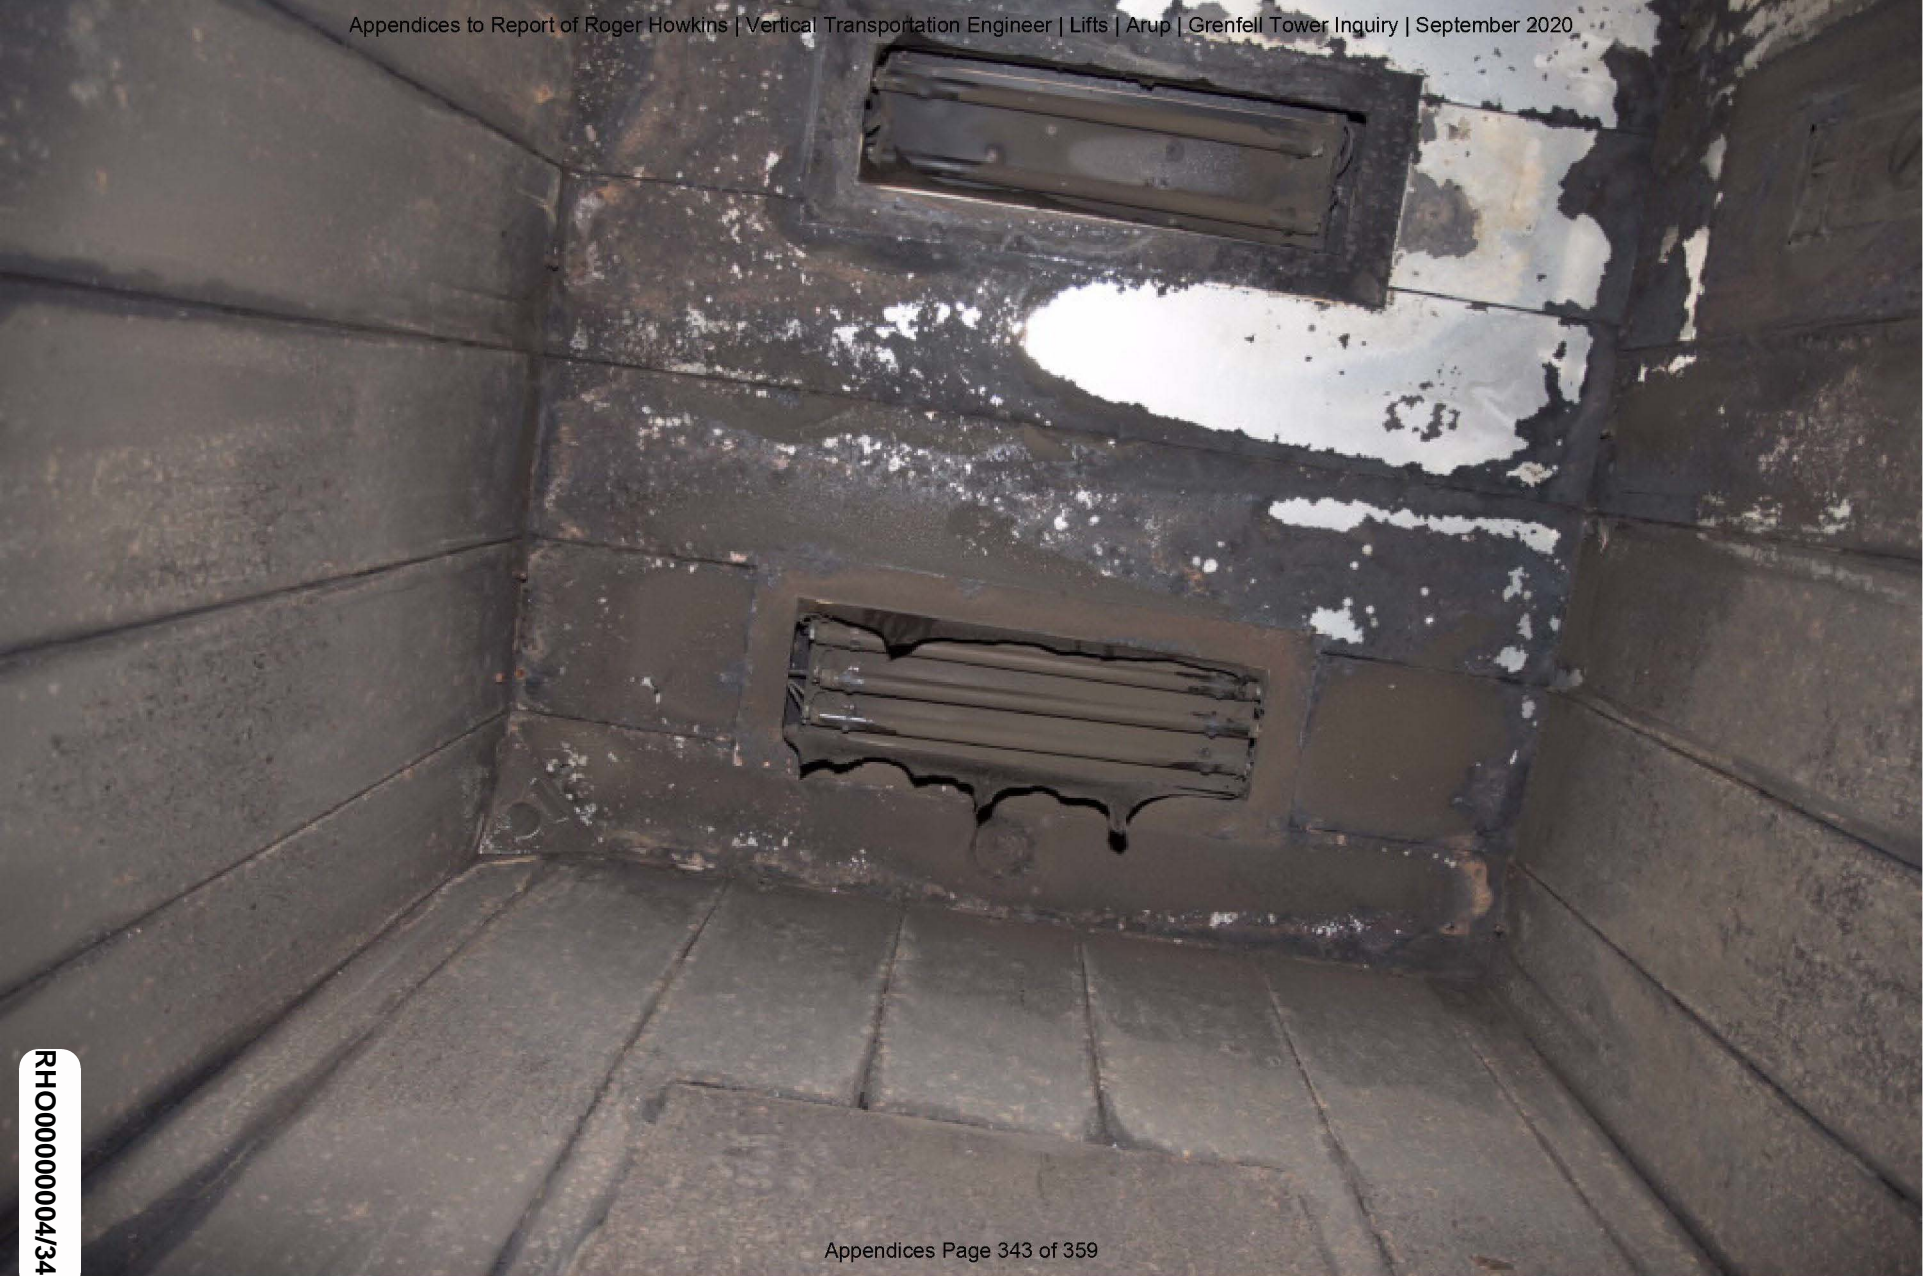
### **MET00065517 – Lift car ceiling**

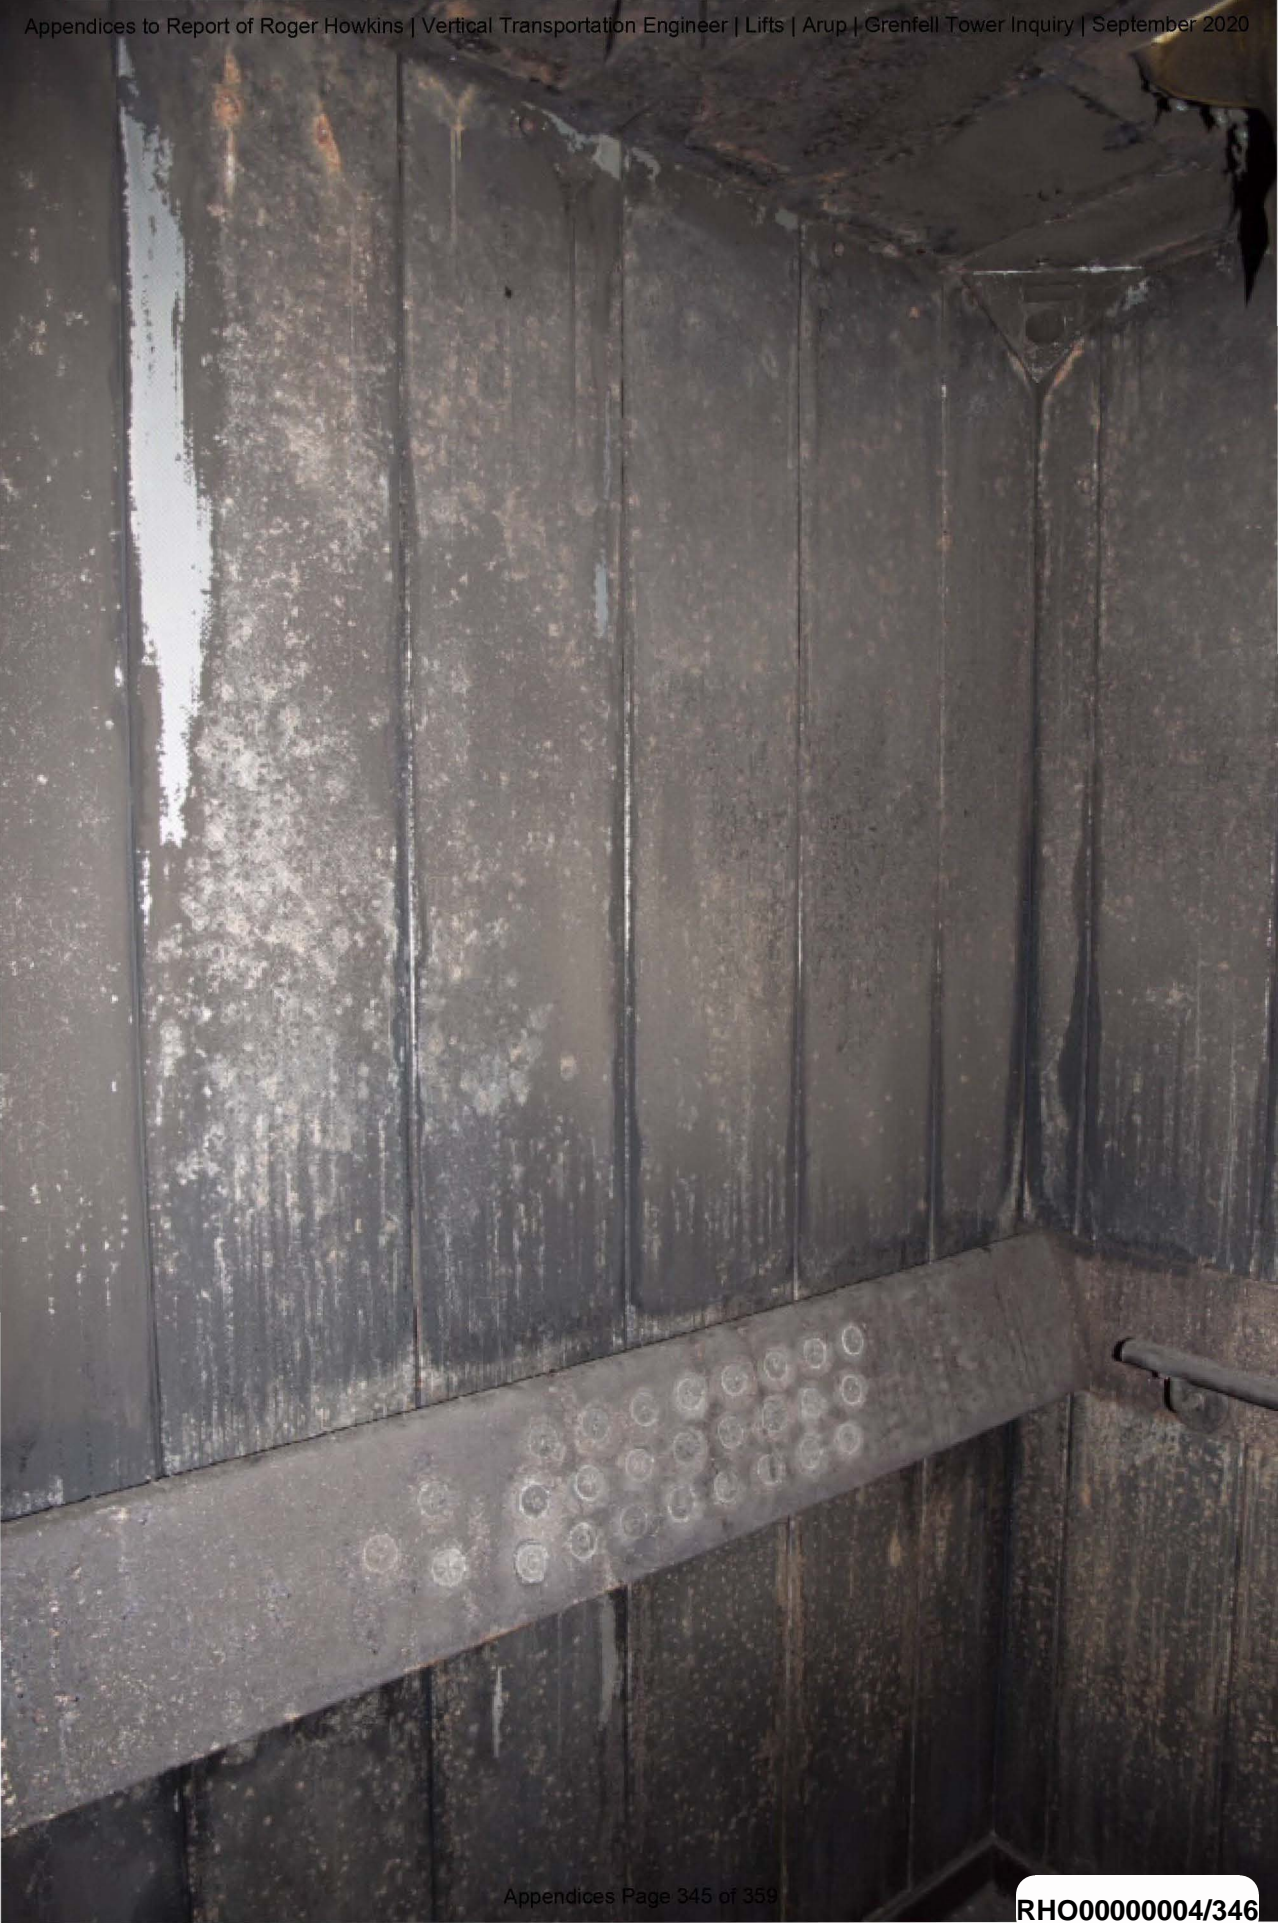
### **MET00065559 – Lift car interior with security camera**

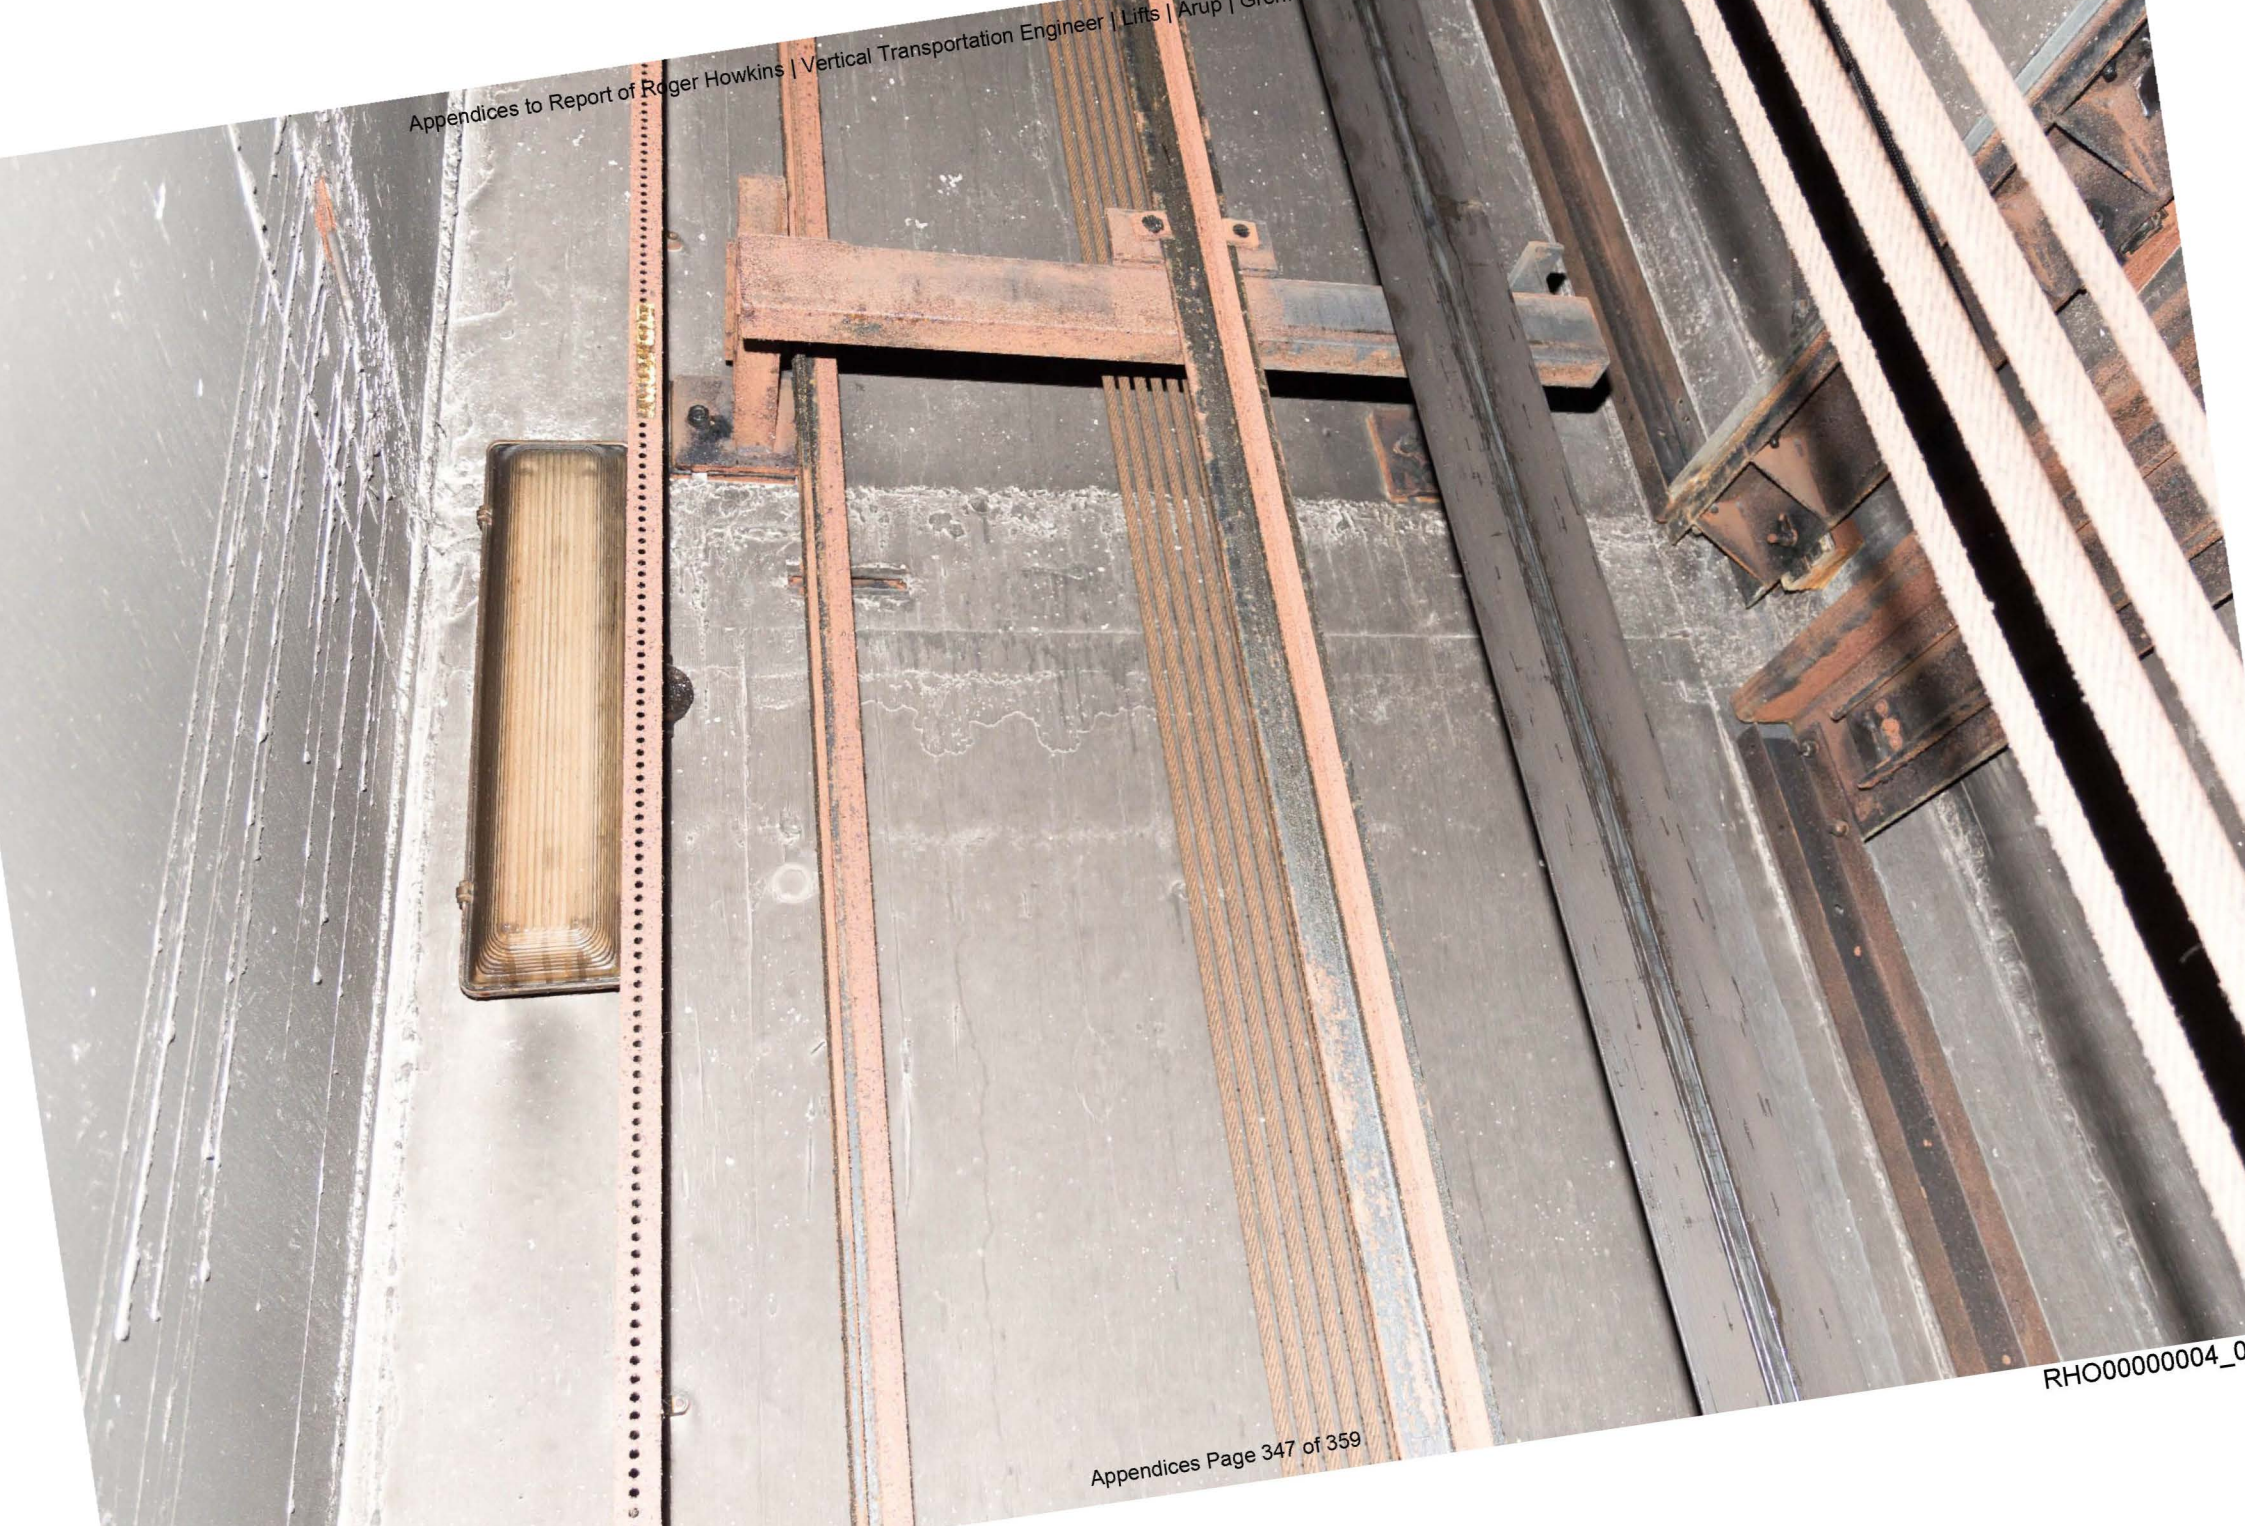
### **MET00065570 – Lift shaft and guide rails**
