## Appendices to the Report of Roger Howkins

### Vertical Transportation Engineer | Lifts | Arup

### Grenfell Tower Inquiry | September 2020

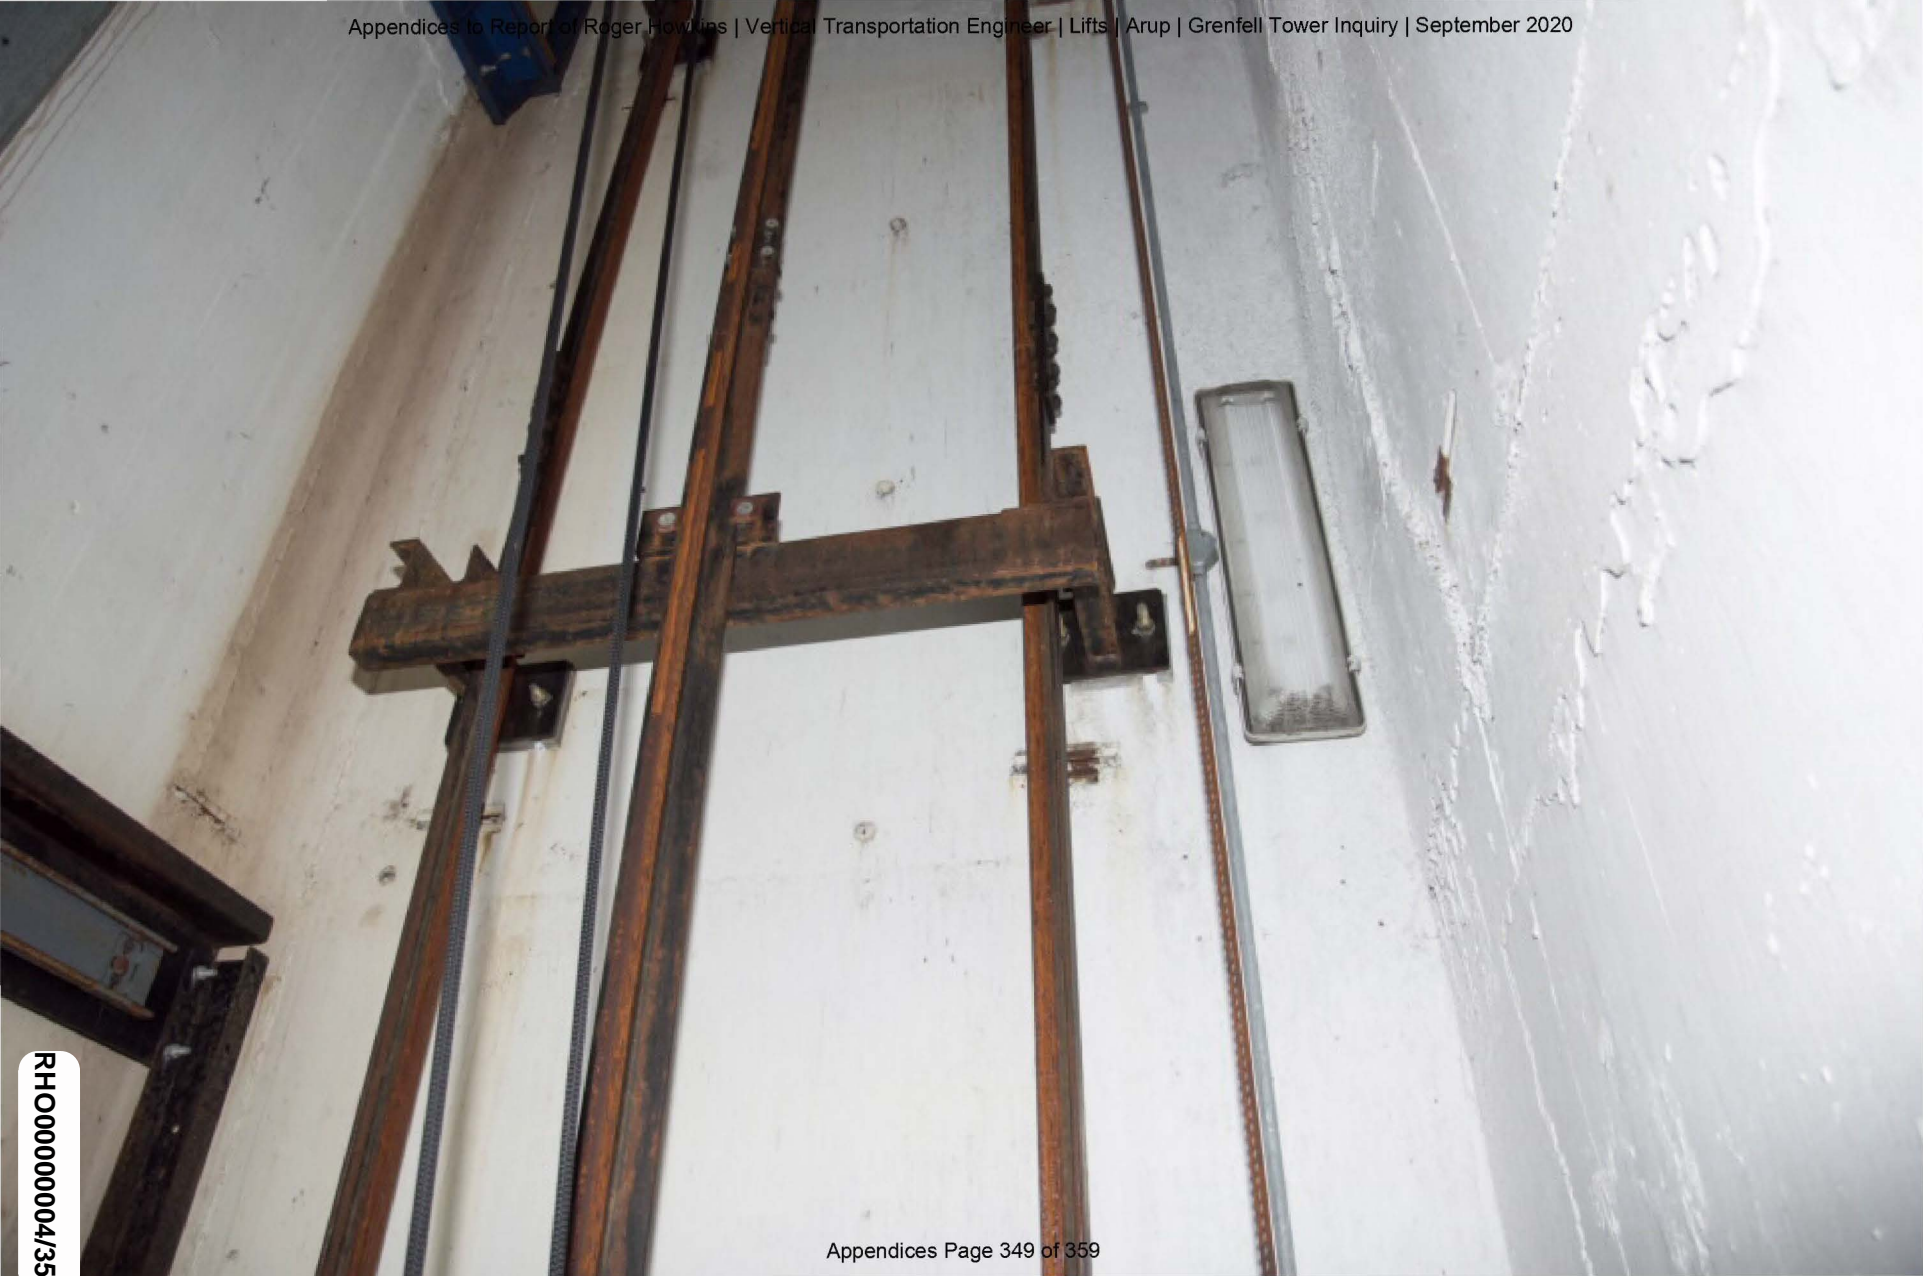
### **MET00065571 – Lift shaft and guide rails**
